Executive Committee Meeting

STAFF REPORT

Application # RV3-59/23

File RV3-5923, Proposed Armor Stone Retaining Wall & Landscaping, 6079 James
Bell, Manotick, ON

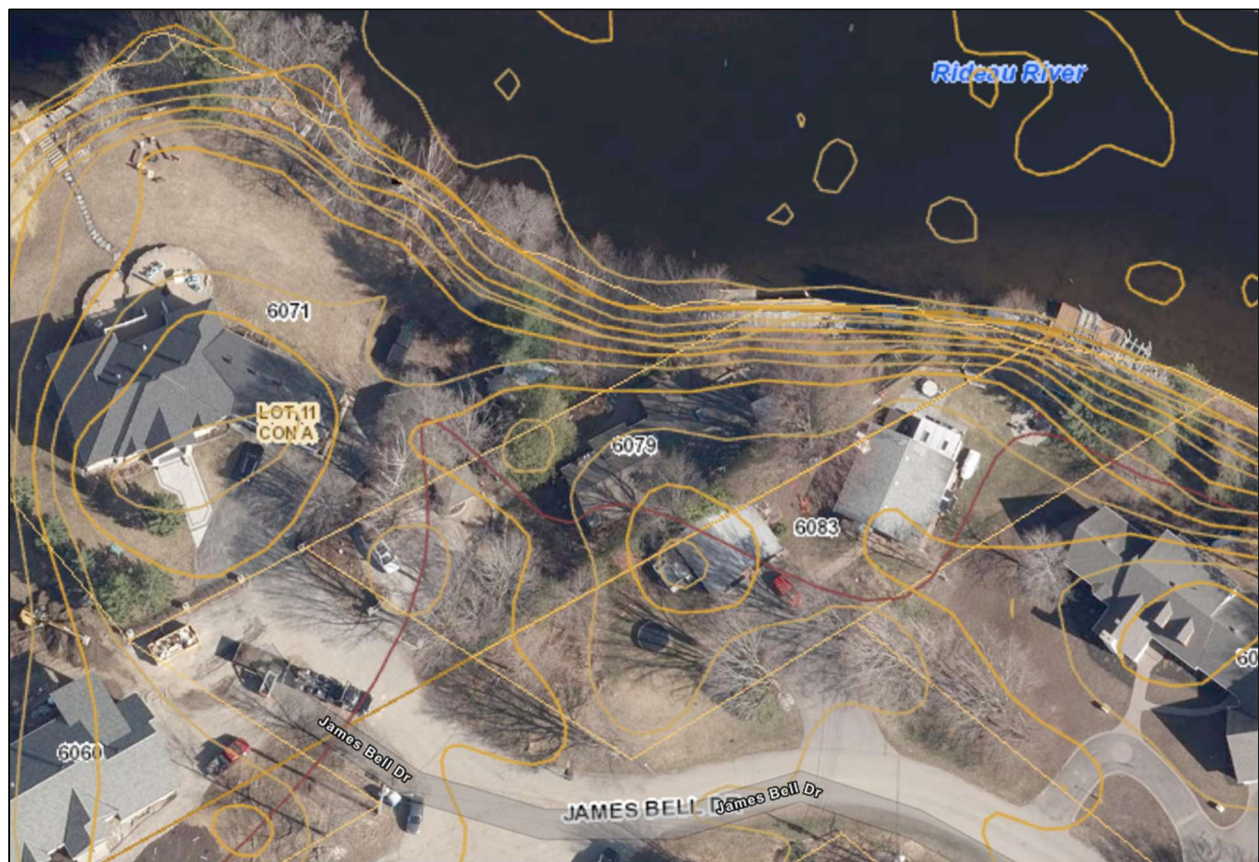
Figure 1. Site location.

The property is situated at 6079 James Bell Drive in Manotick, Ontario, on the southern side of Rideau River, with no setback from the river. The site is surrounded by similar single-family dwelling units on both sides, as shown in Figure 1. The site itself slopes towards the northeast, leading down to the river. There is already a dwelling present on the property, and we understand that the foundation was recently repaired.

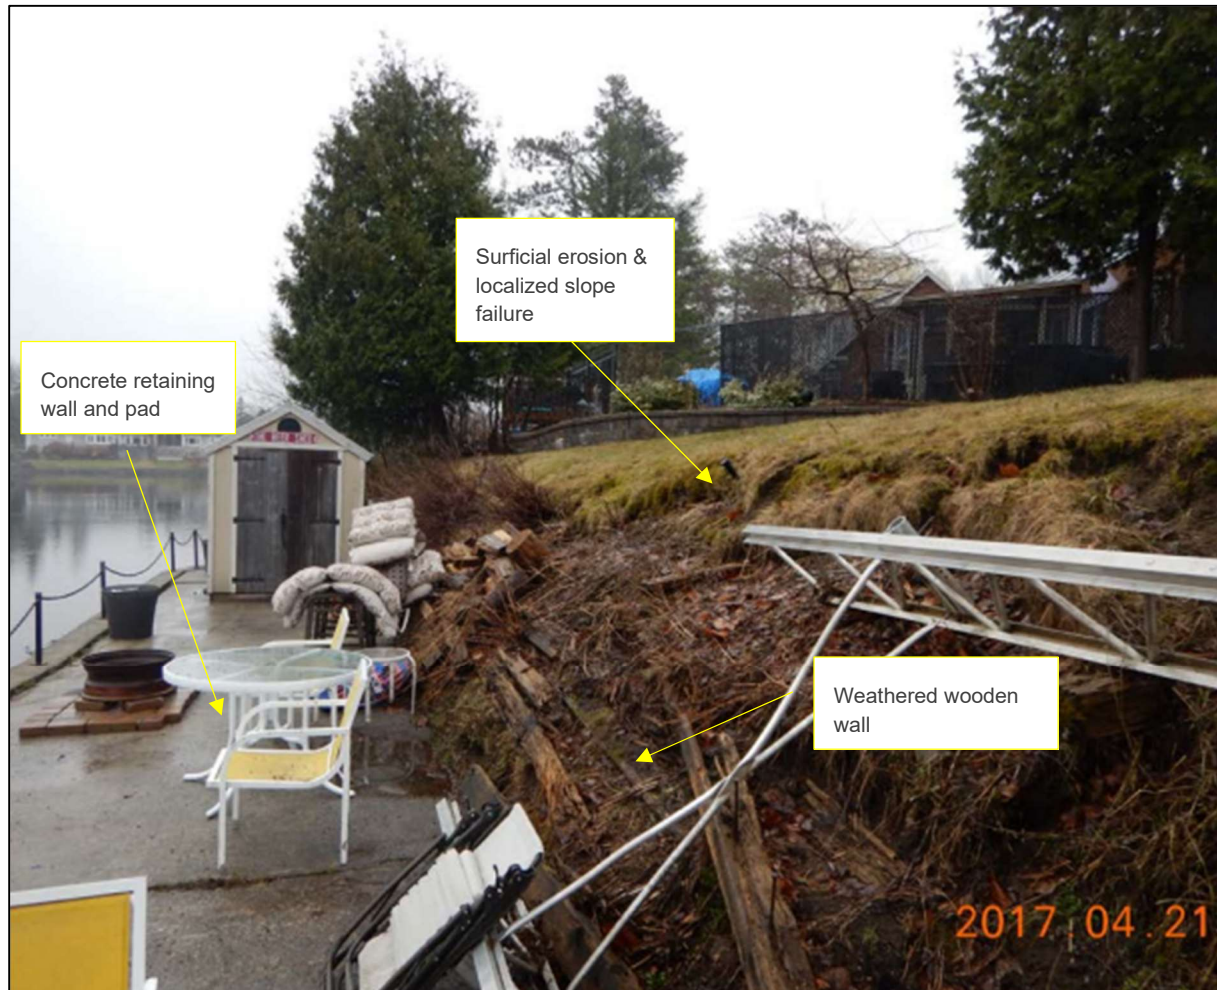
Figure 2. Site prior alteration (2017).

The shoreline slope has an overall height of about 4.5 m, with an inclination of 18 degrees. The shoreline has undergone significant alteration, however, we understand that a concrete retaining wall and pad are located at the base of the slope (see Figure 2).

From historic photos, it is evident that wooden retaining walls were previously integrated into the shoreline slope (refer to examples in Figure 2), along with some vegetation. However, the wooden retaining walls appear heavily weathered in past photos, with some sections even tilting. Additionally, minor surficial slope failure resulting from surficial erosion has been observed (Figure 2).

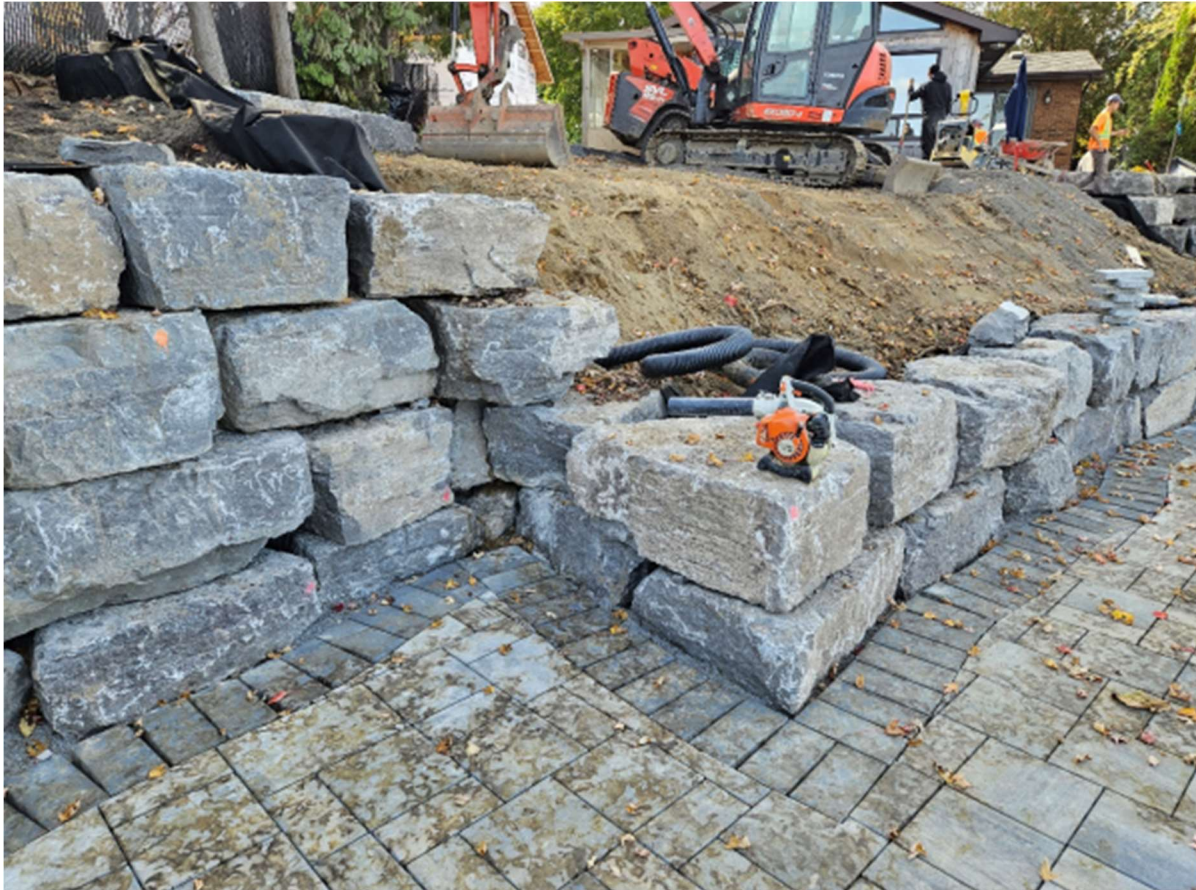
Figure 3. Armor stone retaining wall placed.

The armor stone wall is located above the concrete pad and vary in size between 2 to 4 block high.

Based on the available information provided and a review of local geotechnical conditions, we concluded based on our professional experience, that the slope in question does not require an armor wall for structural support. Several factors contribute to this assessment and are presented below:

Considering these factors, it appears that the retaining wall primarily serves a landscaping purpose, and its role in providing structural support to the slope is not necessary.

- More sustainable erosion mitigation techniques are feasible to be implemented at the site such as regrading, naturalization, or bio-engineering erosion mitigation techniques. These measures can help stabilize the slope and limit erosion risks without the need for a hardscape retaining wall.
 - Naturalizing the shoreline with appropriate vegetation can help control erosion and enhance the resilience of the slope.

- Bio-engineering techniques, such as using erosion control blankets or green retaining wall, can also be considered to mitigate erosion and promote slope stability (if required)
- Implementing and managing runoff water originating from the upper part of the slope, which appears to be the primary factor contributing to some of the surficial erosion observed damages.
- Implementing stormwater management techniques, such as installing permeable surfaces or rain gardens, can help capture and slow down runoff water, reducing its erosive potential. This would involve potentially reducing or revisiting the use of interlocked paver as this would increase the volume of runoff water originating from the top of the slope.
- The use of riparian buffers with appropriate native plants along the shoreline can help absorb and filter runoff water, preventing further erosion.
