# Bilberry Creek 2015 Summary Report

In 2015, 71 sections (7.1 km) of Bilberry Creek were surveyed as part of the City Stream Watch monitoring activities. Surveying in 2015 included both branches of the creek north of Innes Road. The following is a summary of observations made by staff and volunteers along those 71 sections.

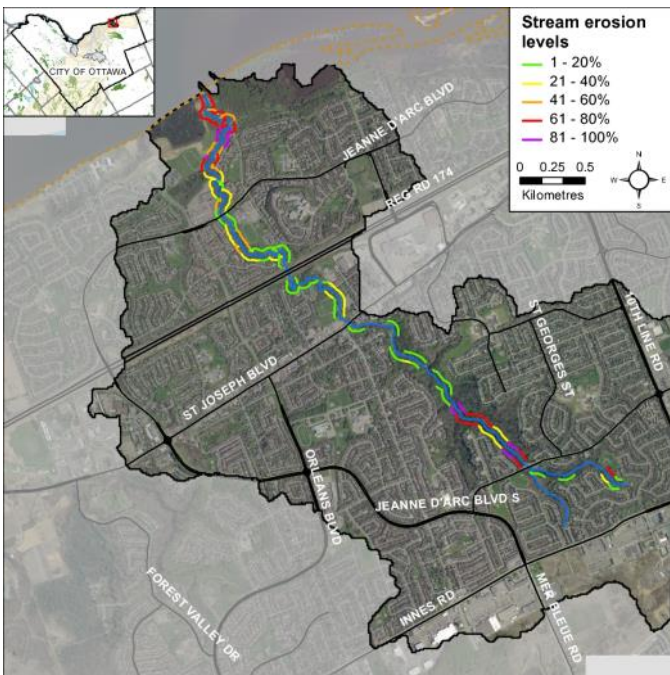
**Figure 4** Erosion along Bilberry Creek

Erosion is a normal, important stream process and may not affect actual bank stability; however, excessive erosion and deposition of sediment within a stream can have a detrimental effect on important fish and wildlife habitat. Poor bank stability can greatly contribute to the amount of sediment carried in a waterbody as well as loss of bank vegetation due to bank failure, resulting in trees falling into the stream and the potential to impact instream migration. Figure 4 shows that moderate levels of bank erosion were observed along most sections of Bilberry Creek. Very high active levels of erosion were observed from the mouth of the creek to just downstream of Jeanne D'Arc Boulevard as well as downstream of Des Epinettes Avenue in the south end of the creek.

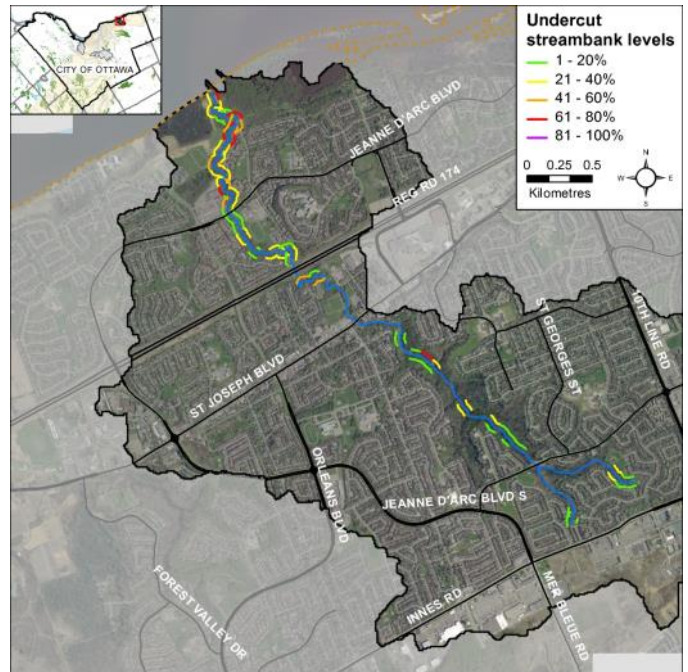
**Figure 5** Undercut stream banks along Bilberry Creek

Undercut banks are a normal and natural part of stream function and can provide excellent refuge areas for fish. Figure 5 shows that the bank undercutting on Bilberry Creek varied considerably. Much of the creek upstream of highway 174 had no bank undercutting interspersed with areas of low level undercutting. There were however, many sections with moderate and high levels of undercutting downstream of highway 174. The bank and substrate composition in this area is dominated by clay, and high levels of erosion were also observed so it is likely that the bank undercutting in this area is leading to bank failure over time.

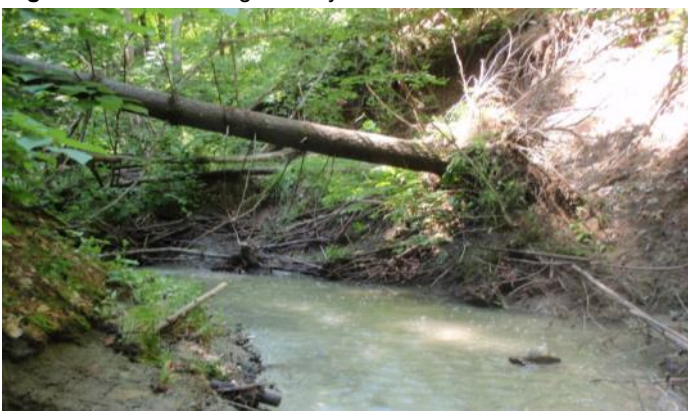
Active stream bank erosion on Bilberry Creek

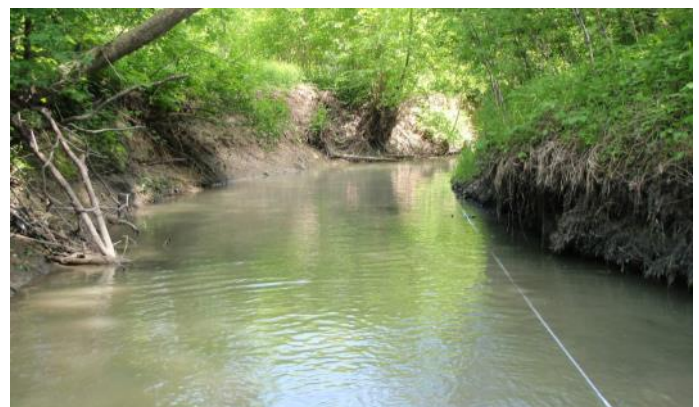
Bank undercutting on the right bank and erosion on the left bank of Bilberry Creek

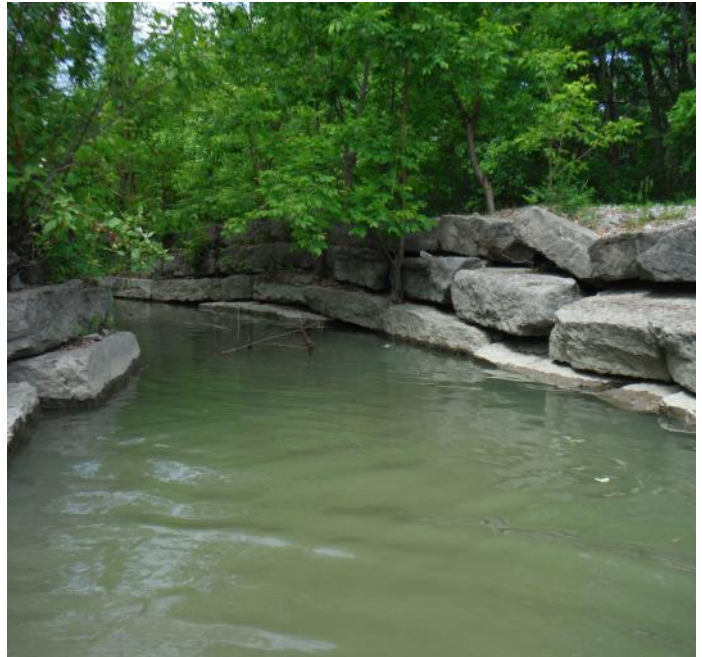
A highly altered section of Bilberry Creek which is channelized and reinforced by armour stone

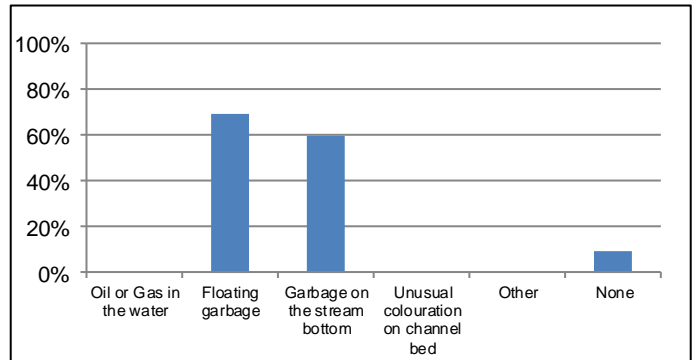
**Figure 21** Pollution observed along Bilberry Creek

Figure 21 demonstrates the incidence of pollution/garbage in Bilberry Creek. Only nine percent of the sections surveyed on Bilberry Creek did not have any observable garbage. Sixty nine percent had floating garbage, and 60 percent had garbage on the stream bottom. Many of the sections where garbage was observed had a combination of both floating garbage and garbage on the stream bottom.

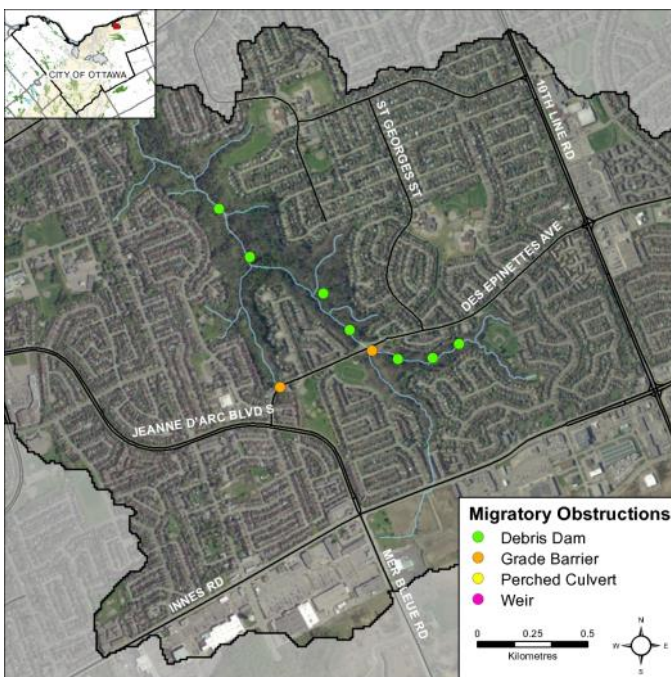
**Figure 29** Bilberry Creek migratory obstructions

It is important to know locations of migratory obstructions because these can prevent fish from accessing important spawning and rearing habitat. Migratory obstructions can be natural or manmade, and they can be permanent or seasonal. Figure 29 shows that along Bilberry Creek, multiple debris dams and two grade barriers were observed in the southern portion of the creek upstream of St. Joseph Blvd. The debris dams observed were the result of high levels of erosion in this area causing trees and debris to fall into the creek. The culverts located along Des Epinettes Avenue were both classified as grade barriers.

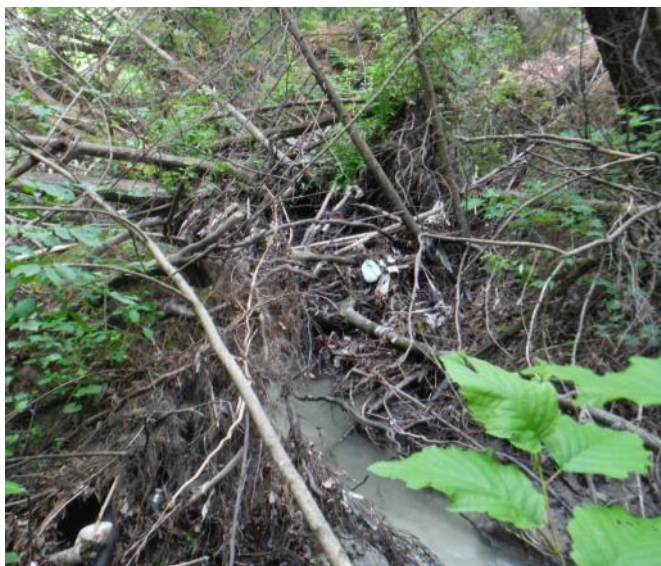
A debris dam observed along Bilberry Creek

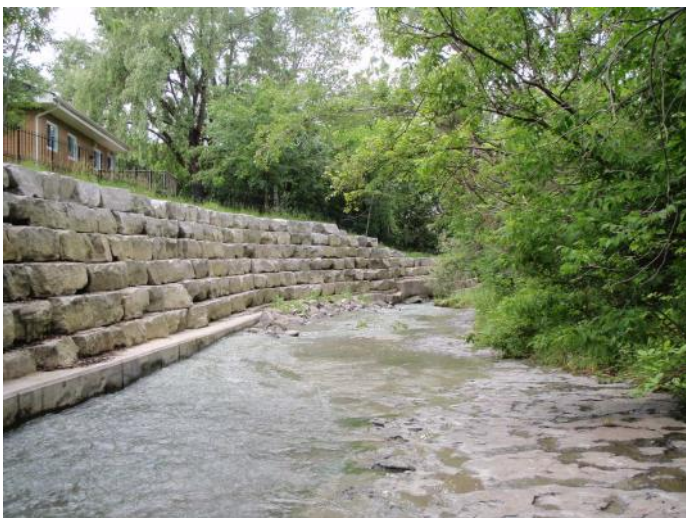
An highly altered section of Bilberry Creek

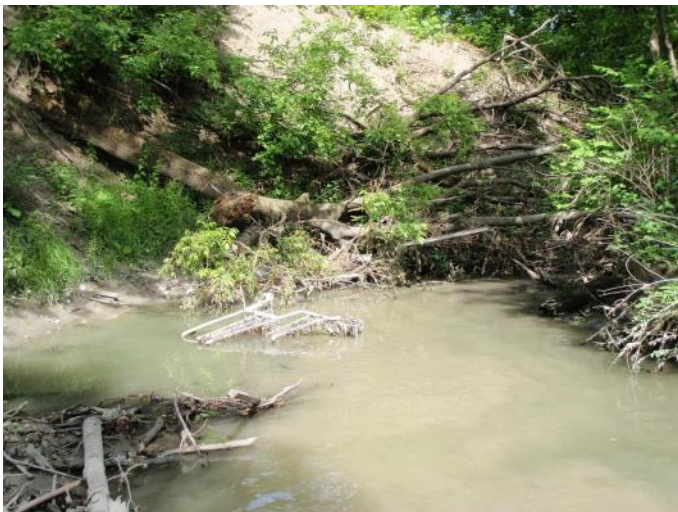
A shopping cart found in Bilberry Creek

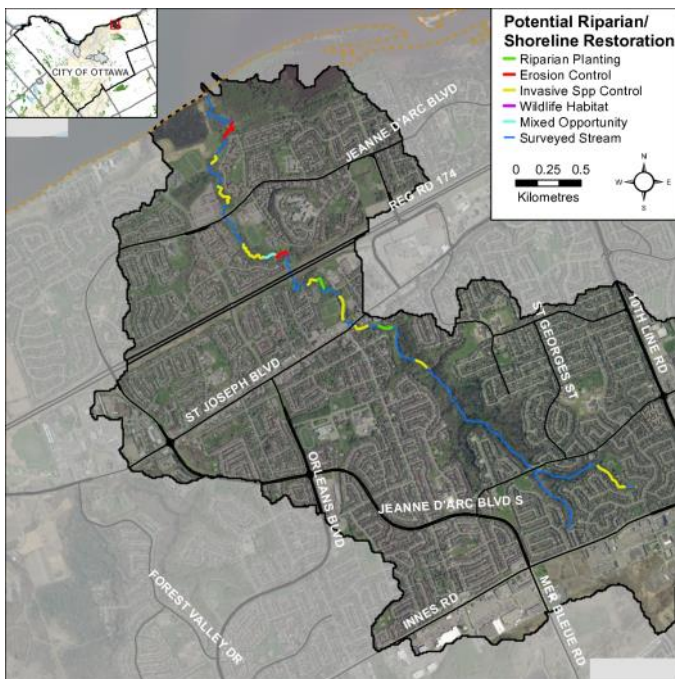
**Figure 40** Potential riparian/shoreline restoration opportunities

The majority of the opportunities listed were invasive species control riparian planting and erosion control. The areas highlighted for invasive species control were where the species Himalayan balsam was observed. The areas highlighted for erosion control were downstream of highway 174 and downstream of Bilberry Drive towards the mouth of the creek.

Figure 40 depicts the locations where City Stream Watch staff and volunteers observed areas where the riparian zone could be restored or enhanced using one or more of the following techniques: riparian planting, erosion control, invasive species control and wildlife habitat creation.

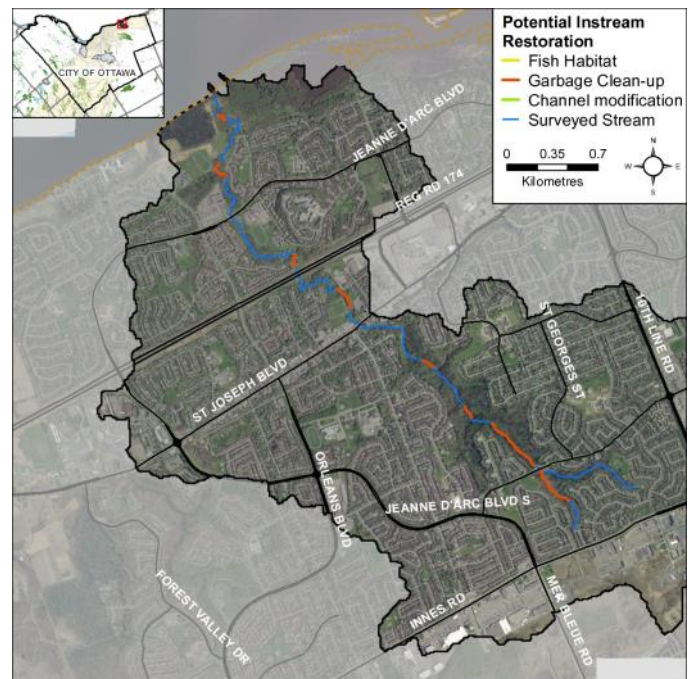
**Figure 41** Potential instream restoration opportunities

All of the opportunities listed for Bilberry Creek were stream garbage cleanups. Most of the garbage noted throughout the creek appeared to be washed downstream through the system where it collects on woody debris.

Figure 41 depicts the locations where City Stream Watch staff and volunteers made note of areas where there were one or more of the following instream restoration opportunities: fish habitat enhancement, garbage cleanup and channel modification.

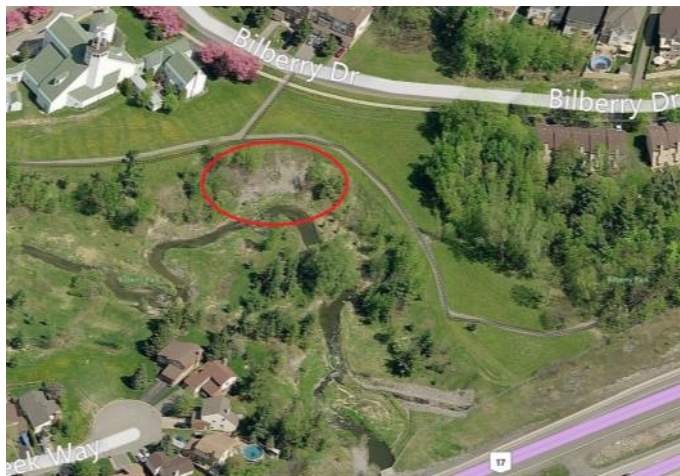
Erosion control opportunity along Bilberry Creek downstream of Highway 174

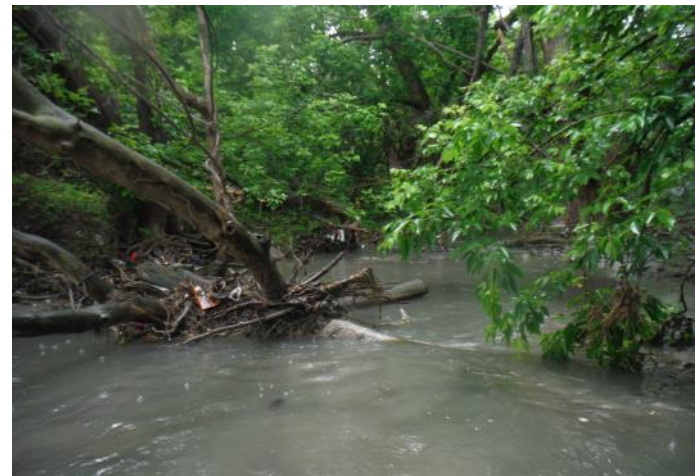
Garbage caught on woody debris in Bilberry Creek
