Bilberry Creek 2023 Catchment Report

Introduction

Bilberry Creek was previously surveyed in 2015 under the City Stream Watch program. In 2023, 71 sections (7.1km) were surveyed as a part of the City Stream Watch monitoring activities. The following is a summary of observations made by staff and volunteers along those 71 sections.

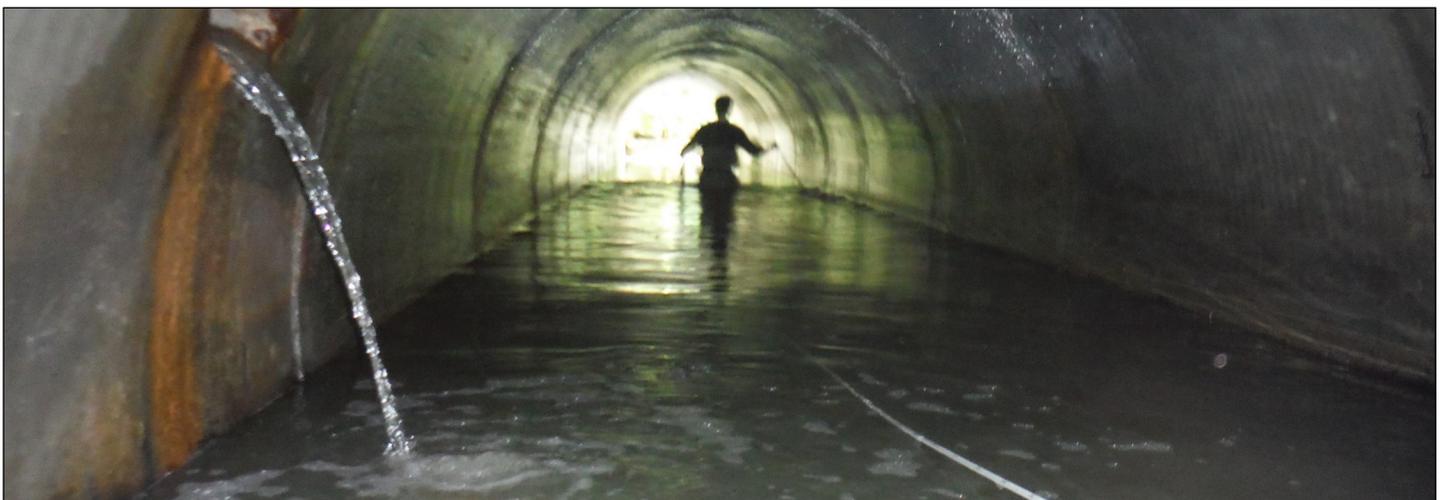
Stormwater outlet in culvert underneath St. Joseph Blvd

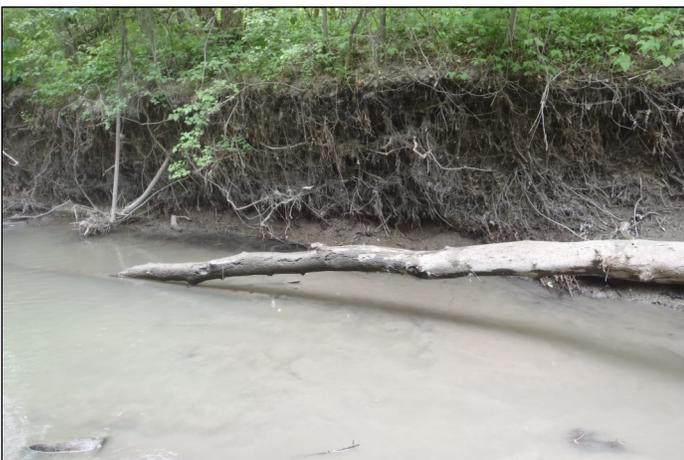
Bank erosion along Bilberry Creek near Bilberry Drive

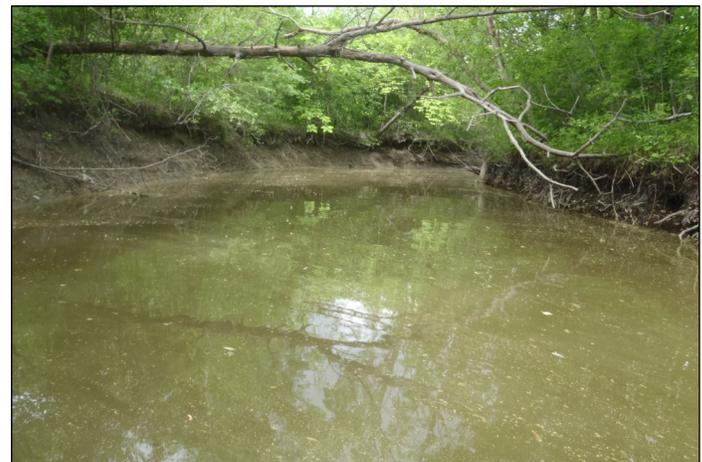
Undercut banks 400m upstream of the mouth of Bilberry Creek

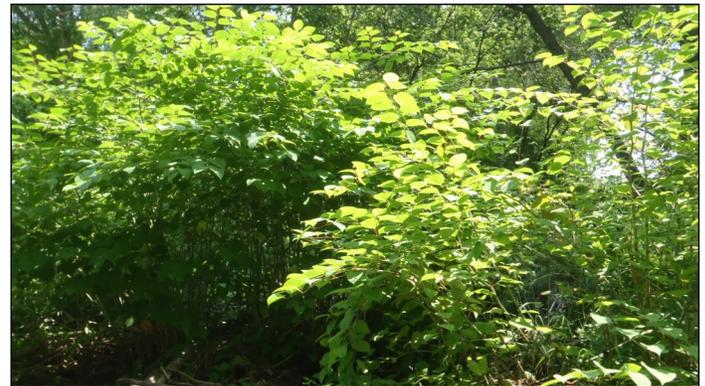
Invasive Japanese observed along surveyed portions of Bilberry Creek

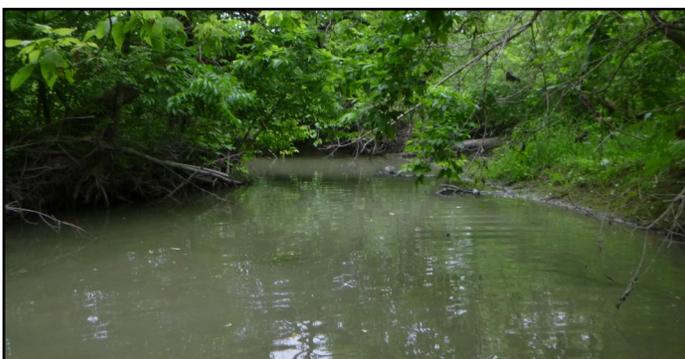
Section on Bilberry Creek downstream of Jeanne D'Arc Blvd with **impaired** oxygen conditions (Dissolved oxygen levels of 3.75 mg/L and 38.7 % saturation)

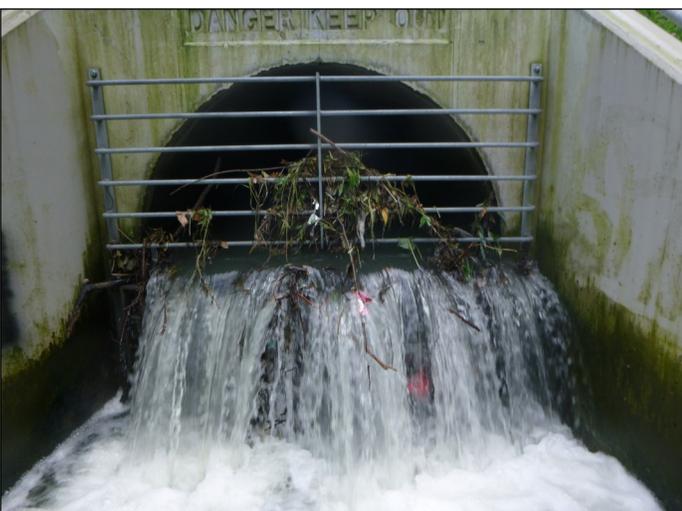
Perched culverts create fish migratory obstructions and loss of aquatic habitat and seasonal grounds for many fish species

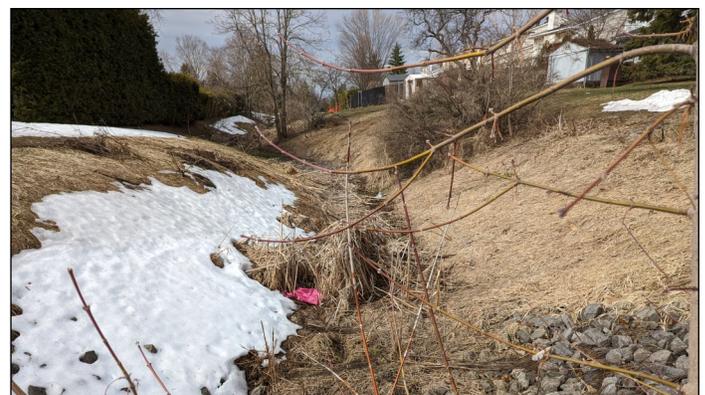
Channelized headwater drainage feature that flows through a neighborhood west of Orleans Blvd

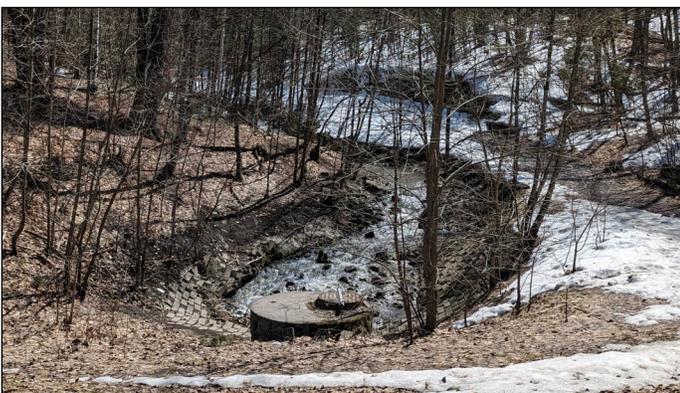
Substantial sediment deposition observed in a headwater drainage feature on Des Epinettes Ave

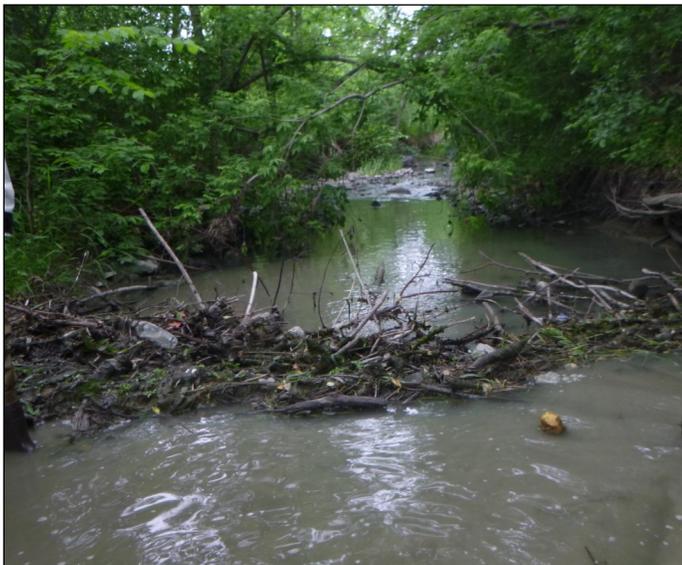
Pollution such as plastics accumulating on a beaver dam upstream of Jeanne D'Arc Blvd.
