Taylor Creek 2018 Catchment Report

In 2018, the City Stream Watch program surveyed fourteen 100 meter sections of Taylor Creek. Four sites were sampled for fish community composition.

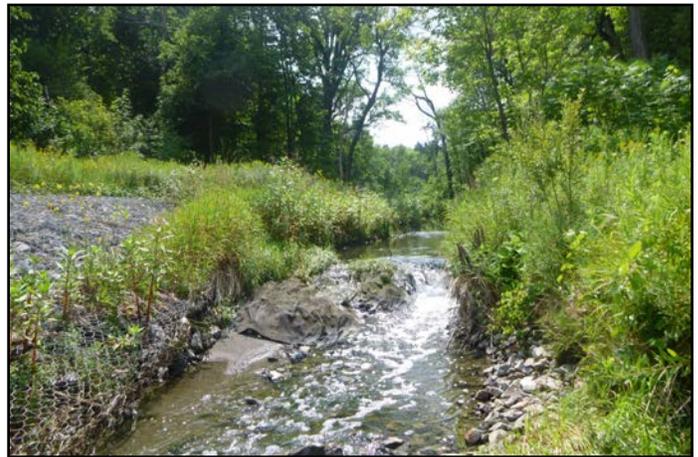
Taylor Creek riparian zones have primarily natural vegetative communities; alterations are associated with channel straightening and infrastructure, including roadways, and pedestrian pathway crossings.

Gabion baskets altering the left bank of Taylor Creek

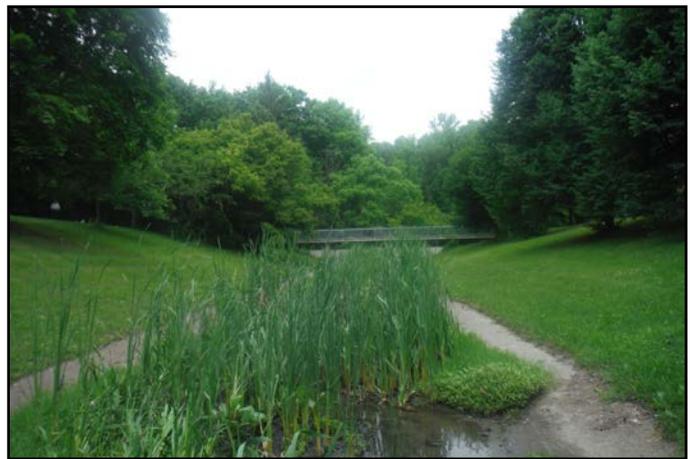
Highly altered sections account for 29 percent of surveyed sections. These sections pass through culverts, have multiple storm water outlets are straightened and a riparian buffer less than 5 meters.

A highly altered section in the upper reaches of Taylor Creek

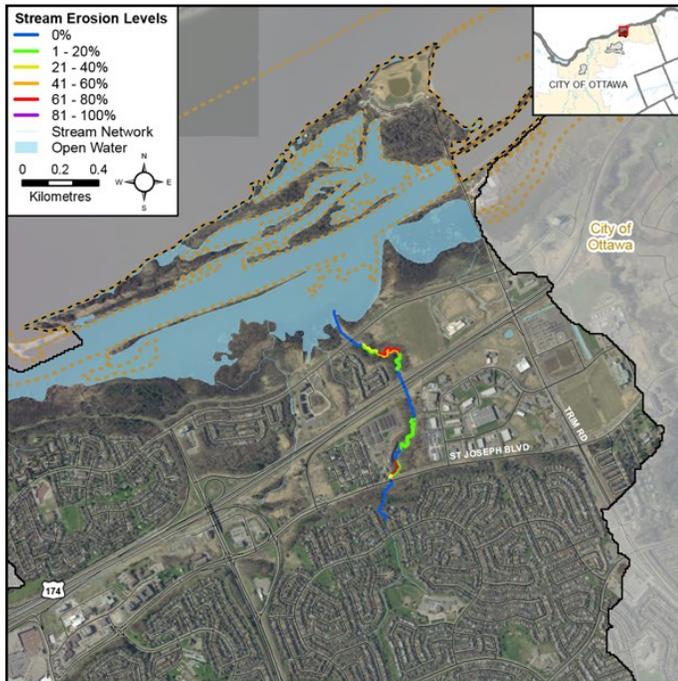
Figure 6 Erosion levels along Taylor Creek

Erosion was observed in 50 percent of the surveyed portions of Taylor Creek. The majority of these sections showed low levels of erosion. Higher levels of erosion were observed downstream of Highway 174 and downstream of Princess Louise Falls at St. Joseph Blvd.

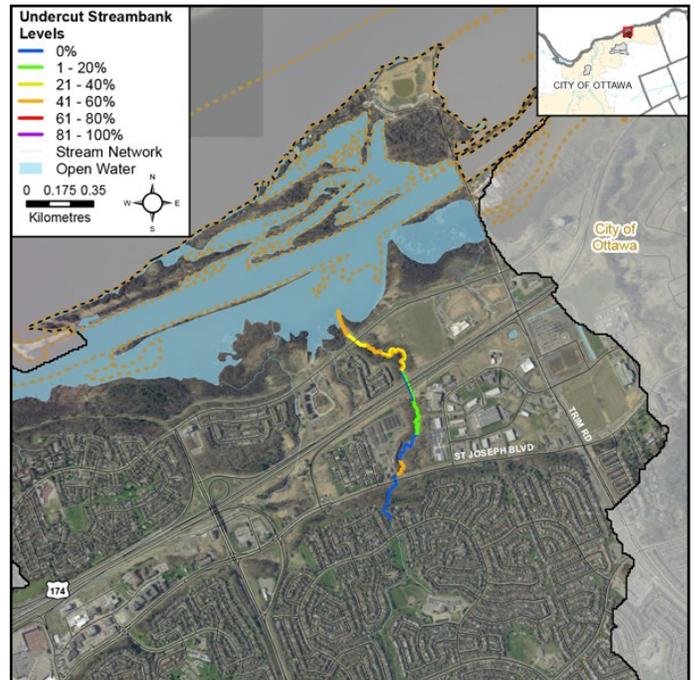
Figure 7 Undercut stream banks along Taylor Creek

Figure 7 shows that undercut banks were present in over half of the sections surveyed in Taylor Creek. Sixty-four percent of the sections had undercutting in the left bank and 57 percent of the right bank.

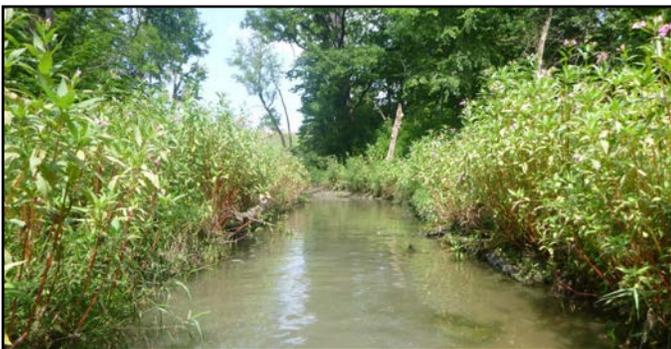
Himalayan balsam found along Taylor Creek

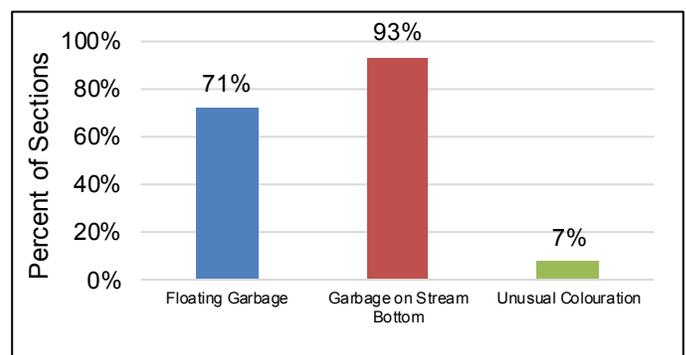
Figure 21 Pollution observed along Taylor Creek

Figure 21 shows the types of pollution observed in Taylor Creek. The levels of garbage found in the main portion of the stream were high, with 93 percent of sections containing garbage on the stream bottom and 71 percent of sections containing floating garbage. Seven percent of the sections surveyed had unusual coloration.

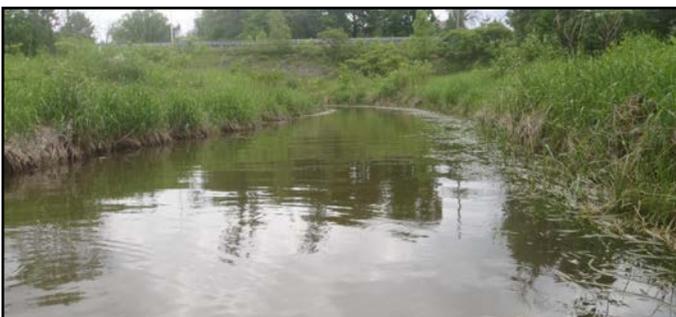
Site on Taylor Creek with **impaired** oxygen conditions (Dissolved oxygen levels of 4.75 mg/L and 53.1% saturation)

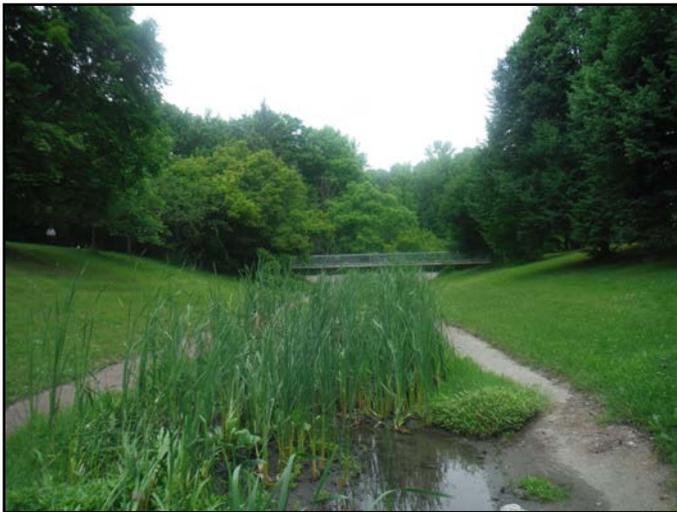
Figure 26 shows relative specific conductivity levels in Taylor Creek. Normal levels were maintained for most of the surveyed portions. Moderately elevated conditions were observed upstream of the waterfall where there is high levels of input from stormwater. Highly elevated conditions were present in the upper reaches of the creek, directly downstream of a stormwater outlet that feeds the creek.

Section of Taylor Creek near Princess Louise Drive with highly elevated levels of specific conductivity

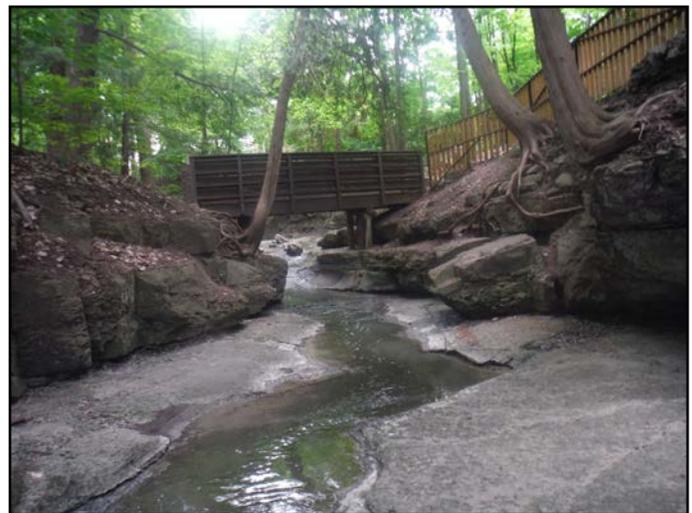
Section of Taylor Creek upstream of Princess Louise Falls with moderately elevated levels of specific conductivity

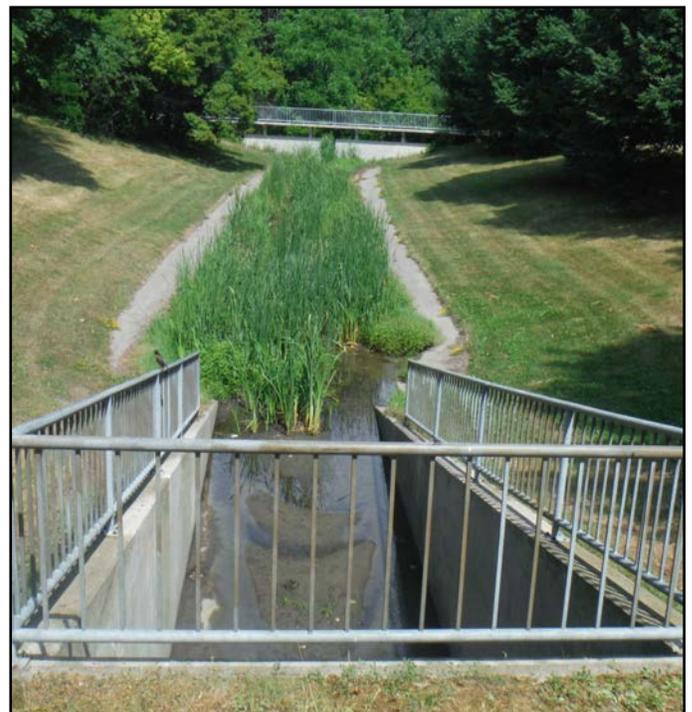
Stormwater outlet flow that passes through weir before flowing downstream towards the Princess Louise Falls

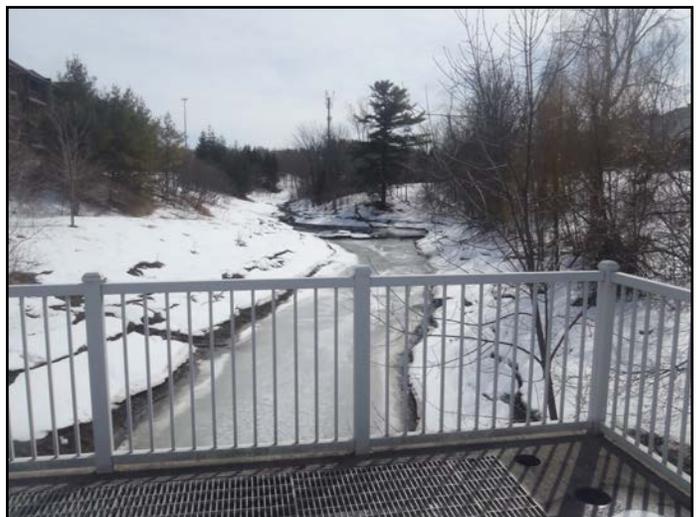
An example of mixed modifications: channel hardening and an online pond. Observed off of Jeanne D'Arc Boulevard

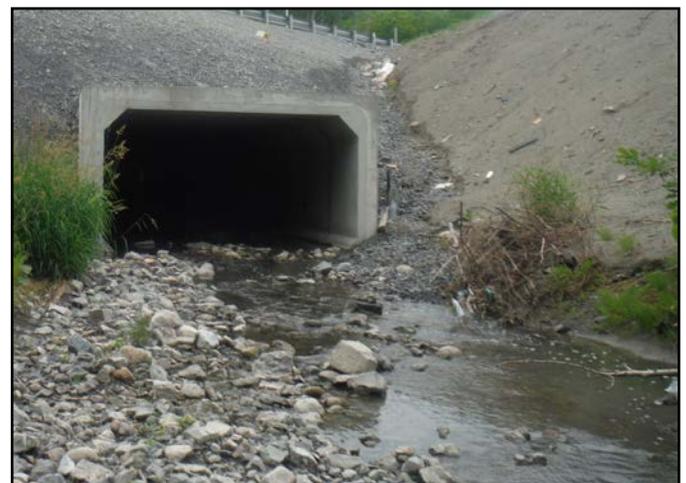
Area with garbage observed downstream of St. Joseph Boulevard that could benefit from a cleanup
