# Hunt Club Creek 2019 Catchment Report

## Introduction

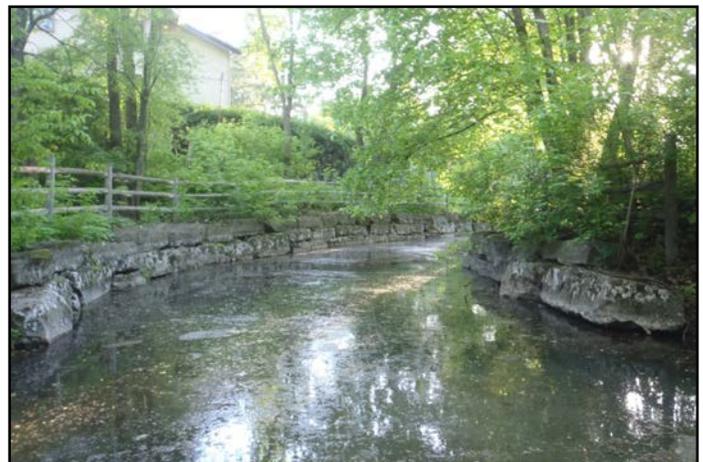
A highly altered section with channelization, reduced riparian buffers and armourstone on the shoreline of Hunt Club Creek east of Riverside Drive

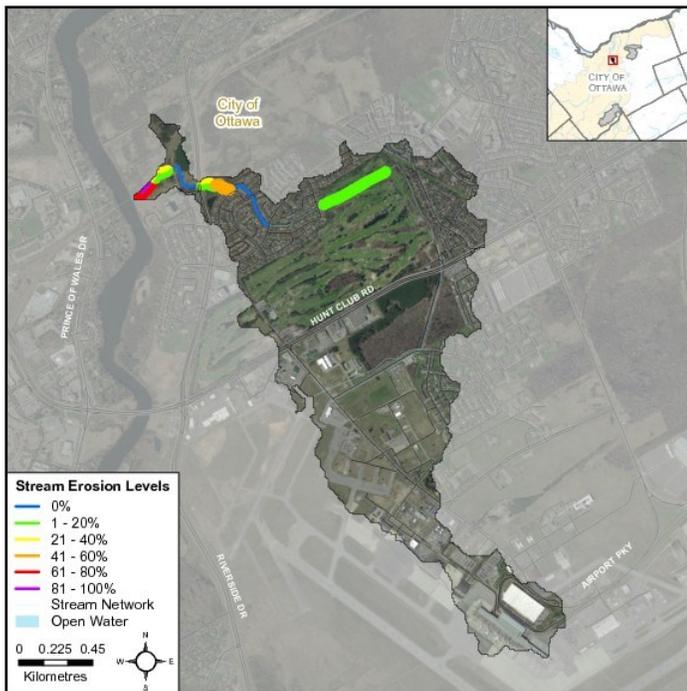
Figure 6 Erosion levels along Hunt Club Creek

Stream erosion is the process by which water erodes and transports sediments, resulting in dynamic flows and diverse habitat conditions. Excessive erosion can result in drastic environmental changes, as habitat conditions, water quality and aquatic life are all negatively affected. Bank stability was assessed as the extent of each section with “unstable” shoreline conditions. These conditions are defined by the presence of significant exposed soils/roots, minimal bank vegetation, severe undercutting, slumping or scour and potential failed erosion measures (rip rap, gabion baskets, etc.). Figure 6 shows significant erosion was observed across the surveyed portions of the creek. Bank instability was observed in 56 percent each of the left and right banks of the sections surveyed.

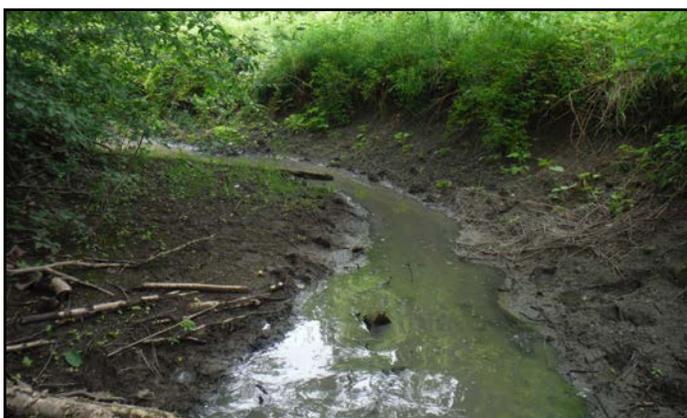
Bank erosion along Hunt Club Creek east of Riverside Drive

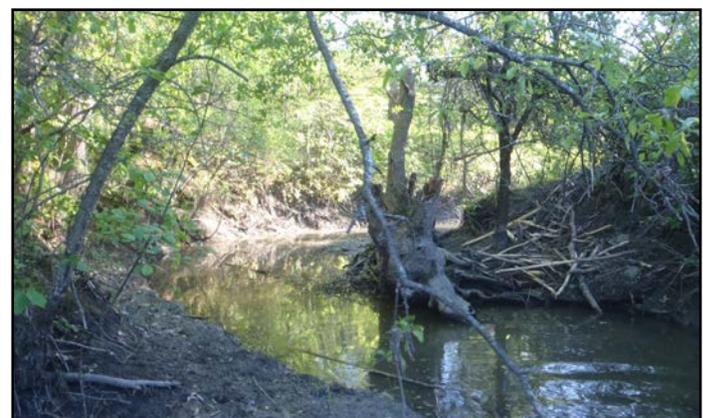
Undercut banks along Hunt Club Creek east of Riverside Drive

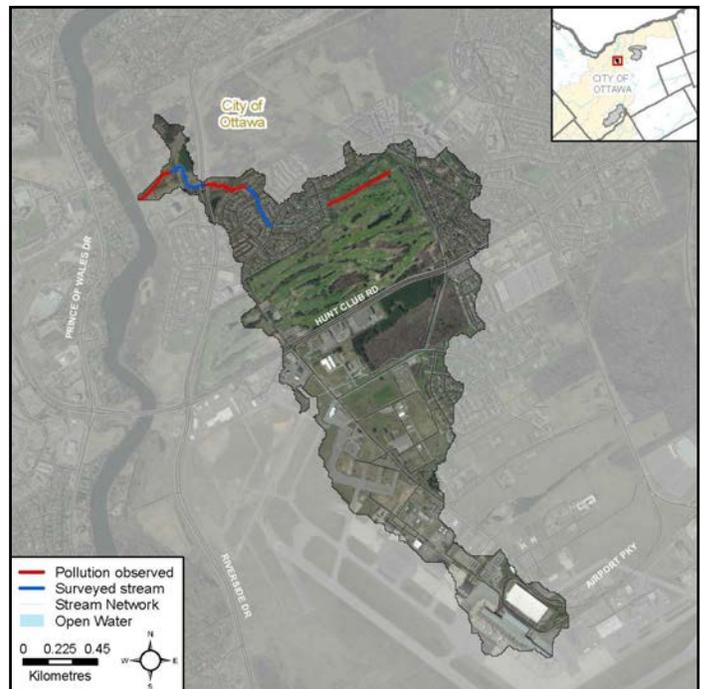
**Figure 21** Pollution observed along Hunt Club Creek

Figure 21 shows where pollution was observed along Hunt Club Creek. Garbage on the stream bottom was found in 50 percent of sections; floating garbage was observed in six percent; and oil or gas trails were observed in one section. The types of garbage observed included tires, cans, drink bottles, plastic bags, small plastic fragments, tarps, metal furniture and a bicycle.

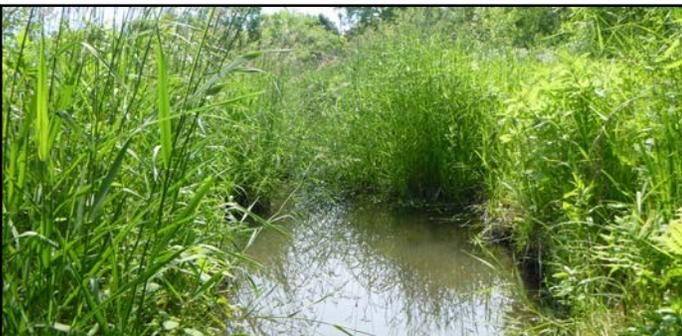
Section on Hunt Club Creek downstream of Riverside Drive with **impaired** oxygen conditions (Dissolved oxygen levels of 5.88 mg/L and 62.3 % saturation)

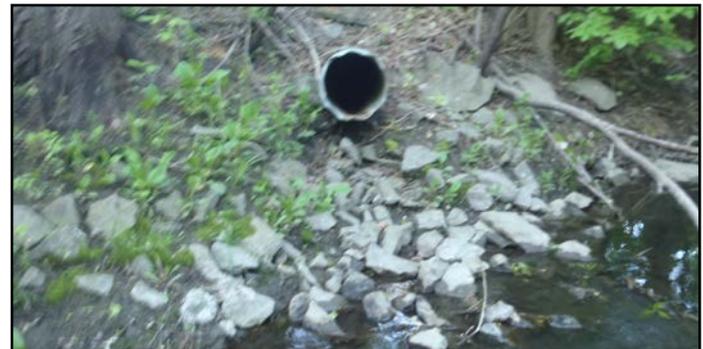
Section of Hunt Club Creek where unmitigated stormwater input elevates conductivity levels near Uplands Drive (above) and the stormwater pond outlets onto the creek upstream of Riverside Drive (below) lowering conductivity levels

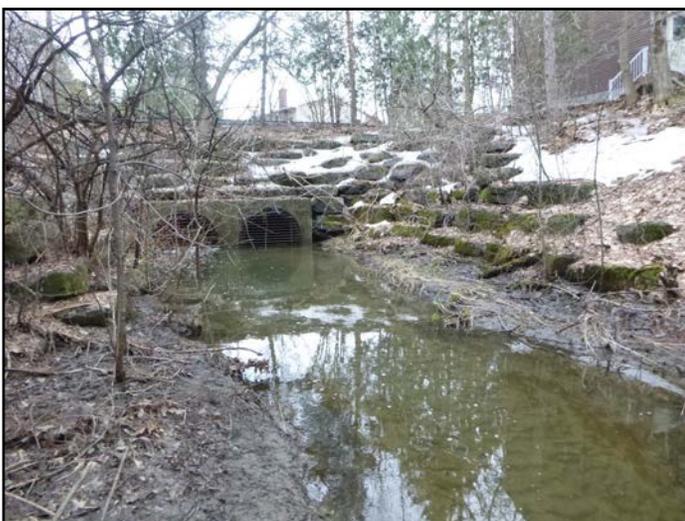
Piped section of Hunt Club Creek that opens up at Uplands Road with moderately elevated conductivity levels

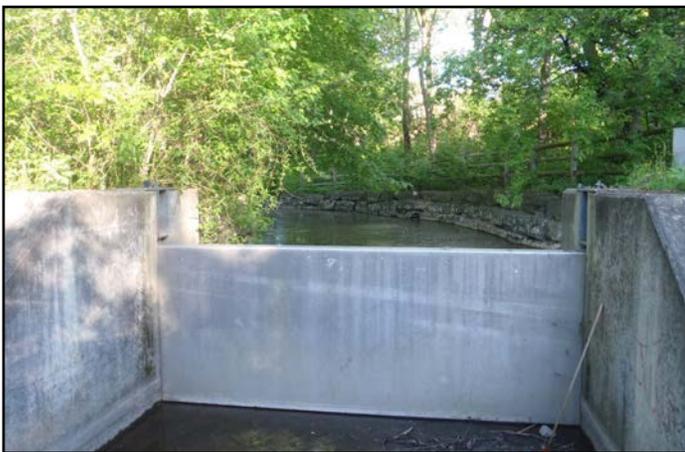
This water control dam on Hunt Club Creek creates a permanent migration barrier to fish communities

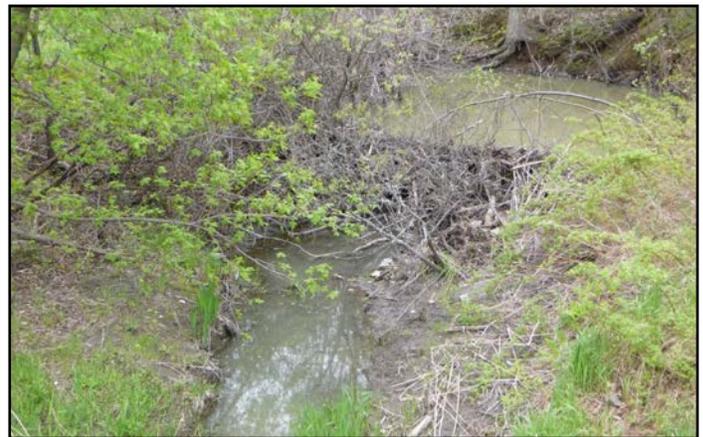
An active beaver dam along Hunt Club Creek near Riverside Drive

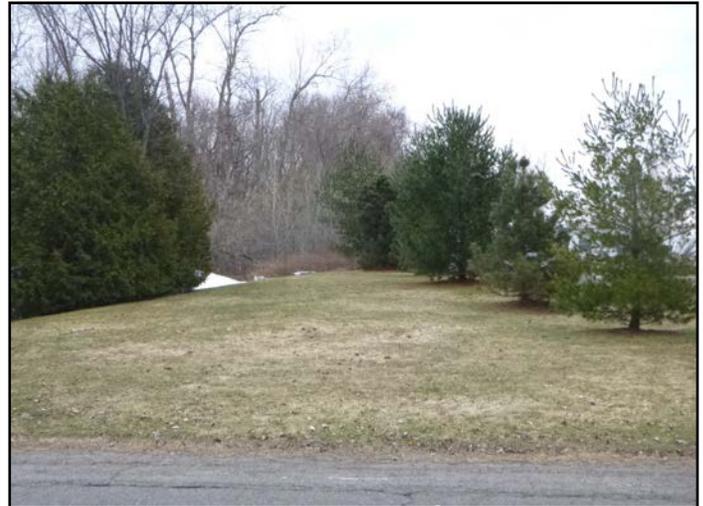
Piped headwater drainage feature on Hunt Club Creek, shows the upstream portion (above) buried and the downstream outlet remains open (below)

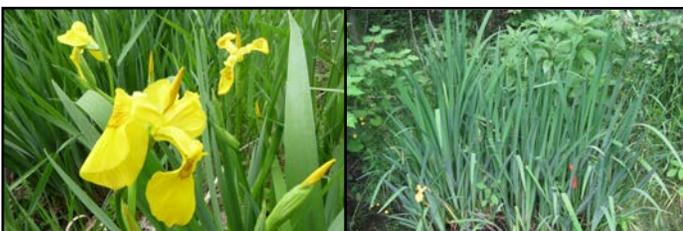
Invasive yellow iris is found throughout Hunt Club Creek

Invasive species management is recommended in the most upstream locations to reduce areas affected. Invasive yellow iris was observed in small clusters throughout, these plants may be effectively managed due to their isolated state. Some removal efforts were implemented in 2019, however isolated plants remain in the system and should be targeted in the future.
