# Taylor Creek 2012 Summary Report

As part of the City Stream Watch monitoring activities in 2012, 17 sections along Taylor Creek were surveyed by staff and volunteers. The following is a summary of the 17 macro stream assessments carried out on Taylor Creek.

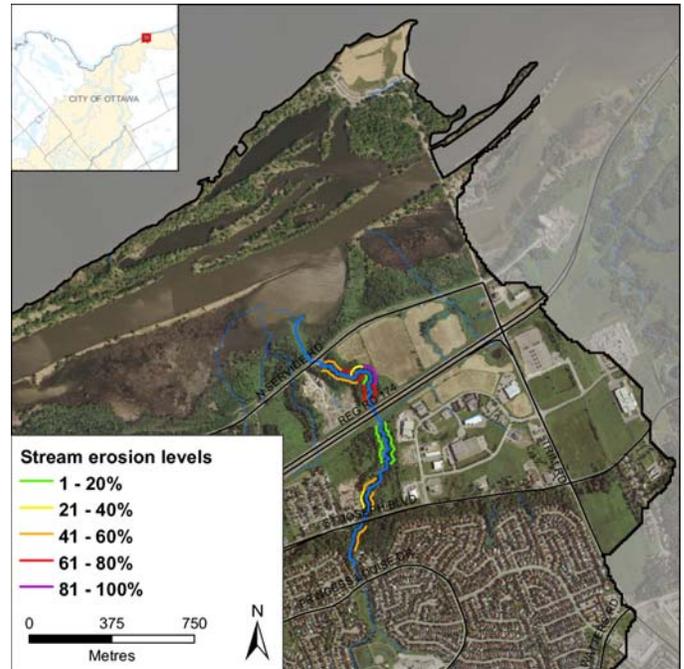
Erosion is a normal, important stream process and may not affect actual bank stability; however, excessive erosion and deposition of sediment within a stream can have a detrimental effect on important fish and wildlife habitat. Bank stability indicates how much soil has eroded from the bank into the stream. Poor bank stability can greatly contribute to the amount of sediment carried in a waterbody as well as loss of bank vegetation due to bank failure, resulting in trees falling into the stream and the potential to impact instream migration. Seventy-three percent of the left bank and 83 percent of the right bank was considered stable along Taylor Creek. Bank stability has improved since this creek was last surveyed in 2007. Improvements are likely the result of the 2009/2010 Taylor Creek Erosion Works project by the City of Ottawa. The project saw erosion control measures implemented from St. Joseph Boulevard to North Service road. Figure 4 shows the observed erosion locations along the Creek. There were some locations downstream of highway 174 where CSW staff and volunteers noted highly unstable banks but apart from those locations low to moderate levels of erosion were observed along the remainder of the creek.

Figure 4. Erosion along Taylor Creek

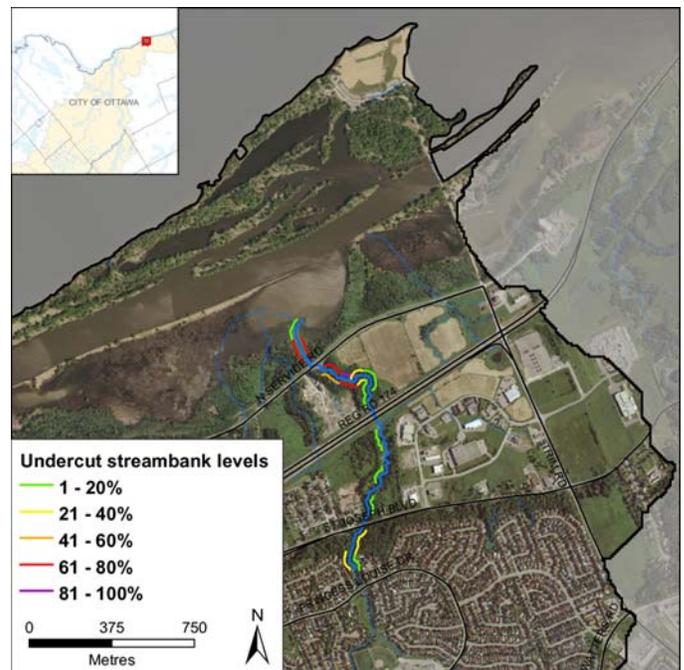
Undercut banks are a normal and natural part of stream function and can provide excellent refuge areas for fish. Figure 5 shows the identified undercut banks on Taylor Creek. The most undercutting was observed on the north and south sides of North Service road.

Figure 5. Undercut streambanks along Taylor Creek

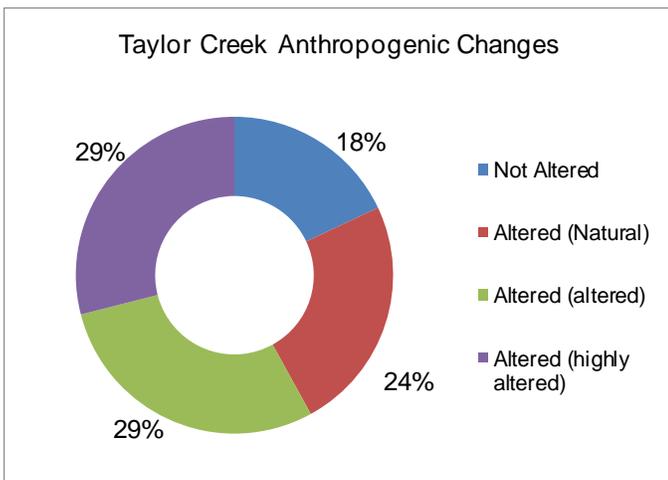
Figure 7 shows that 18 percent of Taylor Creek remains “unaltered.” Sections considered “natural” with some human changes account for 24 percent of sections. “Altered” sections accounted for 29 percent of the stream, with the remaining 29 percent of sections sampled being considered “highly altered” (e.g., include road crossings, shoreline/instream modifications and little or no buffer).

Figure 7. Alterations to Taylor Creek

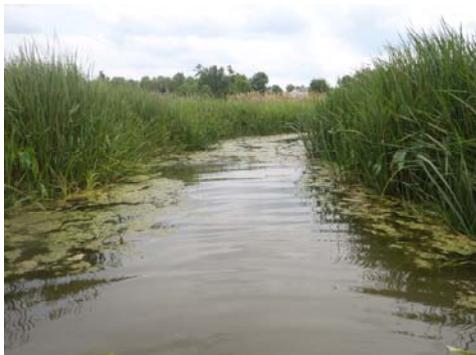
Taylor Creek has very limited diversity of instream vegetation, as seen in Figure 14. The dominant vegetation type at eighty-six percent consisted of algae. A total of six percent of the vegetation community was recorded as submerged vegetation. Narrow emergent, robust emergent, broad emergent, free-floating and floating vegetation made up the remaining eight percent of the vegetation community.

Photo 2. High concentrations of algae on Taylor Creek

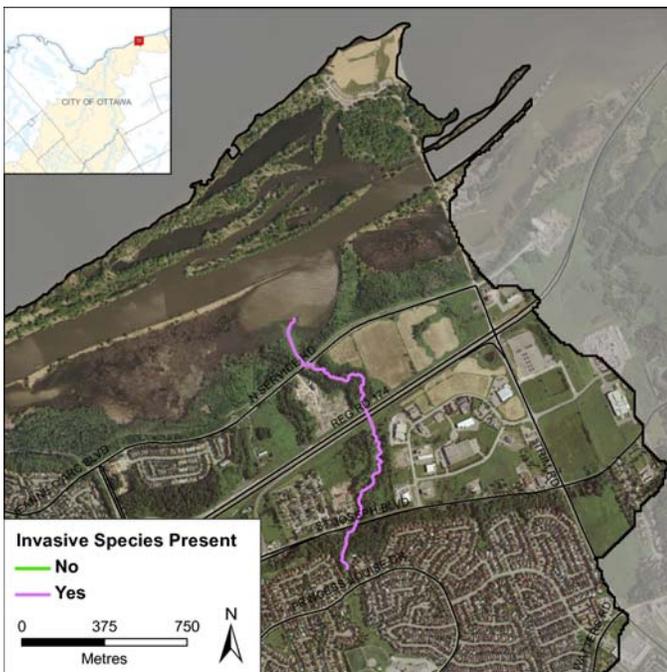
Invasive species can have major implications on streams and species diversity. Invasive species are one of the largest threats to ecosystems throughout Ontario and can outcompete native species, having negative effects on local wildlife, fish and plant populations. In Taylor Creek, invasive species were observed in 100 percent of the sections surveyed, and often more than one species was present in the same area (Figure 16). The invasive species observed in Taylor Creek include purple loosestrife (*Lythrum salicaria*), yellow iris (*Iris pseudacorus*), flowering rush (*Butomus umbellatus*), Himalayan balsam (*Impatiens glandulifera*), garlic mustard (*Alliaria petiolata*), and Japanese knotweed (*Fallopia japonica*).

Figure 16. Invasive species along Taylor Creek

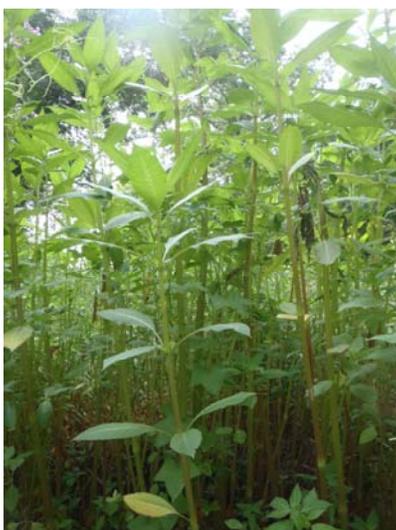
Photo 3. Himalayan balsam on Taylor Creek. This invasive species is especially prolific on Taylor Creek

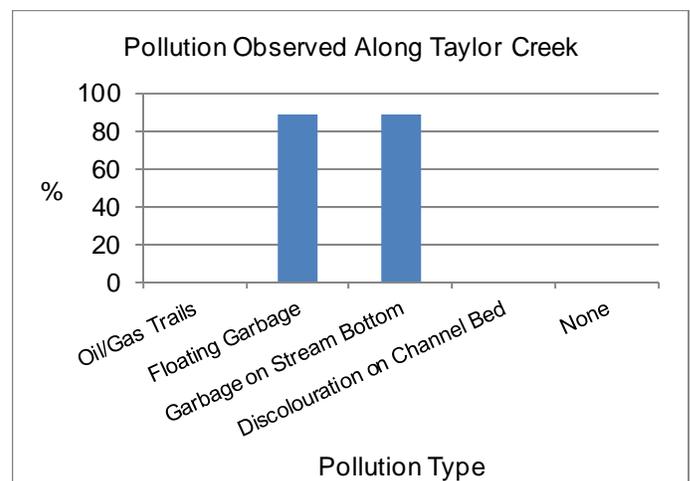
Figure 17 demonstrates the incidence of pollution/garbage in Taylor Creek. Pollution and garbage in the stream is assessed visually and noted for each section where it is observed. None of the sections on Taylor Creek were free from garbage. Floating garbage and garbage on the stream bottom were each recorded in 88 percent of the sections. In 2012 a stream garbage cleanup was held on this creek to remove garbage that had accumulated at the base of the waterfall at St. Joseph boulevard. A cleanup is recommended at this site on an annual basis to help reduce the amount of garbage that travels downstream.

Figure 17. Pollution observed along Taylor Creek

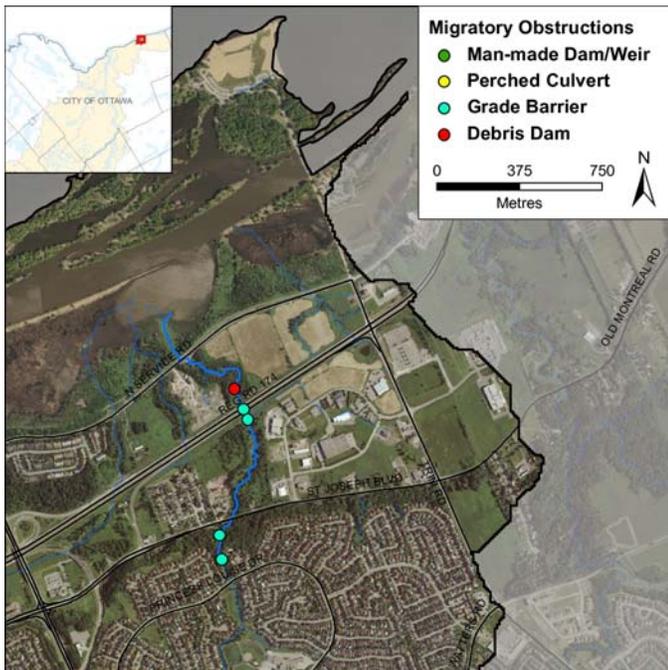
It is important to know locations of migratory obstructions because these can prevent fish from accessing important spawning and rearing habitat. Migratory obstructions can be natural or manmade, and they can be permanent or seasonal. Figure 21 shows the locations of migratory obstructions in Taylor Creek. Most of the obstructions at the time of the survey were grade barriers that may only be barriers during low water conditions with the exception of the Princess Louise Falls.

Figure 21. Migratory obstructions in Taylor Creek

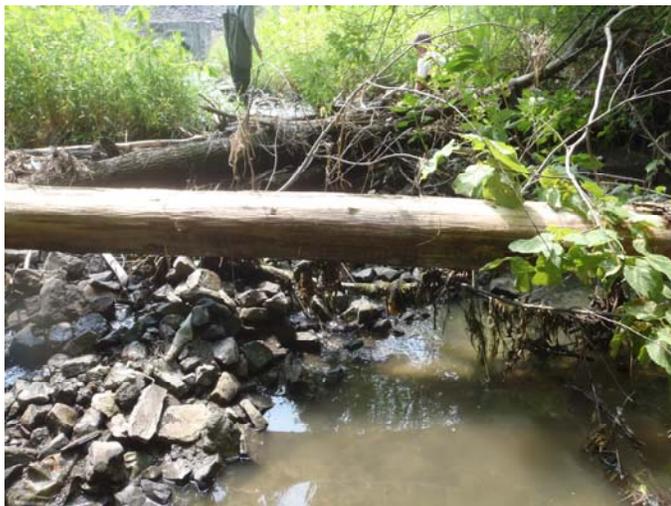
Photo 5. A migratory obstruction on Taylor Creek

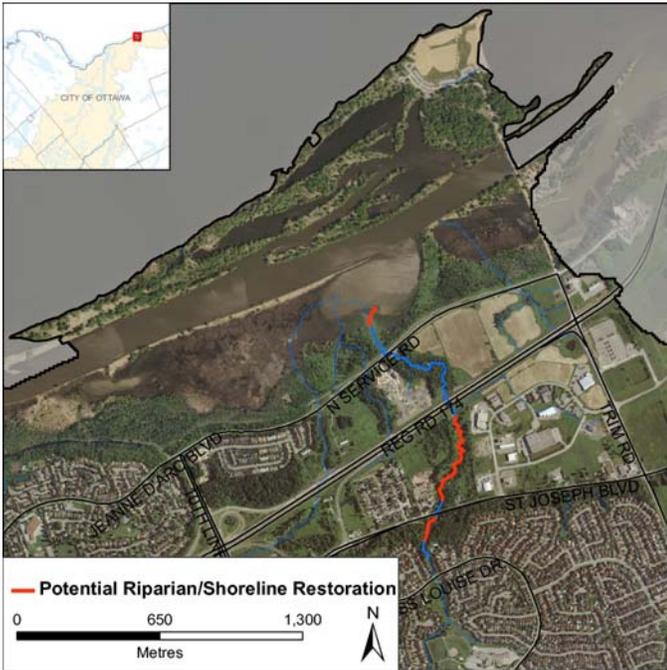
Figure 23 depicts the locations where City Stream Watch staff and volunteers made note of opportunities for future riparian restoration activities on Taylor Creek.

Figure 23. Taylor Creek riparian restoration opportunities

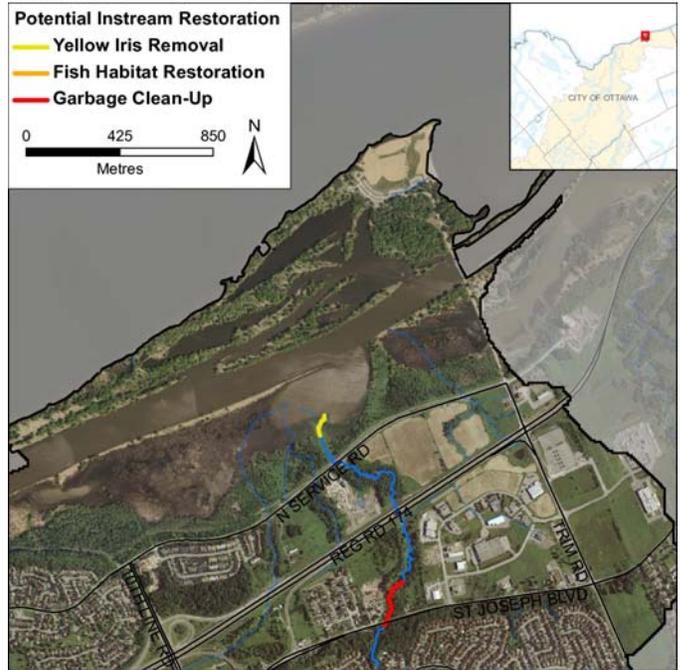
Figure 24 depicts the locations where various instream restoration activities can be implemented as a result of observations made during the stream survey assessments.

Figure 24. Potential instream restoration opportunities along Taylor Creek

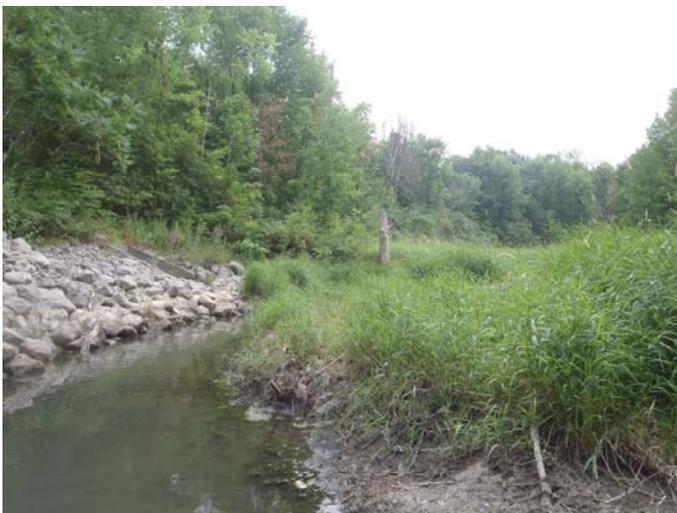
Photo 9. A section of Taylor Creek where riparian planting was identified as a potential restoration opportunity.

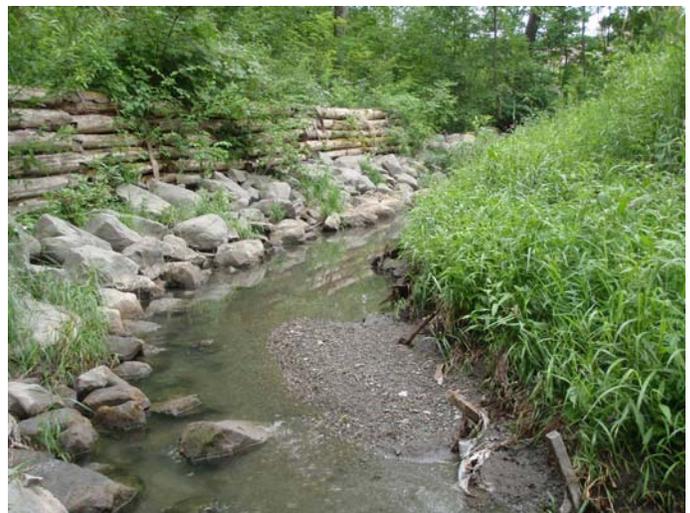
Photo 10. Existing rip rap and wooden retaining wall installed by as part of the City of Ottawa Erosion Control Works on Taylor Creek.
