City Stream Watch 2009 Annual Report

Julia Sutton
City Stream Watch Coordinator
Rideau Valley Conservation Authority

Executive Summary

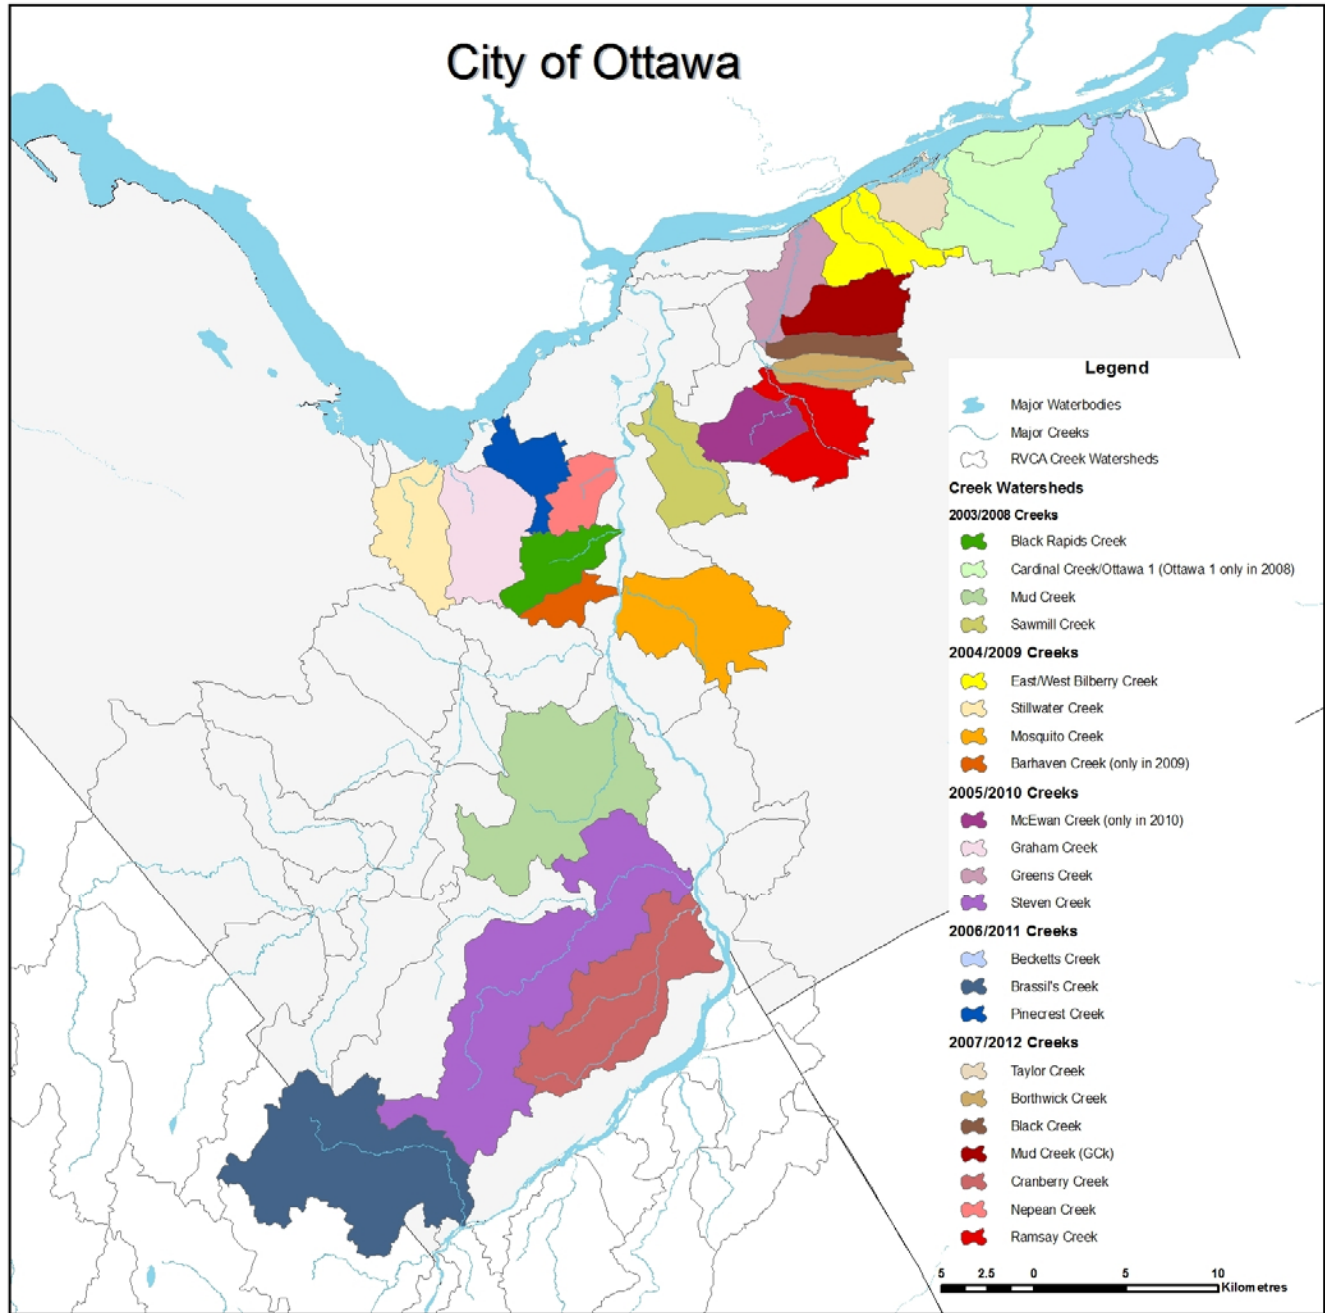
Figure 1. Locations of Streams and Their Watersheds on the 2003-2012 Sampling Schedule

In 2009 the original three streams from 2004 were re-surveyed. Those creeks were Bilberry Creek, Mosquito Creek and Stillwater Creek. In addition, West Bilberry Creek and Barrhaven Creek were surveyed for the first time. Figure 1 shows the locations of the 2009 sample streams as well as all streams sampled from 2003 to 2012.

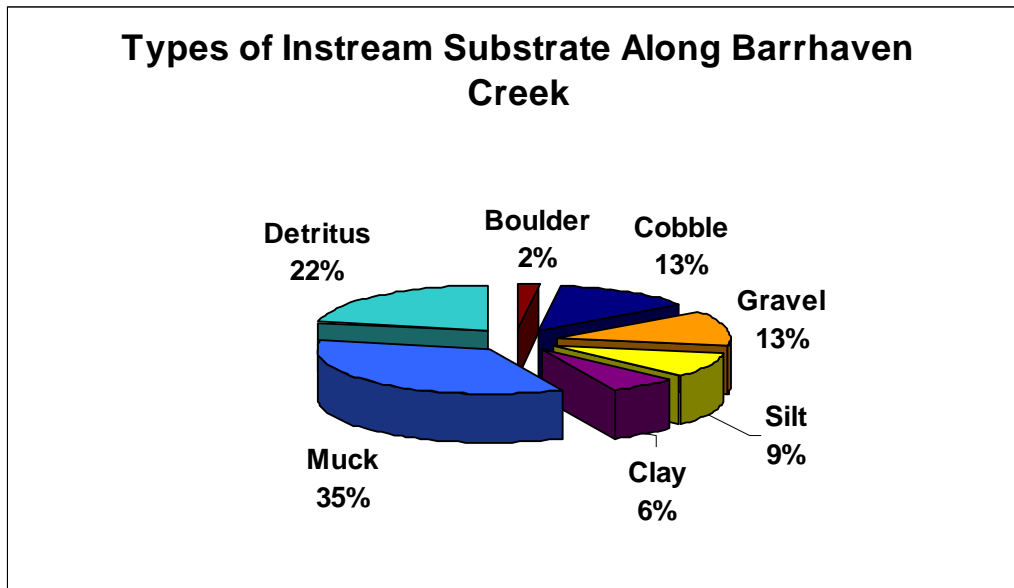
Figure 6. Types of Instream Substrate Along Barrhaven Creek

Diverse substrate is important for fish and benthic macroinvertebrate habitat because some species will only occupy certain types of substrate and will only reproduce on certain types of substrate. Boulders create instream cover and back eddies for large fish to hide and/or rest out of the current, and cobble provides important over wintering and/or spawning habitat for small or juvenile fish. Other substrates also provide instream habitat for fish and macroinvertebrates. A variety of substrate can be found instream along Barrhaven Creek, although over half of the substrate observed was muck (mixture of clay, silt and sand) and detritus, most of which was found upstream of the SWTF. That area runs through a forested buffer, where the channel is quite small and filled with a large amount of woody material and fallen leaves, creating an abundance of organic matter.

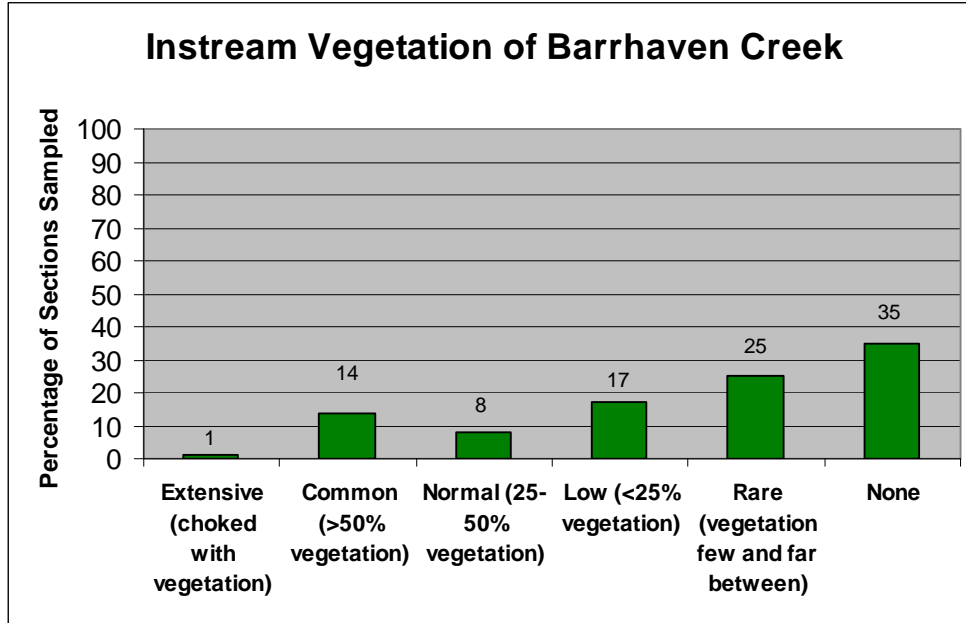
Figure 7. Frequency of Instream Vegetation in Barrhaven Creek

Instream vegetation is an important factor for a healthy stream ecosystem. Vegetation helps to remove contaminants from the water, contributes oxygen to the stream, and provides habitat for fish and wildlife. Figure 7 demonstrates the frequency of instream vegetation in Barrhaven Creek.

The instream vegetation in Barrhaven Creek varied throughout the stream. In 14 percent of sections sampled, vegetation was found to be common and eight percent found to be normal. The areas considered extensive (one percent) were areas with higher nutrient inputs, directly downstream of the SWTF. Areas choked with vegetation can negatively affect the stream due to increased biological oxygen demand (BOD) when the plants die off. Extensive vegetation can also restrict the mobility of aquatic organisms. Many sections had areas with low, rare or no vegetation due; however, this may have been because the headwater surveys were conducted in early spring, before aquatic vegetation had a chance to grow. These sections made up 77 percent of the sections sampled.

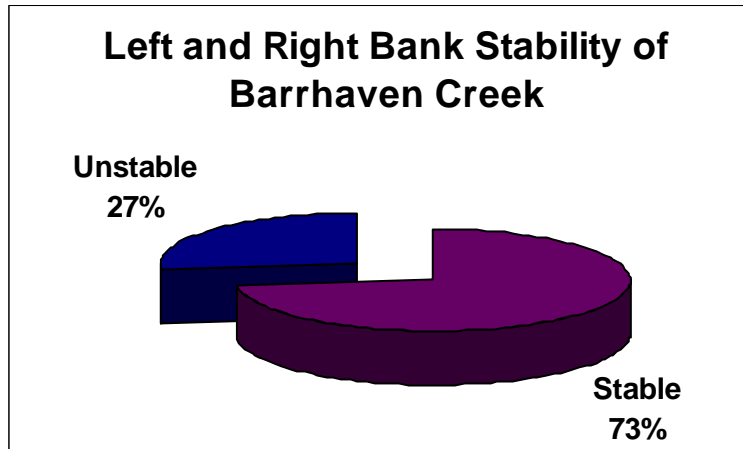
Figure 8. Left and Right Bank Stability of Barrhaven Creek

Erosion is a normal, important stream process and may not affect actual bank stability; however, excessive erosion and deposition of sediment within a stream can have detrimental effects to important fish and wildlife habitat. Bank stability indicates how much soil has eroded from the bank into the stream. Poor bank stability can greatly contribute to the amount of sediment carried in a waterbody as well as loss of bank vegetation due to bank failure, resulting in trees falling into the stream and the removal of aquatic plants, which provide habitat.

instability observed near the mouth, but the majority in the forested section between the SWTF and Woodroffe. Areas of erosion have been identified on an aerial photo of Barrhaven Creek and are detailed in Appendix E.

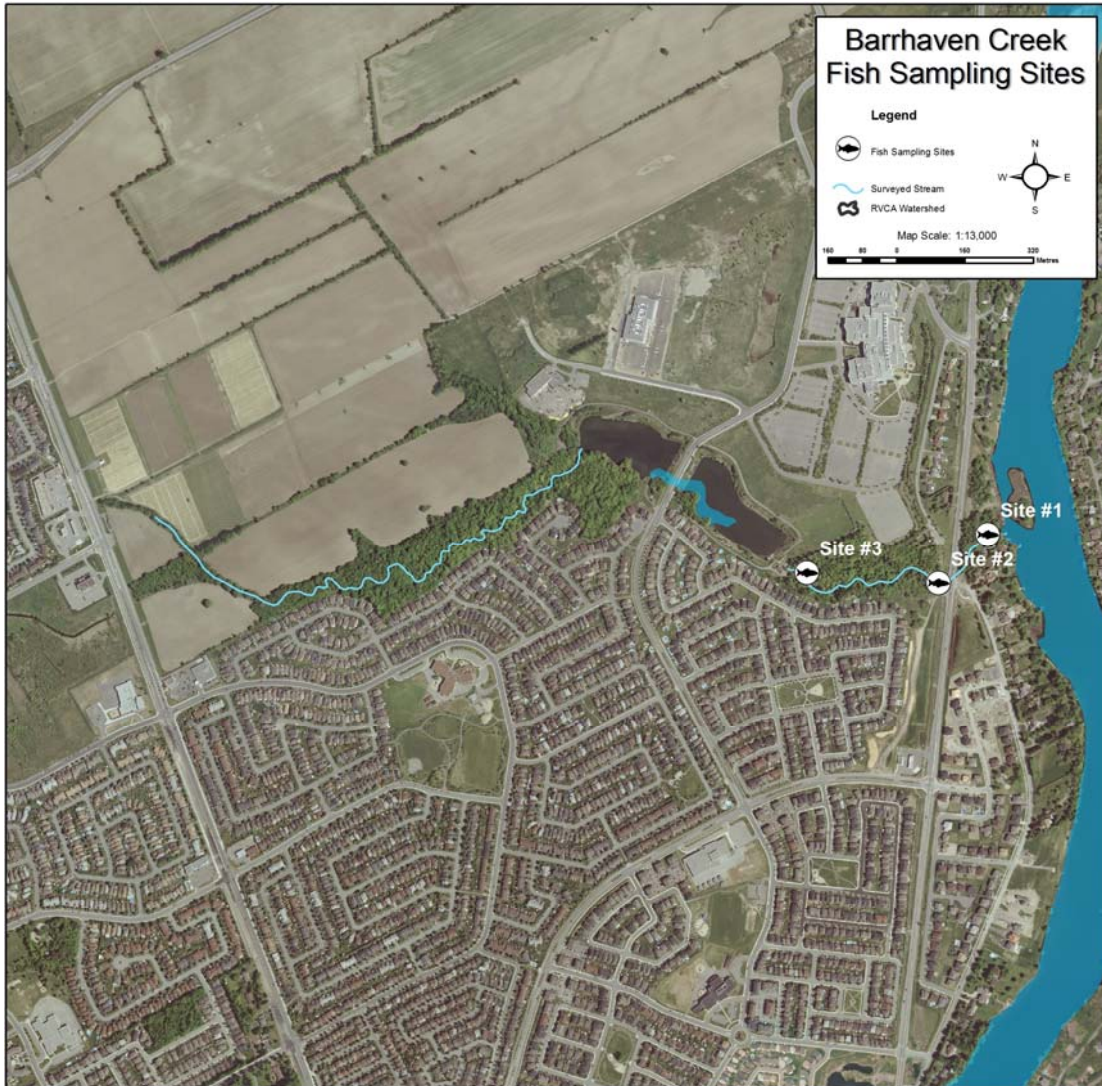
Figure 11. Air Photo of Barrhaven Creek Showing Sampling Sites

Seine netting is an effective way to sample fish communities in streams, rivers and lakes. Seine nets are dragged through the water column to collect fish in the near shore area. The data is used in conjunction with other methods to determine fish communities and distributions. Seine netting was only used near the mouth of Barrhaven Creek, at Site 1. Figure 11 shows the locations of the sampling sites, and Table 4 is a summary of the fish caught.

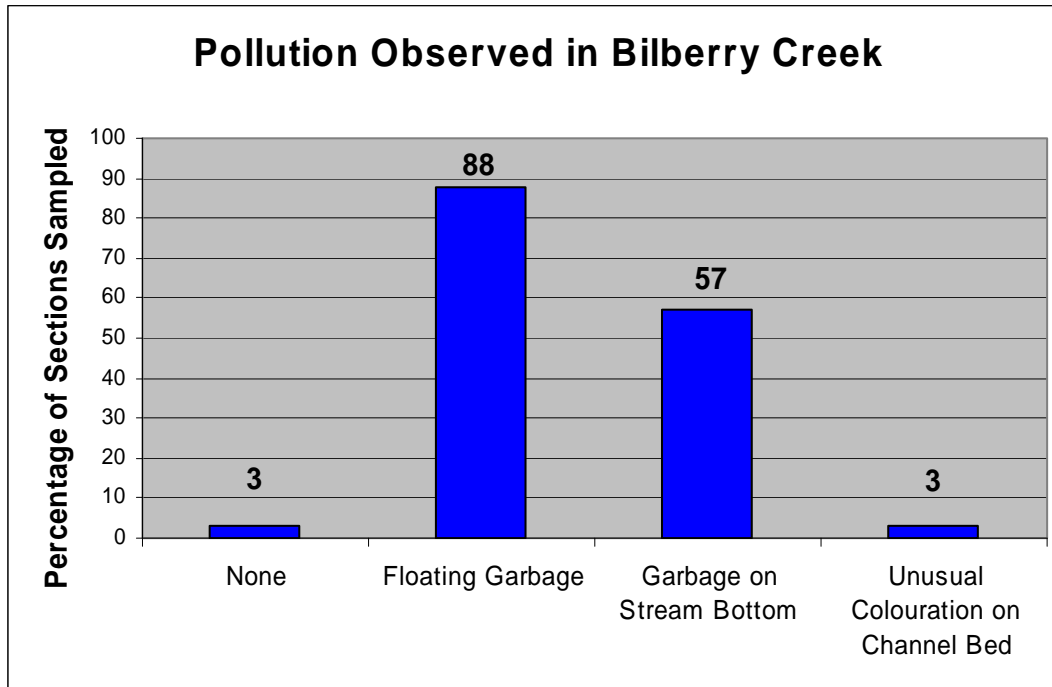
Figure 24. Frequency of Pollution/Garbage Occurring in Bilberry Creek

Unfortunately, Bilberry Creek had an extensive amount of garbage along its course. Only three percent of the stream was free of garbage. The majority of the garbage found was floating. There was also a large amount of garbage on the stream bottom, or embedded in the stream bottom,

such as shopping carts and appliances such as a stove and fridge. In some of the areas where garbage was observed, access would be quite difficult for a stream cleanup. Garbage found included tires, plastic bottles, plastic wrappers, shoes, bicycles, lumber, a flowerpot, scrap metal, chairs, couches, cement objects, tin, a fence, plastic, an old metal drum, aerosol cans, construction refuse, a tarp, carpet, styrofoam and a shed. Figure 24 illustrates the incidence of pollution in Bilberry Creek. The West branch also displayed the same amount of garbage. Only one section was free of garbage. The other nine sections had garbage on the stream bottom and floating, many of the same objects described above, aside from the fridge, stove and shed.

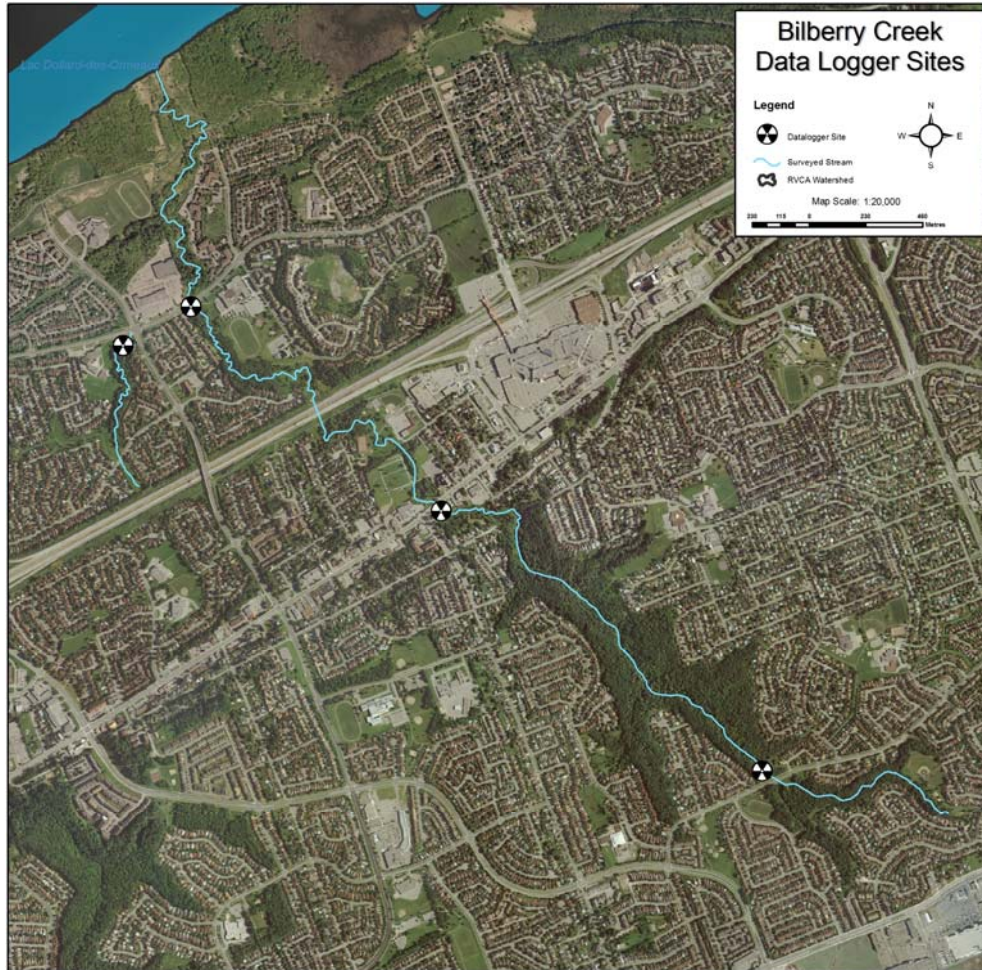
Figure 26. Datalogger Locations Along Bilberry Creek

Four temperature dataloggers were set in Bilberry Creek, but only three could be recovered in September. The dataloggers were deployed on April 2 and retrieved on September 22. Figure 26 shows the locations of dataloggers in Bilberry Creek.

Data loggers were set in four different locations in the stream to give a representative sample of how temperature fluctuates and differs throughout the course of the stream. Sites begin at the downstream end of the creek and were placed in order upstream. Datalogger 1 was set on the West branch, just upstream of Jeanne d'Arc. Datalogger 2 was set on the main branch at Jeanne d'Arc. This was the datalogger that could not be recovered. Datalogger 3 was placed upstream of St. Joseph and Datalogger 4 downstream of Des Epinettes. Figure 27 shows results from Dataloggers 1, 3 and 4.

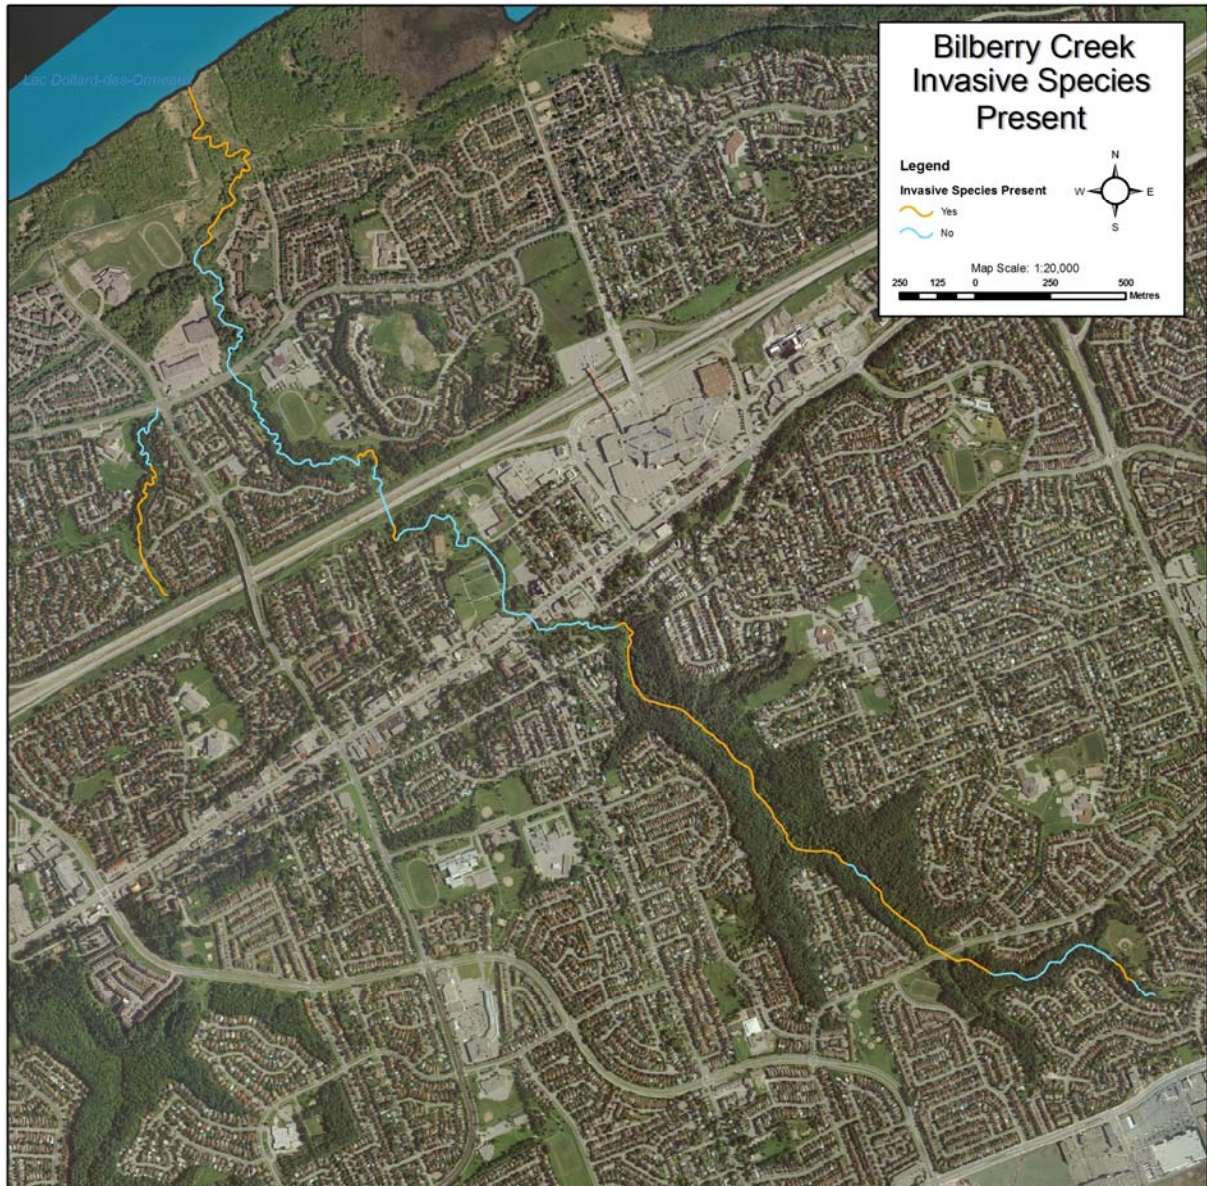
Figure 28. Locations of Invasive Species Observed Along Bilberry Creek

The most common invasive species along Bilberry Creek is Purple Loosestrife (*Lythrum salicaria*); however, in most sections it does not appear to be outcompeting any native vegetation and is serving as a nectar source for pollinator species in areas where there are not many other sources. The other invasive species found along Bilberry Creek are Wild Parsnip (*Pastinaca sativa*), European Buckthorn (*Rhamnus catharticus*) and Garlic Mustard (*Alliaria petiolata*). Figure 28 shows the locations of invasive species found along Bilberry Creek. Sections where invasive species were observed are highlighted in orange.

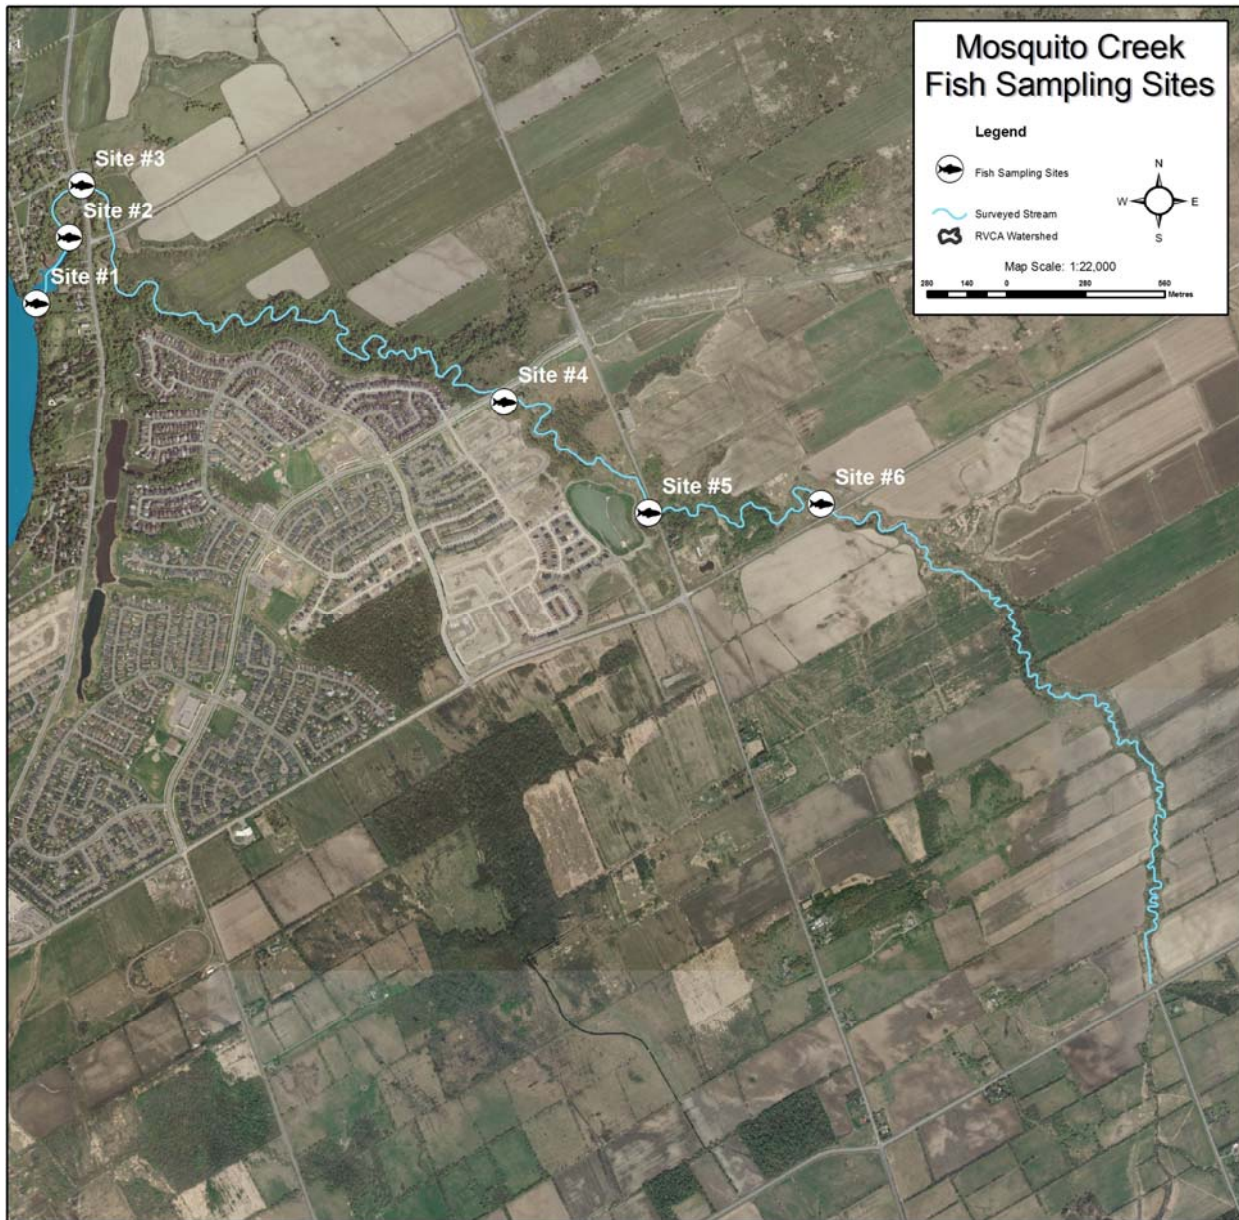
Figure 39. Air Photo of Mosquito Creek Showing Sampling Sites

A total of six sites were sampled on Mosquito Creek. Due to high water levels and the type of sampling method required, three sites were only sampled once. The first two sites sampled were near the mouth of the stream, where it is quite deep and wide. A small motorboat and a large seine net were used to seine these areas. Weather conditions and motor issues made it quite difficult to pull the seine, and they were not as successful as hoped. A fyke net was used on the third site, just upstream of River Road. On sites four to six, a combination of seining and windemere traps were used. No volunteer demonstrations were held on this creek but individuals assisted RVCA staff with seining and picking up windemere traps for a total of 12 hours. All fish

were live released after the sampling was finished, unless taken back to the lab to confirm identification. In total, 22 fish species were caught. Sampling locations are shown in Figure 39.

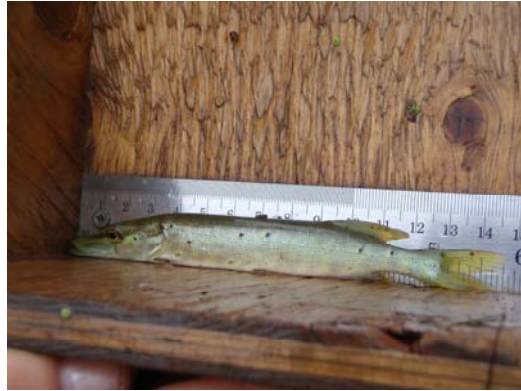
Juvenile pike with blackspot disease

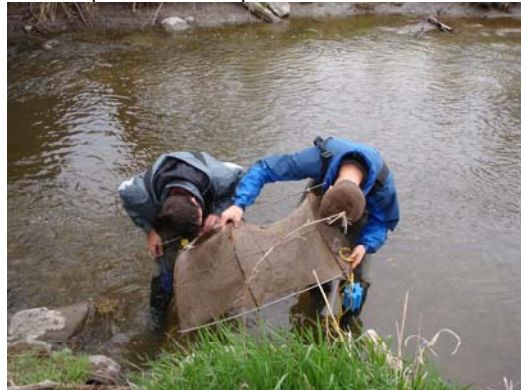
CSW staff and a volunteer picking up a windemere trap

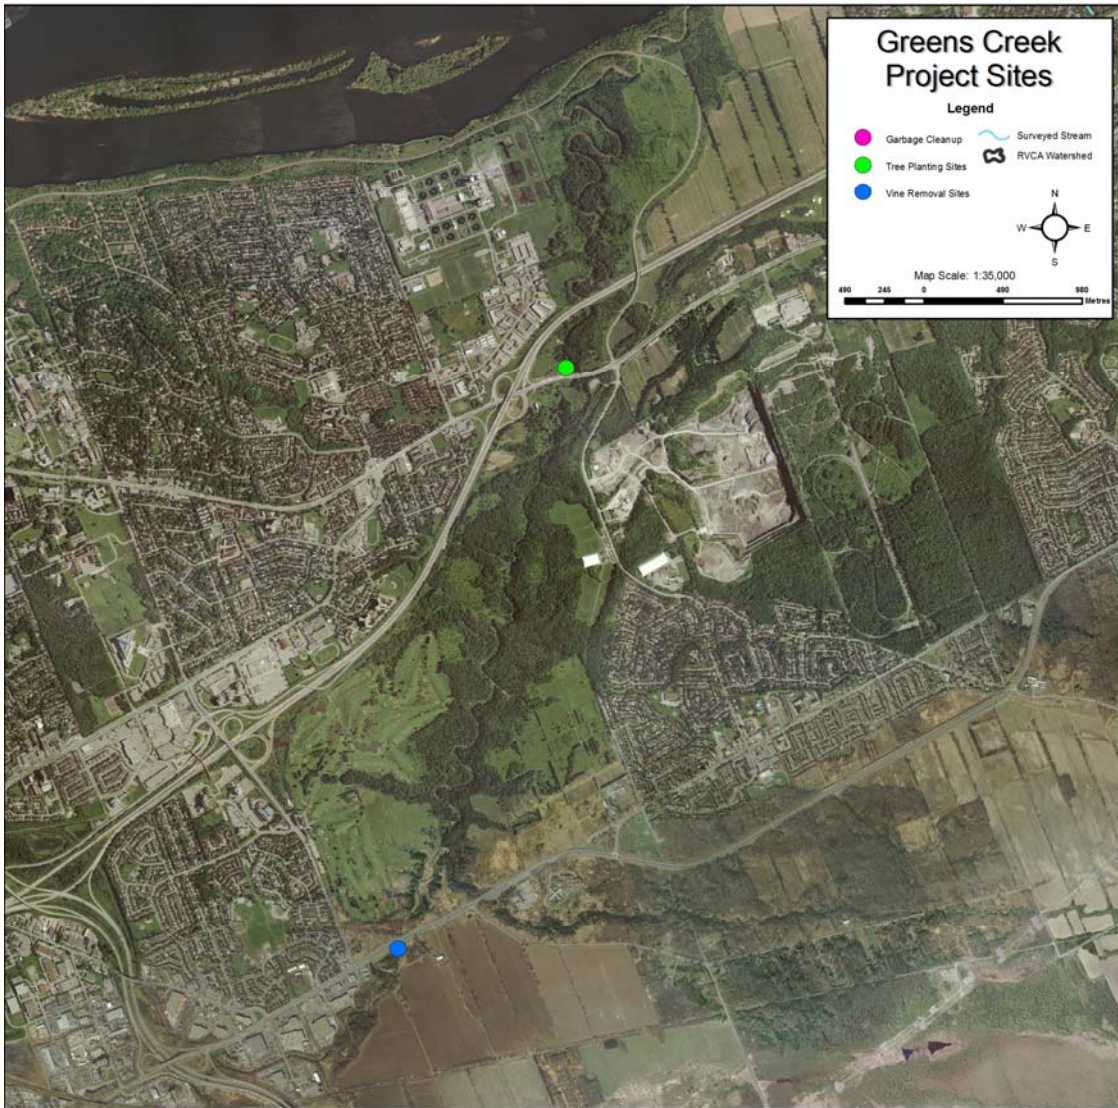
Figure 57. Air Photo of Green's Creek Showing Tree Planting Site and DSV Removal

The Green's Creek planting site was chosen in collaboration with the NCC. This site was an open meadow with few trees, sloping down to the creek. The immediate shoreline was quite compacted with fill, due to recent construction at the Montreal Road crossing. A section closest to the road was not planted on to allow access for future bridge maintenance. Shrubs and trees were planted to improve habitat, slow runoff and improve the buffer area. On May 3, 27 volunteers came out to plant for a total of 79 hours, including Councillor Rainier Bloess. The weather cooperated, and five hundred trees and shrubs were planted at the site.

The dog-strangling vine removal site chosen on Green's Creek is located just upstream of the Innes Road bridge. Dog-strangling vine is taking over the open shoreline area and beginning to wind its way into the scrubland further back from the water's edge. This section of Green's Creek is quite modified and does not have a healthy amount of vegetation along the shoreline, due to a cement retaining wall and rip rap. Although there was a lot of DSV at the Green's Creek site, it was manageable, and we're hopeful that in future years we can control its spread and success. There are a few goldenrod plants already growing at the site which may show some resistance to the vine. The Ottawa Flyfishers Society assisted with the removal, and seven volunteers spent 21 hours clearing the site.

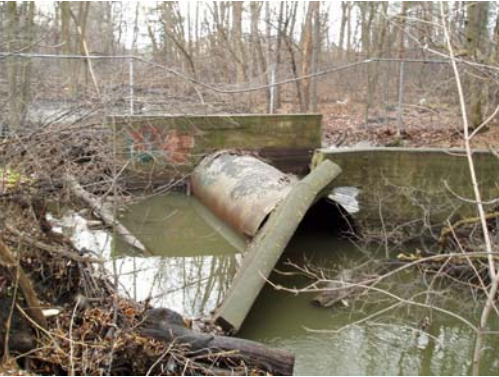
Location	Issue	Picture	Remediation Strategy	Expected Results
Sawmill Creek just north of Hunt Club Road.	A failed culvert has blocked the stream flow and woody material has accumulated upstream of the culvert area. The obstruction has dammed the stream, forcing the stream to alter its course around the sides of the culvert, creating an erosion and siltation problem. The cement wall is creating a flow deflector, which is severely eroding the east bank.

<ul style="list-style-type: none"> • Determine land ownership • Partner with the City of Ottawa with the culvert removal • Work with the NDHQ Fish and Game Club on the project and utilize existing volunteer base of the City Stream Watch program to participate in this rehabilitation effort by removing woody debris blocking the area • Plant shrubs and trees to stabilize banks to help stop erosion or use bioengineering, depending on the damage done to the shoreline 	<ul style="list-style-type: none"> • Community involvement • Enhance fish and wildlife habitat • Reduce erosion of banks • Eliminate possibility of bank failure causing tree collapse into stream • Remove potential migratory obstruction

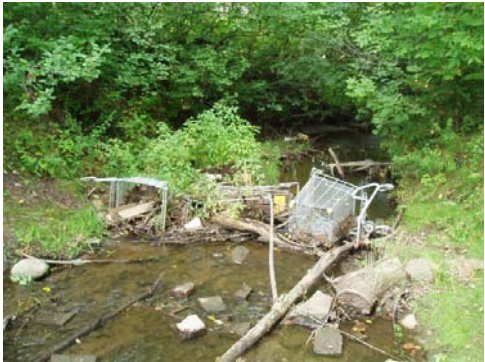
Location	Issue	Picture	Remediation Strategy	Expected Results
Various creeks.	The accumulation of garbage along various stretches of city streams is an ongoing problem. Not only does man-made pollution take away from the aesthetic quality of the stream but it limits and degrades the quality of fish and wildlife habitat.

<ul style="list-style-type: none"> • Determine land ownership • Utilize existing volunteer base of the City Stream Watch to continue garbage cleanups each year in order to rid the stream and riparian areas of unnatural debris. 	<ul style="list-style-type: none"> • Community involvement • Enhancement of fish and wildlife habitat • Enhancement of the creek's aesthetic qualities

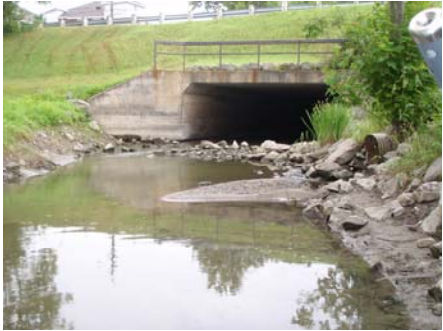
Location	Issue	Picture	Remediation Strategy	Expected Results
Stillwater Creek, at the mouth	Andrew Haydon Park is located at the mouth of Stillwater Creek. The creek has lost its buffer between the mouth and the Carling Avenue crossing. Grass is mowed to the edge of the stream. The sides of the stream erode fluctuating water levels.

<ul style="list-style-type: none"> • Determine land ownership and discuss possible partnership and remediation options • Riparian planting where possible • Identification of areas that require more intensive methods of erosion protection (i.e. bioengineering, etc.) • Utilize existing volunteer base of the City Stream Watch program and recruit volunteers from neighbouring communities to participate in this rehabilitation effort 	<ul style="list-style-type: none"> • Community involvement • Effective stream bank protection • Reduce siltation of fish spawning habitat • The enhancement of conditions for natural colonization of existing plant community • Produce streamside wildlife habitat

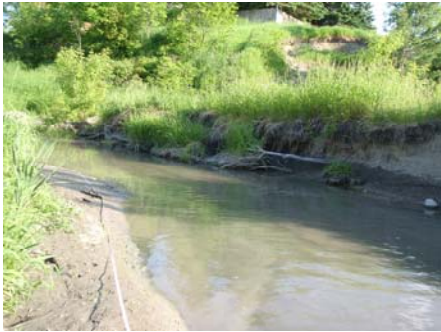
Location	Issue	Picture	Remediation Strategy	Expected Results
<p>Bilberry Creek, upstream of Highway 174</p>	<p>The left bank of Bilberry Creek has slumped in this spot, creating bank instability and increasing sediment loading into the watercourse.</p>

<ul style="list-style-type: none"> • Determine landowners • Examine possibility of completing a bioengineering project to stabilize bank and enhance riparian vegetation • Utilize existing volunteer base of the City Stream Watch program to assist with installation of the plant material 	<ul style="list-style-type: none"> • Community involvement • Enhancement of fish and wildlife habitat • Enhance conditions for natural colonization of existing plant community • Improve water quality and water quantity entering the stream in those areas • Enhancement of the creek's aesthetic qualities
Location	Issue	Picture	Remediation Strategy	Expected Results

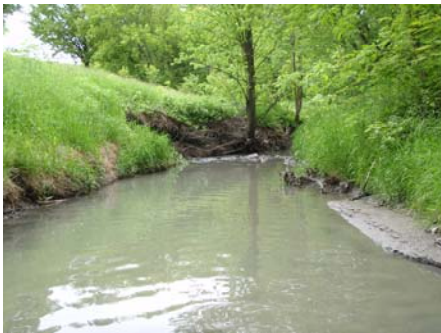
<p>Bilberry Creek, various locations</p>	<p>Along Bilberry Creek, there are small areas that have little riparian vegetation. The banks along Bilberry are quite unstable, and a lack of riparian vegetation aggravates the issue.</p>

<ul style="list-style-type: none"> • Determine land ownership • Utilize existing volunteer base of the City Stream Watch to participate in several planting efforts along the shorelines 	<ul style="list-style-type: none"> • Community involvement • Enhancement of fish and wildlife habitat • Enhance conditions for natural colonization of existing plant community • Improve water quality and water quantity entering the stream in those areas • Enhancement of the creek's aesthetic qualities

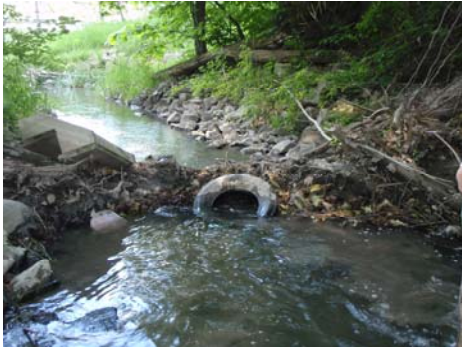
Location	Issue	Picture	Remediation Strategy	Expected Results
<p>Barrhaven Creek, just downstream of Prince of Wales Drive</p>	<p>A migratory obstruction has built up along Barrhaven Creek and is currently collecting garbage. Game fish were caught downstream of the obstruction. The obstruction should be removed so that fish can access potential spawning or rearing areas farther upstream.</p>

<ul style="list-style-type: none"> • Determine land ownership • Apply for any necessary permits • Utilize existing volunteer base and remove the obstruction and garbage out of the creek and dispose of properly 	<ul style="list-style-type: none"> • Enhance fish and wildlife habitat • Enhance the creek's aesthetic qualities. • Prevent further erosion

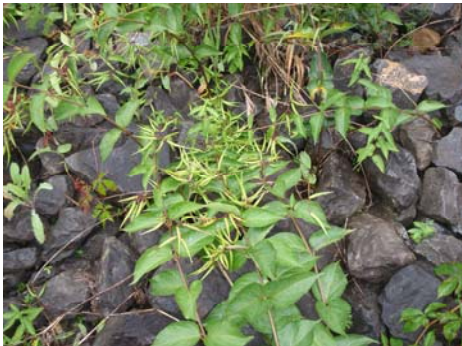
Location	Issue	Picture	Remediation Strategy	Expected Results
<p>Green's Creek</p>	<p>Dog-strangling vine is growing along the shoreline and beginning to expand into the scrubland area on the left bank. The first removal was completed in 2009. Another removal will be necessary in 2010 to keep the vine contained.</p>

<ul style="list-style-type: none"> • Utilize existing volunteer base to clear the vine away • Use RVCA trucks to take vine to the Trail Road facility where the vine can be composted properly • Partner with other groups working on invasive species removal 	<ul style="list-style-type: none"> • Promote community involvement in rehabilitation projects • Enhance fish and wildlife habitat • Increase awareness of invasive species, their impacts and the importance of biodiversity • Enhance the creek's aesthetic qualities.

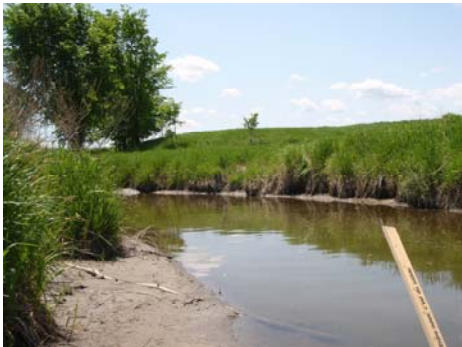
Mosquito Creek, various locations	There are a number of areas along Mosquito Creek that have a limited buffer. These areas are not providing the habitat they should be for fish or wildlife.

<ul style="list-style-type: none"> • Determine land ownership • Address planting proposals with private landowners through existing tree planting programs at the RVCA 	<ul style="list-style-type: none"> • Community involvement • Improve water quality and quantity entering stream • Enhance fish and wildlife habitat • Provide shade to help moderate water temperatures • Enhance conditions for natural colonization of existing plant community
