City Stream Watch 2010 Annual Report

Julia Sutton
City Stream Watch Coordinator
Rideau Valley Conservation Authority

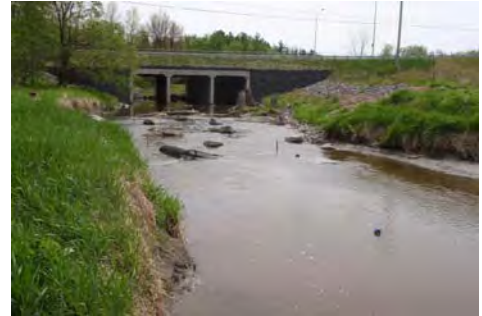
Fyke net set on Green's Creek

A fyke net is a modified hoop net. The net consists of round hoops with funnels leading to the next hoop, followed by a square hoop, joined together with mesh (mesh size, number of hoops and hoop sizes vary). From the square hoop, a lead line is pulled straight out and weighted down. There is a wing on each side of the square hoop which lead out on 45 degree angles, towards the banks. The other end (cottend) of the hoop net is secured with either a weight or an object. The cottend is tied together with a rope to allow for easy processing. The fish find the lead line or a wing and are led into the hoops. Fyke nets can be used in shallow or deeper waters and are good alternatives in places that are difficult to seine or electrofish, for example, at the mouth of a larger stream. The nets can be set up from 24 hours to multiple weeks, but they must be checked every 24 hours to release any fish that have been caught.

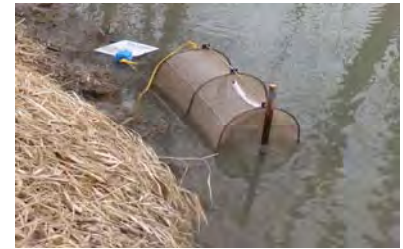
Windemere trap

A windemere trap resembles a lobster trap, only with a metal frame covered in mesh. Mesh funnels at either end guide the fish into the trap. Windemere traps are used in shallow areas, with either slow or fast moving water. They are used on electrofishing sites in April and May during peak spawning periods.

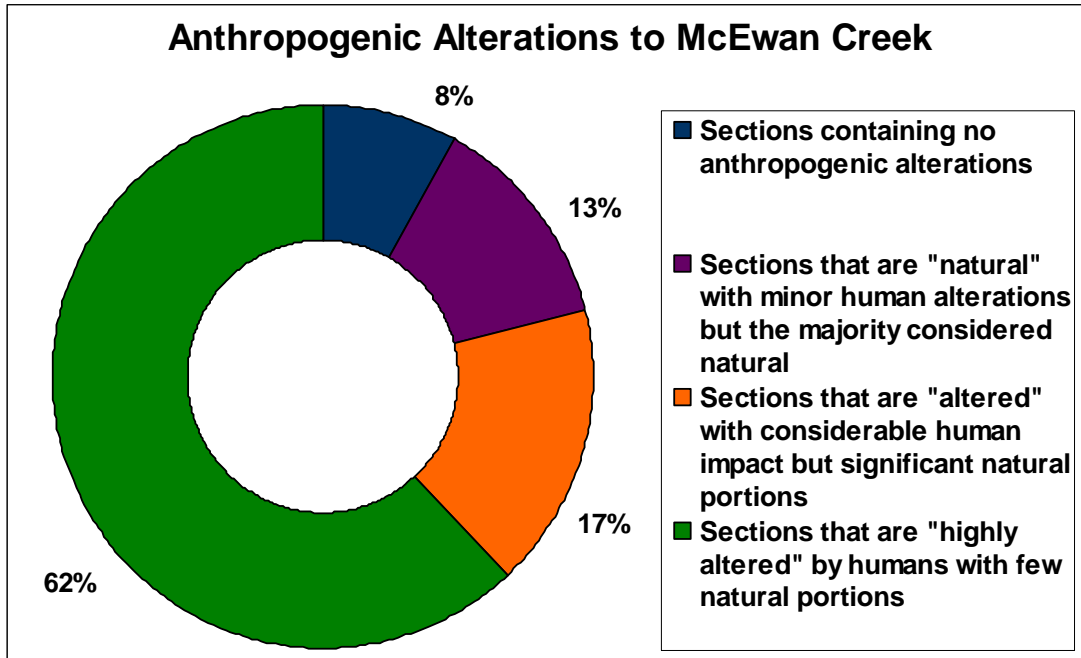
Figure 3. Classes of Anthropogenic Alterations Occurring Along McEwan Creek

Figure 3 illustrates the classes of anthropogenic alterations observed along McEwan Creek. Of the 24 sections sampled, only eight percent of the stream remained without any anthropogenic alterations. Sections considered natural, but with some anthropogenic changes made up 13 percent of the sections sampled, and 17 percent accounted for sections that were considered "altered" but still had natural features. Sixty-two percent of the sampled areas were "highly altered" with few natural portions. Areas that were listed as "altered" or "highly altered" were associated with road crossings, culverts, stormwater inputs, channelized sections or areas that had little or no buffer and little aquatic or wildlife habitat.

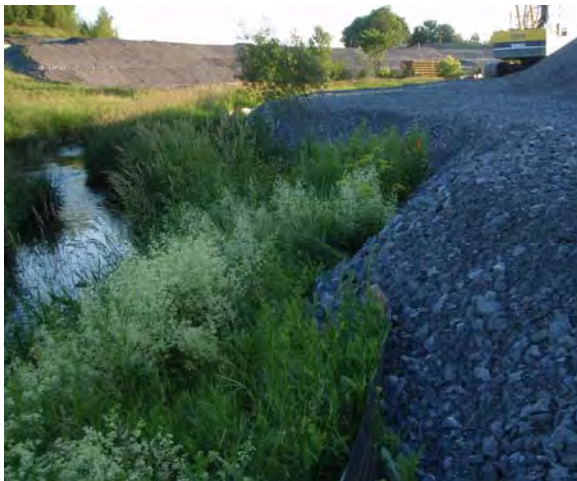
McEwan Creek, highly altered

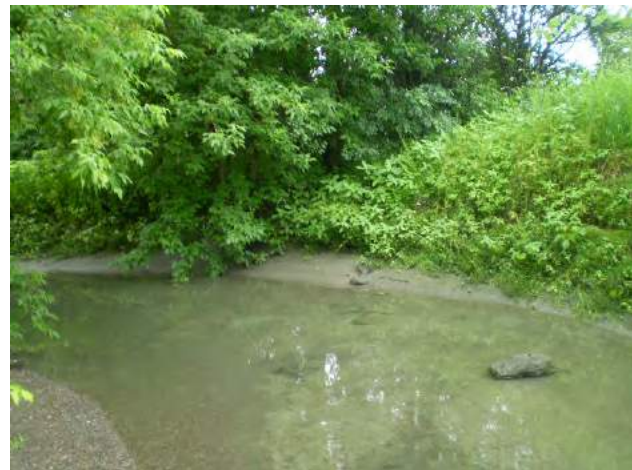
McEwan Creek, no alterations

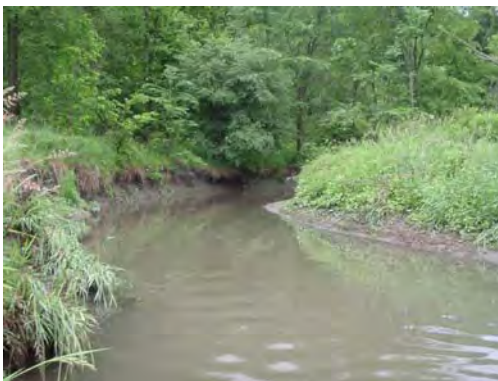
Land use at the mouth of McEwan Creek: mainly forest with some open meadow

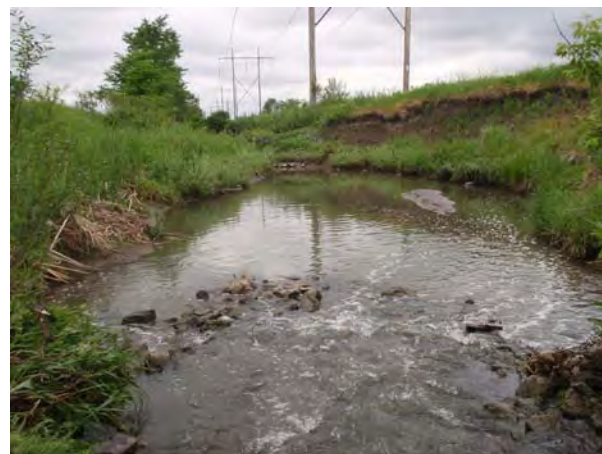
Sandy clay substrate with cobble riffle, McEwan Creek

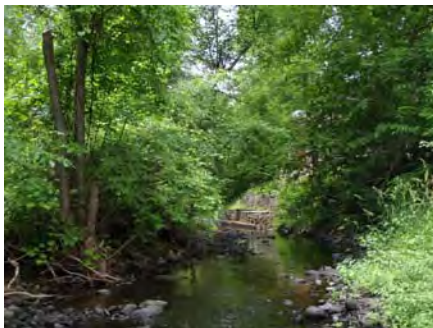
Brassil's Creek, one alteration to shoreline

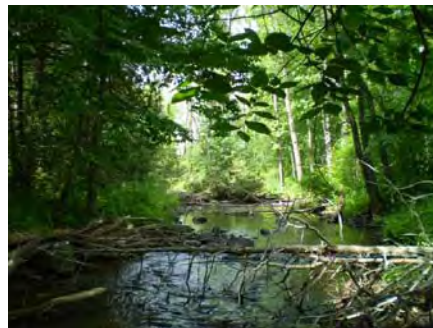
Brassil's Creek, no alterations

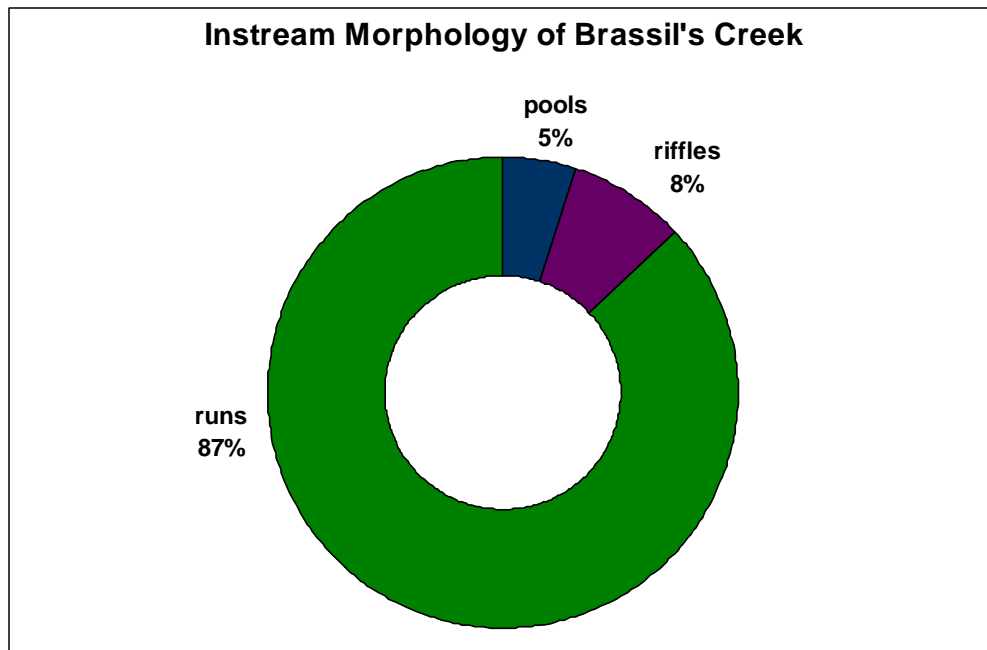
Figure 18. Instream Morphology of Brassil's Creek

Instream morphology of Brassil's Creek is fairly homogeneous and mainly consists of large runs (87 percent) with only five percent pools and eight percent riffles. This is illustrated in Figure 18. The morphology of Brassil's Creek may be highly influenced by the wetland creation. The downstream portion of Brassil's Creek consists mainly of bedrock, which lacks pool habitat features. The majority of the riffles found along Brassil's are in the bedrock section between Paden Road and the mouth.

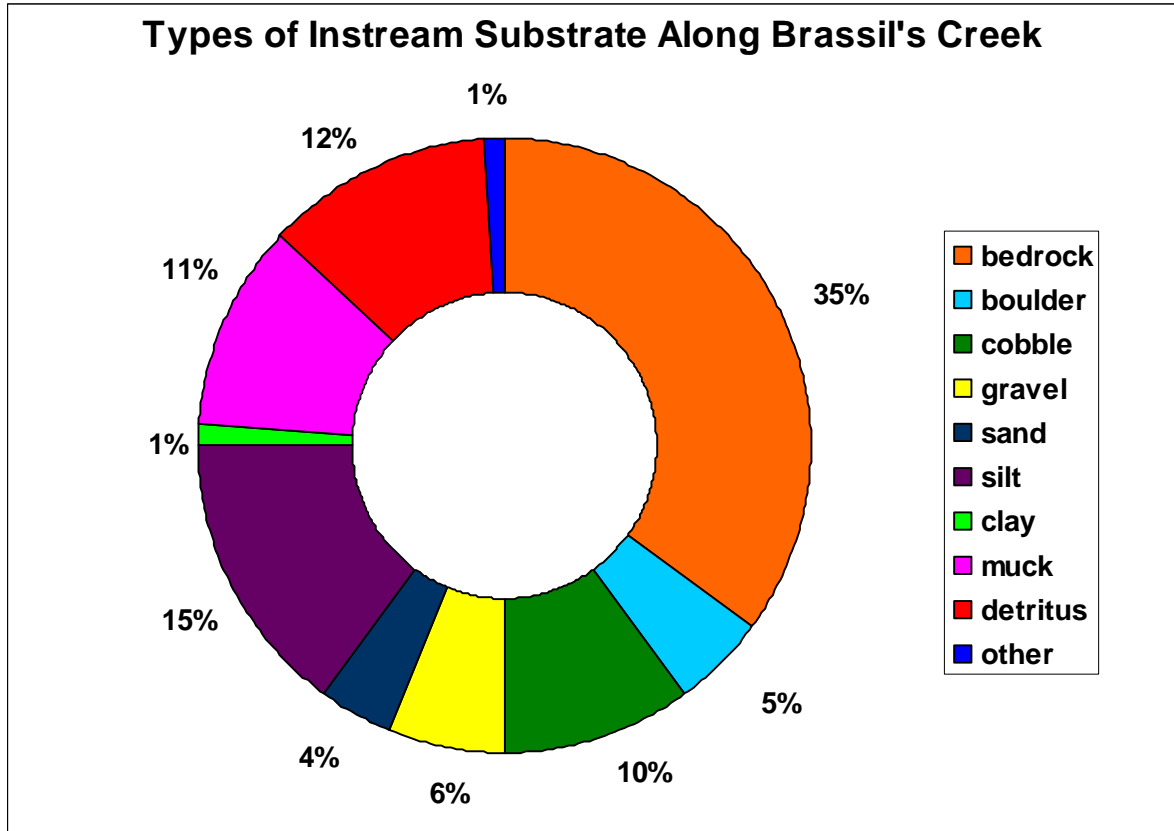
Figure 19. Types of Instream Substrate Along Brassil's Creek

A diverse variety of substrate was observed along Brassil's Creek. Diverse substrate is important for fish and benthic invertebrate habitat because some species will only occupy and/or only reproduce on certain types of substrate. Boulders create instream cover and back eddies for large fish to hide and/or rest out of the current, and cobble provides important over wintering and/or spawning habitat for small or juvenile fish. Other substrates also provide instream habitat for fish and invertebrates. Figure 19 demonstrates the instream substrate that was observed.

Thirty-five percent of the surveyed area was bedrock, with some cobble and boulder. The areas close to the wetland creation consisted mainly of muck, silt and detritus with some sand and clay. Gravel was observed in six percent of the areas sampled, and one percent was classified as "other", which refers to culverts without any sediment deposition on the base.

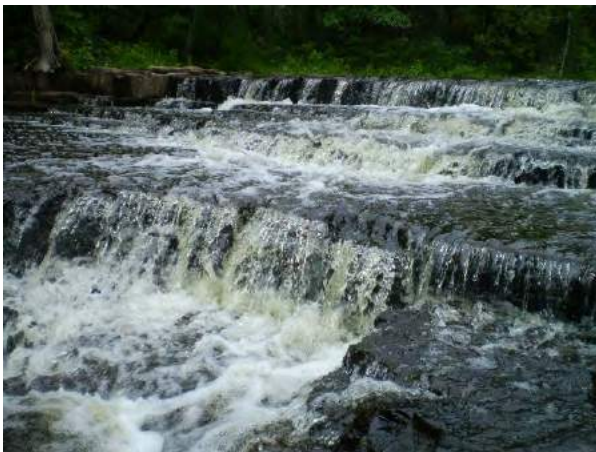
Bedrock substrate creating waterfalls along Brassil's Creek

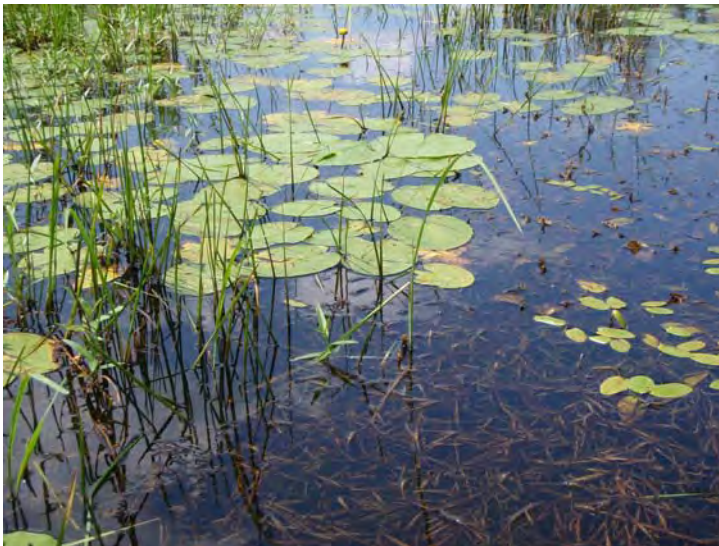
Example of extensive aquatic vegetation in Brassil's Creek, close to the wetland. The different types of vegetation observed include submergents, emergents and floating.

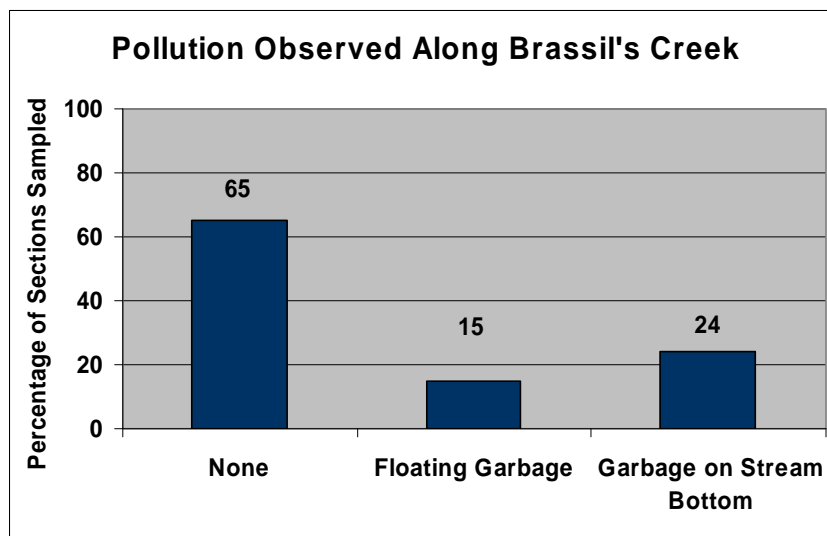
Figure 23. Frequency of Pollution/Garbage Occurring in Brassil's Creek

Sixty-five percent of the sections surveyed on Brassil's Creek were free of garbage. In the remaining thirty-five percent, garbage observed was either floating, on the bottom or both. In most areas, where garbage was found, it was low in abundance and would not require a large cleanup. Some of the items found were tin cans, a window frame, steel bars, coffee cups, broken glass, styrofoam, plastic tarps, plastic pipes, a bucket of transmission fluid, a printer, tires, a boot cleat, an old saw and plastic items such as wrappers, bags, pipes and a tub. The bucket of transmission fluid was found near the residential area. All garbage of human origin can be negatively impact a stream, but items such as transmission oil and printers (any type of electronics), can impact the water quality of a stream and affect the fish and wildlife in that area.

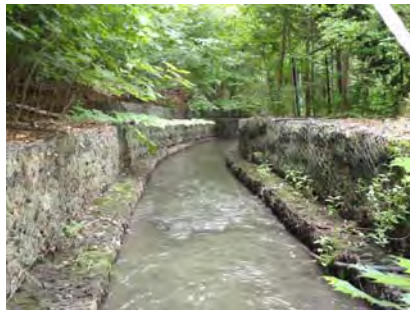
Graham Creek, highly impacted

Many residents have drainage pipes leading straight into the creek from driveways, rooftops and lawns. Pipes should be directed into a vegetated area prior to running into the creek so that plants can filter out contaminants, allowing some of the water to infiltrate into the ground and reduce the amount of stormwater running into the creek, helping to reduce water level fluctuations during storm events or freshets.

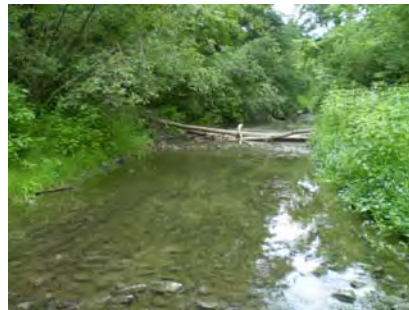
Graham Creek, one of the few natural areas

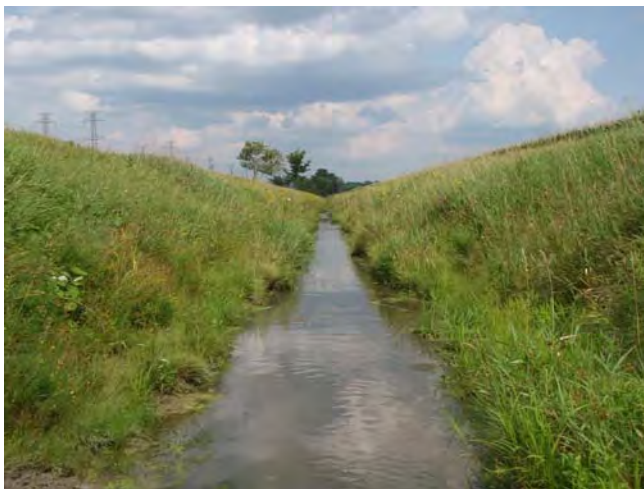
Channelized section of Graham Creek headwaters

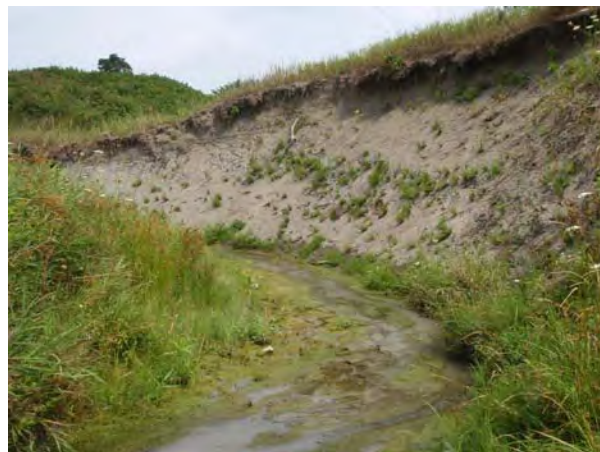
Bank erosion in headwaters of Graham

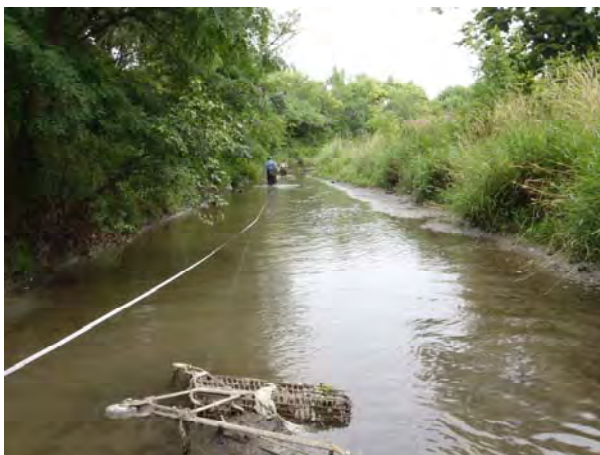
Shopping cart with plastic caught in the basket on Graham Creek

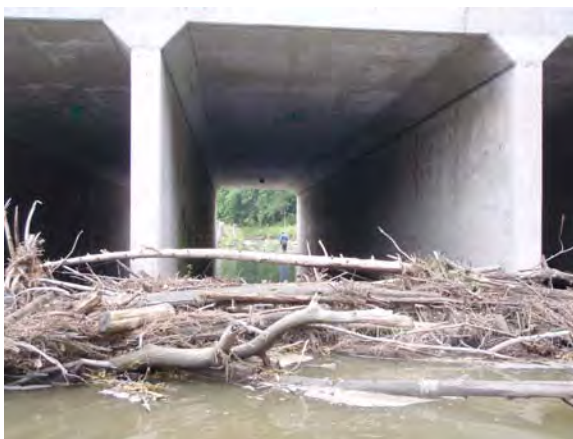
Triple box culvert at St. Joseph causing log jams

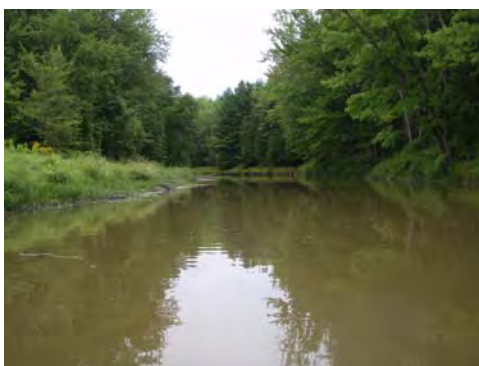
Forested land use near the mouth of Green's Creek, with a bit of open meadow

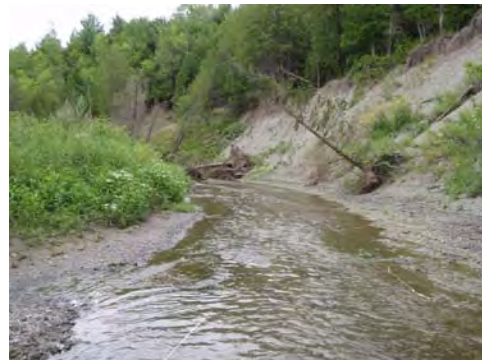
Photo of an unstable bank between Innes Road and St. Joseph Boulevard

Along Green's Creek, the right bank was considered 66 percent stable and 34 percent unstable. The left bank was considered 64 percent stable and 36 percent unstable. The area of greatest instability was recorded between St. Joseph Boulevard and Innes Road, where landslides have occurred and large unstable bluffs line the creek. In some areas, only RVCA staff carried out the surveys because of unstable creek conditions; volunteers resumed participation when more appropriate areas were reached.

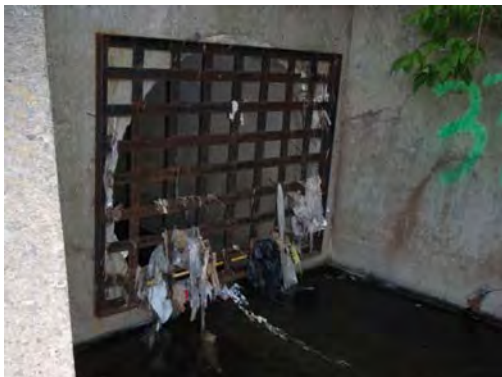
Stormwater outlet on Green's Creek

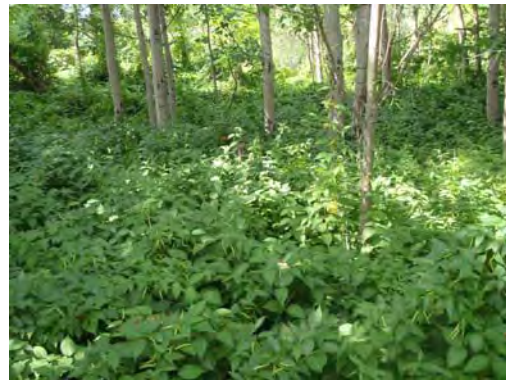
Dog-strangling vine (DSV) was observed by City Stream Watch in 2008 on Green's Creek in an area where the program had previously planted shrubs and trees. DSV is a non-native, aggressive species which spreads by seed pods and roots. It outcompetes other native species, including shrubs and trees (smothering effect). Recent studies have also shown that monarch butterflies will lay their eggs on the plant, because its seed pods are similar to that of our native common milkweed. The only

host plant that the monarch butterfly can survive on is **dog-strangling vine along Green's Creek** the common milkweed; therefore when the eggs are laid on DSV, all of the eggs die. Common milkweed still remains on the noxious weed list of Ontario, regardless of concerns over monarch populations. After consulting with members of the Fletcher Wildlife Garden, who have a long history of dog-strangling vine control, the best method for removal and disposal were chosen and a removal on was held on Green's Creek and Sawmill Creek in 2009. The vine was cut at the base, as opposed to being dug out. It was then bagged and composted at the Trail Rd. facility, where temperatures were hot enough to kill the seeds. The removals were held after the seed pods had formed to prevent further spread of the plant. Another removal was held in 2010 on the same site along Green's Creek. There is an ongoing study between native goldenrod and DSV, and it appears that goldenrod is establishing itself in areas where DSV grows. A future initiative may be to plant goldenrod at the Green's Creek site to see if it will withstand the DSV.

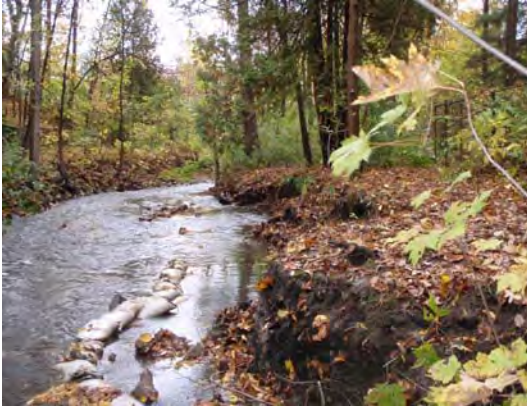
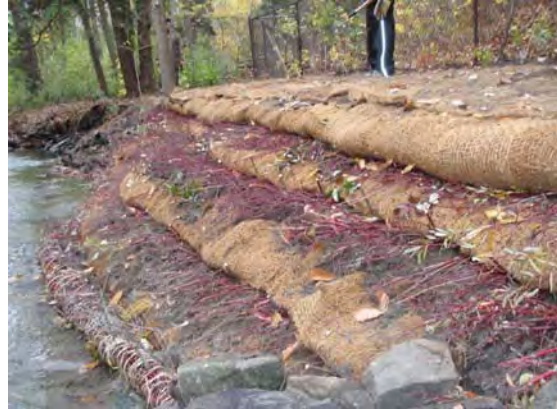
In the fall of 2010, 28 volunteers spent 121 hours on a bioengineering project on Graham Creek.

Before

After

Bioengineering is an erosion control method that combines engineering with ecological function, designed to mimic what nature already does. It is an old science that has been around since 28 B.C. (Riparian Workshop, 2010) and uses plant species with specific growth habits (willows, dogwoods) to create structures that form large root masses which stabilize soil and provide riparian habitat. The exposed area of vegetation (branches, leaves) creates a rough surface, helping to slow water flows and reduce the velocity of the water. When this occurs, the energy the water carries is dispersed through the vegetation and not the soil. The root systems hold the soil together and the structures are created in a way that provides a much larger and denser root mass, as opposed to individual trees, which is key in stabilizing the shoreline. The benefits of improving the riparian area are numerous and include improved aesthetics, better habitat for both instream and riparian areas (nesting, shelter, food), and improved water quality (filtration and uptake of contaminants, nutrients). In terms of structural benefits, bioengineering can be used on steep slopes and sensitive areas with limited access or in areas where machinery cannot be brought in. Another structural benefit is that plants are flexible, can bend and are able to repair themselves, whereas harder structures can break, require maintenance and the costs are much higher.

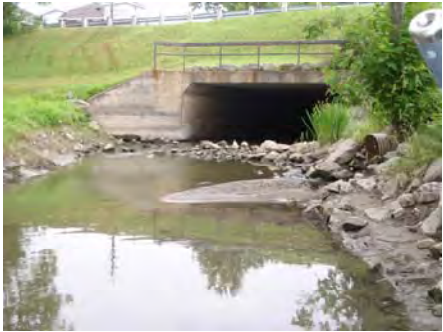
Location	Issue	Picture	Remediation Strategy	Expected Results
Stillwater Creek, at the mouth	Andrew Haydon Park is located at the mouth of Stillwater Creek. The creek has lost its buffer between the mouth and the Carling Avenue crossing. Grass is mowed to the edge of the stream. The streambanks have eroded due to fluctuating water levels.

<ul style="list-style-type: none"> • Determine land ownership and discuss possible partnership and remediation options • Riparian planting where possible • Identification of areas that require more intensive methods of erosion protection (i.e. bioengineering, etc.) • Utilize existing volunteer base of the City Stream Watch program and recruit volunteers from neighbouring communities to participate in this rehabilitation effort 	<ul style="list-style-type: none"> • Community involvement • Effective stream bank protection • Reduce siltation of fish spawning habitat • The enhancement of conditions for natural colonization of existing plant community • Produce streamside wildlife habitat • Provide public demonstration site of a healthy shoreline

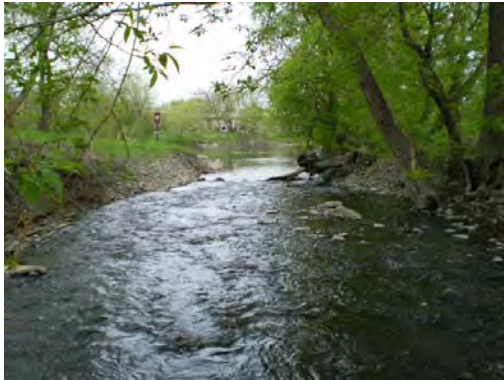
Sawmill Creek, at the mouth	The mouth of Sawmill Creek flows into the Rideau River near Billing's Bridge. There is a well-used park and walking path in its vicinity. There is little riparian vegetation along the banks at the mouth, and the shoreline needs stabilization as previous stabilization efforts have failed and washed into the creek. Banks could be re-graded and bioengineering techniques could be used to enhance to restore the bank, provide more riparian habitat and create a visual buffer demonstration for the public to experience.

<ul style="list-style-type: none"> • Determine possible project partnership and design with landowner • Use bioengineering methods • Plant a variety of native species at top of slope, after bioengineering is complete • Utilize existing volunteer base of the City Stream Watch program and recruit volunteers from interested neighbourhood community associations 	<ul style="list-style-type: none"> • Community involvement • Effective stream bank protection • Reduce siltation of fish spawning habitat • Produce streamside wildlife habitat and enhance biodiversity • Create attractive buffer demonstration site for public to showcase a healthy shoreline

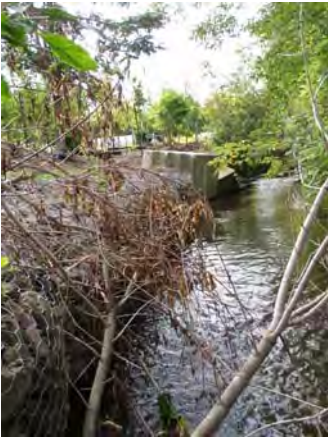
Location	Issue	Picture	Remediation Strategy	Expected Results
Sawmill Creek, at Artistic Landscape	Sawmill Creek has been channelized in this area and has lost much of its buffer. The banks are eroding and need natural stabilization techniques.

<ul style="list-style-type: none"> • Determine landowner interest and/or permission • If landowner is interested, develop project partnership and design with a number of stakeholders • Use bioengineering methods • Plant a variety of native species at top of slope, after bioengineering is complete • Utilize existing volunteer base of the City Stream Watch program and recruit volunteers from interested neighbourhood community associations 	<ul style="list-style-type: none"> • Community involvement • Effective stream bank protection • Reduce siltation of fish spawning habitat • Produce streamside wildlife habitat and enhance biodiversity • Create attractive buffer demonstration site for public

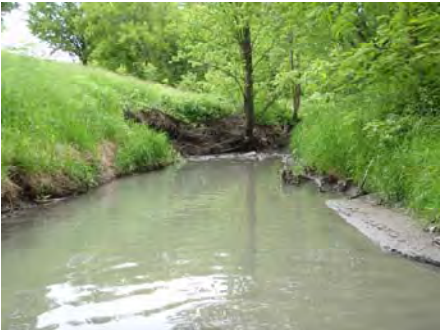
Location	Issue	Picture	Remediation Strategy	Expected Results
Bilberry Creek, various locations	Along Bilberry Creek, there are small areas that have little riparian vegetation. The banks along Bilberry are quite unstable, and a lack of riparian vegetation exacerbates the issue.

<ul style="list-style-type: none"> • Determine land ownership • Utilize existing volunteer base of the City Stream Watch to participate in several planting efforts along the shorelines 	<ul style="list-style-type: none"> • Community involvement • Enhancement of fish and wildlife habitat • Enhance conditions for natural colonization of existing plant community • Improve water quality and water quantity entering the stream in those areas • Enhancement of the creek's aesthetic qualities

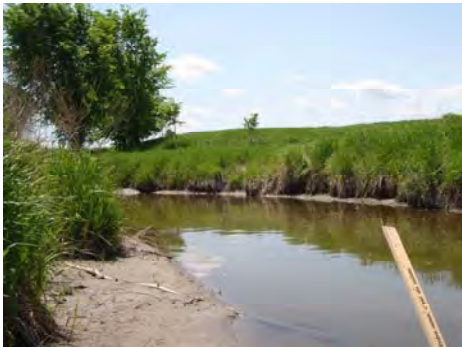
Mosquito Creek, various locations	There are a number of areas along Mosquito Creek that have a limited buffer. These areas are not providing the habitat they should be for fish or wildlife.

<ul style="list-style-type: none"> • Determine land ownership • Address planting proposals with private landowners through existing tree planting programs at the RVCA and the Shoreline Naturalization Program 	<ul style="list-style-type: none"> • Community involvement • Improve water quality and quantity entering stream • Enhance fish and wildlife habitat • Provide shade to help moderate water temperatures • Enhance conditions for natural colonization of existing plant community

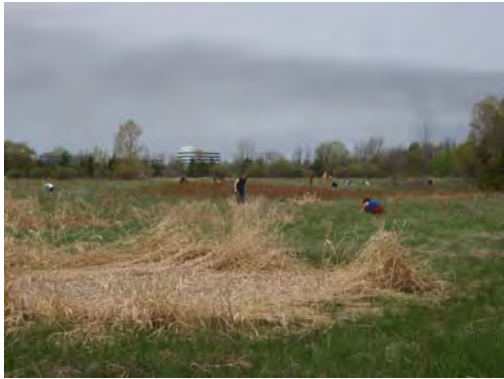
Location	Issue	Picture	Remediation Strategy	Expected Results
Green's Creek	Between the Pineview Golf Course and Green's Creek is open field and there are erosion issues along that shoreline, despite an existing buffer. One planting of the tableland was carried out in 2010, but due to the large area, it requires several more years of planting.

<ul style="list-style-type: none"> • Carry out riparian planting in future years when feasible in collaboration with Pine View Golf Course and the NCC • Continue to monitor the site and evaluate shrub and tree survival 	<ul style="list-style-type: none"> • Community involvement • Protection of lower slope by planting the tableland above • Enhance biodiversity and provide greater wildlife food and habitat
Location	Issue	Picture	Remediation Strategy	Expected Results
Green's Creek, south of Innes Road	There is a section along Green's Creek where flowering rush (an invasive species) is becoming problematic and choking the creek. This can affect fish passage and stream health. Native aquatic plants, such as pickerelweed, are being outcompeted.

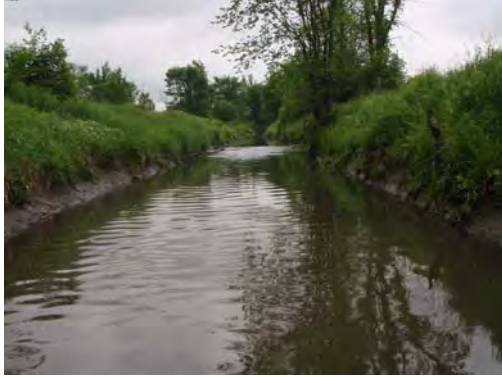
Location	Issue	Picture	Remediation Strategy	Expected Results
McEwan Creek	McEwan Creek has been channelized between the 417 and the mouth. The creek has widened out and is flat and shallow. There is an area where a bank is eroding into the creek.

<ul style="list-style-type: none"> • Determine possible project partnership and design with landowner • Use bioengineering methods for shoreline area needing stabilization • Plant a variety of native species at top of slope • Enhance fish habitat with boulder placement, old Christmas trees and root wads • Utilize existing volunteer base of the City Stream Watch program and recruit volunteers from interested neighbourhood community associations 	<ul style="list-style-type: none"> • Community involvement • Effective stream bank protection • Reduce siltation of fish spawning habitat • Enhance fish habitat by providing refuge areas and instream structure • Produce streamside wildlife habitat • Improve water quality and water level fluctuations through increased riparian vegetation and roughness

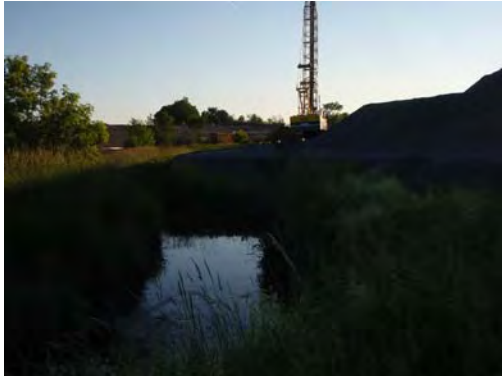
Location	Issue	Picture	Remediation Strategy	Expected Results
McEwan Creek	The new Hunt Club extension runs adjacent to McEwan Creek in two major areas, the headwaters and adjacent to Hwy 417. The proximity of the extension and the increased stormwater runoff may have detrimental impacts to the creek.

<ul style="list-style-type: none"> • Conduct site visits post-construction to determine any problem areas • If problem areas are identified, contact appropriate landowner and discuss remediation solution (riparian planting or bioengineering) 	<ul style="list-style-type: none"> • Determine whether future riparian plantings and buffer enhancements are needed
