# Pinecrest Creek 2011 Summary Report

Pinecrest Creek is considered to be one of Ottawa's most urbanized streams. Land use within the subwatershed has been transformed from forest to agricultural to urbanized, its current state. The past land use changes have altered the creek considerably (Sabourin, J.F. & Associates, Inc., 2011). Pinecrest Creek is 4.2 kilometres long, beginning south of Hunt Club Road as agricultural drains, and flows north, emptying into the Ottawa River just west of Westboro Beach. Although it is 4.2 kilometres long, only 2.5 kilometres of the stream is open to air; the rest of the creek is entombed. The stream is piped from the headwaters to Baseline and then Carling Avenue to just north of the Ottawa River Parkway. Much of the past development occurred without any stormwater management implementation, and this has heavily impacted proper stream function, accelerated erosion and led to degradation of water quality and fish habitat. A field inventory conducted by J.F. Sabourin and Associates Inc. (2011) identified 52 outfalls within the watershed. There is also a culvert near the mouth of the creek that is an obstruction to fish passage; as a result, only a s

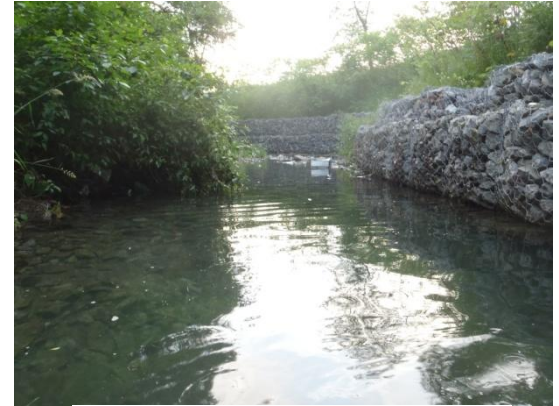
Photo of gabion baskets, a bank alteration

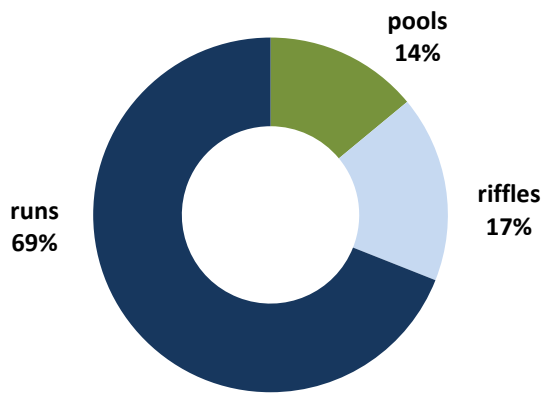
Figure 5. Instream Morphology of Pinecrest Creek

Pools and riffles are important features for fish habitat. Riffles are areas of agitated water, and they contribute higher dissolved oxygen to the stream and act as spawning substrate for some species of fish, such as walleye. Pools provide shelter for fish and can provide refuge in the summer if water levels drop and water temperature in the creek increases. Pools also provide important over-wintering areas for fish. Runs are usually moderately shallow, with unagitated water surfaces, and areas where the thalweg (deepest part of the channel) is in the center of the channel. Pinecrest Creek had a good variety of runs, pools and riffles as, illustrated in Figure 5.

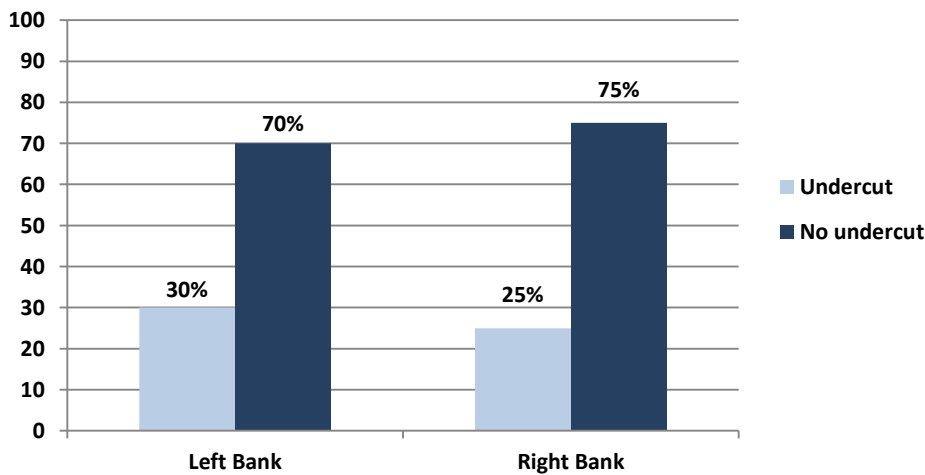
Figure 8. Amount of Undercut Banks Along Pinecrest Creek

Undercut banks are a normal and important part of stream function. The overhanging banks provide excellent refuge areas for fish. Of the sections surveyed, 30 percent of the left bank and 25 percent of the right bank were considered undercut.

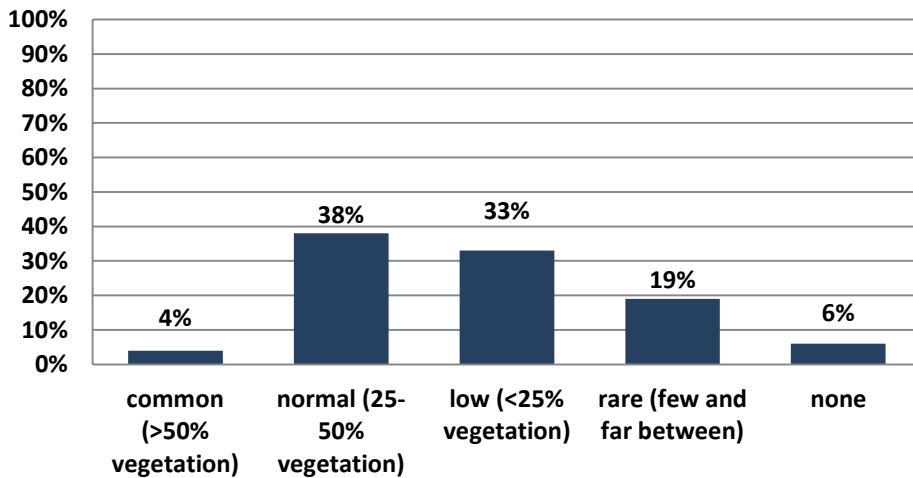
Figure 10. Amount of Instream Vegetation in Pinecrest Creek

Instream vegetation is an important factor for a healthy stream ecosystem. Vegetation helps to remove contaminants from the water, contributes oxygen to the stream, and provides habitat for fish and wildlife. However, too much vegetation can be detrimental. Figure 10 demonstrates the frequency of instream vegetation in Pinecrest Creek. Pinecrest Creek did not have a healthy level or variety of instream vegetation for most of its length; only 42 percent was considered to have common or normal levels, and in these areas, the majority of the vegetation observed was algae. Fifty-two percent of the stream was considered to have low or rare levels, and six percent of the surveyed areas had no vegetation at all. Pinecrest Creek has flashy water level fluctuations that could make it challenging for instream vegetation to establish itself.

The amount of instream vegetation has increased significantly since 2006. The percentages of common and normal levels of vegetation have increased, although so have low levels. The percentage of rare levels has decreased. Despite the increased amount of vegetation in 2011, it was still 99 percent algae, which is indicative of high nutrient enrichment.

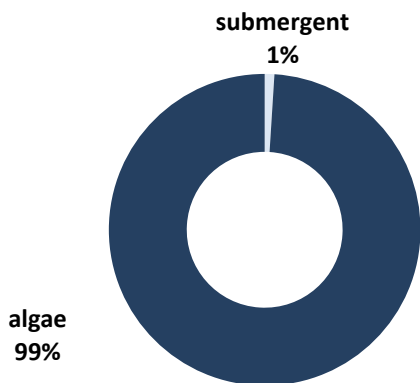
Figure 11. Types of Instream Vegetation in Pinecrest Creek

Different types of vegetation are required for different species of fish, birds and wildlife. A healthy stream will have a variety of instream vegetation. Pinecrest Creek did not have a healthy diversity of instream vegetation. Ninety-nine percent of sections surveyed consisted of algae, and only one percent had submergent vegetation which was located at the mouth of the stream.

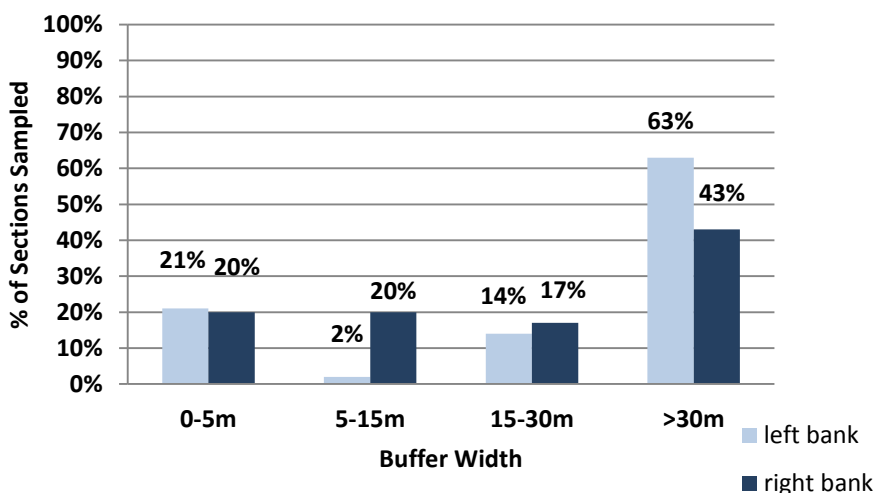
Figure 12. Buffer Evaluation of Pinecrest Creek

Natural buffers between watercourses and human alterations are extremely important for filtering excess nutrients running into the creek, infiltrating rainwater, maintaining bank stability and providing wildlife habitat. Natural shorelines also shade the creek, helping maintain baseflow levels and keeping water temperatures cool. According to the document *How Much Habitat Is Enough*, it is recommended that a stream have a minimum of 30 metres of riparian area or more (the more the better). Along Pinecrest Creek, 20 to 21 percent had a buffer of only zero to five metres. Two percent of the left bank and 20 percent of the right bank had a buffer of five to 15 metres. Fourteen to 17 percent had a buffer of 15 to 30 metres. Sixty-three percent of the left bank met the minimum buffer recommendation from the Environment Canada document; however, this was only achieved on 43 percent of the right bank.

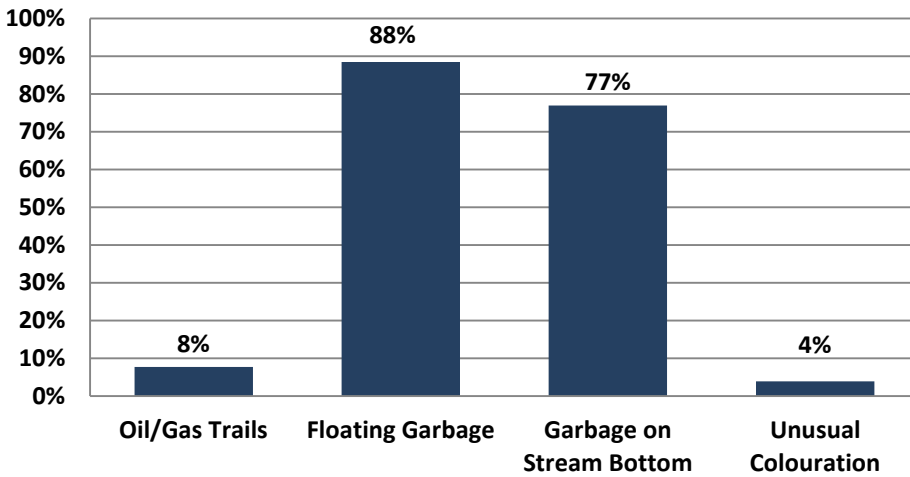
Figure 14. Frequency of Pollution/Garbage Occurring in Pinecrest Creek

Figure 14 demonstrates a high incidence of pollution/garbage found along Pinecrest Creek. Pollution and garbage in the stream is assessed visually and noted for each section where it is observed. All sections surveyed had some type of garbage. Eighty-eight percent had floating garbage and 77 percent had garbage on the stream bottom. In eight percent of the sections, oil and gas trails were observed, and in four percent of the sections, there was unusual colouration of the stream channel. Pinecrest is a very accessible creek, surrounded by residential, commercial and recreational areas, resulting in a higher level of garbage found. There were many different types of garbage seen along Pinecrest Creek. There is a significant problem with fast food waste (bags, wrappers, drink cups) and smashed beer bottles in certain areas of the creek. There were also hundreds of cigarette butts and an abundance of plastic (containers, bags, wrappers, bottles). More interesting items included action figure and dolls, clothing, scrap metal, tires, shopping carts, bicycles, rubber, caution tape, election signs, skis, jump rope and bags of carrots.

The incidence of garbage has increased. In 2006, eight percent of the sections surveyed were free from garbage. In 2011, no sections surveyed were garbage free. There was a significant increase in floating garbage and a slight decrease in garbage on the stream bottom. In 2006, no sections had oil or gas trails, and in 2011, eight percent of the sections did. In 2011, unusual colouration of the stream bed was observed in four percent of the sections surveyed. This category was added to the field protocol in 2008, and therefore cannot be compared with 2006.

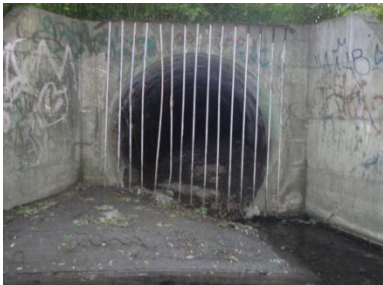
Photo of stormwater outlet in Section 4

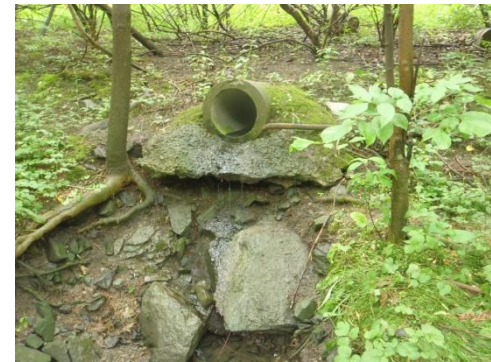
Photo of stormwater outlet in Section 22

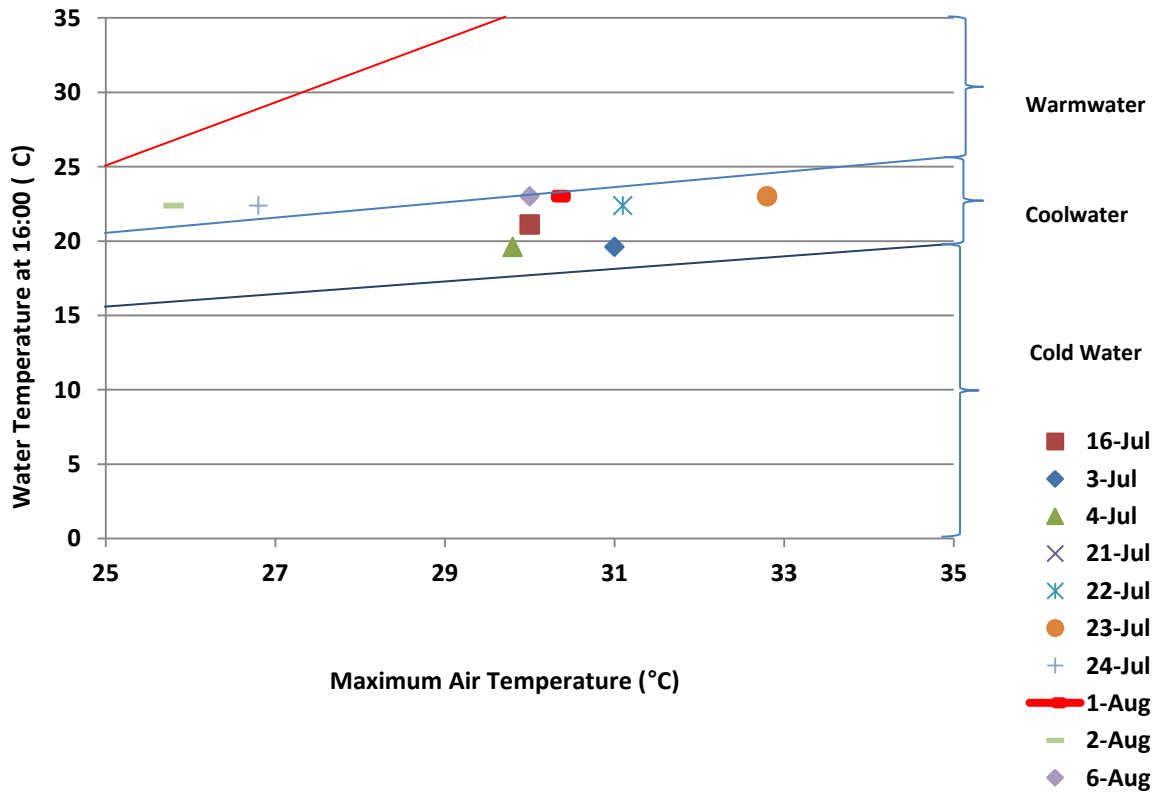
Figure 19. Thermal Classification for Temperature Dataloggers on Pinecrest Creek

When analyzed on the nomograph (Figure 19), it appears that Pinecrest Creek is a coolwater system. All temperature dataloggers were within that range, aside from two which were in the warmwater range.
