# Mosquito Creek 2015 Summary Report

In 2015, 75 sections (7.5 km) of Mosquito Creek were surveyed as part of the City Stream Watch monitoring activities. The following is a summary of observations made by staff and volunteers along those 75 sections.

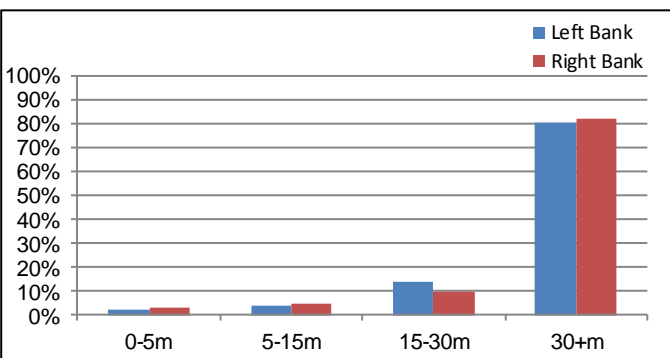
The riparian or shoreline zone is that special area where the land meets the water. Well-vegetated shorelines are critically important in protecting water quality and creating healthy aquatic habitats, lakes and rivers. Natural shorelines intercept sediments and contaminants that could impact water quality conditions and harm fish habitat in streams. Well established buffers protect the banks against erosion, improve habitat for fish by shading and cooling the water and provide protection for birds and other wildlife that feed and rear young near water. A recommended target (from Environment Canada's Guideline: How Much Habitat is Enough?) is to maintain a minimum 30 meter wide vegetated buffer along at least 75 percent of the length of both sides of rivers, creeks and streams. Mosquito Creek has a very healthy buffer width along most of its length. It surpassed the target above by having a buffer of greater than 30 meters along 80 percent of the right bank and 82 percent of the left bank. Figure 2 demonstrates the buffer conditions of the left and right banks separately.

Figure 2 Vegetated buffer width along Mosquito Creek

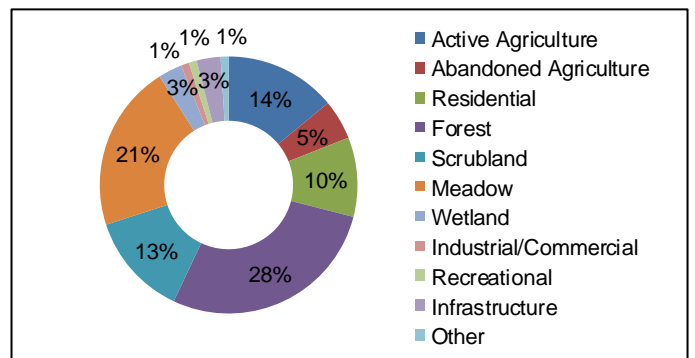
The RVCA's City Stream Watch Program identifies 11 different land uses beside Mosquito Creek (Figure 3). Surrounding land use is considered from the beginning to end of each survey section (100m) and up to 100m on each side of the creek. Land use outside of this area is not considered for the surveys but is nonetheless part of the subwatershed and will influence the creek. Natural areas made up 65 percent of the surveyed stream, characterized by forest, scrubland, meadow and wetland. Nineteen percent of the land use along the surveyed sections of the stream was made up of agriculture and abandoned agriculture while 10 percent was residential use. The remaining six percent of the land use surveyed was recreational, industrial/commercial and infrastructure which includes any road crossings.

Figure 3 Land use along Mosquito Creek

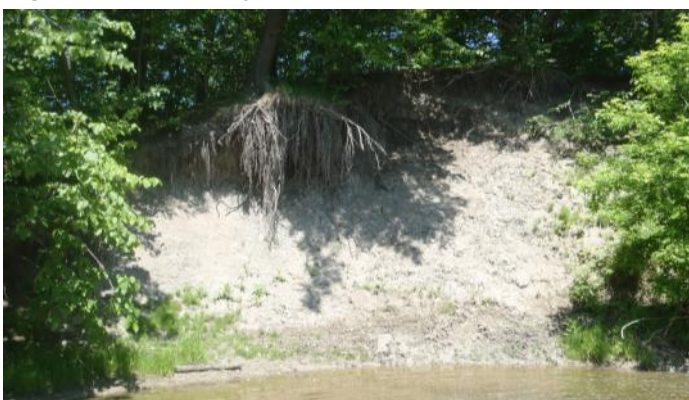
Stream bank erosion along Mosquito Creek

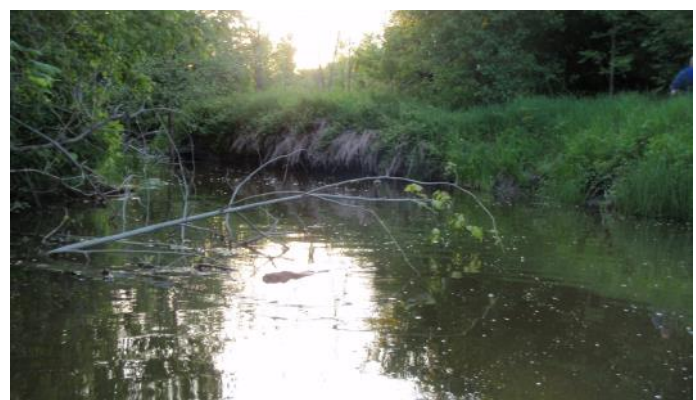
Bank undercutting along Mosquito Creek

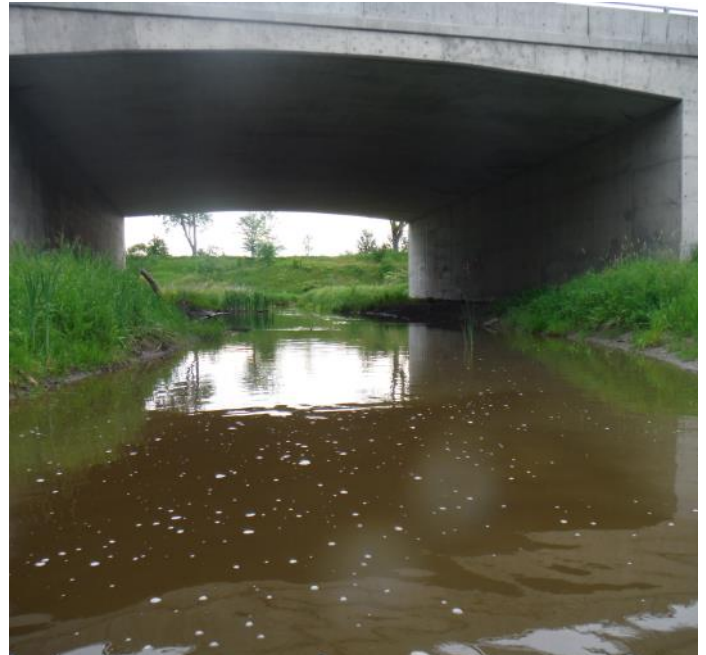
A highly altered section of Mosquito Creek running through the culvert at Limebank Road

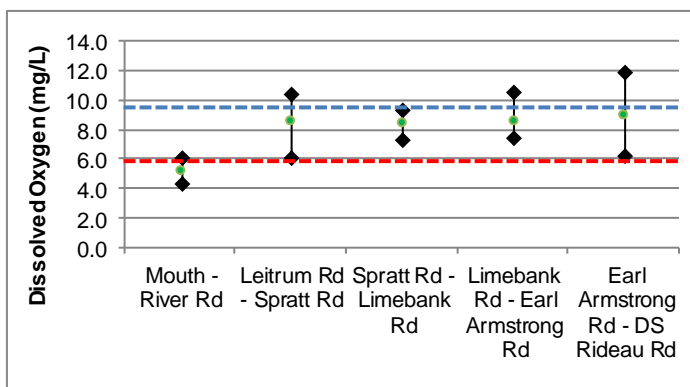
Dissolved oxygen is a measure of the amount of oxygen dissolved in water. The Canadian Environmental Quality Guidelines of the Canadian Council of Ministers of the Environment (CCME) suggest that for the protection of aquatic life the lowest acceptable dissolved oxygen concentration should be 6 mg/L for warmwater biota (red line in Figure 22) and 9.5 mg/L for coldwater biota (blue line in Figure 22) (CCME, 1999). Figure 22 shows that most of the stretches of Mosquito Creek meet the standard for warmwater biota. The stretch of creek from the mouth of the creek to River Road had lower average dissolved oxygen compared to other stretches and doesn't meet standard of 6 mg/L for warmwater biota.

Figure 22 Dissolved oxygen ranges in Mosquito Creek

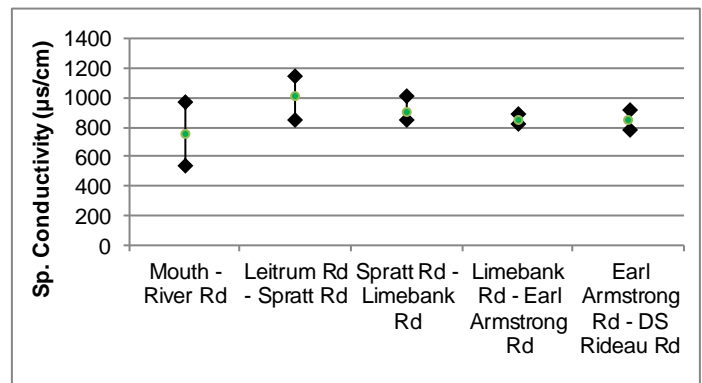
Conductivity in streams is primarily influenced by the geology of the surrounding environment, but can vary drastically as a function of surface water runoff. Currently there are no CCME guideline standards for stream conductivity, however readings which are outside the normal range observed within the system are often an indication of unmitigated discharge and/or stormwater input. The average specific conductivity observed within Mosquito Creek was 874  $\mu\text{s}/\text{cm}$ . Figure 23 shows that the conductivity readings varied moderately along the course of the creek. The lowest average specific conductivity reading on Mosquito Creek was 752  $\mu\text{s}/\text{cm}$  which was recorded in the stretch of the creek from the mouth to River Road. A slightly elevated average specific conductivity of 1011  $\mu\text{s}/\text{cm}$  was recorded between Leitrim Road and Spratt Road, then the average specific conductivity moderates in the last three sections at 899  $\mu\text{s}/\text{cm}$ , 852  $\mu\text{s}/\text{cm}$  and 855  $\mu\text{s}/\text{cm}$  respectively.

Figure 23 Conductivity ranges in Mosquito Creek

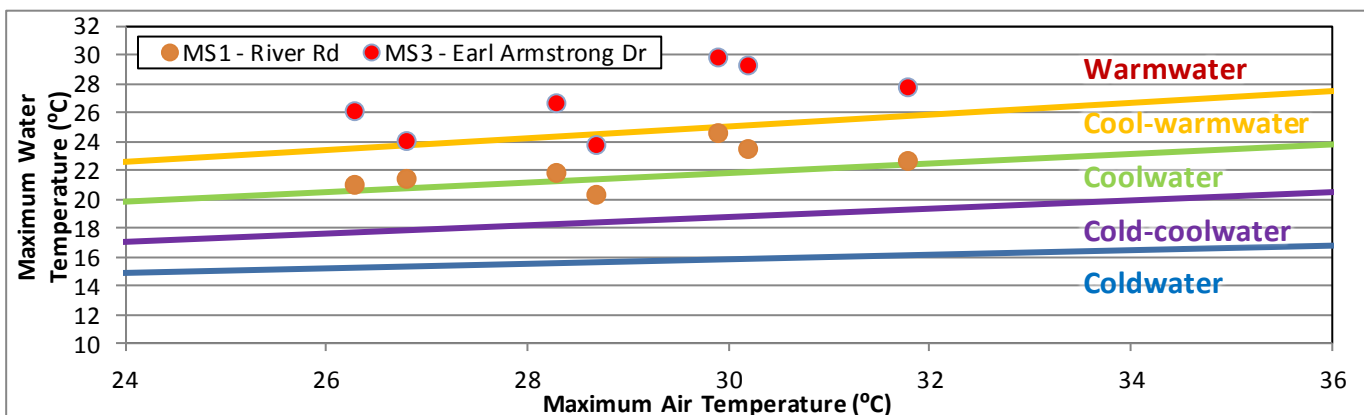
Analysis of the data collected indicates that the thermal classification of Mosquito Creek ranges between cool-warm water and warm water (Figure 27).

Figure 27 Thermal Classification for Mosquito Creek

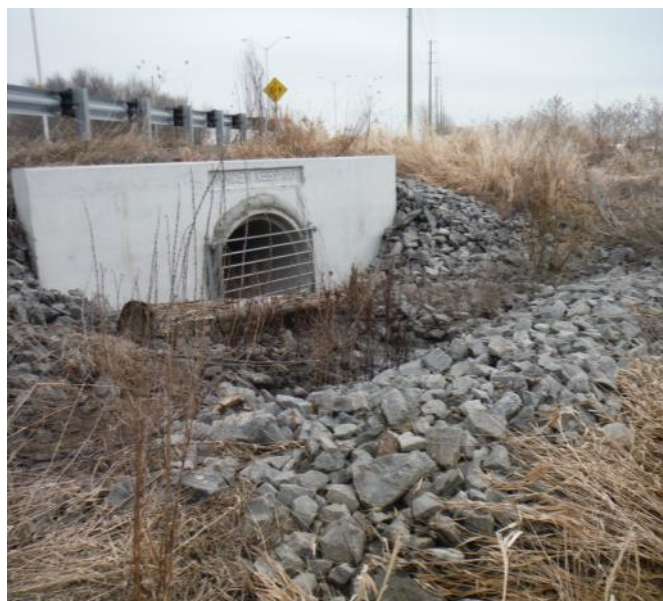
Culvert along Earl Armstrong Road creating a grade barrier

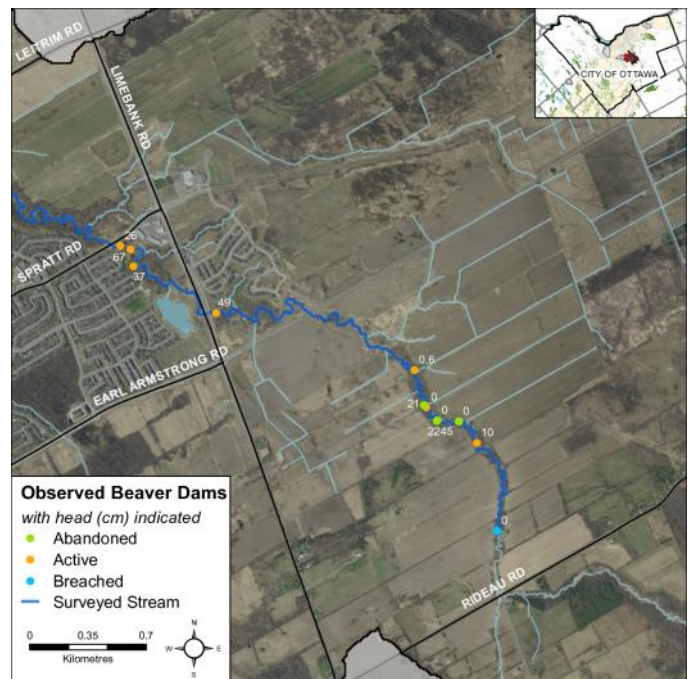
Beaver dams can also act as obstructions to fish migration. Figure 30 shows that many beaver dams were observed on Mosquito Creek upstream of Spratt Road and in the upper reaches of the creek. The head, or difference between the water level up and down stream, of the beaver dams ranged from 0 cm to 45 cm.

**Figure 30** Beaver dams observed on Mosquito Creek

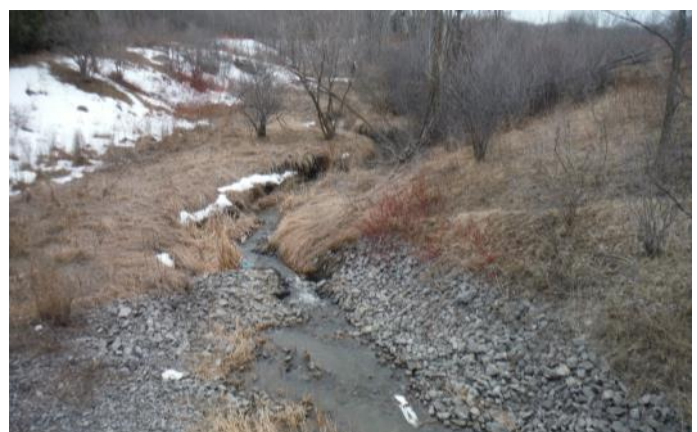
Channel hardening at an HDF site along Limebank Road

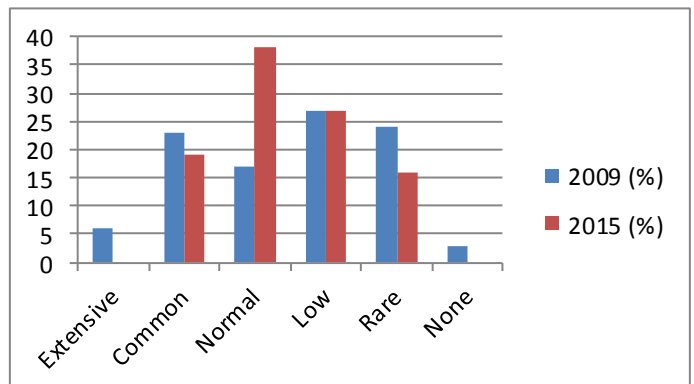
Figure 39 shows that there has been a slight overall decrease in instream vegetation in Mosquito Creek since 2009. The amount of extensive and common levels of vegetation totaled 29 percent in 2009. In 2015 no extensive levels were recorded and common levels totaled 19 percent. The amount of normal levels of vegetation totaled 17 percent in 2009 and increased to 38 percent in 2015. The amount of low levels of vegetation has remained the same at 27 percent in both 2009 and 2015 whereas the rare levels have decreased from 24 percent in 2009 to 16 percent in 2015. The vegetation levels in Mosquito Creek appear to be normal overall so the change and shift over time may be attributable to climatic variables as well as the stage of the growing season when observations took place.

**Figure 39** Comparison of instream vegetation levels between 2009 and 2015
