Pinecrest Creek 2017 Catchment Report

Introduction

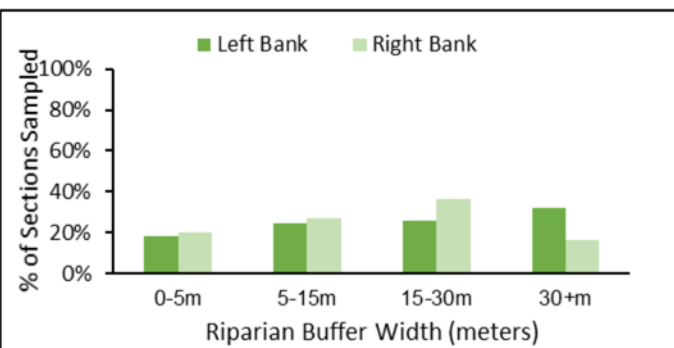
Figure 2 Vegetated buffer width along Pinecrest Creek

Figure 2 demonstrates buffer conditions along the left and right banks of the surveyed sections of Pinecrest Creek. Buffers greater than 30 meters were present along 32 percent of the left bank and 17 percent of the right bank. Buffers of 15 to 30 meters in length were observed in 26 percent of the left bank and 36 percent of the right bank. Buffers of five to 15 meters were found in 24 percent of the left bank and 27 percent of the right bank. Buffers smaller than five meters were present along 18 percent of the left banks and 20 percent of the right bank.

Improvements can be made in the riparian buffer in the areas where buffers are lower than the guidelines along 68 percent of the left bank and 83 percent of the right bank. Many areas along the right bank are park lands where there is opportunity to expand these buffer.

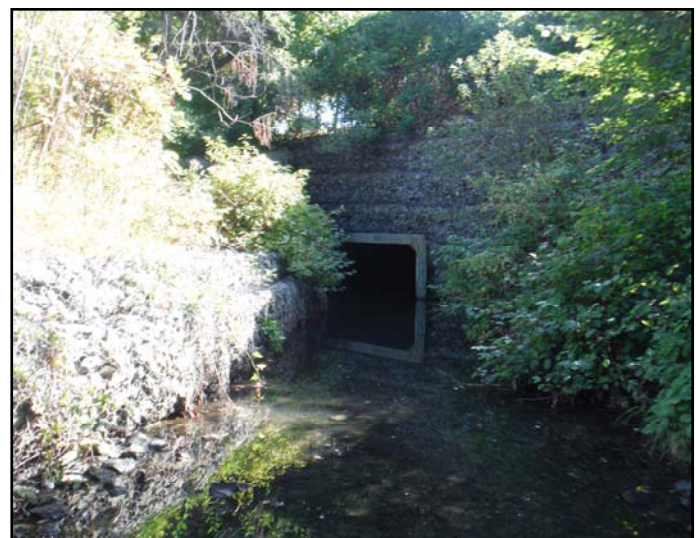
Heavily modified stream section along Pinecrest Creek

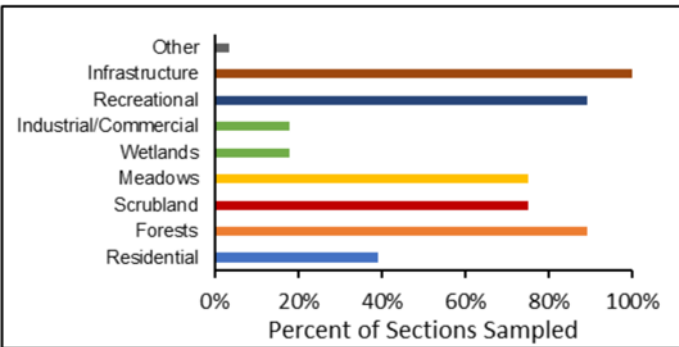
Figure 4 Adjacent land use 100 m from each shoreline and percentage of presence along open areas of Pinecrest Creek

Forests and scrubland were present in 89 percent and 75 percent of the sections surveyed. Meadows were present in 75 percent of the open creek areas, and wetland were in 18 percent. Wetland areas were mostly found at the mouth and small fragmented areas along stormwater drainage features.

Aside from the natural areas, the most common land uses in the catchment were associated with parks, transit corridors and roadways, with 100 percent of the sections containing infrastructure and 89 percent of the areas had recreational uses. Other uses observed included residential areas present in 39 percent of sections, industrial or commercial and other uses were identified in 18 percent of the adjacent land use.

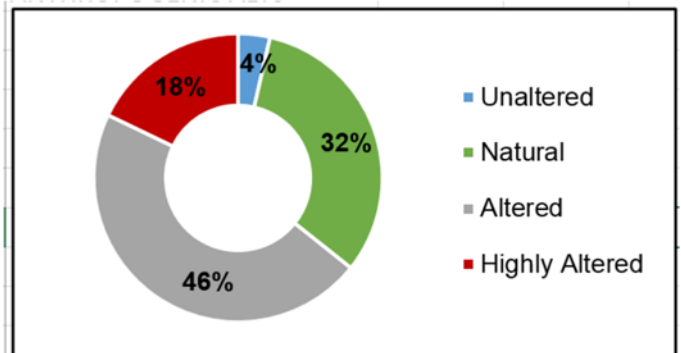
Figure 5 Anthropogenic alterations along Pinecrest Creek

Figure 5 shows the level of anthropogenic alterations of the 28 open sections surveyed in Pinecrest Creek. With only four percent remaining without any human alteration. Of the open sections, 32 percent fall in the classification of natural. Natural sections have not been straightened or diverted, have a riparian buffer greater than 15 meters, contain few lawns, ornamental gardens, beaches, rip rap or constructed wooden structures.

Altered sections account for 46 percent of surveyed areas, they may contain diverted or straightened sections and riparian buffers of five to 15 meters. Shoreline alterations also include concrete. One or two storm water outlets could also be present. Highly altered sections (18% of sections) have the highest proportions of alterations. Including riparian buffers less than five meters, shoreline alterations are found on most of the section, and portions of the stream may flow through culverts.

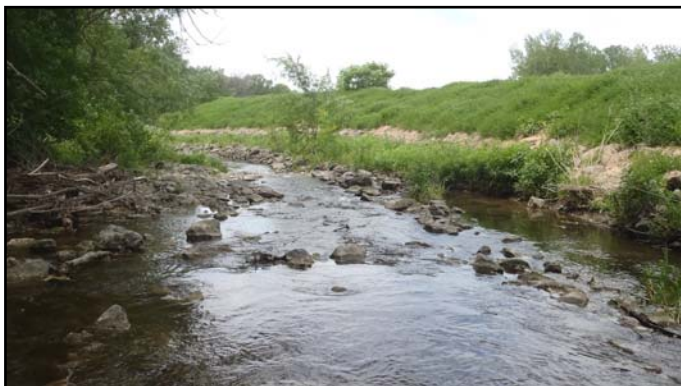
Shoreline re-grading by NCC for erosion control along Pinecrest Creek

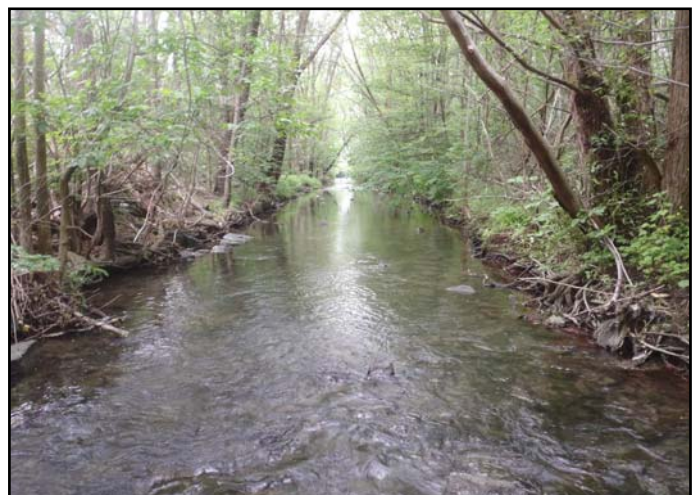
Undercut banks along Pinecrest Creek

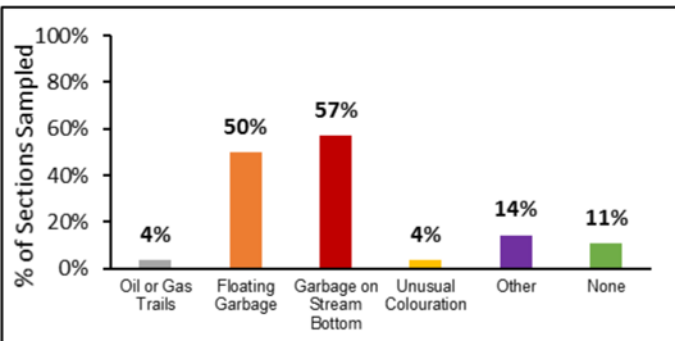
Figure 21 Pollution observed within Pinecrest Creek

Figure 21 shows the types of pollution observed in Pinecrest Creek. The levels of garbage found in the stream were high, with 25 of the 28 sections surveyed containing some type of pollution. Some of the garbage observed included styrofoam, plastics, cans, shopping carts, cigarette filters, furniture and dog waste.

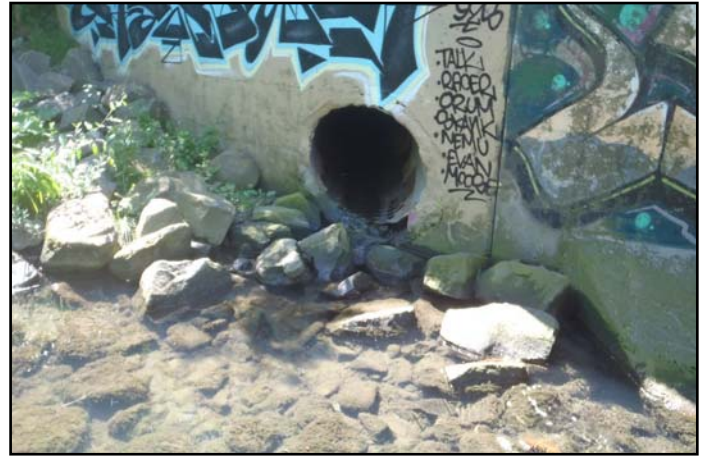
Storm water outflows in a section of Pinecrest Creek with elevated conductivity and reduced oxygen conditions downstream of Woodroffe Avenue

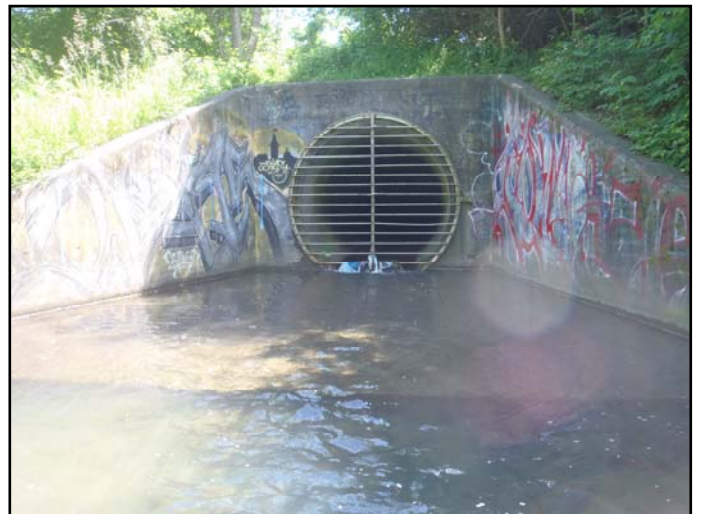
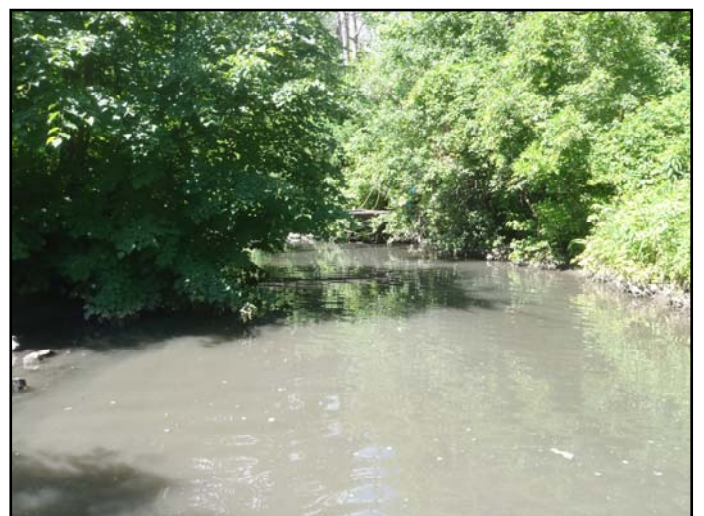
Section of Pinecrest Creek with elevated conductivity levels downstream of Woodroffe Avenue

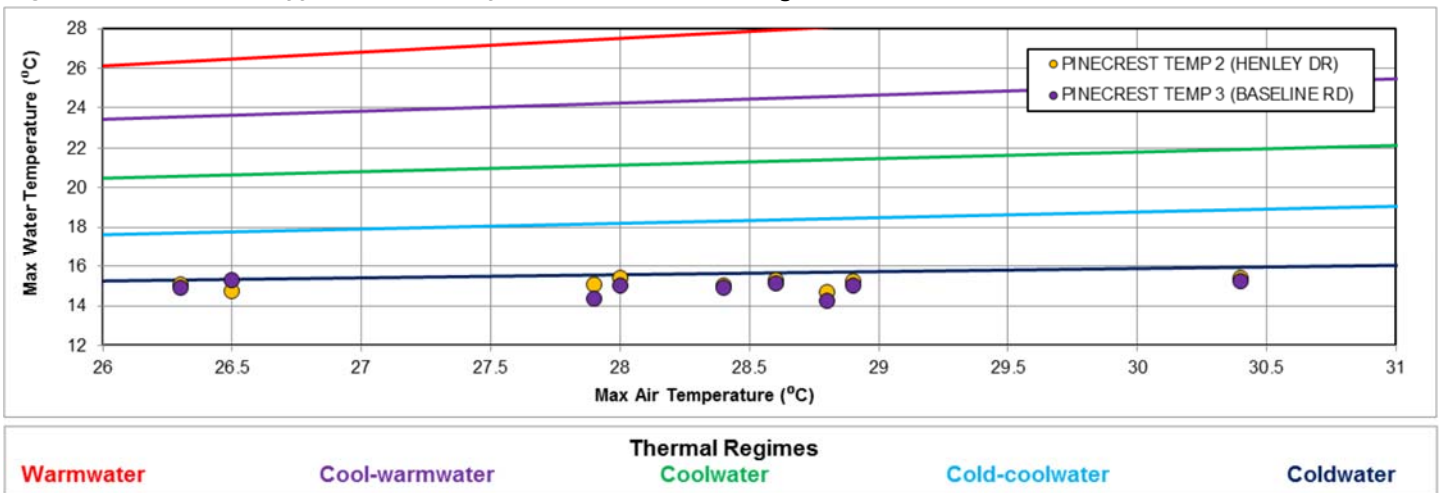
Figure 27 shows where thermal sampling sites were located. Analysis of data from two loggers (using the Stoneman and Jones method adapted by Chu et al., 2009), Pinecrest Creek is classified as **cold water** (Figure 28).

Figure 28 Thermal Classification for Pinecrest Creek with the five thermal regimes adapted from Stoneman and Jones (1996) by Chu et al. (2009): **cold water** category for twosites sampled on Pinecrest Creek

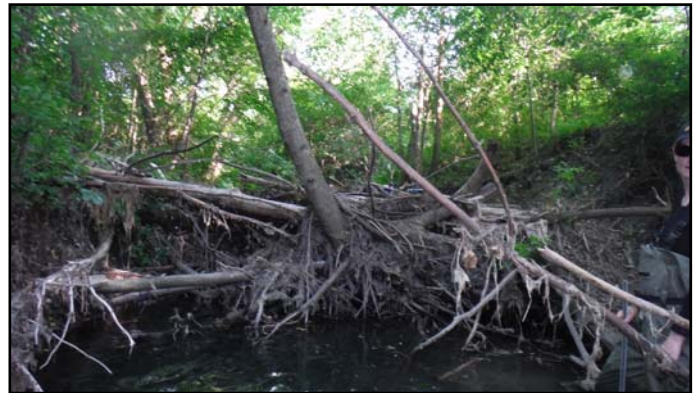
Woody material dam along Pinecrest Creek in the Connaught Park area

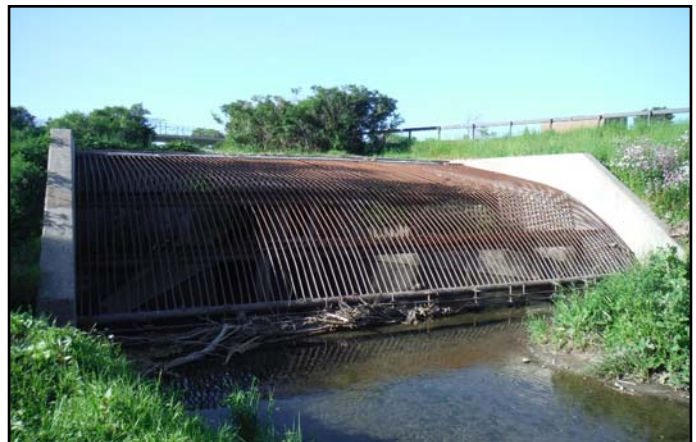
Entombment of Pinecrest Creek near Carling Avenue

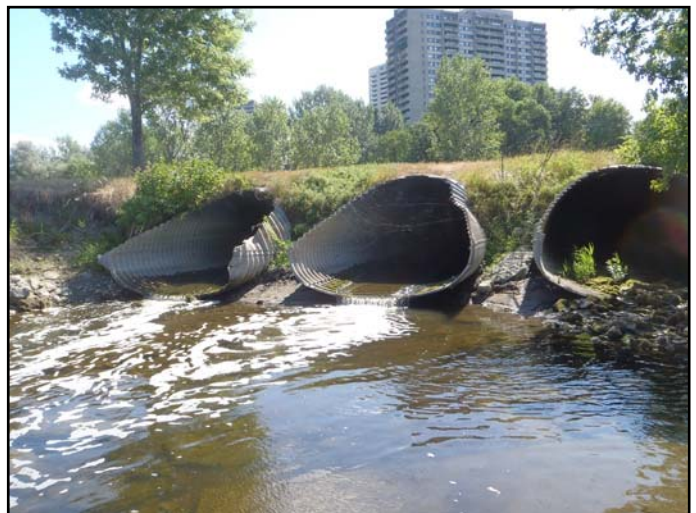
The most notorious obstructions along Pinecrest Creek is the perched culverts by the Sir John A. Macdonald Parkway, located downstream of the Carling entombment. In the Connaught Park area, there is one woody material dam that was observed, and further upstream there is a grade barrier created by bedrock ledges. The locations of the obstructions observed in 2017 are shown in Figure 31.

Perched culverts near the Sir John A. Macdonald Parkway (downstream of the Carling Avenue entombment)

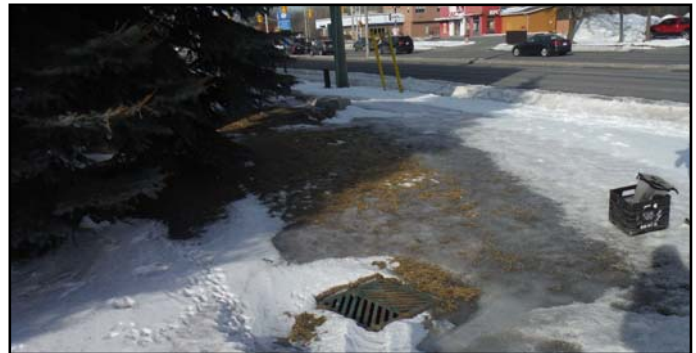
The images below show the conditions of these features sampled in 2017. The feature located along Baseline Road is located in a parking lot and was modified to a stormwater drain. The HDF along Centrepoint Road is no longer present, with no stormwater drains present at the site. The third feature evaluated along Hunt Club Road, was an intermittent constrained channel that conveyed snowmelt and rain water adjacent to a cropped field.

Headwater drainage feature in Pinecrest Creek catchment heavily modified into a stormwater drain along Baseline Road

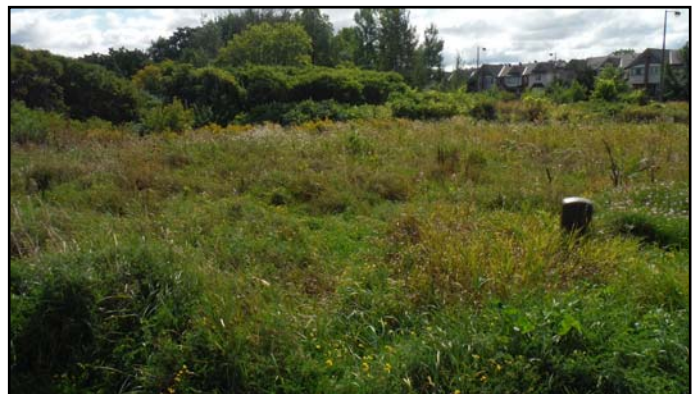
HDF is no longer present/connected to the Pinecrest Creek catchment along Centrepoint Road near Baseline Road

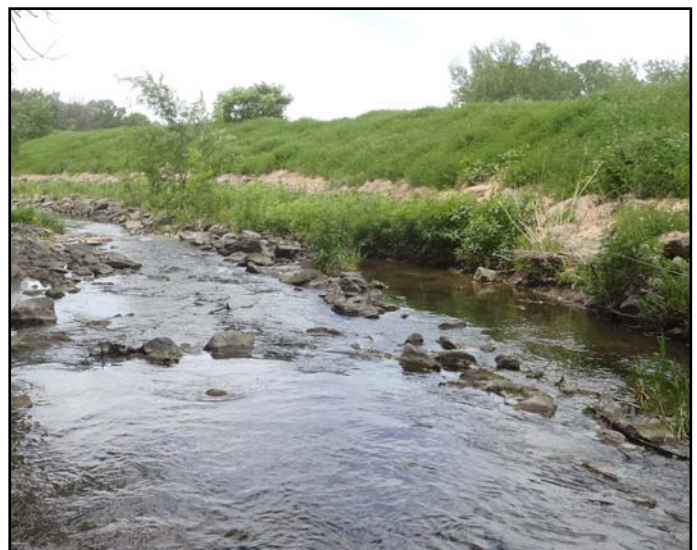
Low diversity riparian area that can benefit from riparian planting along Pinecrest Creek
