# Nepean Creek 2018 Catchment Report

## Introduction

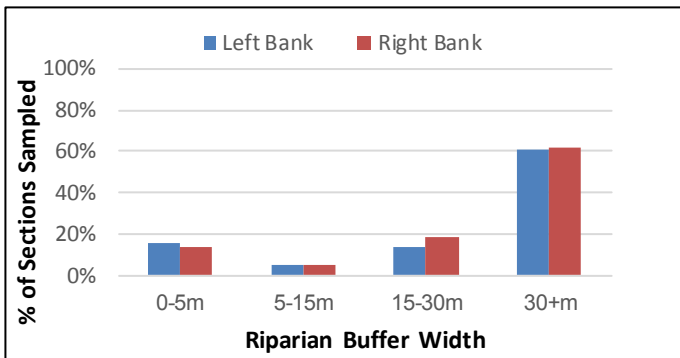
Figure 2 Vegetated buffer width along Nepean Creek

Figure 2 demonstrates buffer conditions along the left and right banks of Nepean Creek. Buffers greater than 30 meters were present along 61 percent of the left bank and 62 percent of the right bank. A 15 to 30 meter buffer was present along 14 percent of the left bank and 19 percent of the right bank; five to 15 meter buffers were observed along five percent of the left bank and six percent of the right bank. A five meter buffer or less was present along 16 percent of the left banks and 14 percent of the right bank. Efforts have been made to maintain generous buffer widths when possible along this urban stormwater system.

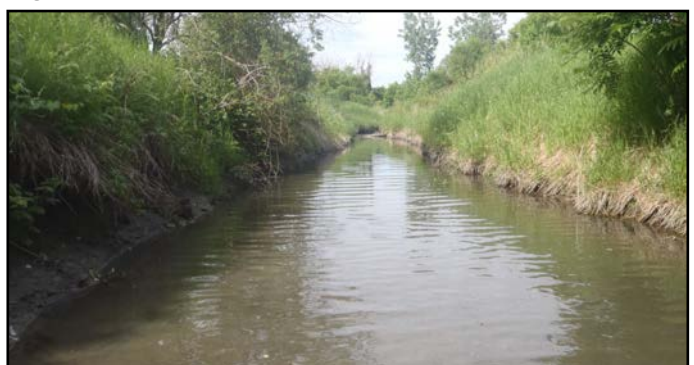
Channel straightening along Nepean Creek

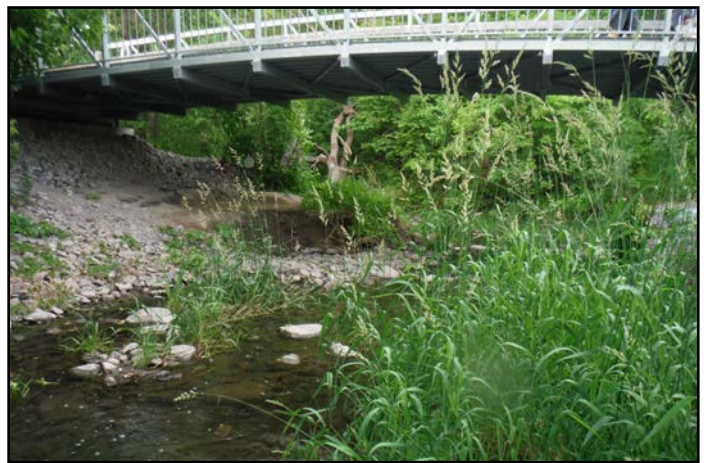
Pedestrian pathway altering a section of Nepean Creek

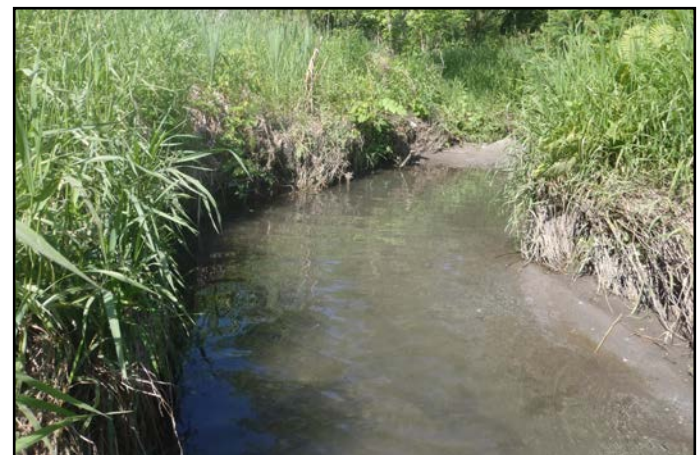
Exposed tree roots and bank undercutting along Nepean Creek

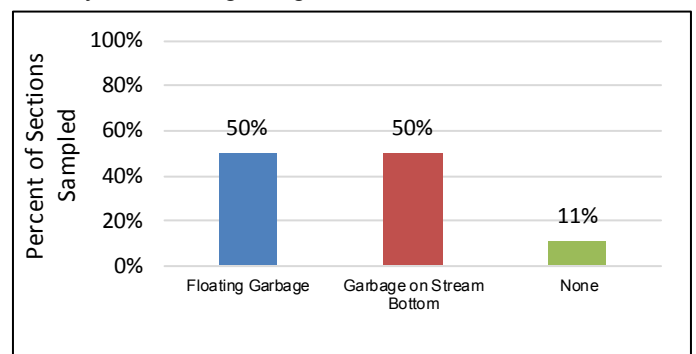
**Figure 21** Pollution observed along Nepean Creek

Figure 21 shows the types of pollution observed in Nepean Creek. The levels of garbage found in the main portion of the stream were high, with 50 percent of sections surveyed containing floating garbage and 50 percent of sections containing garbage on the stream bottom. Eleven percent of the sections surveyed had no garbage.

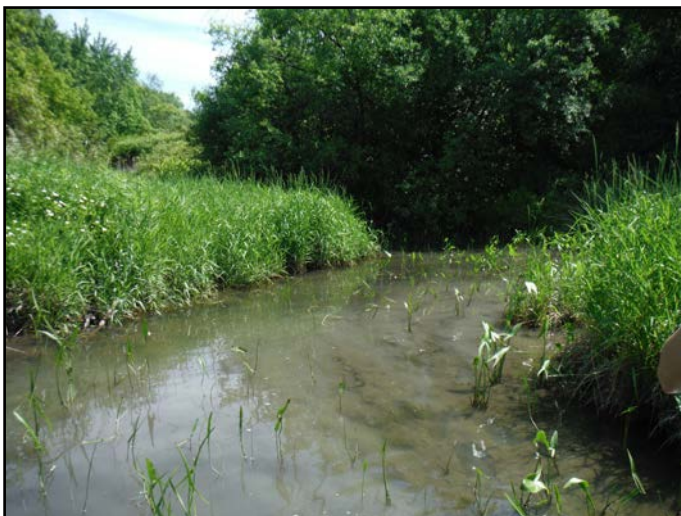
Section of Nepean Creek adjacent to the offline stormwater management pond with moderately elevated levels of specific conductivity

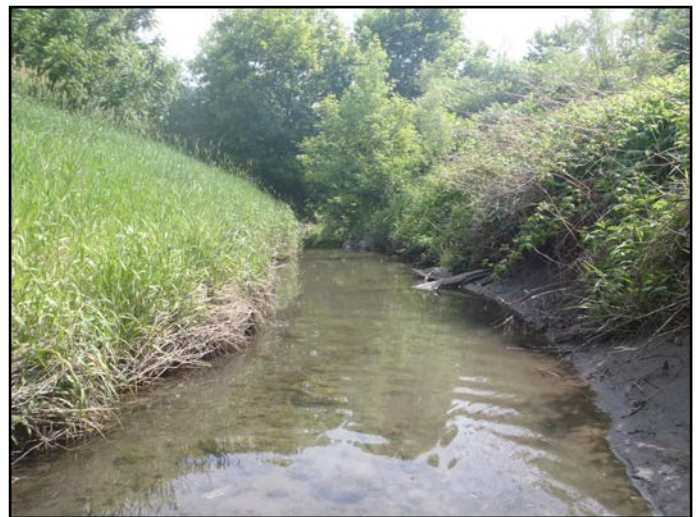
Section of Nepean Creek upstream of online stormwater pond with moderately elevated levels of specific conductivity

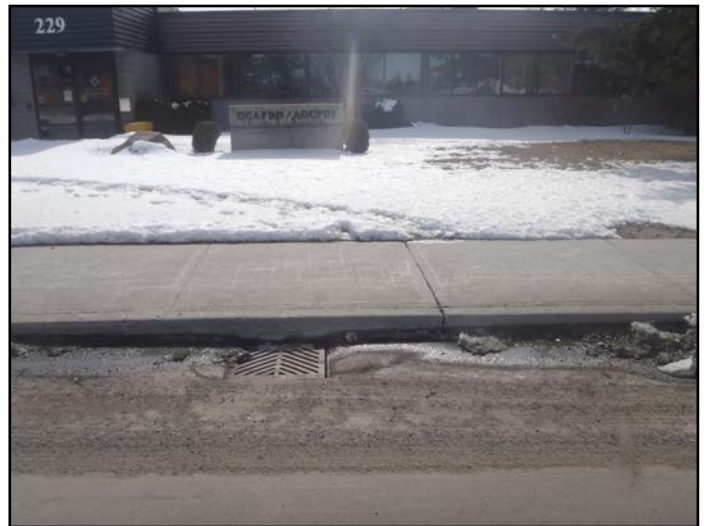
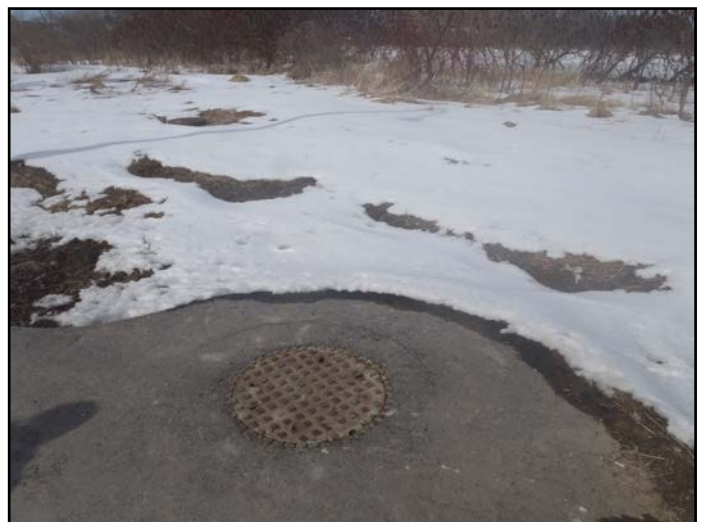
Both top and bottom images show the conditions of the features sampled in 2018. These features are located along Colonnade Road. Once natural features, they are now a part of the stormwater system for Nepean Creek

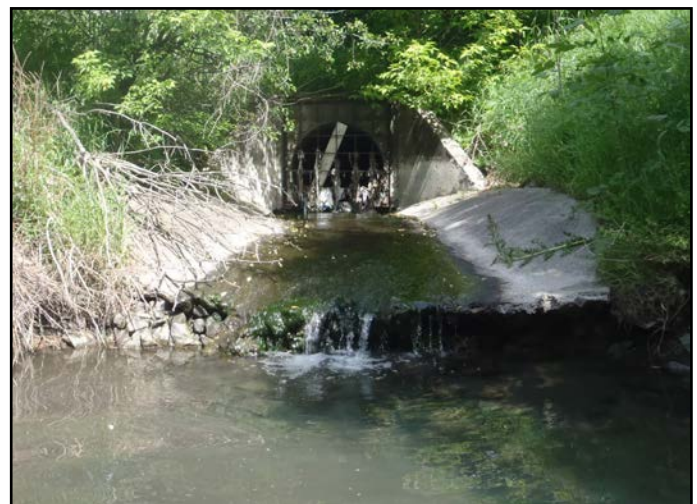
Stormwater outlet partially blocked with garbage and debris; out-letting into Nepean Creek
