Borthwick Creek 2019 Catchment Report

Introduction

In 2019 the City Stream Watch program surveyed 32 sections (3.2 km) of the main stem of Borthwick Creek and 15 sections (1.5 km) of its northern branch. Six sites were sampled for fish community composition and data from one temperature logger was collected at one of these sites. Three headwater drainage feature sites were assessed in the spring and in the summer. The following is a summary of our observations and assessment.

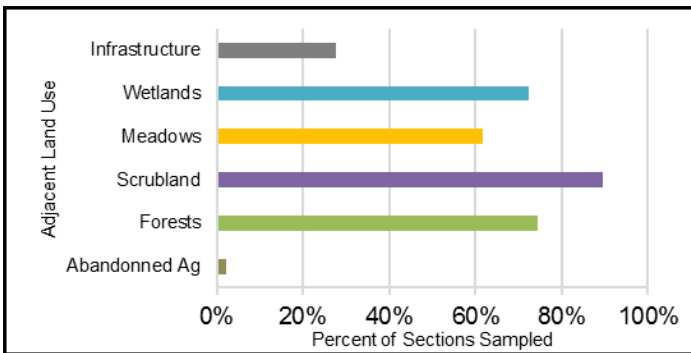
Figure 4 Adjacent land use 100 meters from each shoreline and percentage of presence along Borthwick Creek and Borthwick Creek Branch combined

Forest and scrubland were present in 74 percent and 89 percent of the sections surveyed, being the most common land use observed. Wetlands were present in 72 percent of the surveyed areas, and meadow was present in 62 percent of sections.

Aside from the natural areas, the most common land use in the catchment was infrastructure, with 28 percent of the sections containing public facilities including roads, bridges and culverts. The other two percent of land use was attributed to abandoned agriculture.

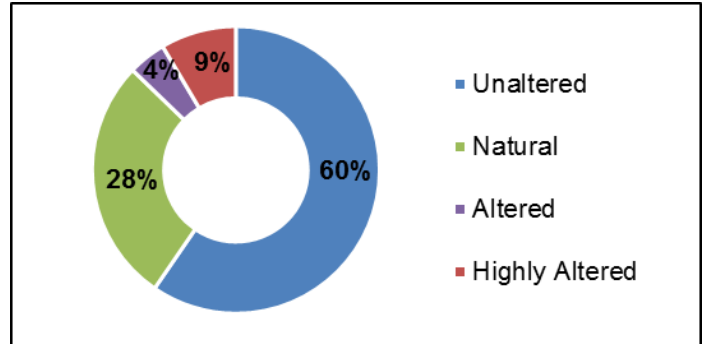
Figure 5 Anthropogenic alterations along Borthwick Creek and Borthwick Creek Branch combined

Four of the surveyed sections were highly altered. The riparian buffers were less than five meters in width, shoreline alterations were found on most of the sections including rip rap and storm water outlets were present at road crossings. These sections were mostly found near road and highway infrastructure.

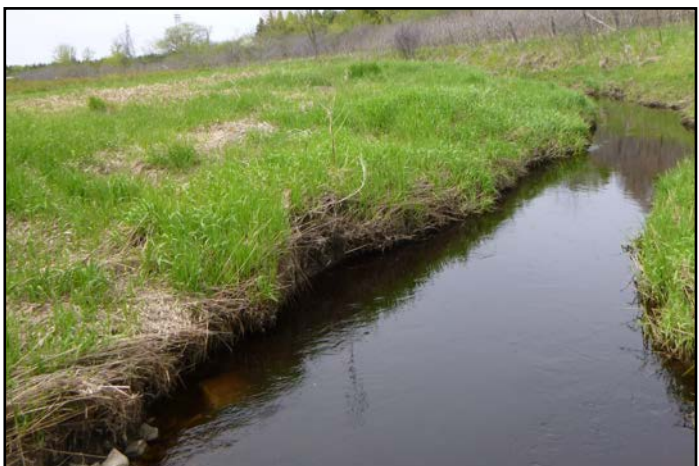
Bank sloughing along Borthwick Creek between Highway 417 and Anderson Road

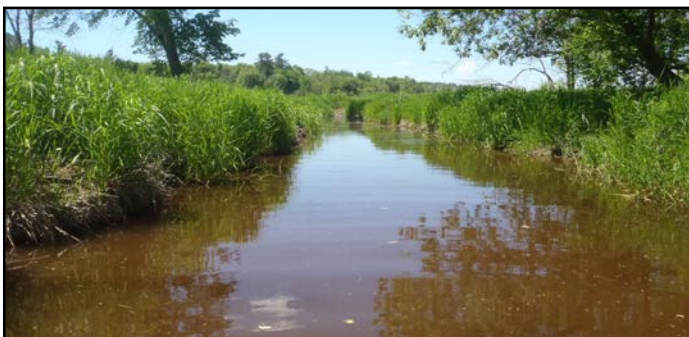
Section on Borthwick Creek west of Anderson Road with **impaired** oxygen conditions (Dissolved oxygen levels of 2.24 mg/L and 23.5 % saturation)

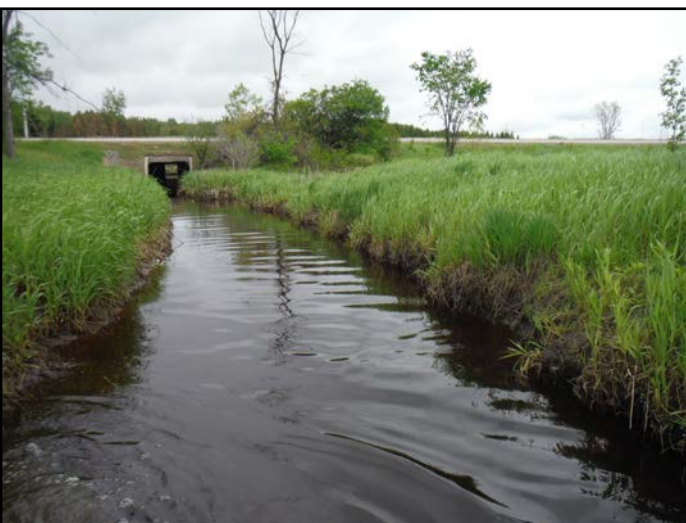
Section of Borthwick Creek near highway 417 with highly elevated levels of specific conductivity

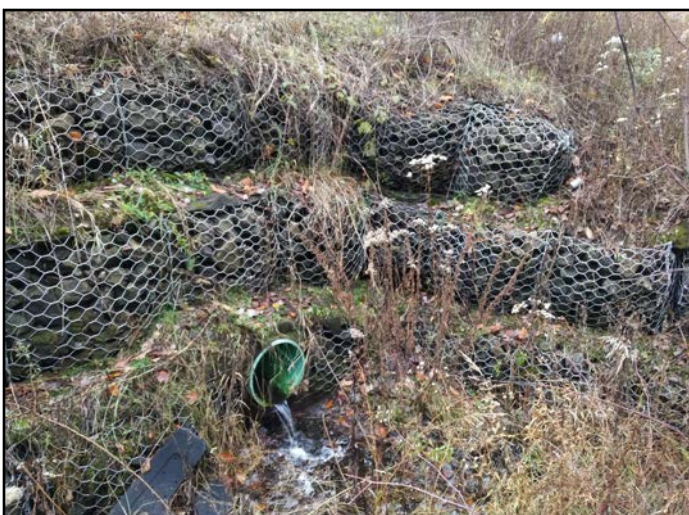
There were no migratory obstructions observed along the surveyed portions of Borthwick Creek. The location of a migratory obstruction observed during headwater drainage feature assessments in 2019 is shown in Figure 31. This headwater feature had a perched culvert acting as a migration barrier.

Perched culverts create fish migratory obstructions and loss of aquatic habitat and seasonal grounds for many fish species

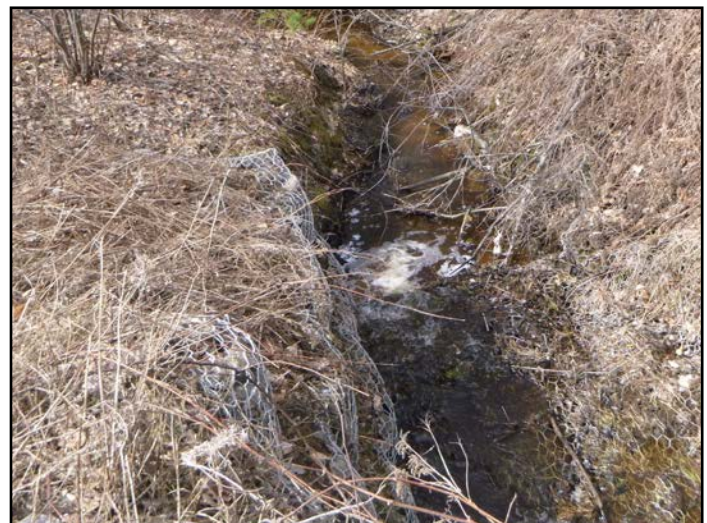
An example of the use of gabion baskets on a headwater drainage feature on Anderson Road

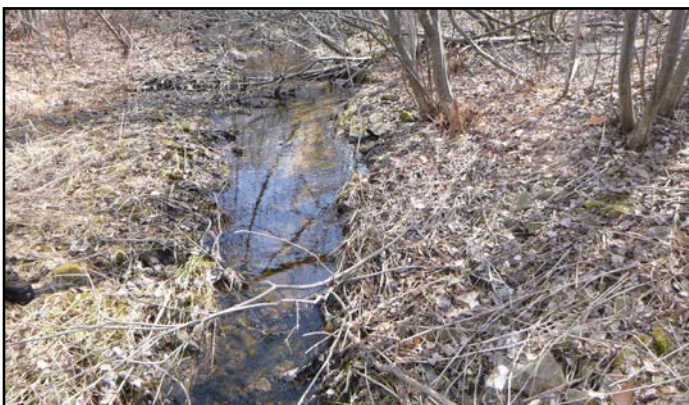
Substantial sediment deposition observed in a headwater drainage feature on Anderson Road
