Ramsay Creek 2019 Catchment Report

Introduction

In 2019 the City Stream Watch program surveyed 101 sections (10.1 km) of the main stem of Ramsay Creek and nine sections (0.9 km) of one of its tributaries. Five sites were sampled for fish community composition and data from one temperature logger was collected at one of these sites. Twenty two headwater drainage feature sites were assessed in the spring and in the summer. The following is a summary of our observations and assessment.

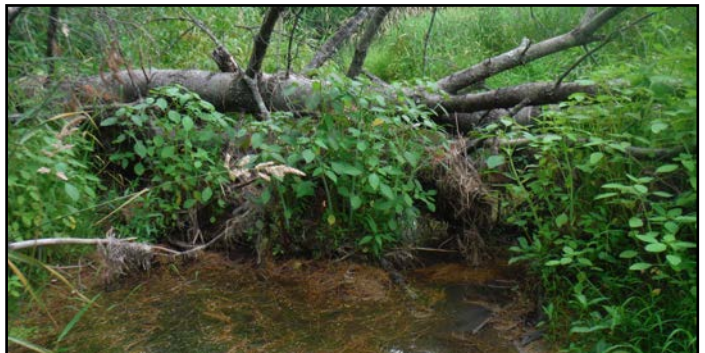
Figure 16 Instream wood structures along Ramsay Creek

Figure 16 shows that a portion of Ramsay Creek had moderate levels of instream wood structure in the form of branches and trees. Instream wood structure is important for fish and wildlife habitat, by providing refuge and feeding areas. Excessive amounts can result in temporary seasonal migration barriers.

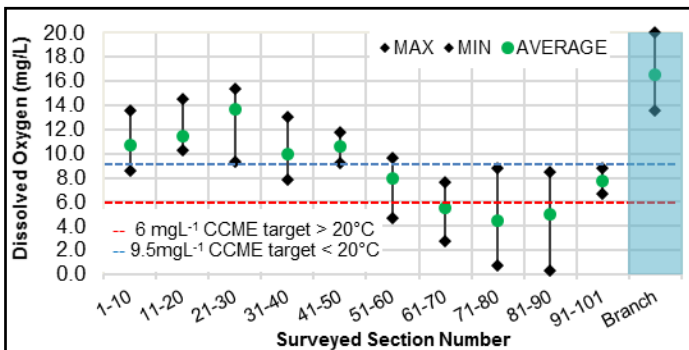
Figure 22 Dissolved oxygen ranges along surveyed sections of Ramsay Creek and in blue the branch (9 sections)

Figure 22 shows the concentration levels found in the surveyed portions of Ramsay Creek. The two dashed lines depicted represent the Canadian water quality guidelines. Most of the surveyed portions were found to have oxygen levels within the Canadian water quality guidelines (sec. 1-60; 91-101; branch). Areas that had low oxygen levels (sec. 61-90) had no vegetation as the dominant type and four beaver dams, conditions that can lead to low oxygen levels. Average concentration levels across the system were 9.2 milligrams per liter.

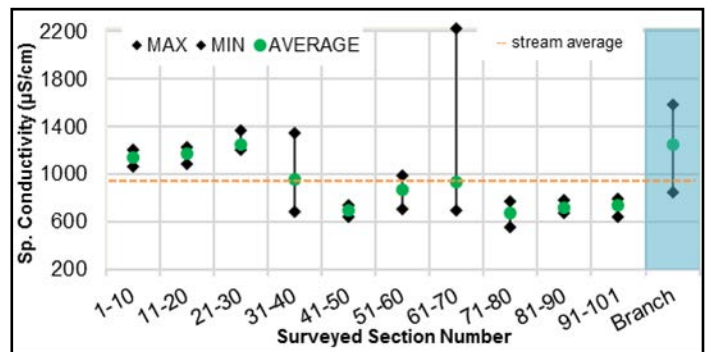
Figure 23 Specific Conductivity ranges along surveyed sections of Ramsay Creek and in blue the branch (9 sections)

Figure 23 shows specific conductivity levels in Ramsay Creek, the average level is depicted by the dashed line (954 $\mu\text{S}/\text{cm}$). Conductivity levels are lower in areas approaching headwater reaches. Higher levels were observed in the sections downstream of the confluence with McEwan Creek (sec. 34) and at the branch. A peak was recorded near highway 417, which was undergoing construction at the time of the survey (sec. 61-70).

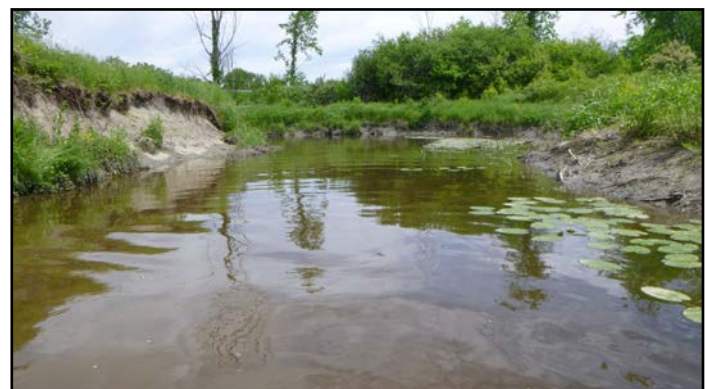
Section on Ramsay Creek near Anderson Road with **optimal** oxygen conditions for cold-water biota (Dissolved oxygen levels of 10.4 mg/L and 107.7 % saturation)

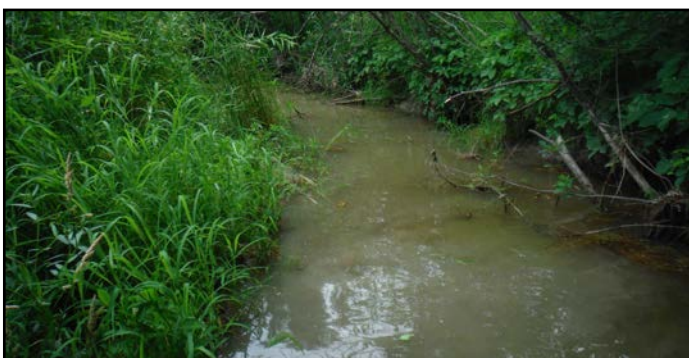
Section on Ramsay Creek north of Letrim Road with **impaired** oxygen conditions (Dissolved oxygen levels of 0.33 mg/L and 6.2 % saturation)

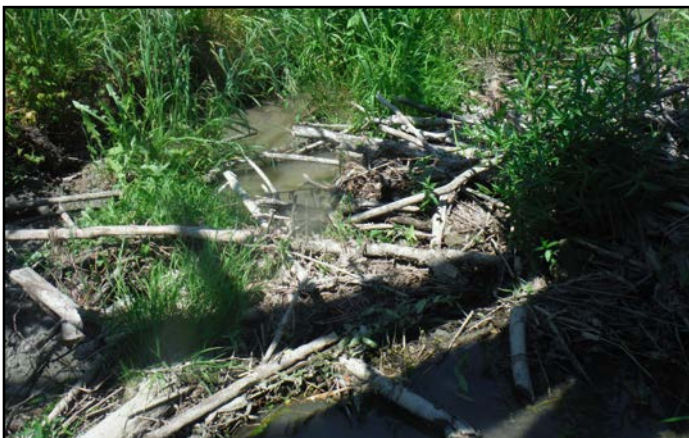
Debris dams, such as the one north of Russell Road (above) can create seasonal fish migratory obstructions

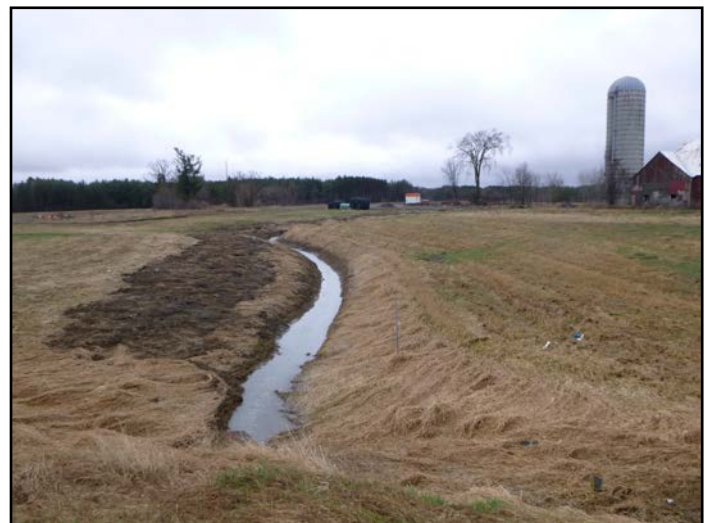
An example of a dredged headwater drainage feature on Russell Road

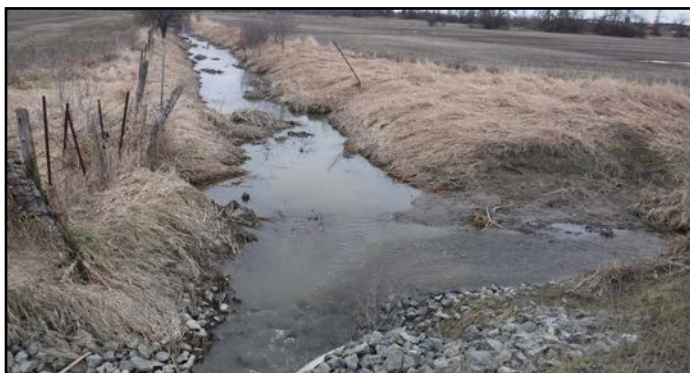
Substantial sediment deposition observed in a headwater drainage feature on Anderson Road

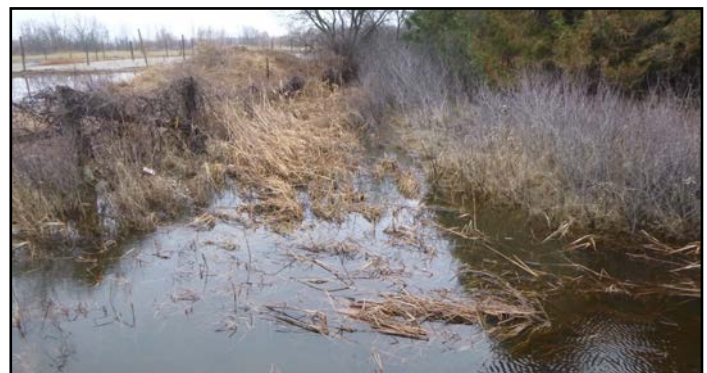
Extreme roughness due presence of materials that diffuse flow

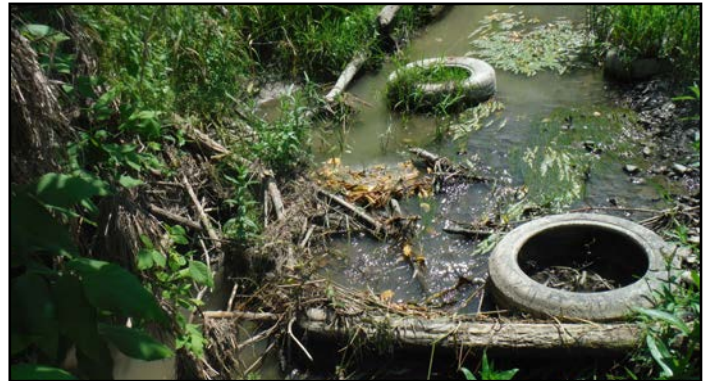
Tires found along surveyed portions of Ramsay Creek (above) were removed by volunteers and staff (below)

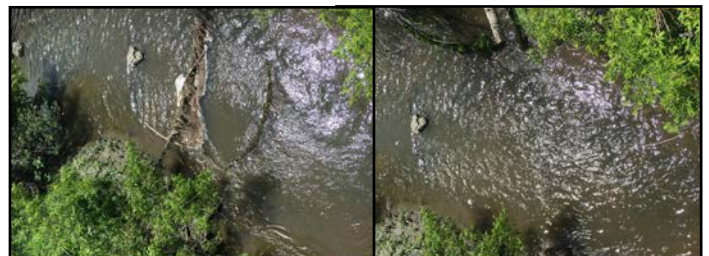
Before (left) and after (right) the removal of abandoned communications lines on Ramsay Creek near Ramsayville Rd
