Barrhaven Creek 2022 Catchment Report

Barrhaven Creek was previously surveyed in 2015 under the City Stream Watch program. In 2022, 16 sections (1.6 km) of Barrhaven Creek were surveyed as part of the City Stream Watch monitoring activities. The following is a summary of observations made by staff and volunteers along those 16 sections.

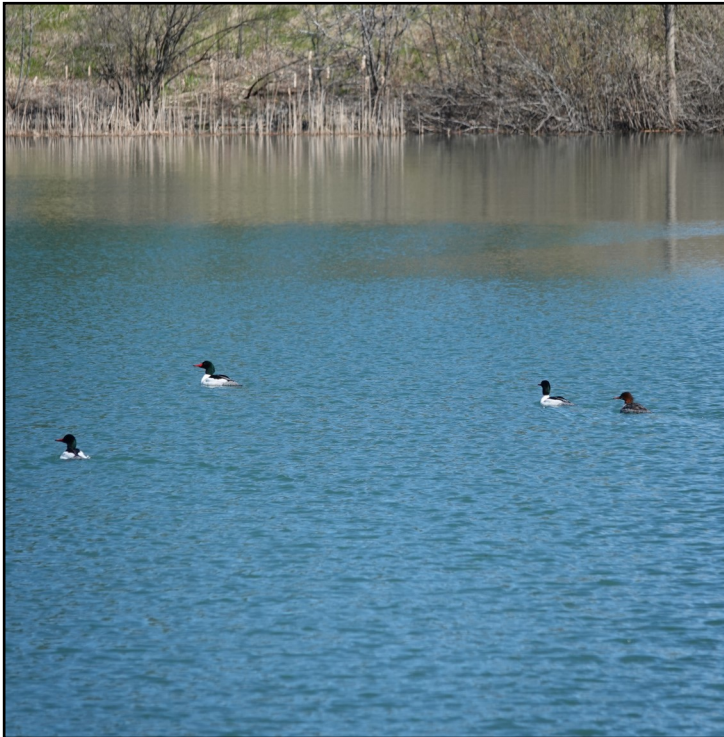
Clarke Bellingher Stormwater Facility located on Barrhaven Creek.

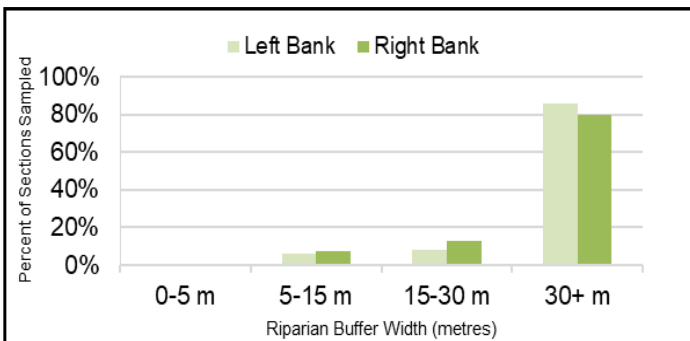
Figure 2 Vegetated buffer width along Barrhaven Creek.

Figure 2 demonstrates buffer conditions along the left and right banks of the surveyed sections of Barrhaven Creek. Buffers greater than 30 meters were present along 86 percent of the left bank and 80 percent of the right bank. A 15 to 30 meter buffer was present along eight percent of the left bank and thirteen percent of the right bank. A 5 to 15 meter buffer was present along six percent of the left bank and eight percent of the right bank. A five meter buffer or less was not observed along the creek. The buffer width evaluation on the sections surveyed of Barrhaven creek are below recommended guidelines primarily along the right bank.

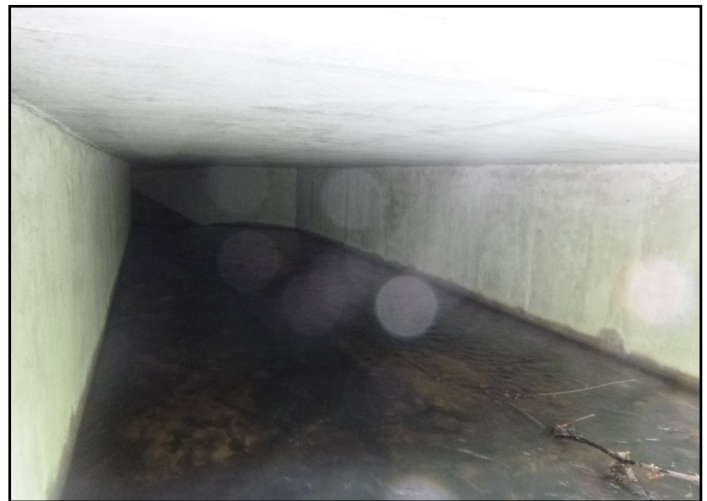
Channelized section of Barrhaven Creek under Prince of Wales Drive.

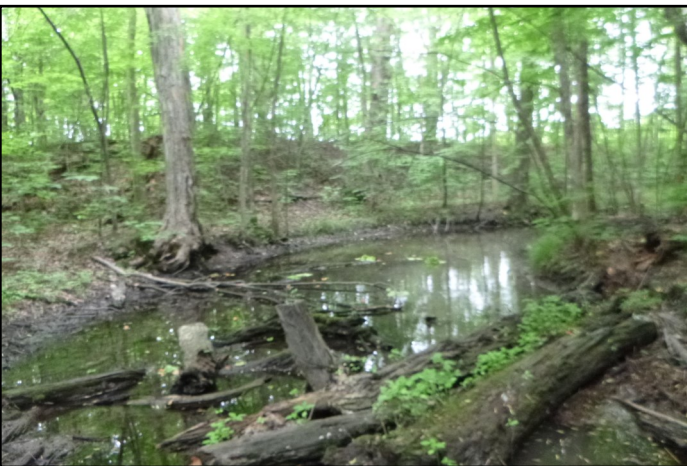
Bank erosion observed along Barrhaven Creek downstream of the stormwater pond.

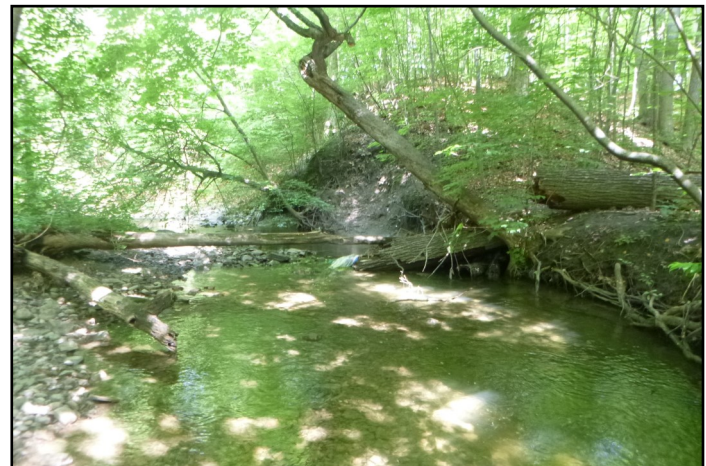
Undercut banks west of Prince of Wales Drive along Barrhaven Creek.

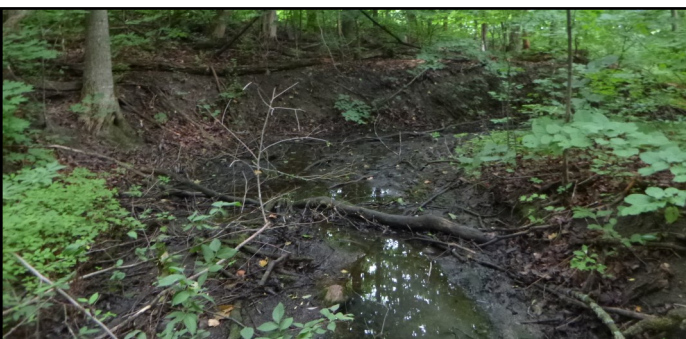
Section on Barrhaven Creek upstream of the stormwater management facility with **impaired** oxygen conditions (Dissolved oxygen levels of 3.97 mg/L and 39.7% saturation).

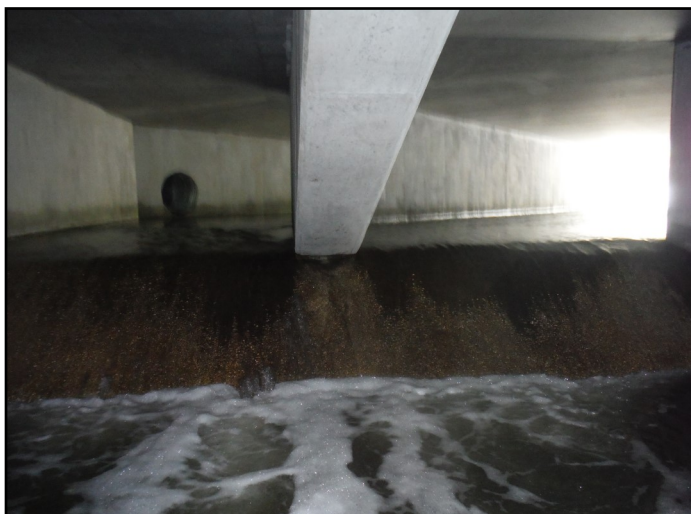
Perched culverts can result in fish passage obstructions which can reduce species diversity along a watercourse.

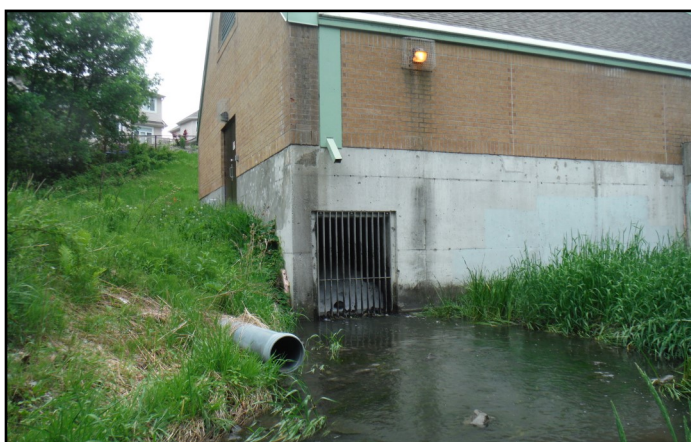
Building structure at the stormwater management facility on Barrhaven Creek is a permanent migratory obstruction.

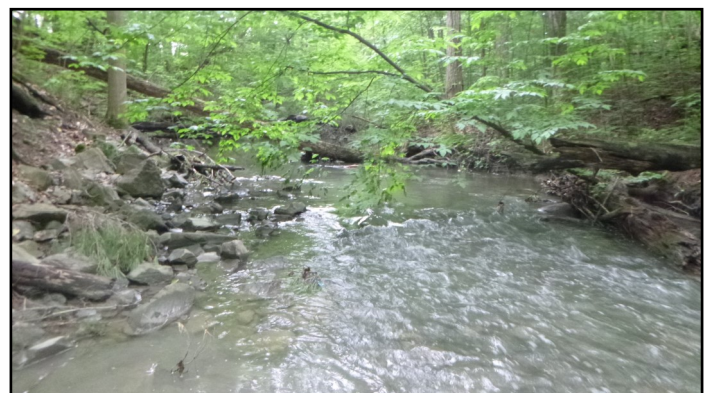
Section of Barrhaven Creek near Prince of Wales Drive with increased erosion levels that may require erosion mitigation measures in the future.

The surveys of Barrhaven creek will enable the City Stream Watch program to monitor ongoing invasive species distribution and potential high erosion sites. Although at this time there are no recommendations for riparian restoration opportunities they may potentially be needed if there are future changes in the system. In particular high erosion areas near Prince of Wales Drive and upstream of the stormwater management facility may need attention in the future.
