Cardinal Creek

2022 Catchment Report

Cardinal Creek 2022 Catchment Report

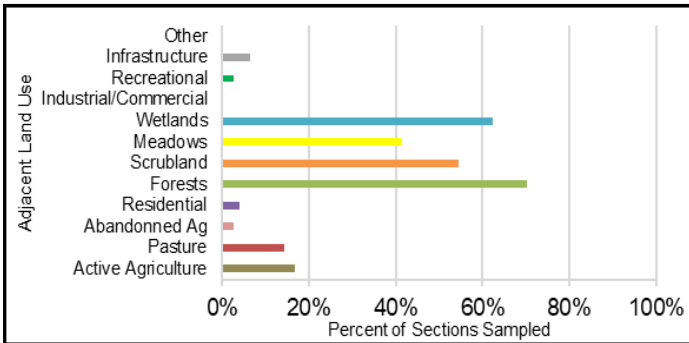
Figure 4 Adjacent land use 100 meters from each shoreline and percentage of presence along Cardinal Creek and two tributaries of Cardinal Creek.

Forest and scrubland were present in 70 percent and 55 percent of the sections surveyed, being two of the most common land use observed. Wetlands were present in 62 percent of the surveyed areas, and meadow was present in 42 percent of sections.

Aside from the natural areas, the most common land use in the catchment was active agriculture, in 17 percent of sections surveyed. Additionally, abandoned agricultural lands were observed in three percent of sections and pastures were present in 14 percent of sections. Four percent of land use was residential and three percent was attributed to recreational uses, such as walking trails and parks. The other land use observed in six percent of sections was infrastructure, which included the highway, roads and bridges.

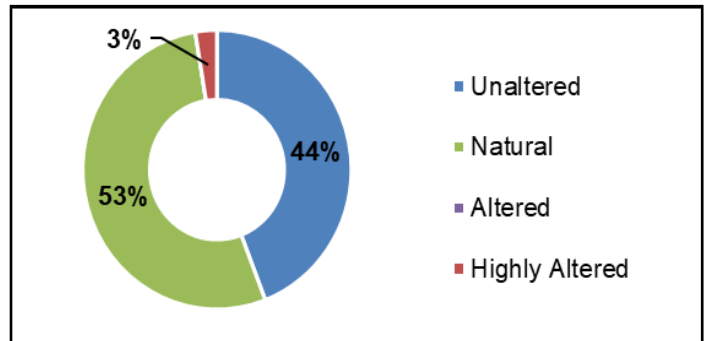
Figure 5 Anthropogenic alterations along Cardinal Creek Cardinal Creek and two tributaries of Cardinal Creek.

Two of the surveyed sections were highly altered. The riparian buffers were less than five meters in width in some areas. Two sections were highly altered, containing long road overpasses and reduced riparian buffers.

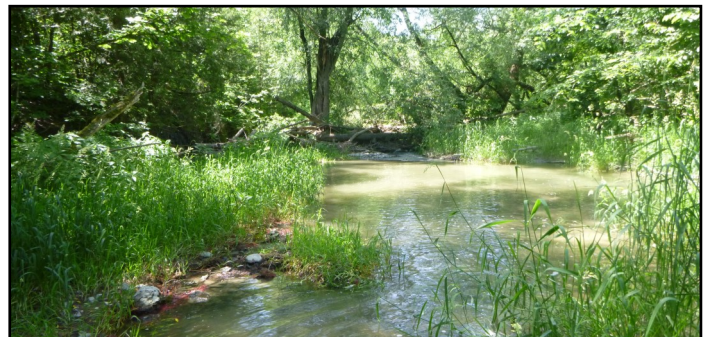
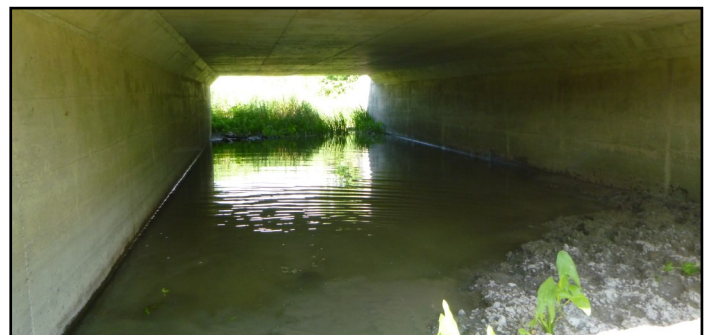
Unaltered section of Cardinal Creek with large riparian buffers near Old Montreal Road (above); and a highly altered area with a concrete over pass on Cox County Road (below).

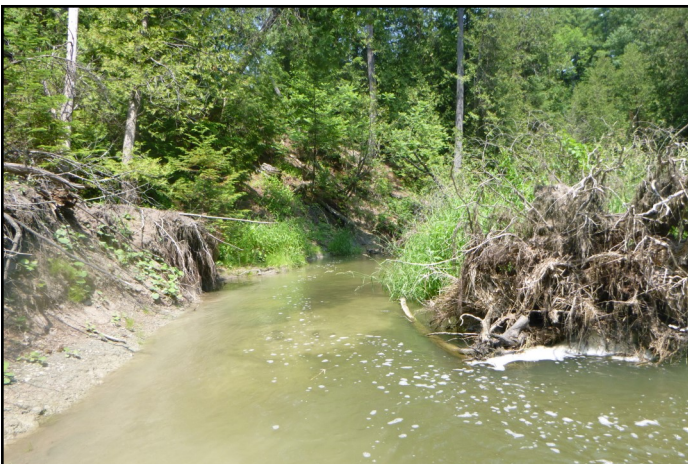
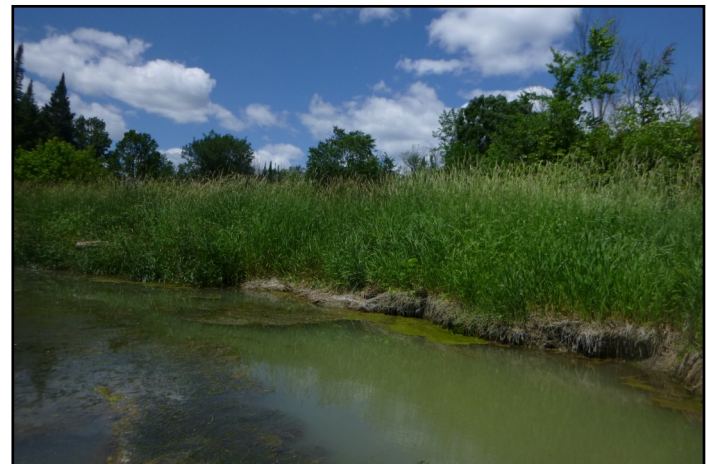
Bank erosion exposing tree roots, creating instability for trees along the right bank of Cardinal Creek.

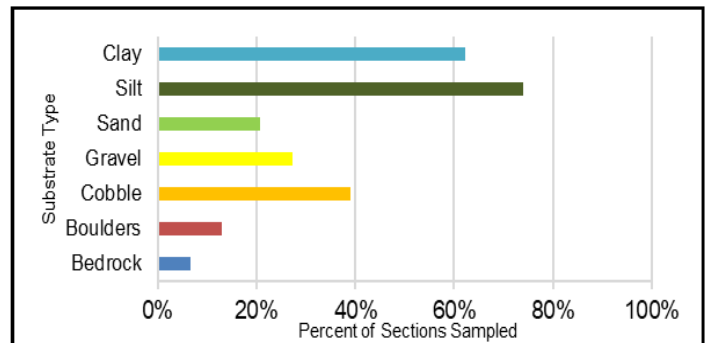
Figure 12 Instream substrate along Cardinal Creek and two tributaries of Cardinal Creek.

Substrate complexity along Cardinal Creek was observed to be fairly homogenous in 75 percent of sections surveyed, and heterogenous in the remaining 25 percent. Figure 12 shows the substrate types observed. It is a system dominated by silt and clay, with 74 percent of sections containing silt and 62 percent with clay. Over a quarter of the sections surveyed also contained gravel and cobble. Other substrate types included sand, boulders and bedrock.

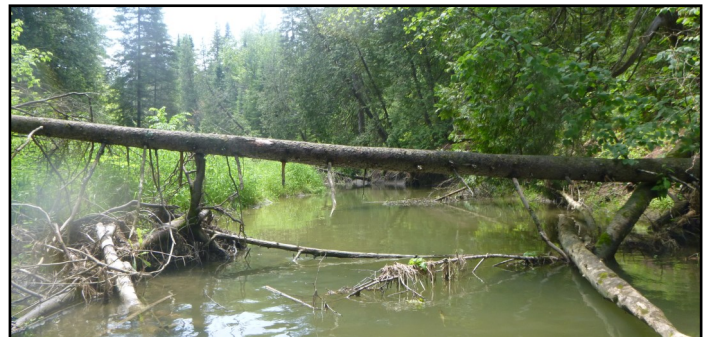
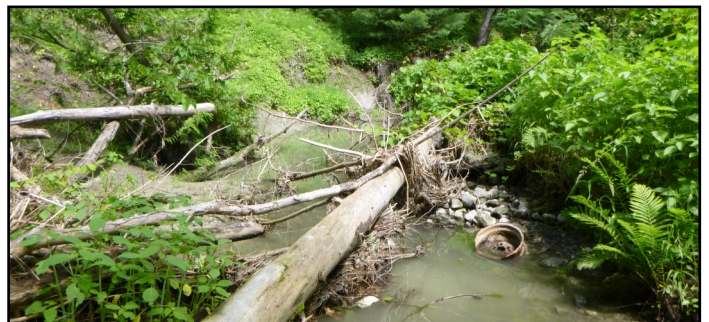
Instream wood structures found along Cardinal Creek are important for fish and wildlife habitat (above), some can become seasonal migration barriers (below).

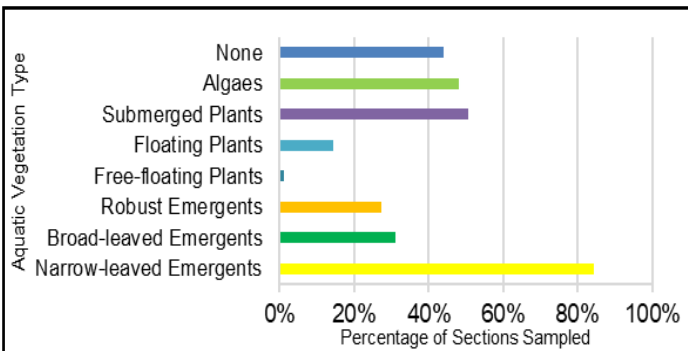
Figure 17 Aquatic vegetation presence along Cardinal Creek and two tributaries of Cardinal Creek.

Figure 17 shows the aquatic vegetation community structure along Cardinal Creek. Vegetation types included: narrow-leaved emergent vegetation in 65 sections; submerged vegetation in 39 sections; algae in 37 sections; broad leaved emergent plants in 24 sections; and robust emergent plants in 21 sections; floating plants in 11 sections; and free-floating plants in one section. There were 34 sections which had areas where no vegetation was present. Figure 18 shows the diversity of the dominant instream aquatic vegetation type by section.

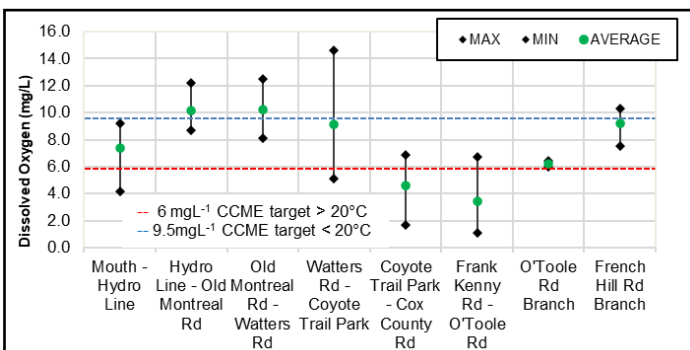
Figure 22 Dissolved oxygen ranges along surveyed sections of Cardinal Creek and two tributaries of Cardinal Creek.

Figure 22 shows the concentration levels found in the surveyed portions of Cardinal Creek. The two dashed lines depict the Canadian water quality guidelines. Dissolved oxygen levels that are sufficient to support warm-water aquatic life were found in the majority of sections, from the karst areas to the confluence with the Ottawa River (Coyote Trail Park to the mouth). Oxygen levels below the Canadian water quality guidelines were also observed in the upper reaches (Coyote Trail Park to O'Toole Road). Adequate levels of dissolved oxygen were observed in the sections that are classified as agricultural drains, in the headwater reaches, including the two branches. Average concentration levels across the system were 7.4 mg/L.

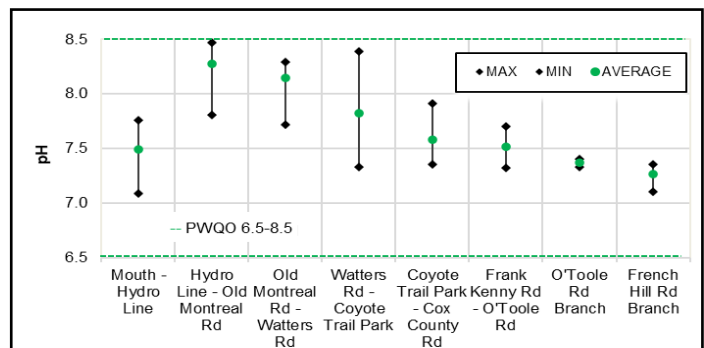
Figure 24 pH ranges along surveyed sections of Cardinal Creek and two tributaries of Cardinal Creek.

Figure 24 shows Cardinal Creek had pH levels that meet the PWQO, depicted by the dashed lines. The average levels across the system was pH 7.77.

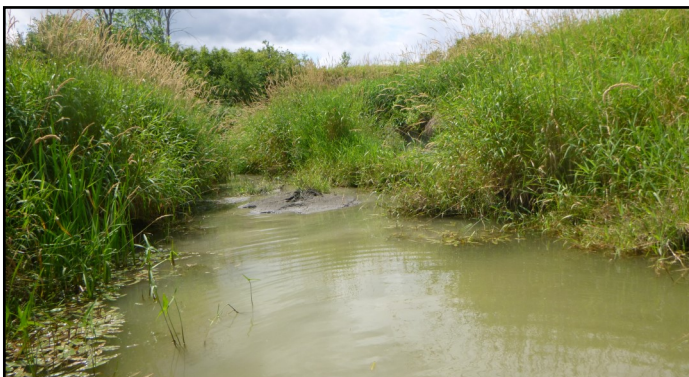
Section on Cardinal Creek near Innes Road with **impaired** oxygen conditions (Dissolved oxygen levels of 5.18 mg/L and 63.7 % saturation).

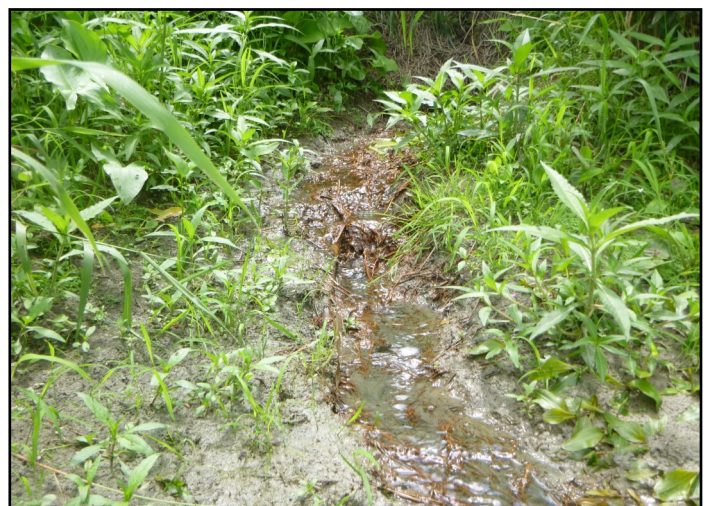
Section of Cardinal Creek where a groundwater seep was observed with visible iron staining.

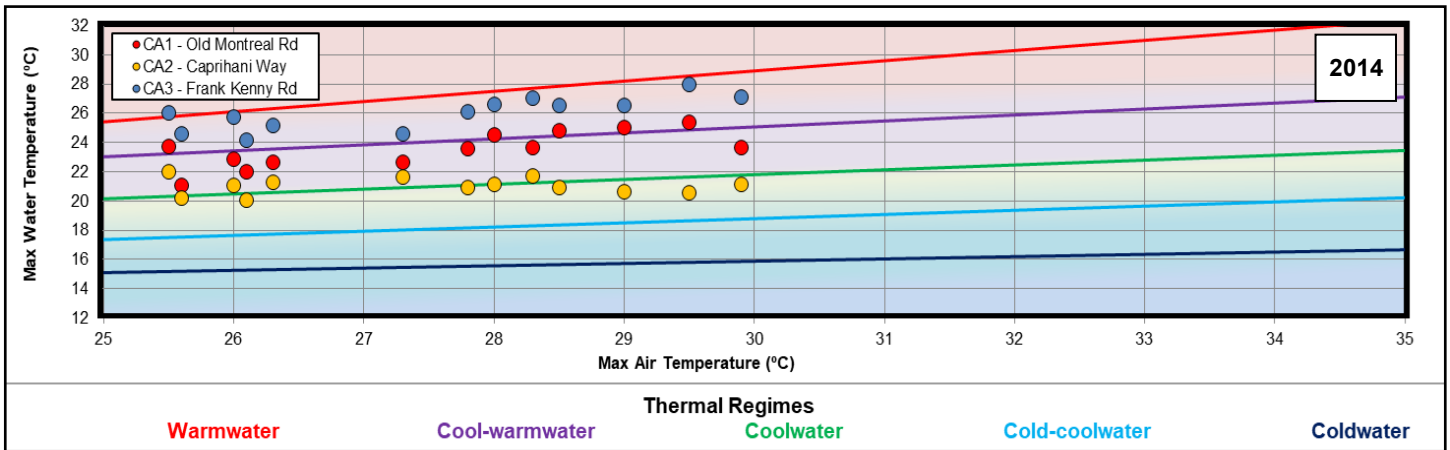
Figure 29 Thermal Classification for Cardinal Creek with the five thermal regimes adapted from Stoneman and Jones (1996) by Chu et al. (2009): conditions range from **cool-warm water** (CA1 and CA2) to the **warmwater** (CA3) category for Cardinal Creek in 2014.

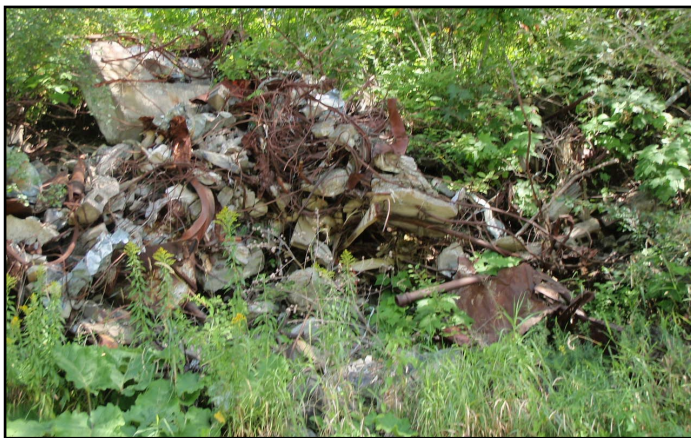
Garbage dumping of scrap metal on Cardinal Creek.

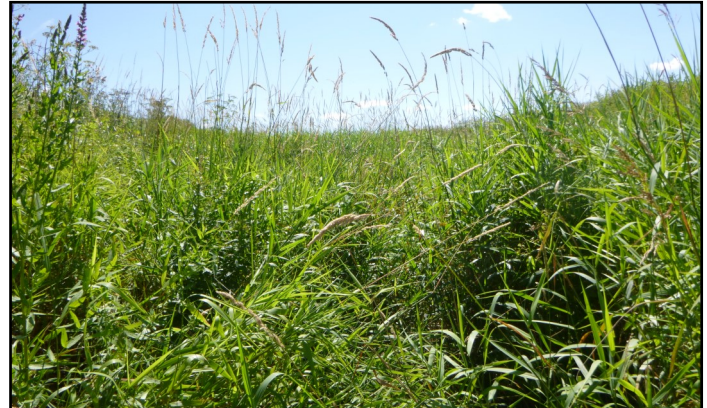
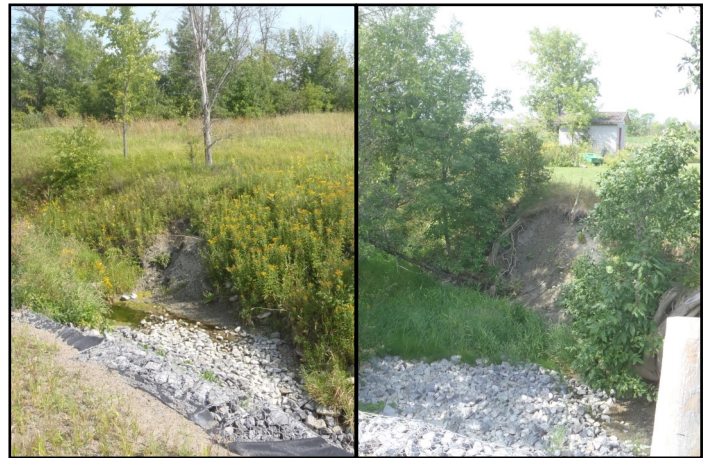
Area of Cardinal Creek east of O’Toole Road that would benefit from riparian planting (above) and headwater reaches that would benefit from erosion control measures (below).
