Sawmill Creek 2022 Catchment Report

In 2022, 96 sections (9.6 km) of the main stem of Sawmill Creek and its tributaries were surveyed as part of the City Stream Watch monitoring activities. The following is a summary of observations made by staff and volunteers along those surveys.

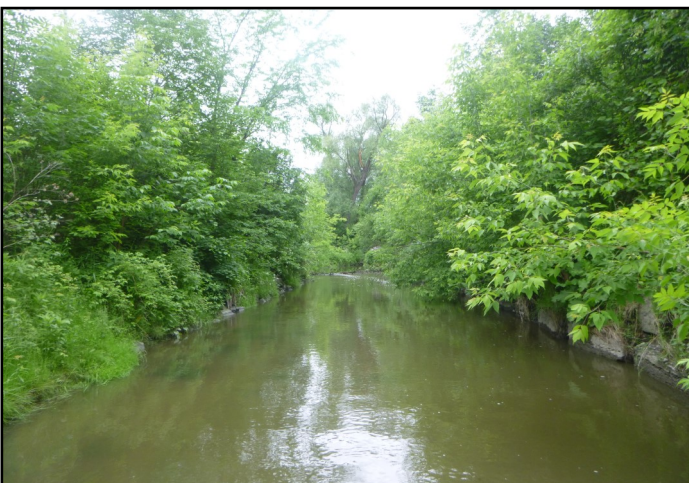
Vegetated buffer greater than 30 meters in width along Sawmill Creek upstream of Bank Street.

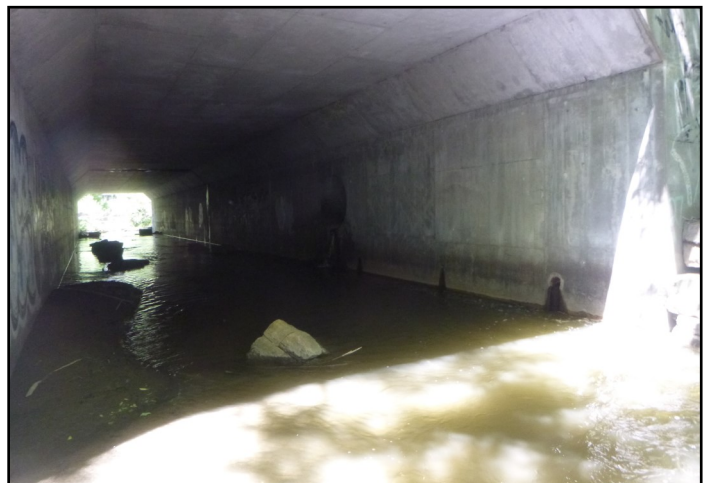
Roadway infrastructure on the transitway along Sawmill Creek.

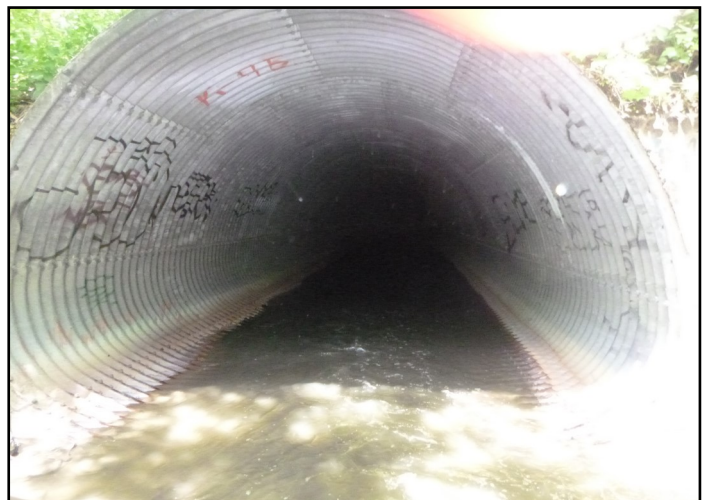
Channelized section of Sawmill Creek under Walkley Road.

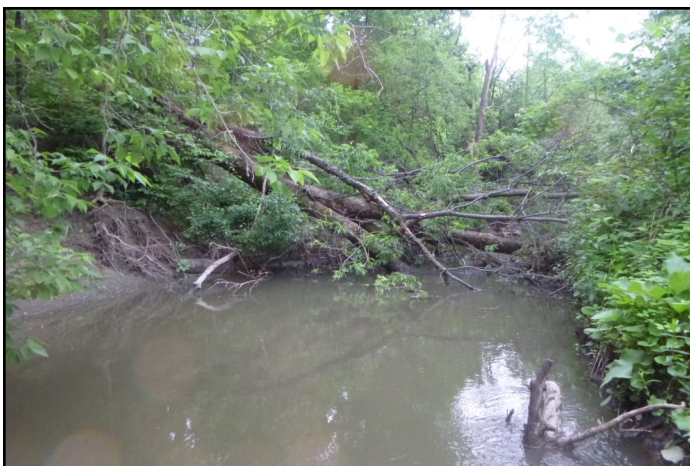
Bank erosion exposing tree roots, creating instability for trees along the left bank of Sawmill Creek.

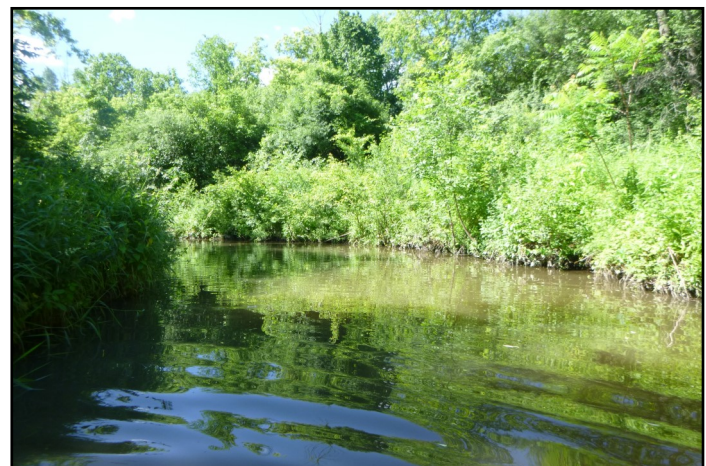
Undercut right banks downstream of Heron Road along Sawmill Creek.

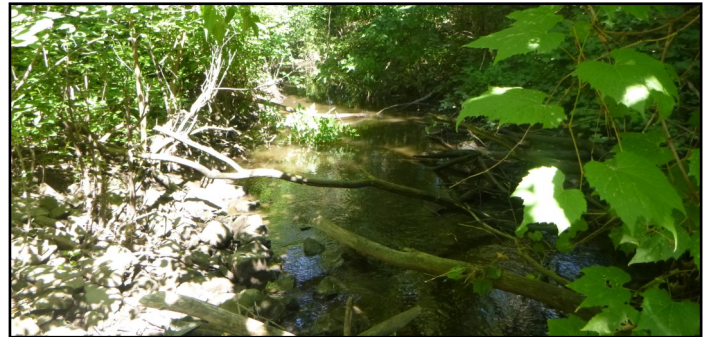
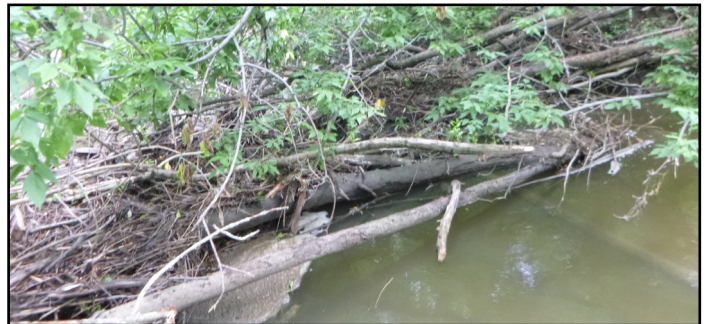
Instream wood structures found along Sawmill Creek are important for fish and wildlife habitat (above), some can become seasonal migration barriers (below).

Figure 16 shows that a large portion of Sawmill Creek had moderate levels of instream wood structure in the form of branches and trees. Instream wood structure is important for fish and wildlife habitat, by providing refuge and feeding areas. Excessive amounts can result in temporary seasonal migration barriers. The May 2022 wind storm resulted in a number of trees being downed into Sawmill Creek (RVCA, 2022).

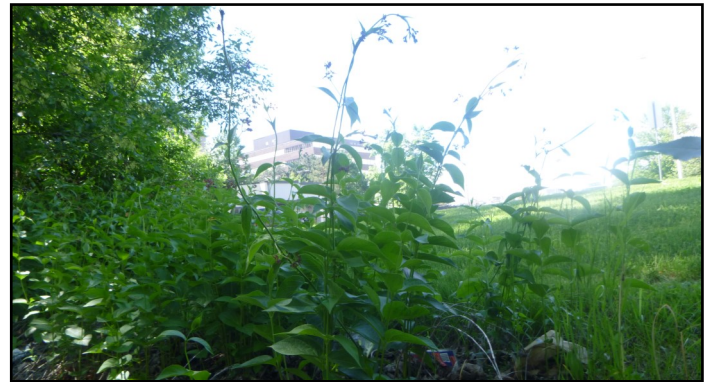
Dog strangling vine (*Cynanchum nigrum*) observed along surveyed portions of Sawmill Creek for the first time in 2022.

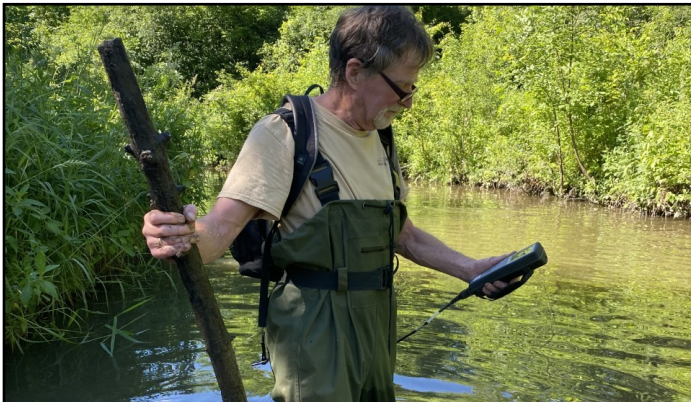
Volunteer collecting water chemistry measurements with a multiparameter probe.

Water chemistry collection is done at the start and end of each 100 meter section with a multiparameter YSI probe. Monitored parameters include: air and water temperature, pH, conductivity, dissolved oxygen concentration and saturation.

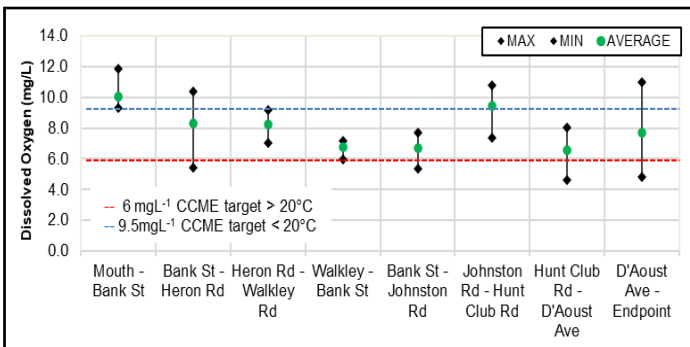
Figure 22 Dissolved oxygen ranges along surveyed sections of Sawmill Creek.

Figure 22 shows the concentration levels found in the surveyed portions of Sawmill Creek. The two dashed lines depict the Canadian water quality guidelines. Most of the surveyed portions were found to have oxygen levels within or above the Canadian water quality guidelines. These levels are sufficient to support warm-water aquatic life. Lower levels of dissolved oxygen seen near D'Aoust Avenue may relate to wetland habitats which can have these conditions. Average concentration levels across the system were 7.9 mg/L.

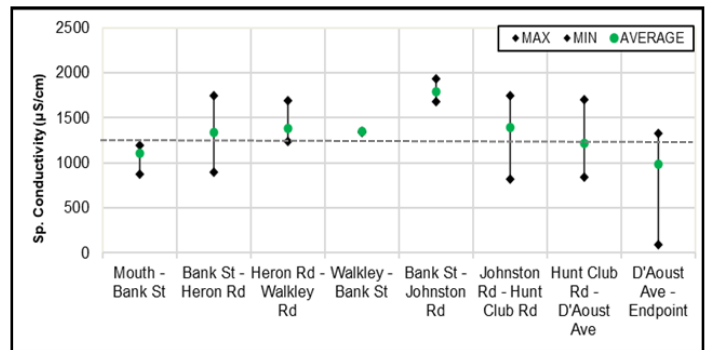
Figure 23 Specific Conductivity ranges along surveyed sections of Sawmill Creek.

Figure 23 shows specific conductivity levels in Sawmill Creek. The average level is depicted by the dashed line (1251.3 $\mu\text{S}/\text{cm}$). Conductivity levels are lower in areas approaching headwater reaches. Higher levels were observed in the sections closer to road infrastructure and high urban land uses with impervious surfaces (Bank Street to Hunt Club Road).

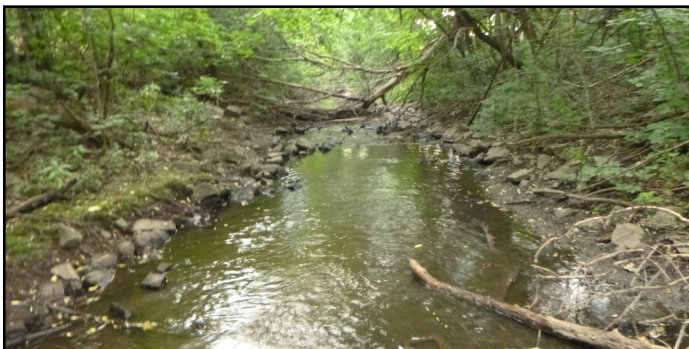
Section on Sawmill Creek west of Albion Road with **impaired** oxygen conditions (Dissolved oxygen levels of 4.78 mg/L and 52.3 % saturation).

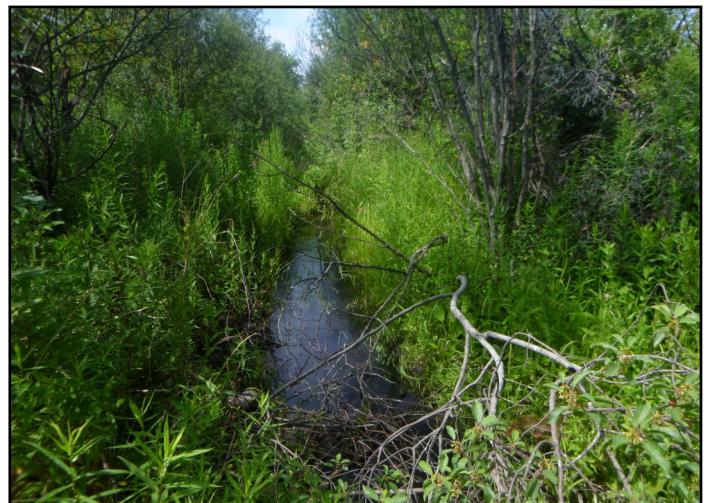
The majority of sections of Sawmill Creek where groundwater was observed were in the headwaters near the Lester Road Wetland Complex which provides important baseflow to Sawmill Creek.

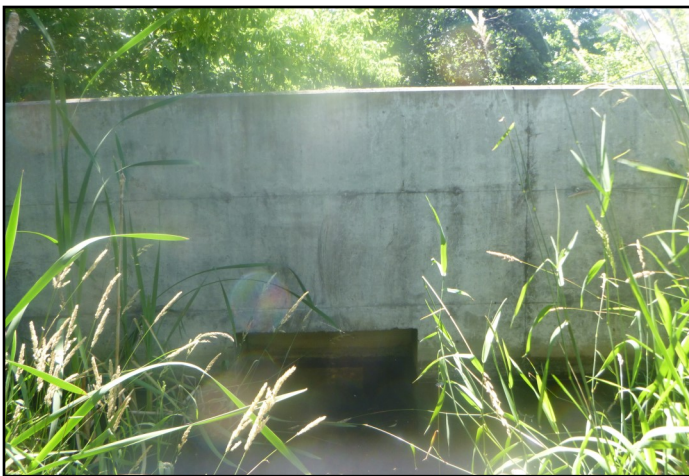
Weirs can result in fish passage obstructions, however in the case of the weir at Daze Road on Sawmill Creek it was installed to create a flow bypass and direct flow in to the constructed wetlands along the Airport Parkway; this has mitigated downstream flooding on Sawmill creek.

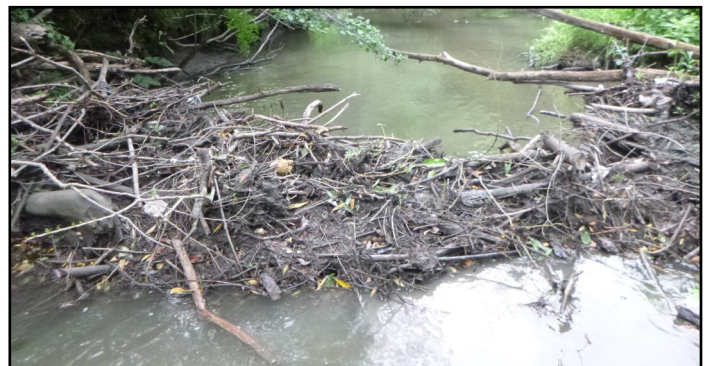
An active beaver dam along Sawmill Creek downstream of Walkley Road.

In 2022 a total of 11 beaver dams were identified on the surveyed portions of Sawmill Creek and are shown in Figure 33. During the stream surveys a beaver was observed swimming in the creek. Additionally, a beaver lodge were noted as well.
