Black Creek 2012 Summary Report

Black Creek is approximately four kilometers long and is one of five major tributaries of Greens Creek in the east end of the City of Ottawa. The headwaters of Black Creek begin in the Mer Bleue Wetland, which is a popular recreation destination as well as being recognized as a wetland of International Importance by the Ramsar convention, an Area of Natural and Scientific Interest (ANSI) and a Provincially Significant Wetland. From its headwaters Black Creek flows through property owned by the National Capital Commission (NCC), before it empties into Green's Creek just south of Innes road.

As part of the City Stream Watch monitoring activities in 2012, 36 sections along Black Creek were surveyed. Surveys were completed up to Anderson road where the stream morphology changes to a wetland for the remaining length of the stream. As some wetland environments have no defined channel, this area could not be surveyed using the macro stream assessment protocol.

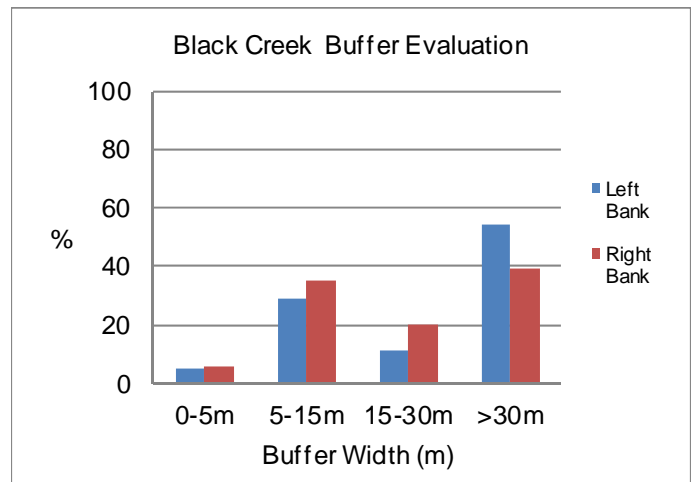
Figure 2. Vegetated buffer width along Black Creek

The riparian or shoreline zone is that special area where the land meets the water. Well-vegetated shorelines are critically important in protecting water quality and creating healthy aquatic habitats, lakes and rivers. Natural shorelines intercept sediments and contaminants that could impact water quality conditions and harm fish habitat in streams. Well established buffers protect the banks against erosion, improve habitat for fish by shading and cooling the water and provide protection for birds and other wildlife that feed and rear young near water. A recommended target (from Environment Canada's Guideline: *How Much Habitat is Enough?*) is to maintain a minimum 30 meter wide vegetated buffer along at least 75 percent of the length of both sides of rivers, creeks and streams. Figure 2 demonstrates the buffer conditions on Black Creek for the left and right banks separately. Results show that 54 percent of the left bank and 39 percent of the right bank of Black Creek has a buffer width greater than 30 meters.

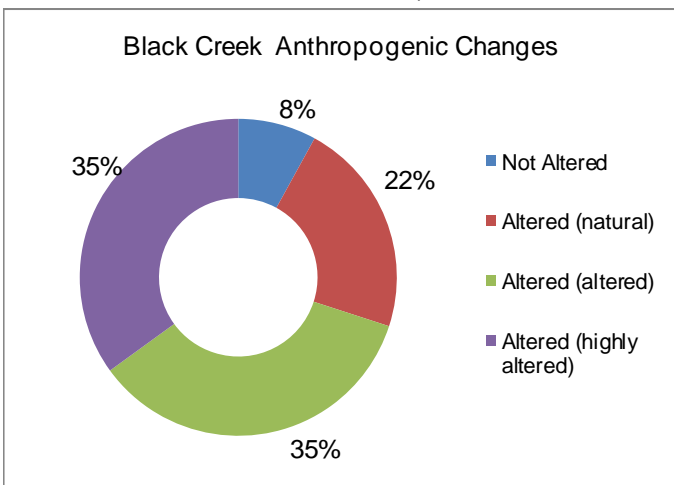
Figure 7. Alterations to Black Creek

Figure 7 shows eight percent of Black Creek remains “unaltered.” Sections considered “natural” with some human changes account for 22 percent of sections. “Altered” sections accounted for 35 percent of the stream, with the remaining 35 percent of sections sampled being considered “highly altered” (e.g. include road crossings, shoreline/instream modifications and little or no buffer).

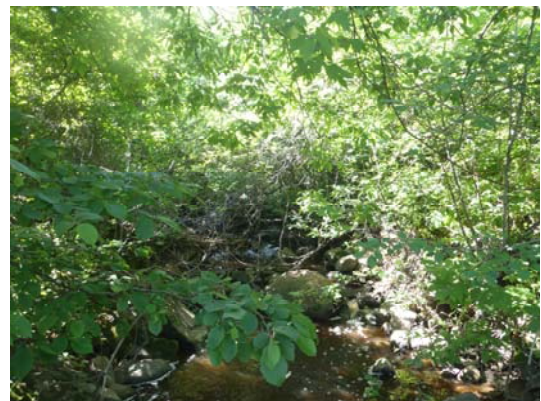
Photo 1. One of the few areas of Black Creek with overhanging trees and branches

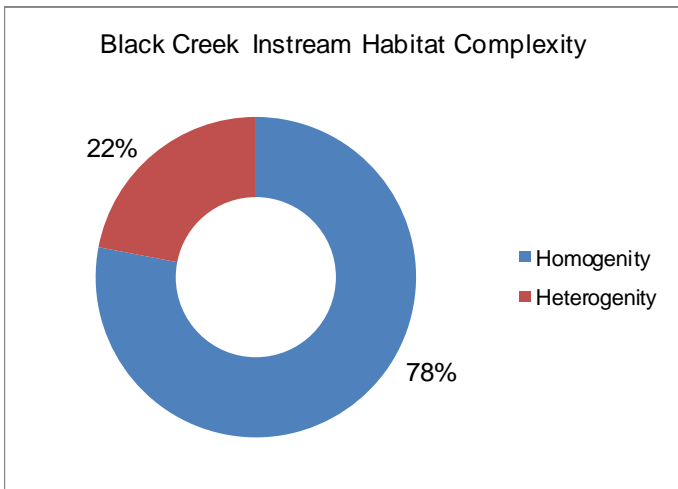
Figure 10. In-stream habitat complexity in Black Creek

Streams are naturally meandering systems and move over time, there are varying degrees of habitat complexity, depending on the creek. A high percentage of habitat complexity (heterogeneity) typically increases biodiversity of aquatic organisms within a system. Seventy-eight percent of Black Creek was considered homogeneous as shown in Figure 10.

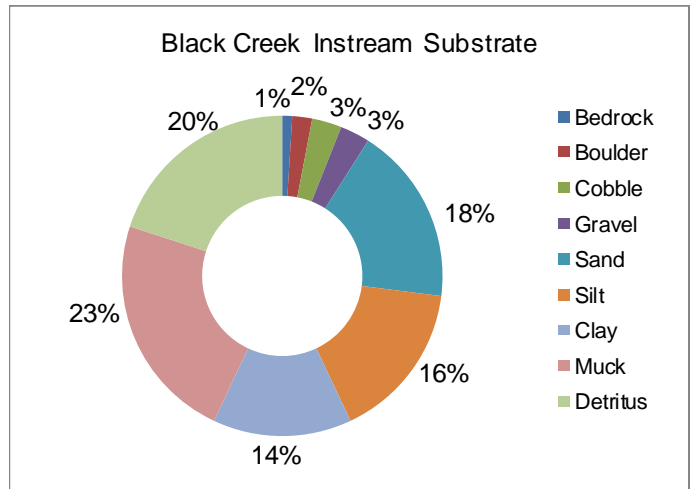
Figure 11. In-stream Substrate in Black Creek

Diverse substrate is important for fish and benthic invertebrate habitat because some species have specific substrate requirements and for example will only reproduce on certain types of substrate. Figure 11 demonstrates that the substrate in Black Creek is mainly composed of a mix of sand, silt, clay, muck and detritus.

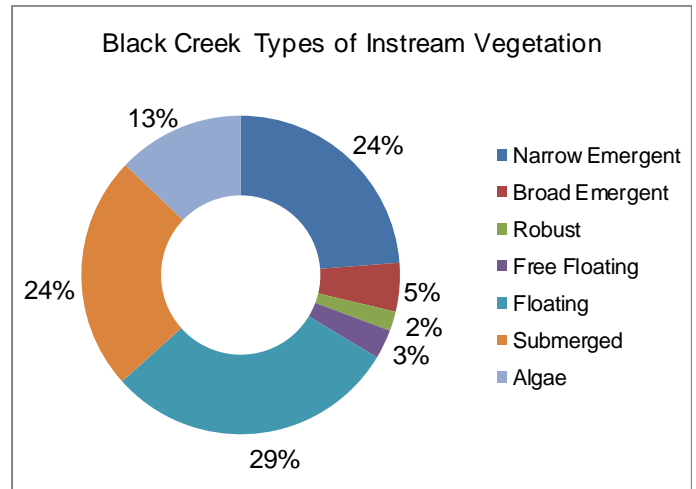
Figure 14. Instream vegetation types in Black Creek

Black Creek has good diversity in types of instream vegetation as shown in Figure 14. The dominant vegetation type recorded at thirty percent consisted of floating plants. Narrow-leaved emergents and submerged vegetation were both recorded at 24 percent. A total of 13 percent of the vegetation community was recorded as algae. Broad-leaved emergents were recorded at five percent and robust emergents and free floating plants made up the remaining five percent of the vegetation community.

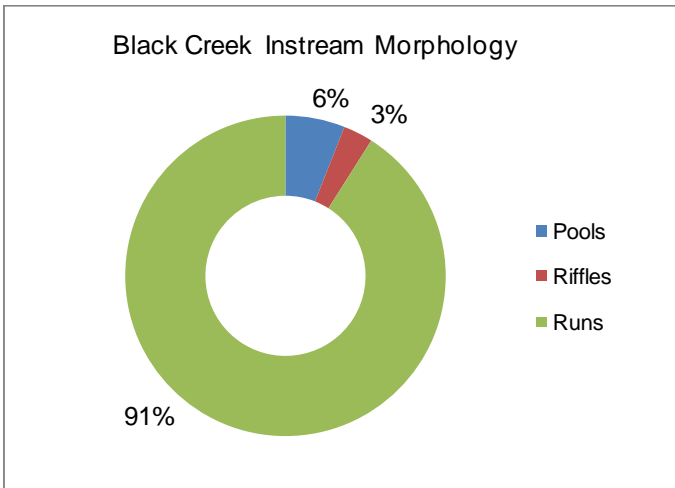
Figure 13. Instream morphology in Black Creek

Pools and riffles are important features for fish habitat. Riffles are areas of agitated water that contribute higher dissolved oxygen to the stream. They act as spawning substrate for some species of fish, such as walleye. Pools provide shelter for fish and can be refuge pools in the summer if water levels drop and water temperature in the creek increases. Pools also provide important overwintering areas for fish. Runs are usually moderately shallow, with unagitated surfaces of water and areas where the thalweg (deepest part of the channel) is in the center of the channel. Figure 13 shows that Black Creek is very uniform; 91 percent consists of runs, six percent pools and three percent riffles.

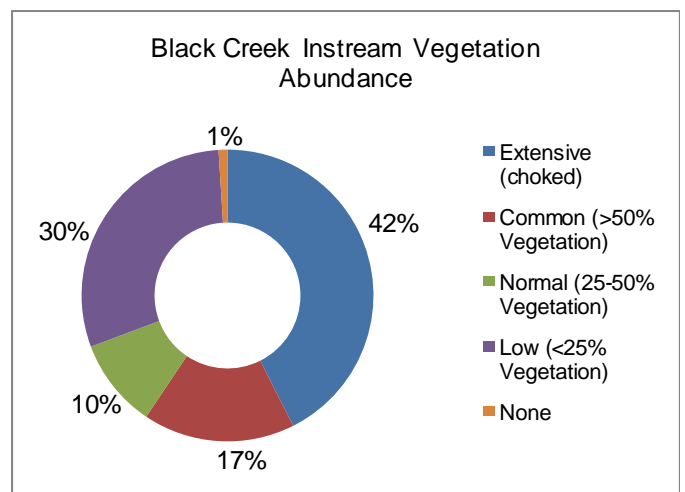
Figure 15. Vegetation abundance in Black Creek

Instream vegetation is an important factor for a healthy stream ecosystem. Vegetation helps to remove contaminants from the water, contributes oxygen to the stream, and provides habitat for fish and wildlife. Too much vegetation can also be detrimental. Figure 15 demonstrates that Black Creek had high levels of instream vegetation. Forty-two percent of the creek had extensive (choked) levels of vegetation, and 17 percent had common levels. Thirty percent of the creek had low levels of vegetation and 10 percent had normal levels. The percentage of extensive levels of vegetation may have been elevated in this case as the creek transitioned in to the Mer Bleue Wetland.

There has been a shift in the amount of instream vegetation found in Black Creek between 2007 and 2012. The percentage of extensive levels of vegetation has increased from 21 percent to 43 percent but the amount of common levels of vegetation has decreased from 58 percent to 17 percent since 2007. The amount of low levels of vegetation has increased from 3 percent to 30 percent while the amount of normal levels has remained relatively the same. The increase in the extensive levels of vegetation is likely due to the increase presence of invasive species like European frogbit.

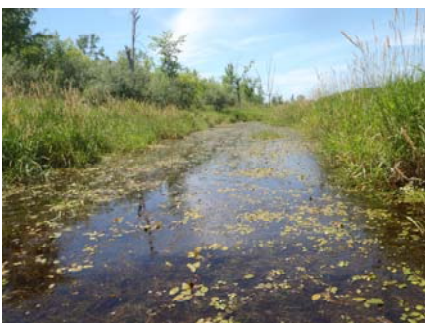
Photo 2. A variety of instream vegetation in Black Creek

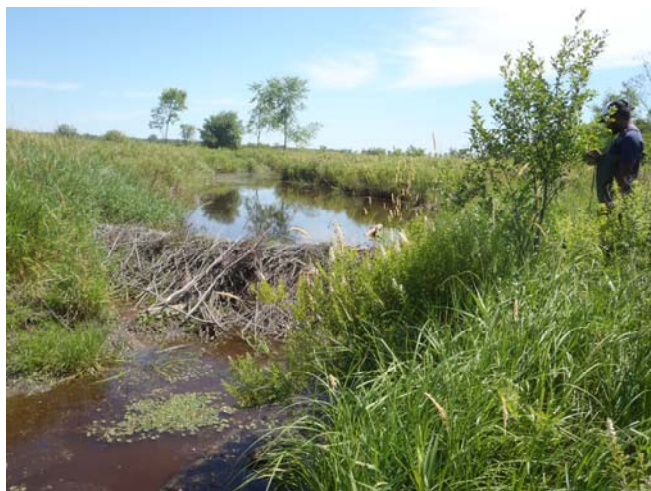
Photo 3. A patch of invasive European frogbit at the base of a beaver dam on Black Creek

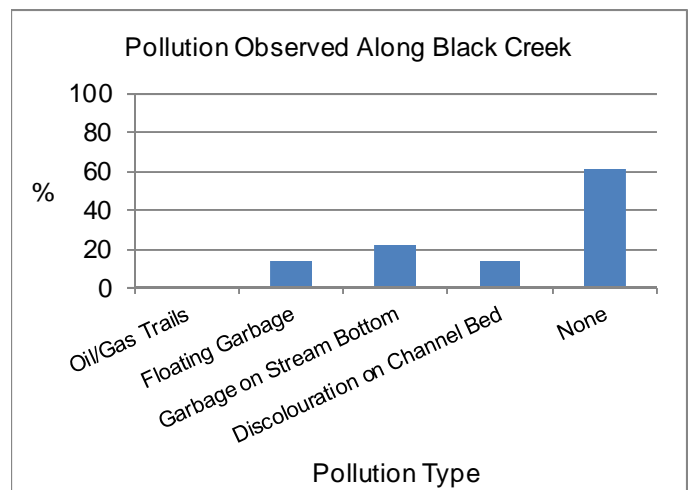
Figure 17. Pollution observed along Black Creek

Figure 17 demonstrates the incidence of pollution/garbage in Black Creek. Pollution and garbage in the stream is assessed visually and noted for each section where it is observed. Black Creek is relatively clear of garbage as 61 percent of the sections did not have any garbage. Fourteen percent had floating garbage, 22 percent had garbage on the stream bottom and 14 percent of the sections had discoloration on the channel bed.

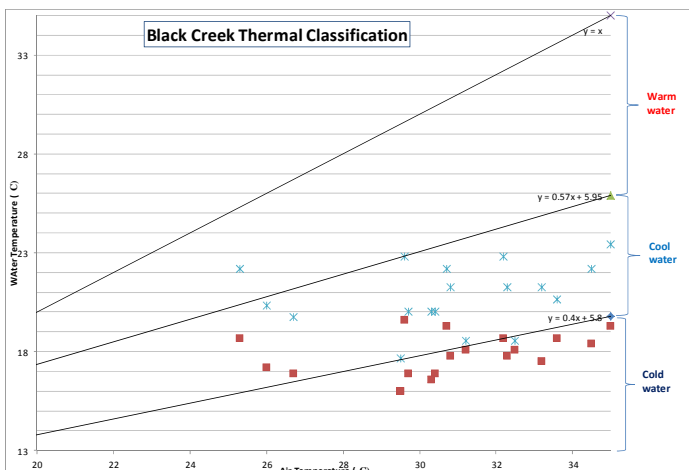
Figure 19. Thermal Classification for Black Creek

Many factors can influence fluctuations in stream temperature, including springs, tributaries, precipitation runoff, discharge pipes and stream shading from riparian vegetation. Water temperature is used along with the maximum air temperature (using the Stoneman and Jones method) to classify a watercourse as either warmwater, coolwater or coldwater. Analysis of the data collected indicates that Black Creek is a coolwater system with coldwater reaches.

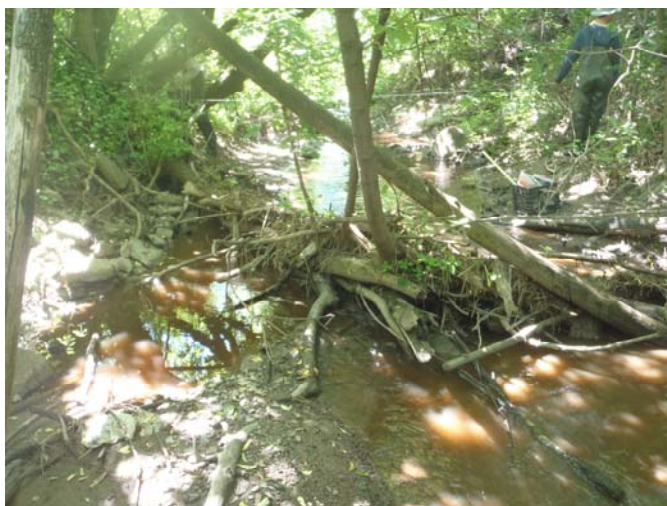
Photo 4. A debris dam on Black Creek
