# Borthwick Creek 2013 Summary Report

## Introduction

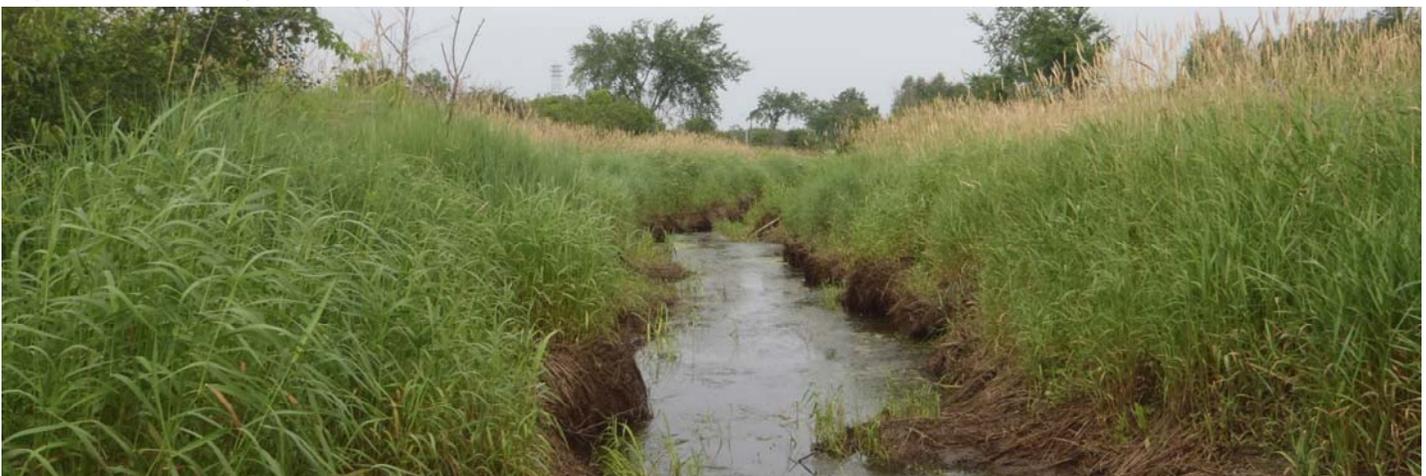
Low level stream bank undercutting along Borthwick Creek between Walkley Rd. and Ramsayville Rd.

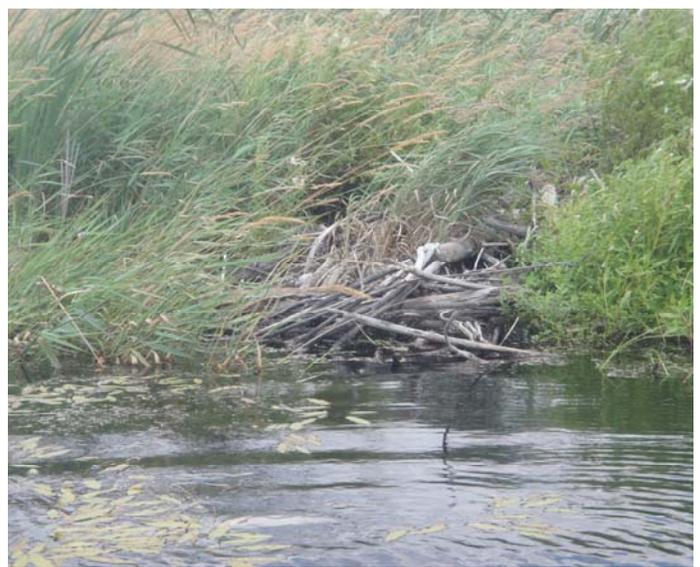
Instream woody debris resulting from beaver activity on Borthwick Creek

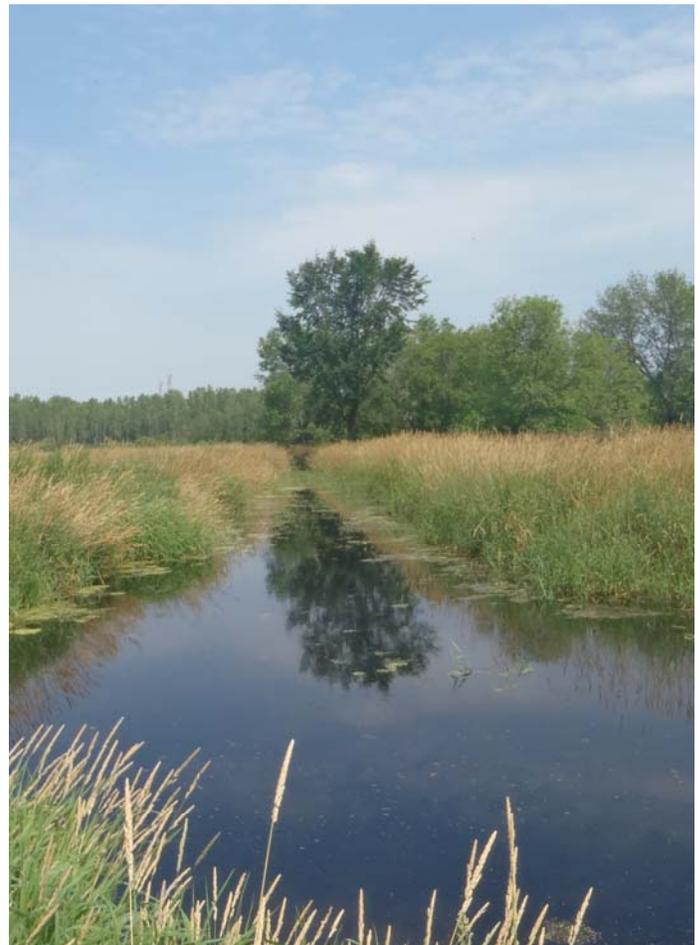
Stream channelization along Borthwick Creek

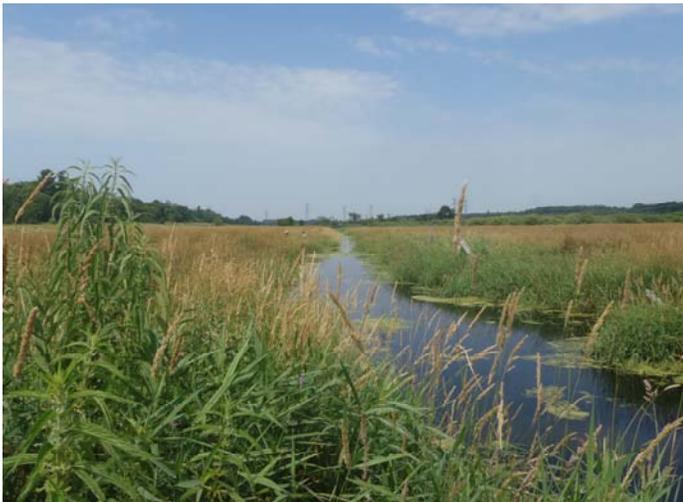
Table 4 shows that between 2007 and 2013 anthropogenic alterations along Borthwick Creek have increased. This change can be attributed to changes in the stream survey protocol and the classification of channelization. In 2010 anthropogenic alterations were further defined in the protocol, which has caused some land uses to shift categories.

A channelized section of Borthwick Creek considered highly altered in 2013
