Black Rapids Creek 2014 Summary Report

Introduction

In 2014, 55 sections (5.5 km) of the main stem of Black Rapids Creek and 18 sections (1.8km) of the tributaries were surveyed as part of the City Stream Watch monitoring activities. The following is a summary of observations made by staff and volunteers along those 73 sections.

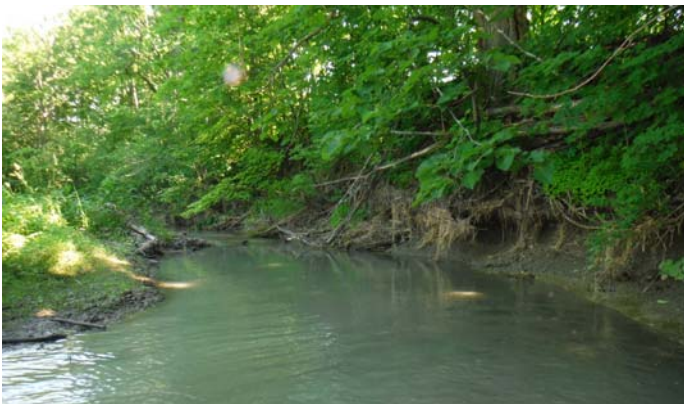
Moderate stream bank erosion along Black Rapids Creek

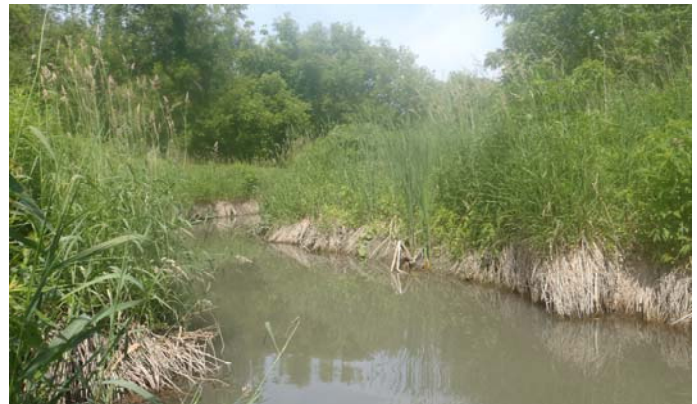
Low level bank undercutting along Black Rapids Creek

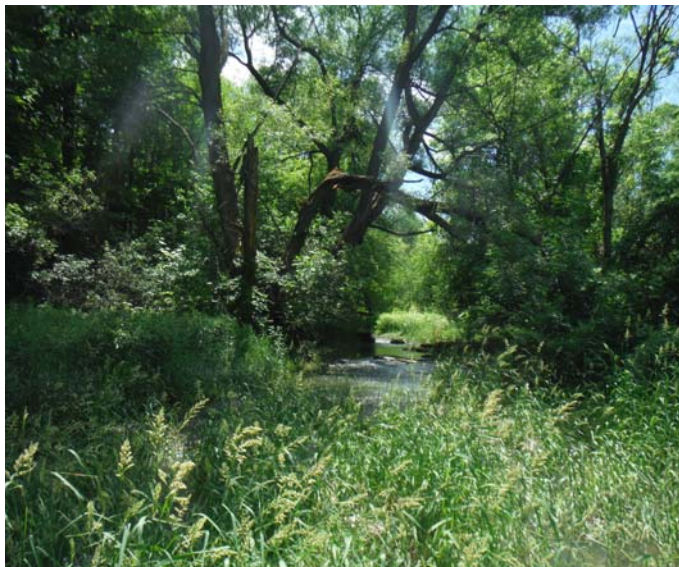
Stream shade along Black Rapids Creek

Grasses, shrubs and trees all contribute towards shading a stream. Shade is important in moderating stream temperature, contributing to food supply and helping with nutrient reduction within a stream. Figure 6 shows stream shading along Black Rapids Creek. Moderate to high levels of shading were seen along most of the creek. Very high levels of stream shading were seen along the tributaries of Black Rapids Creek which was resulting from long grasses overhanging the creek and minimal channel width.

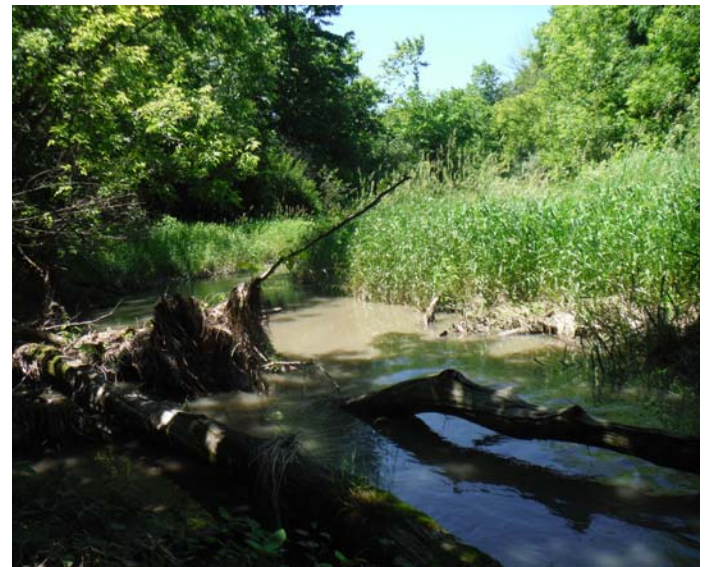
Instream woody debris along Black Rapids Creek

Figure 7 shows that overall, the surveyed sections along Sawmill Creek had moderate levels of instream woody debris in the form of branches and trees. Instream woody debris is important for fish and benthic habitat, by providing refuge and feeding areas. Some areas with high levels of instream woody debris were observed downstream of Merivale Road and along one of the tributaries of the creek.

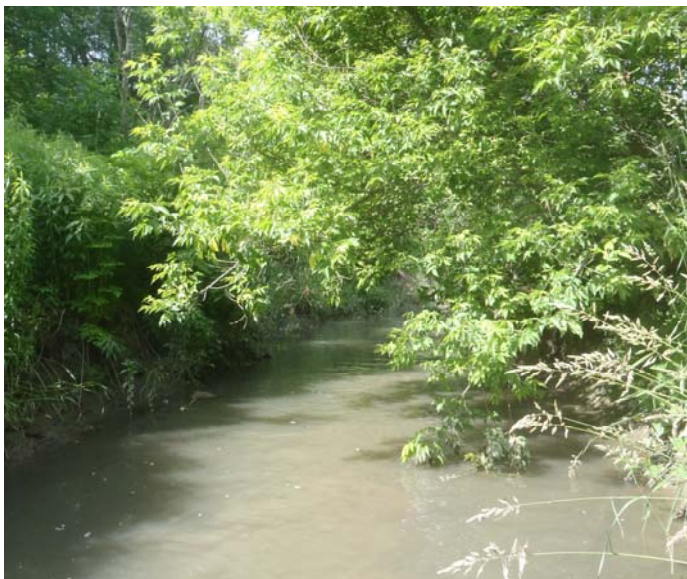
Overhanging trees and branches on Black Rapids Creek

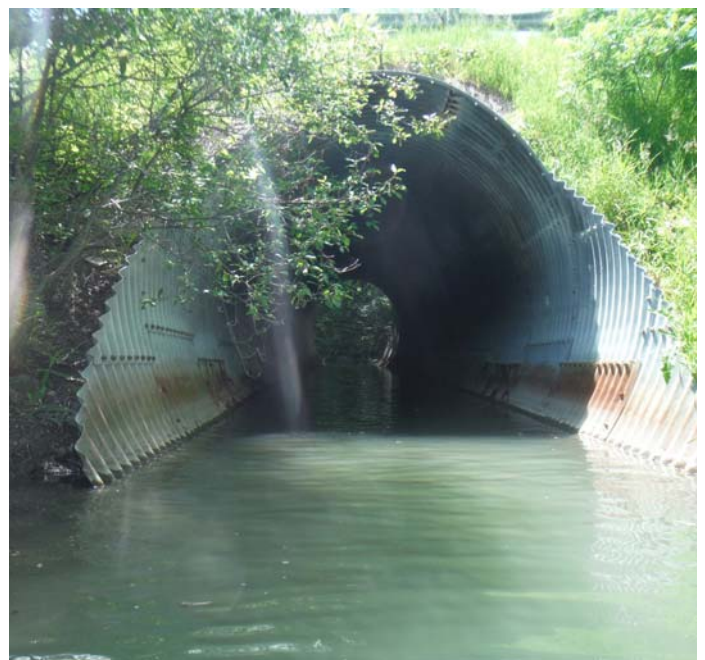
A highly altered section of Black Rapids Creek where it crosses Merivale Road.

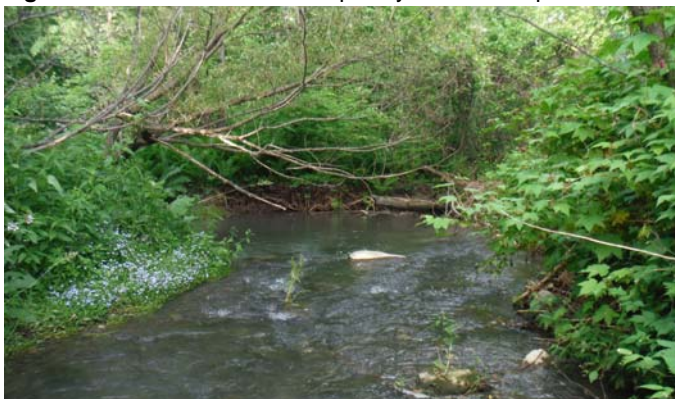
Habitat complexity on Black Rapids Creek

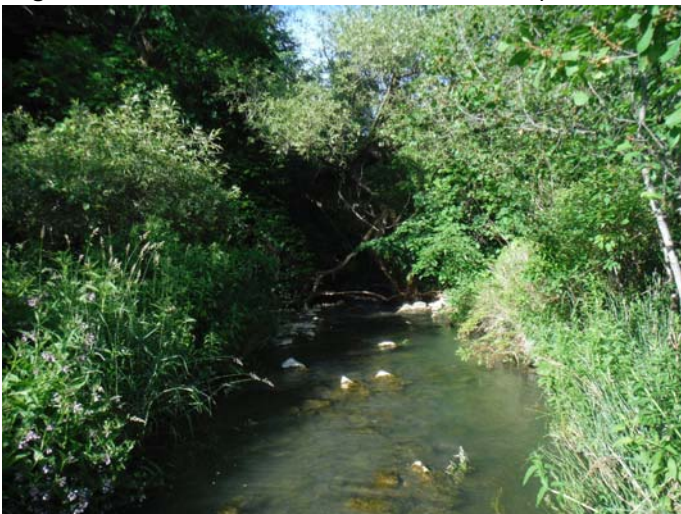
Cobble and boulder habitat observed along Black Rapids Creek

Boulders create instream cover and back eddies for large fish to hide and/or rest out of the current. Cobble provides important over-wintering and/or spawning habitat for small or juvenile fish. Cobble can also provide habitat conditions for benthic invertebrates that are a key food source for many fish and wildlife species. Figure 13 shows the distribution of cobble and boulder habitat along Sawmill Creek. Areas of cobble and boulder habitat are found primarily downstream of Merivale Road and near the railway and road crossing around Woodroffe Avenue.

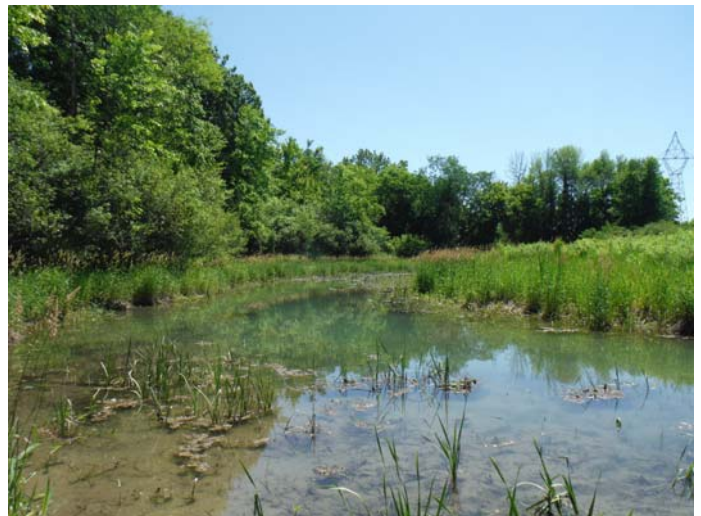
Instream vegetation in Black Rapids Creek

Instream vegetation provides a variety of functions and is a critical component of the aquatic ecosystem. For example emergent plants along the shoreline can provide shoreline protection from wave action and important rearing habitat for species of waterfowl. Submerged plants provide habitat for fish to find shelter from predator fish while they feed. Floating plants such as water lilies shade the water and can keep temperatures cool while reducing algae growth. Figure 16 depicts the diversity of plant community structure in Black Rapids Creek. Submerged plants, algae and narrow leaved emergents were all recorded in high percentage at 27 percent, 23 percent and 23 percent respectively. The distribution of overall dominant types of instream vegetation is reflected in Figure 17 where submerged plants, algae and narrow leaved emergents stand out as the dominant vegetation types.

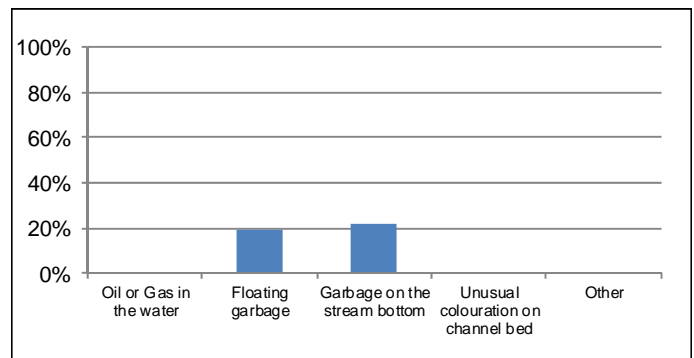
Figure 21 Pollution observed along Black Rapids Creek

Figure 21 demonstrates the incidence of pollution/garbage in Black Rapids Creek. Sixty eight percent of the sections surveyed on Black Rapids Creek did not have any observable garbage. Garbage on the stream bottom was seen most often at 22 percent followed by floating garbage at 19 percent.

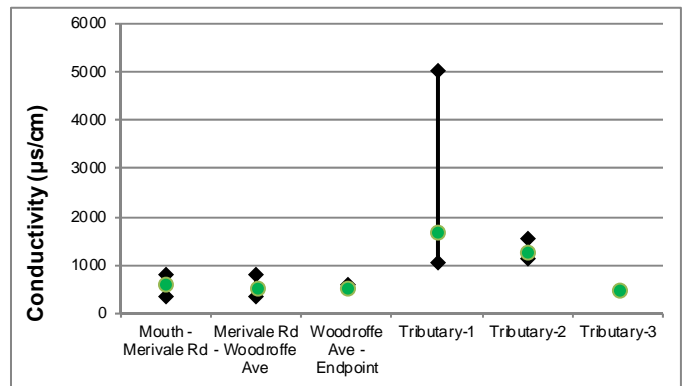
Figure 23 Conductivity ranges in Black Rapids Creek

Conductivity in streams is primarily influenced by the geology of the surrounding environment, but can vary drastically as a function of surface water runoff. Currently there are no CCME guideline standards for stream conductivity, however readings which are outside the normal range observed within the system are often an indication of unmitigated discharge and/or stormwater input. The average conductivity observed within the main stem of Black Rapids Creek was 577 $\mu\text{s/cm}$. Figure 23 shows that the conductivity readings in two of the tributaries of Black Rapids Creek was significantly higher than the readings in the main stem of the creek. In Tributary 1 the average conductivity was 1681 $\mu\text{s/cm}$. In tributary 2 the average conductivity was 1293 $\mu\text{s/cm}$. The high conductivity in these tributaries is likely heavily influenced by runoff from Fallowfield Road as well as adjacent agricultural fields.

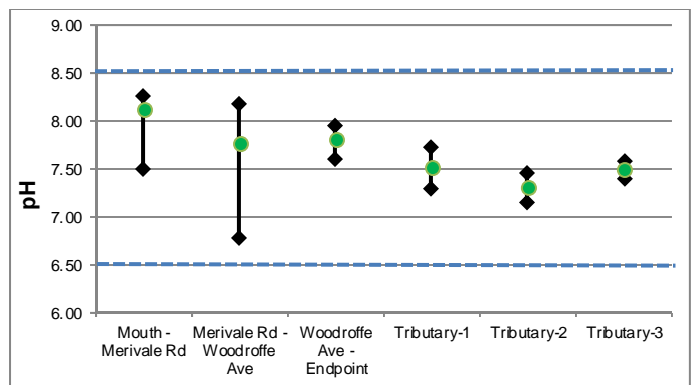
Figure 24 pH ranges in Black Rapids Creek

Based on the PWQO for pH, a range of 6.5 to 8.5 should be maintained for the protection of aquatic life. Average pH values for black Rapids Creek ranged between 7.0 and 8.3, thereby meeting the provincial standard.

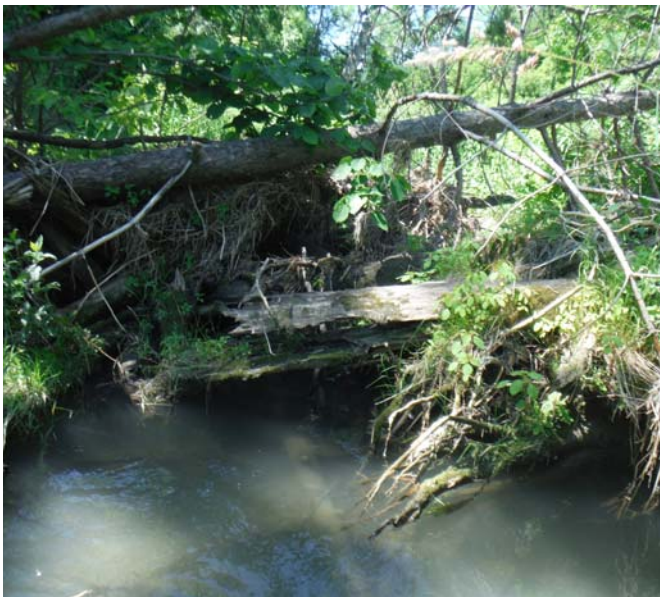
A debris dam observed along Black Rapids Creek

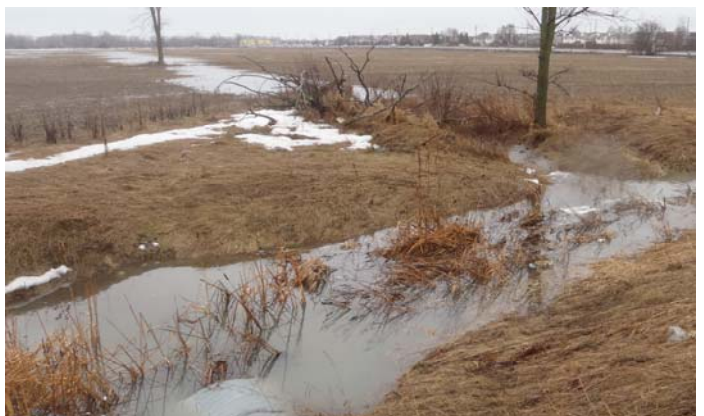
A headwaters site at Fallowfield Road

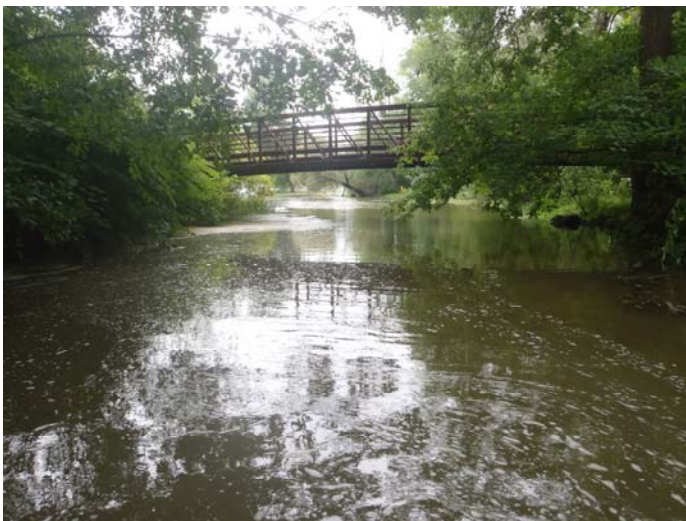
An anthropogenic alteration on Black Rapids Creek

Figure 9 shows that 59 percent of the sections on Black Rapids Creek remain “unaltered” or “natural”. Sections considered “altered” account for five percent of the stream, while 36 percent of the sections sampled were considered “highly altered”. Black Rapids Creek crosses multiple roads and is channelized where it flows through agriculture fields in the upper reaches and the tributaries, which accounts for the high percentage of highly altered sections.

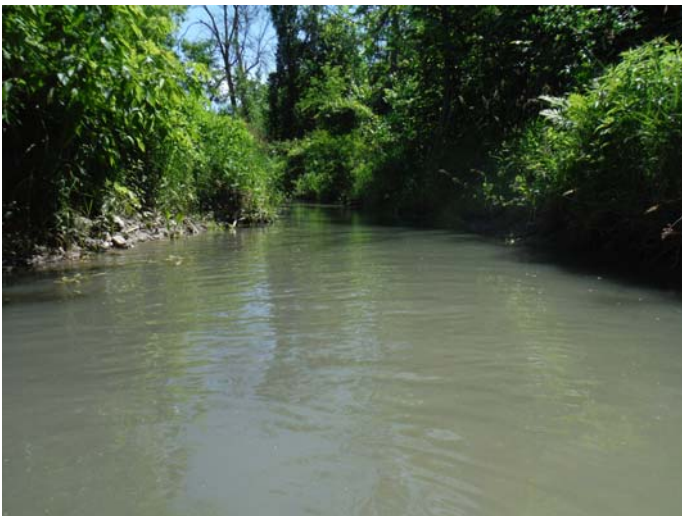
Black Rapids Creek upstream of Prince of Wales Drive

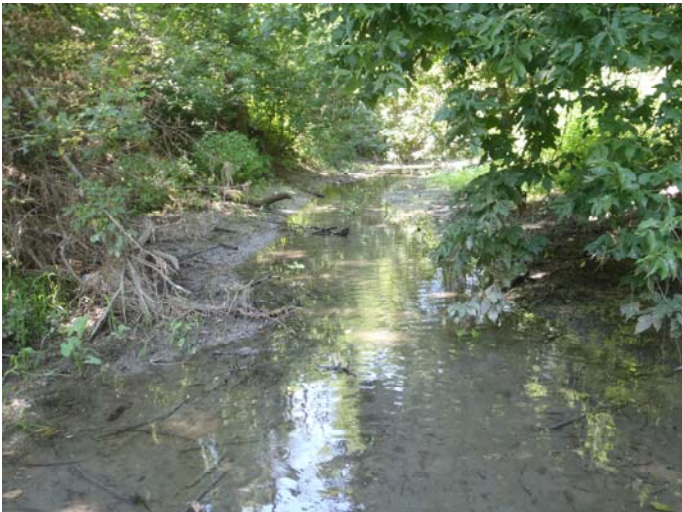
Black Rapids Creek upstream of Woodroffe Avenue

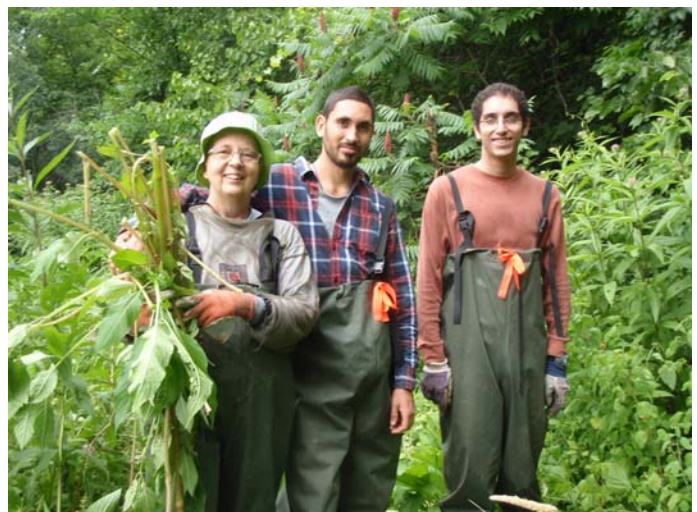
Volunteers at the Black Rapids Creek Himalayan balsam removal

Patches of Himalayan Balsam were observed along Black Rapids Creek during stream surveys in 2014. A removal effort was planned to stop the spread of this prolific species along the shoreline. Three volunteers spent nine volunteer hours removing the invasive species from 300m of shoreline.

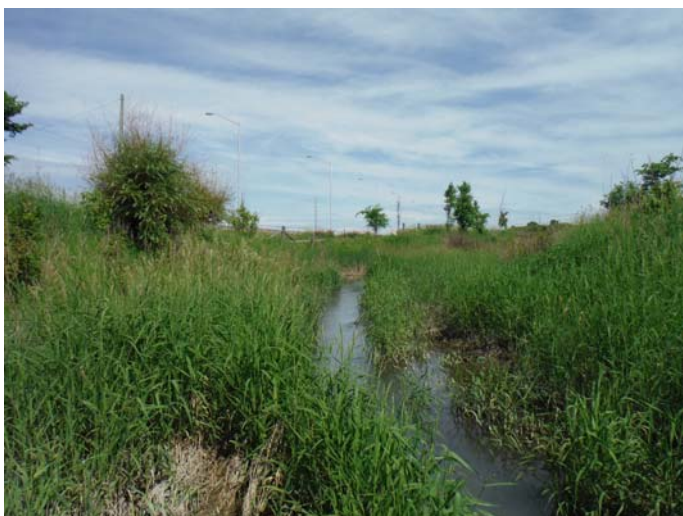
Riparian planting opportunity downstream of Woodroffe Avenue

Figure 34 depicts the locations where City Stream Watch staff and volunteers observed areas where the riparian zone could be restored or enhanced using one or more of the following techniques: riparian planting, erosion control, invasive species control and wildlife habitat creation.

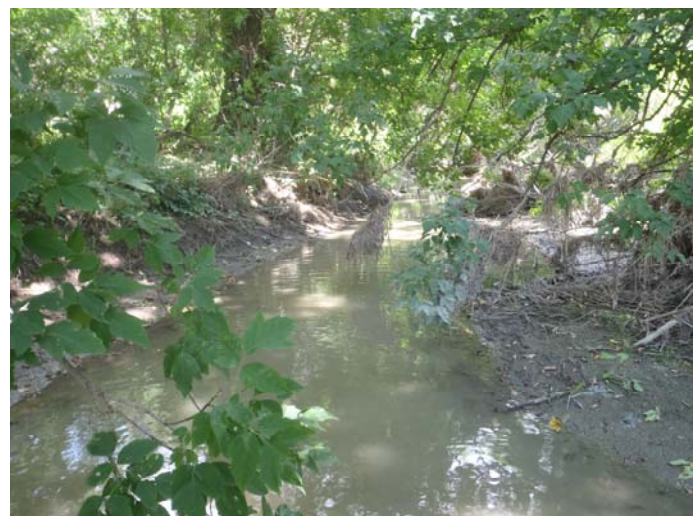
A fish habitat enhancement opportunity where there has been significant silt accumulation upstream of Woodroffe Avenue
