**SHORELINE CLASSIFICATION PROJECT**

**2003 REPORT**

**Prepared by Brad Stephens**

**May 2004**

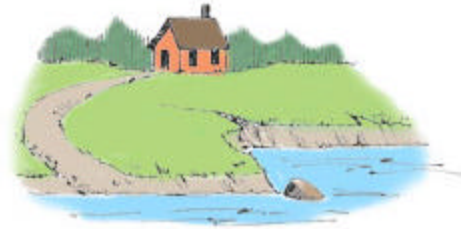
**Figure 3.4.1: Representation of a Property with a ‘Degraded’ Classification.**

Degraded areas are areas where restoration is needed as soon as possible. Development with little consideration for river ecology or impacts from boat wakes can result in areas where erosion is present, runoff from roads and driveways flows directly into the water, and/or garbage and debris is polluting the shoreline habitat (Figure 3.4.1).

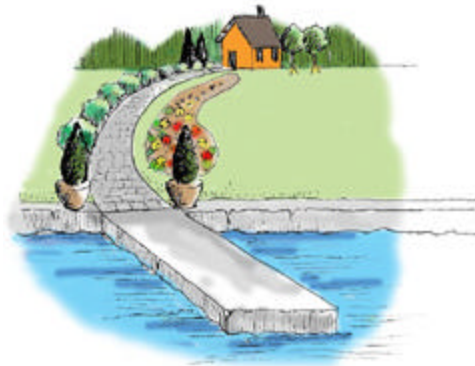
**Figure 3.4.2: Representation of a Property with an ‘Ornamental’ Classification.**

Ornamental areas are areas where development has focused on shoreline aesthetics and industry. No significant buffer exists along the shoreline. Construction of retaining walls, onshore structures and docks has significantly impacted wildlife habitat and the ability of the shoreline to slow runoff inputs of nutrients and pollution (Figure 3.4.2).

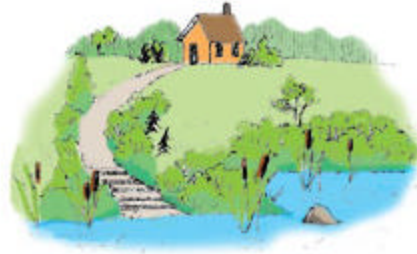
**Figure 3.4.3: Representation of a Property with a 'Regenerative' Classification.**

Regenerative areas are areas where there have been significant efforts made to restore the shoreline to a pre-development state. Presence of native vegetation is vital to regeneration. This would consist of a thick shrub buffer, developing canopy and diverse aquatic vegetation. The ability of the property to control erosion and runoff is good (Figure 3.4.3).

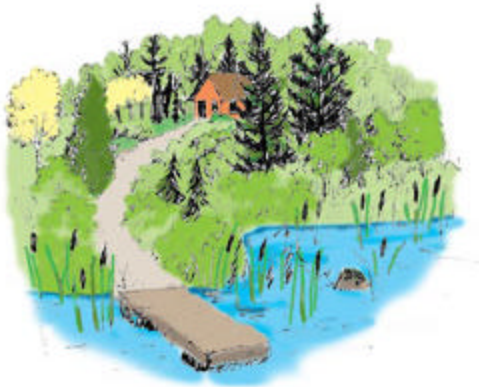
**Figure 3.4.4: Representation of a Property with a 'Natural' Classification.**

Natural areas are areas where human disturbance on land or in the river is minimal. Vegetation is established at all strata providing habitat for various organisms. Ecological health of the river depends on natural areas (Figure 3.4.4).

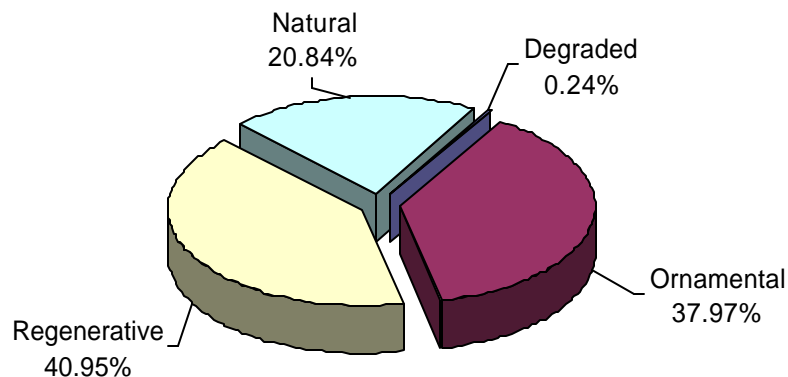
**Figure 5.1.1: Shoreline Classification Percent Frontage for Rideau River 2003.**

Shoreline classification percentages are represented in Figure 5.1.1. Ornamental and regenerative designations were close at 37.97% and 40.95% respectively. This is a drop in ornamental frontage percent from 61% in the 2002 study between Mooney's Bay and the Kars Bridge. It is evident that development pressures are less intense, as one moves upstream (away from the heart of the City of Ottawa) along the Rideau River, which is reflected in these figures.

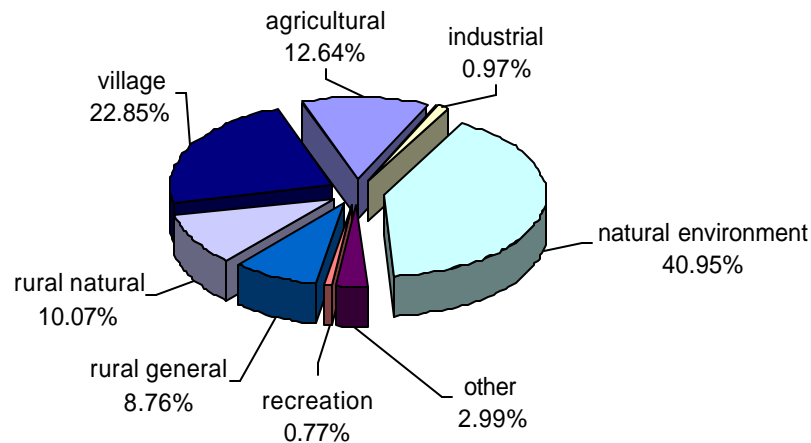
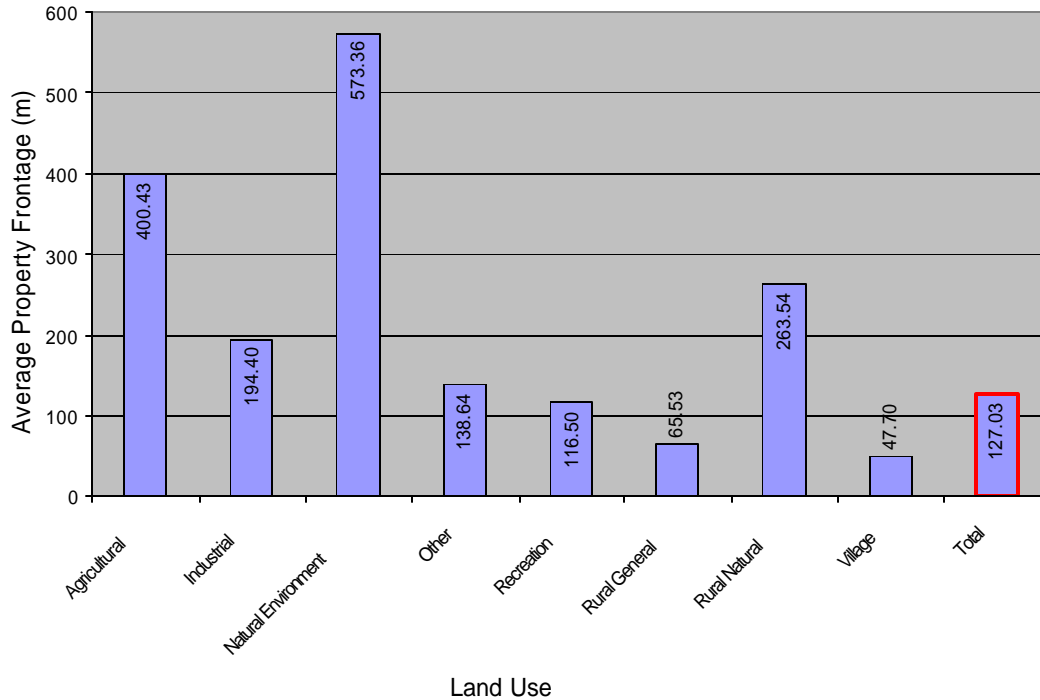
**Figure 5.3.1: Land Use Percent Frontage for Rideau River 2003.**

**Figure 5.3.2: Average Property Frontage by Land Use for Rideau River 2003.**

Agricultural land use represented 12.64% of the 2003 study area. The majority of these properties were concentrated into the area between Burritts Rapids and Becketts Landing. Within the 38 agricultural properties, livestock were observed in the river in 3 locations. A total of 6 properties showed evidence of livestock accessing the river. In all instances a complete lack of riparian plants and signs of widespread erosion were present.

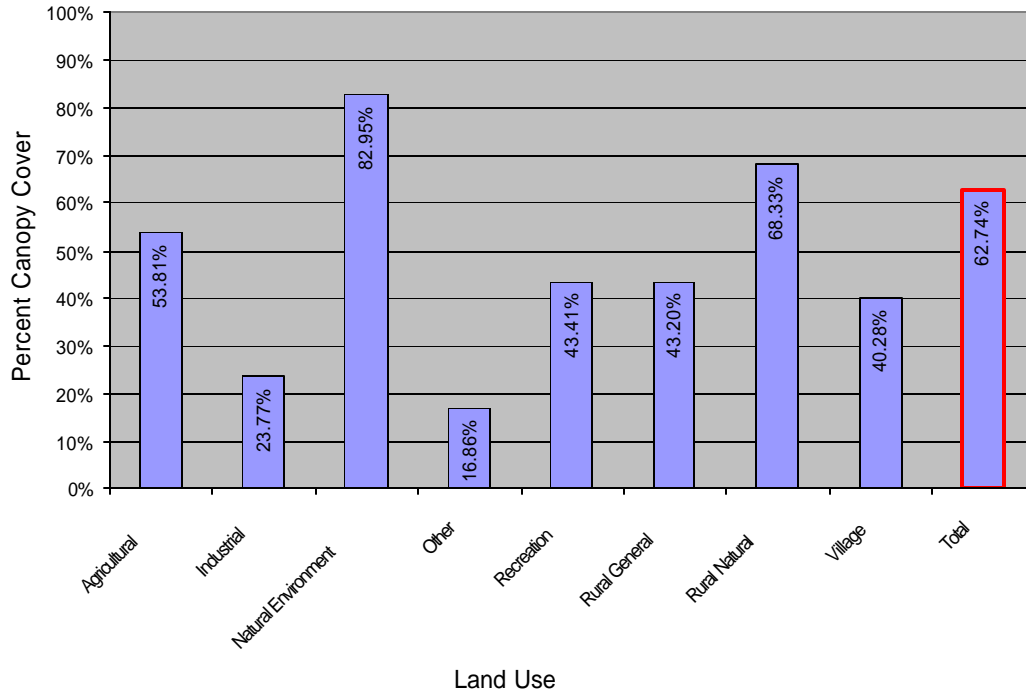
**Figure 5.3.4: Percent Shoreline Canopy Cover by Land Use for Rideau River 2003.**

Canopy cover versus land use is shown in figure 5.3.4. Natural Environment, the dominant land use above Becketts Landing, showed the highest values at 82.95% canopy cover. The dominant land uses downstream from Becketts Landing, village and rural general show canopy cover values at 40.28% and 43.20% respectively. This is well below cover for the entire 2003 study area at 62.74%. This helps explain why fragmentation occurs when mixing residential (village and rural general) and natural environment properties.

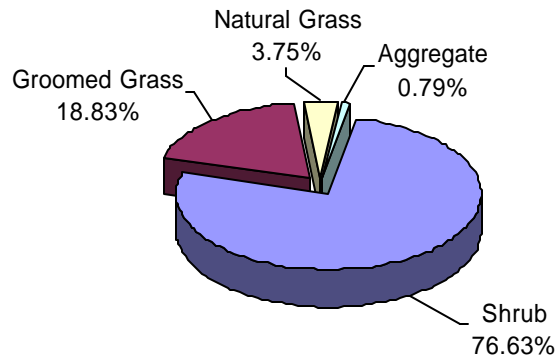
**Figure 5.3.5: Shoreline Shrub Layer Composition for Rideau River 2003.**

Shrub layer composition is represented in Figure 5.3.5. Shrubs dominate this layer with 76.63% shoreline cover. However, by querying the GIS database, it was identified that the majority of the properties with greater than 90% shrub cover were upstream from Becketts Landing. Further queries showed that in this stretch of river 83.86% of the surveyed shoreline had shrub cover. Whereas downstream from Becketts Landing (closer to the City of Ottawa) shrub cover was 55.66%. In the same areas, groomed grass cover was 12.39% and a much higher 29.80%. Queries of the residential land uses, village and rural general, showed shrub cover as 53.01% and groomed grass cover as 43.69%.
