Board of Directors Meeting

Thursday, July 23, 2020

**6.0 RVCA Low Water Response Program
Report #: 1-200715**

**8.0 Britannia Village Flood Control Works: Wall Repair
Report #: 3-200715**

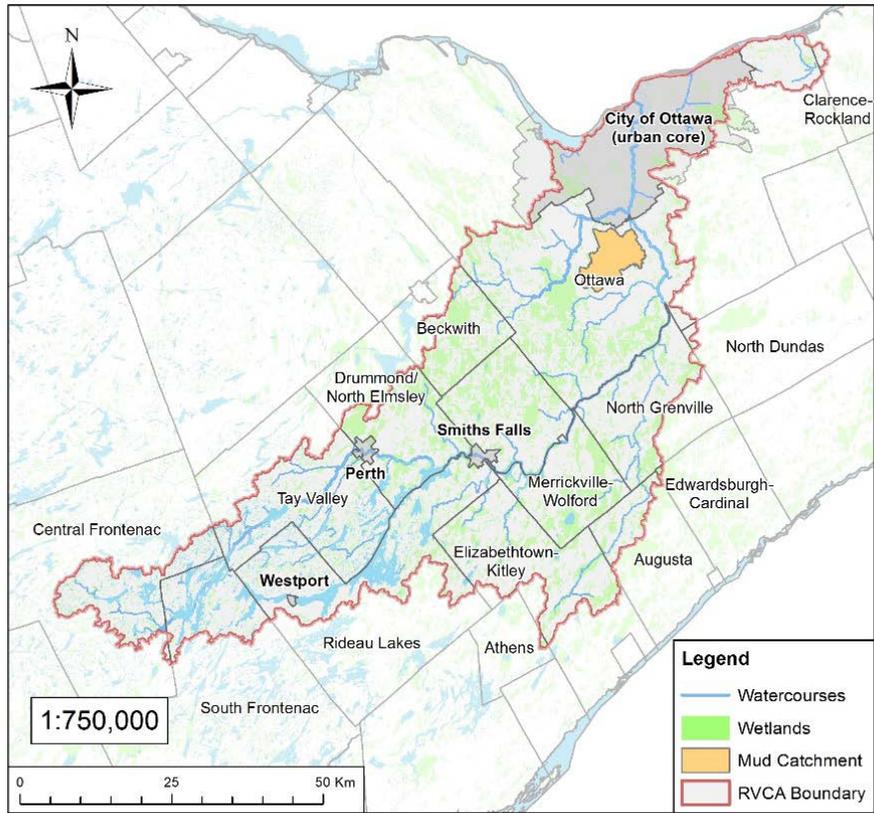
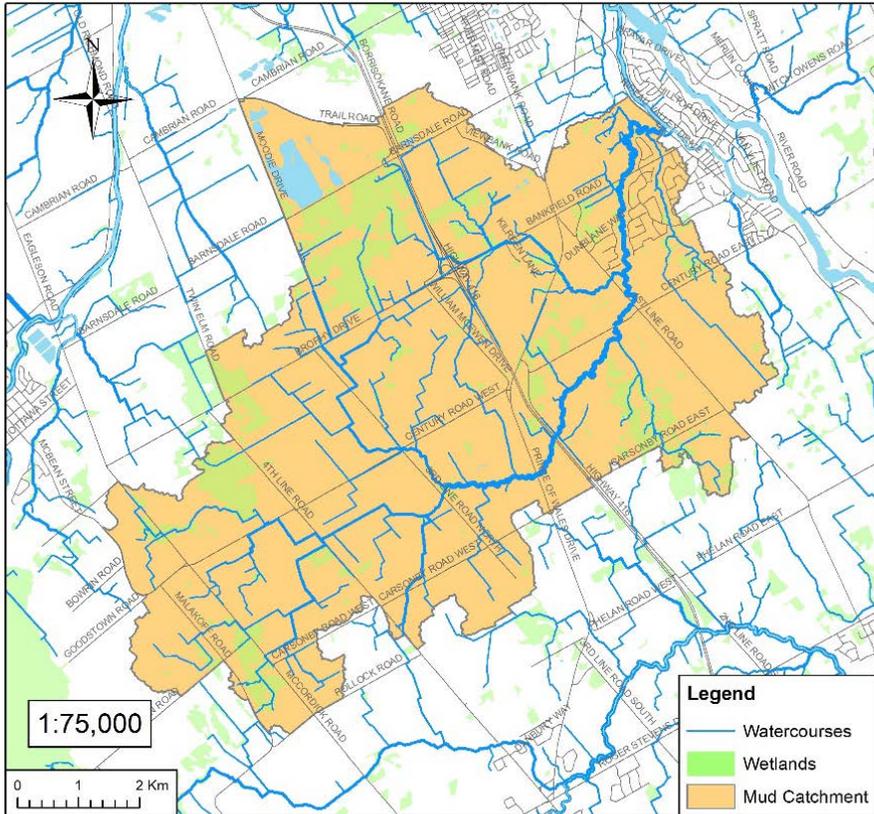
There is no existing flood hazard or regulation limits mapping on Mud Creek so the RVCA has mapped it for the first time. Mapping was undertaken from 3rd Line Road North to the Rideau River. Below are two maps that show where the Mud Creek catchment is located within the Rideau watershed.

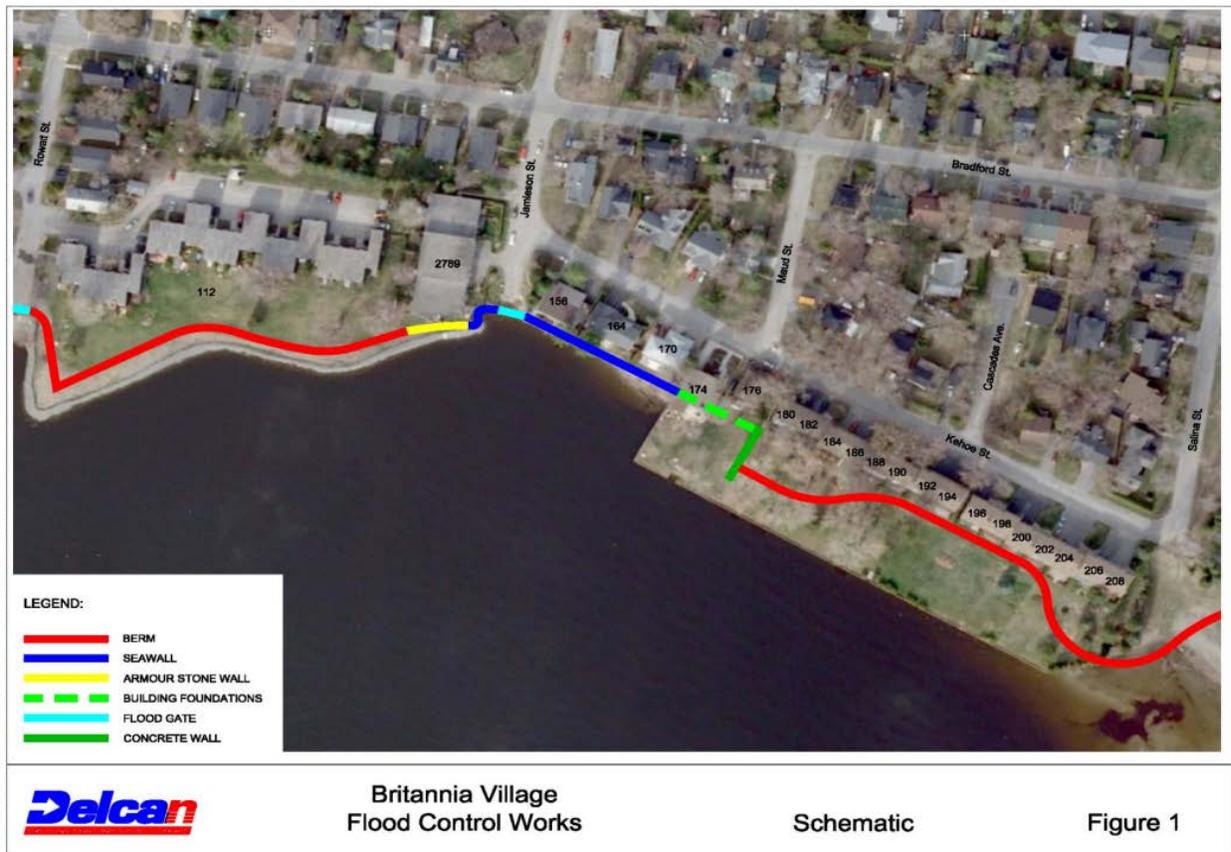
Following years of design work in consultation with the local community, the RVCA and City of Ottawa began construction on the flood control project in 2015. The flood control works are made up of a series of modified retaining walls, modified earth berms, new earth berms and other features (see schematic below). The flood control measures were designed and built to protect Britannia Village against the 1:100 year flood event with a 30 cm freeboard incorporated into the design as an added margin of safety.

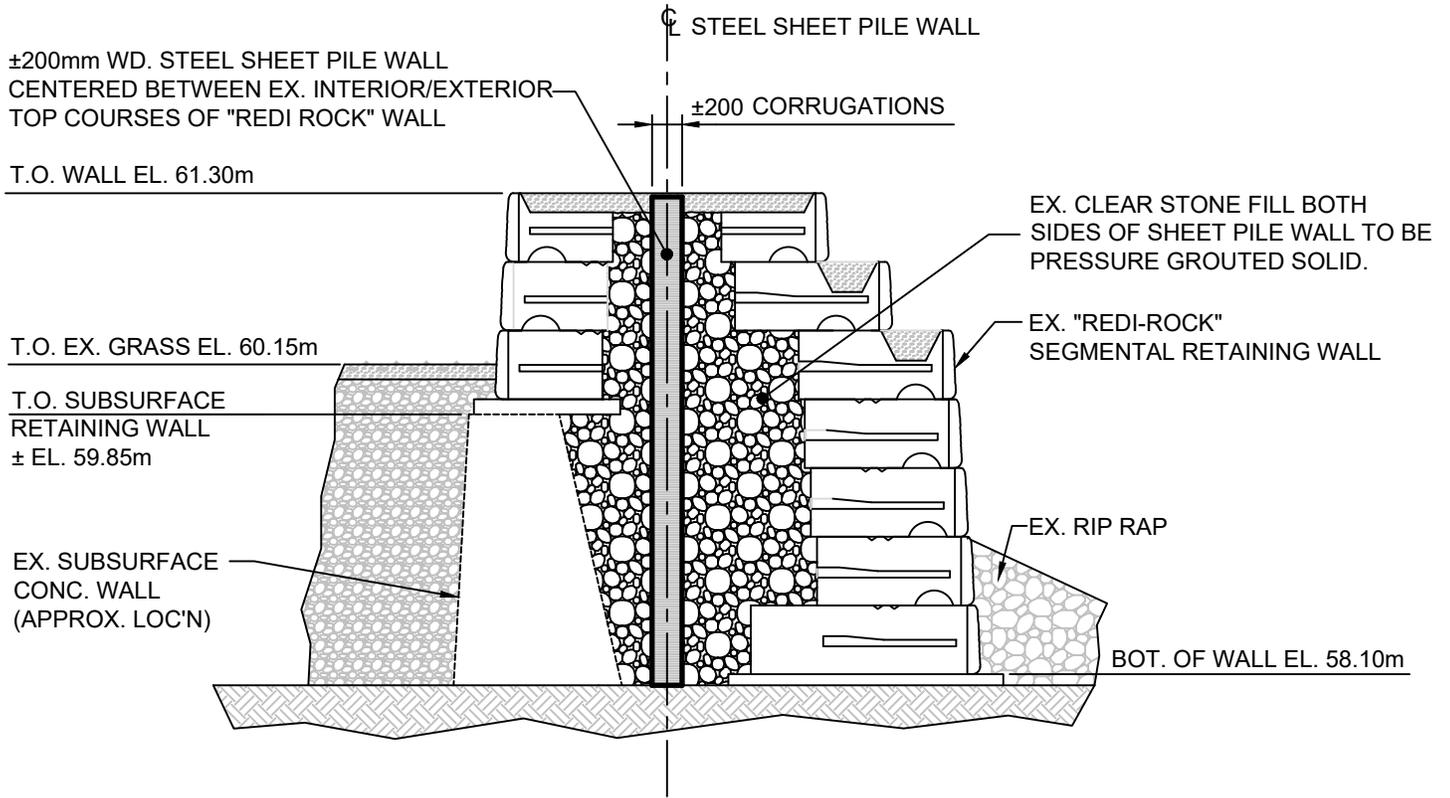
**SECTION AT EXISTING RETAINING WALL
SHOWING PROPOSED STEEL SHEET PILE WALL LOCATION**

Steel sheet pile walls are a common method used for water retention and erosion control in the construction industry. For this option, steel sheet piles would be driven through the clear stone between the primary and secondary Redi-Rock retaining walls, creating a solid barrier between the walls. Although the sheet piles interlock, pressure grouting the clear stone fill is recommended to further assist in sealing the wall. Refer to SK-1, attached, for concept sketch. JLR anticipates that the sheet piles could be installed from the north end of the site or from the boat ramp area at the south during lower river water levels, avoiding the need for significant in-water work.

This option is deemed to be less preferable due to concerns regarding the effectiveness of cutting off the flow of water at the base of the sheet piles, and the possibility of damaging the existing wall structure when installing the sheet piles. The Geotechnical Report prepared by Gemtec in support of this project indicates that the bedrock in the area around the wall is highly fractured so it is anticipated that the base of the wall would not provide a uniform barrier to prevent the flow of water. It is also possible that cobbles, boulders or construction debris from previous structures in the area are present in the soil above the bedrock and would prevent the sheet piles from being properly driven to the depth of the bedrock. It is not possible to confirm whether the pressure grouting will provide a consistent seal to prevent flow, impacting the effectiveness of this option. Termination details for the steel sheet pile system at the junction with the existing concrete “No Trespassing” wall would pose an additional challenge, and some seepage between these two systems would be expected. A secondary ‘sump pump-type’ dewatering pit could be included within the clear stone on the land-side of the sheet piling.

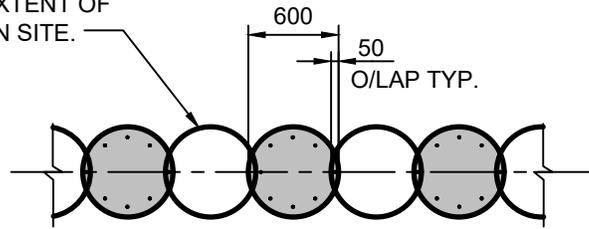
PART PLAN @ T.O. SECANT PILE WALL

600mmØ CONCRETE SECANT PILES
OVERLAPPED AS SHOWN. EXTENT OF
WALL TO BE DETERMINED ON SITE.

NOTE:
EX. "REDI ROCK" WALL
& TOPSOIL NOT SHOWN
FOR CLARITY

Unlike the sheet pile option, the nature of using poured concrete piles means that the concrete will contour with any surface roughness of the underlying bedrock. Additionally, given that installation of the piles will require drilling through the soil materials rather than driving, any cobbles, boulders, subgrade concrete including the existing gravity retaining wall, or upper fractured bedrock would be removed and would therefore not interfere with the wall system. As per the recommendations in the geotechnical report prepared by Gemtec the secant pile wall should extend at least 2 metres into the bedrock to seal off the upper fractured zone and cut off the path of travel for seepage under the barrier. Refer to SK-2, attached, illustrating the concept.

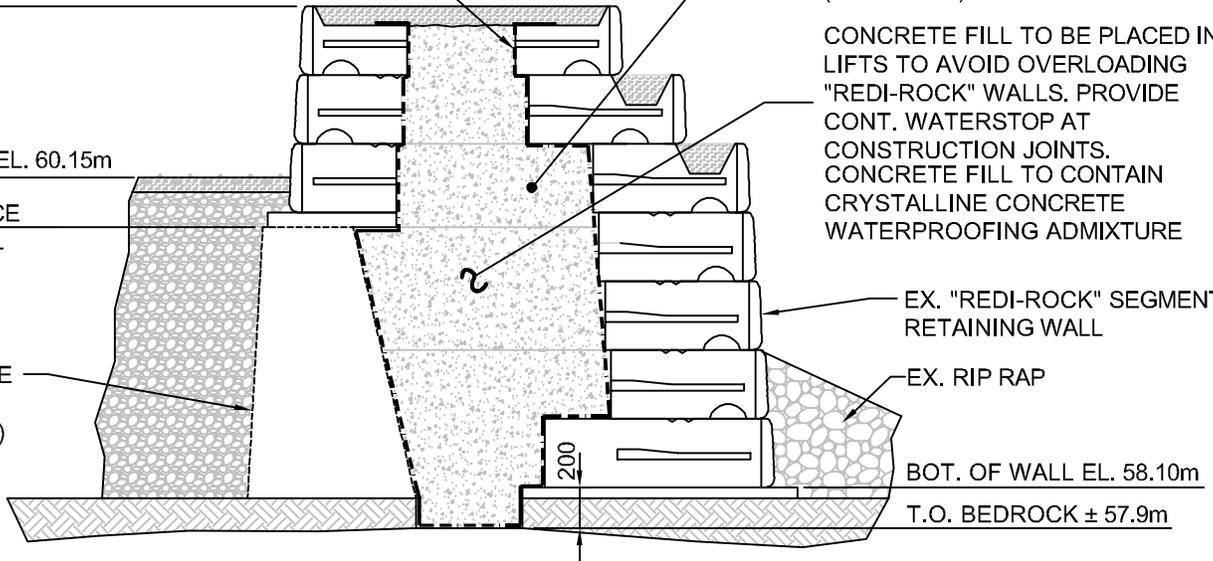
**SECTION AT EXISTING RETAINING WALL
 SHOWING PROPOSED LEAN CONCRETE FILL**

REPLACEMENT OF EX. CLEAR STONE WITH LEAN CONCRETE

With this option, the existing clear stone backfill would be removed from within the inner and outer walls to expose the bedrock surface and be replaced with lean (low strength, unreinforced) concrete fill. Lean concrete fill would extend to the north to tie into the existing clay berm, and would be tied into the existing no-trespassing wall at the south. A concrete extension would be poured on top of the no-trespassing wall to bring it up to a height matching the top of the existing Redi-Rock retaining wall. Although this option would require removal and reinstatement of the

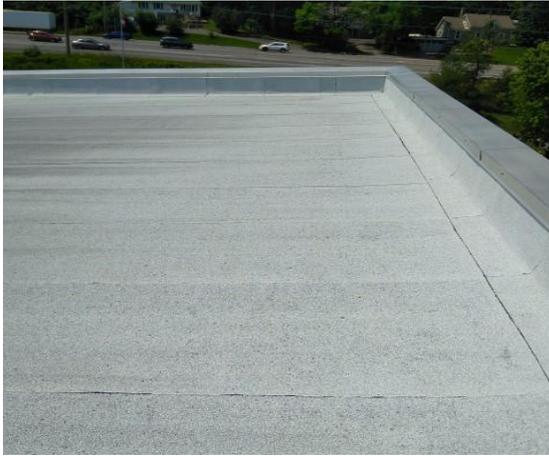
Photo #1 – No blisters and few surface degranulation at north elevation (Roof R1) – July 4, 2019

Roof degranulation was visible in the roof Sections R1, R2, R3, R4, R5, and R9 where the slope is higher than 6:12. Granules are important to protect the roofing membrane against UV Solar Radiation. The radiation causes oxidation of the membrane, therefore reducing its useful life. Also, degranulation causes the roof surface becomes darker reducing its emissivity (reflection of solar radiation).

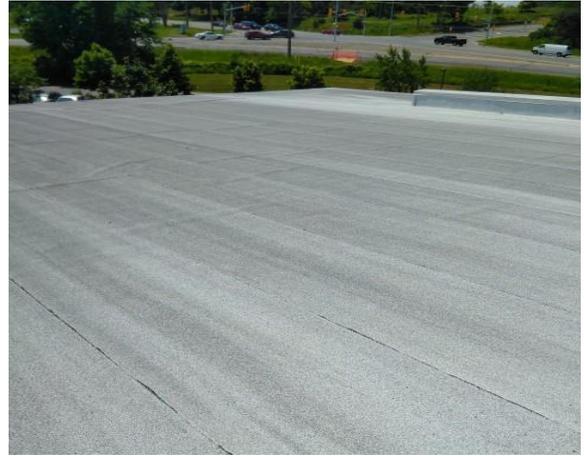
Photo #2 – Blisters and surface degranulation at southwest elevation (Roof R1) – July 4, 2019

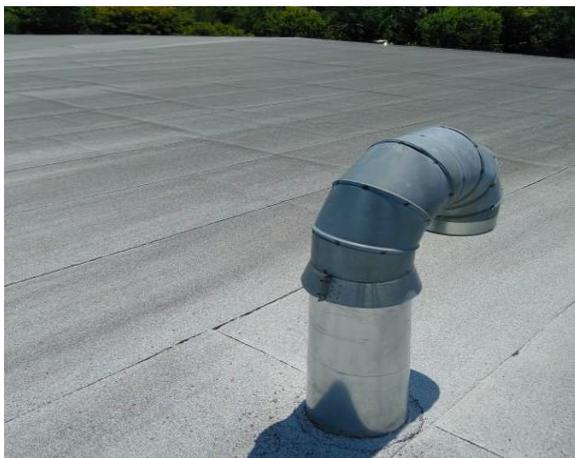
Photo #3 – Blisters and surface degranulation at north elevation and centre of the roof (Roof R1) – July 4, 2019

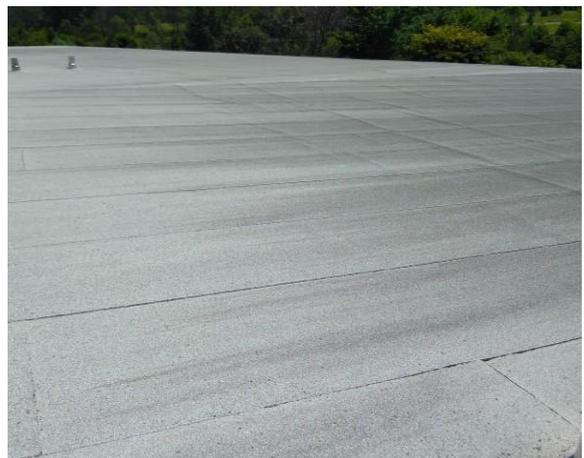
Photo #4 – Roof R1 - Blisters and surface degranulation at north and centre of the roof (Roof R1) – July 4, 2019

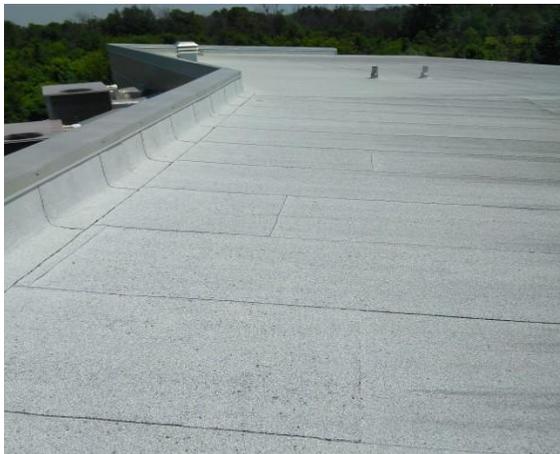
Photo #5 – Roof R1 - No blisters and few surface degranulation at north elevation (Roof R1) – July 4, 2019

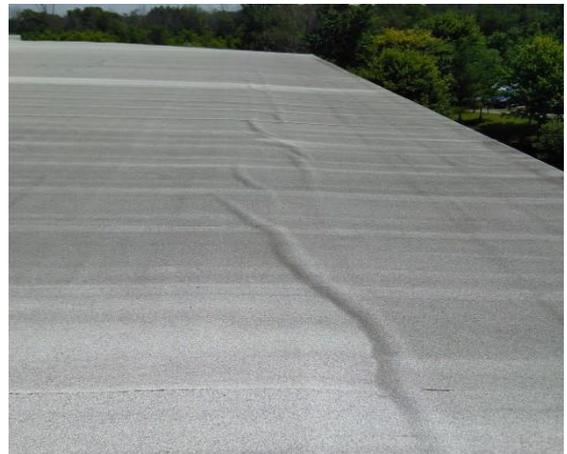
Photo #6 – Extensive blisters and surface degranulation at south elevation (Roof R1) – July 4, 2019

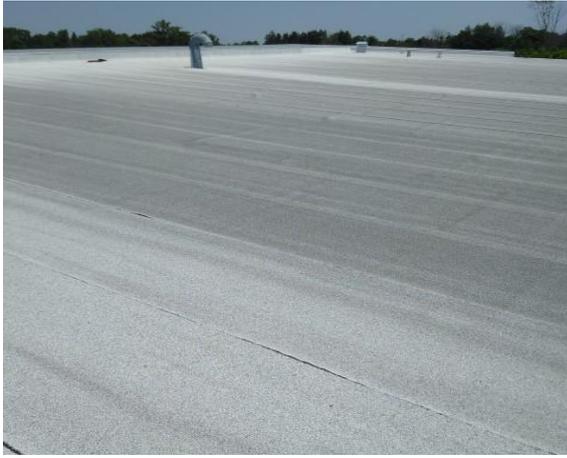
Photo #7 – Blisters and surface degranulation at centre of the roof (Roof R1) – July 4, 2019

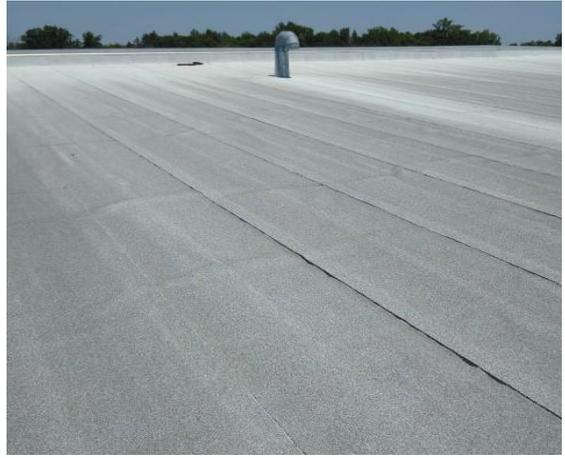
Photo #8 – Blisters and surface degranulation at centre of the roof (Roof R1) – July 4, 2019

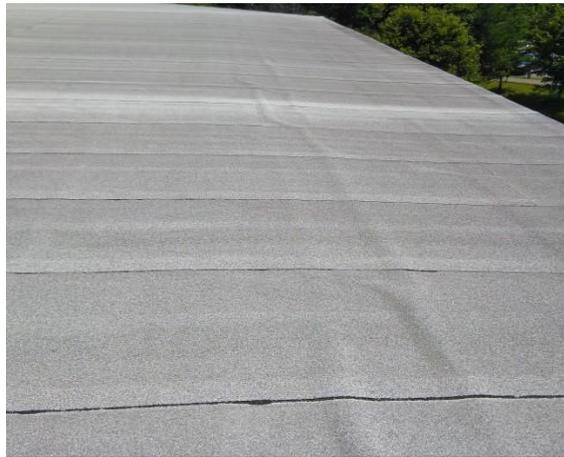
Photo #9 - Blisters and surface degranulation at south elevation (Roof R1) – July 4, 2019

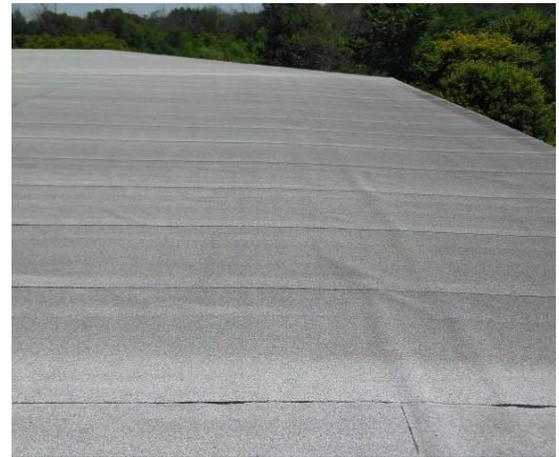
Photo #10 – Blisters and surface degranulation at south elevation (Roof R1) – July 4, 2019

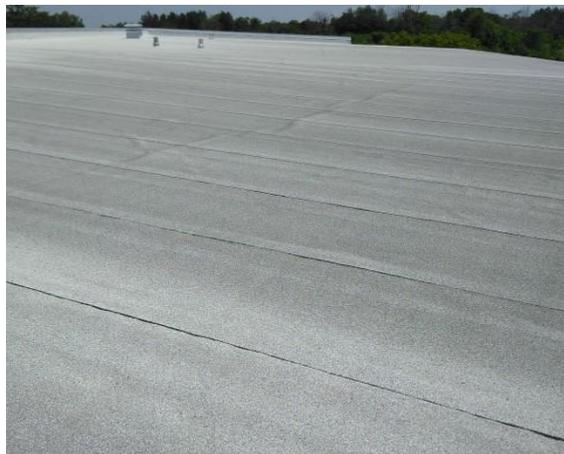
Photo #11 - Blisters and surface degranulation at centre of the roof (Roof R1) – July 4, 2019

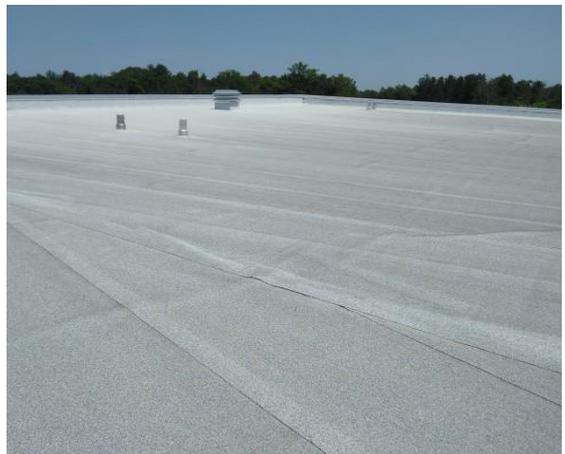
Photo #12 - Blisters and surface degranulation at centre of the roof (Roof R1) – July 4, 2019

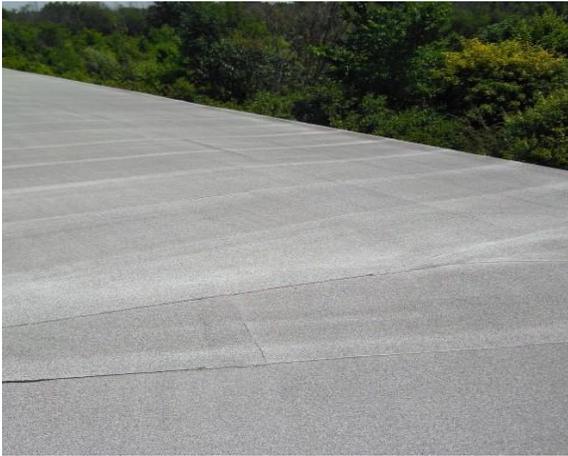
Photo #13 – Blisters and surface degranulation at south elevation (Roof R1) – July 4, 2019

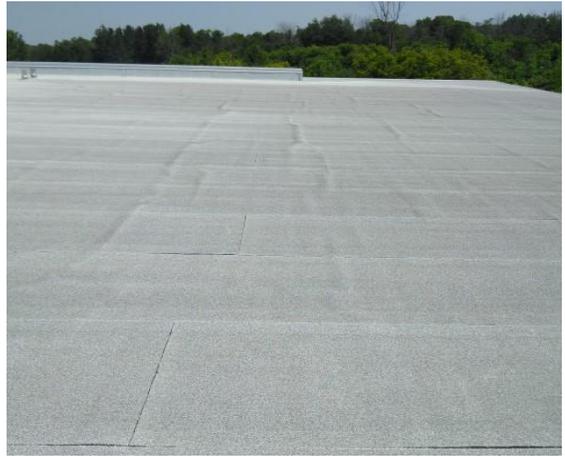
Photo #14 - Blisters and surface degranulation at south elevation (Roof R1) – July 4, 2019

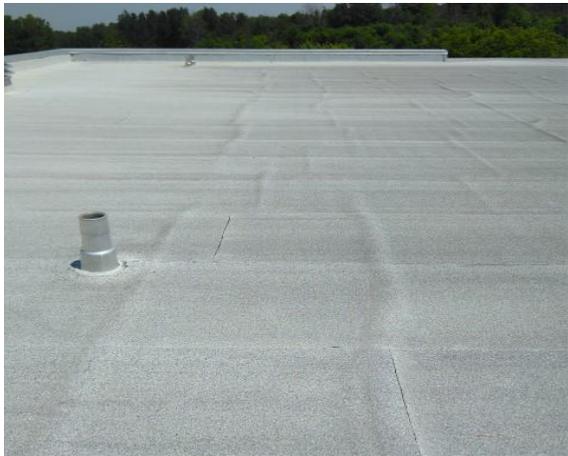
Photo #15 – Blisters and surface degranulation at centre of the roof (Roof R1) – July 4, 2019

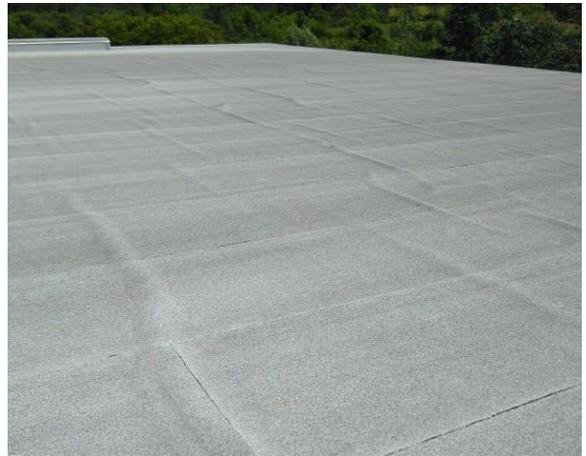
Photo #16 – Blisters and surface degranulation at centre of the roof (Roof R1) – July 4, 2019

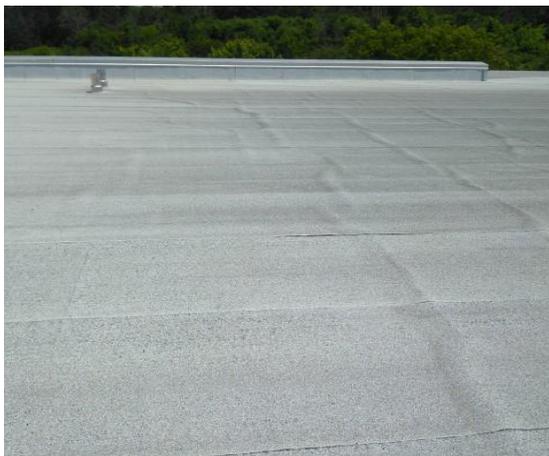
Photo #17 - Blisters and surface degranulation at east elevation (Roof R1) – July 4, 2019

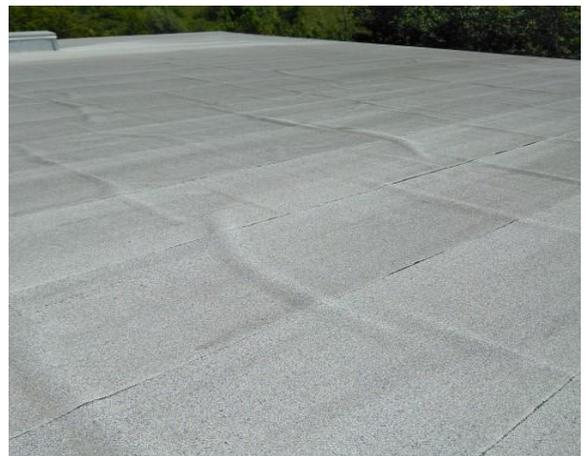
Photo #18 - Blisters and surface degranulation at southeast elevation (Roof R1) – July 4, 2019

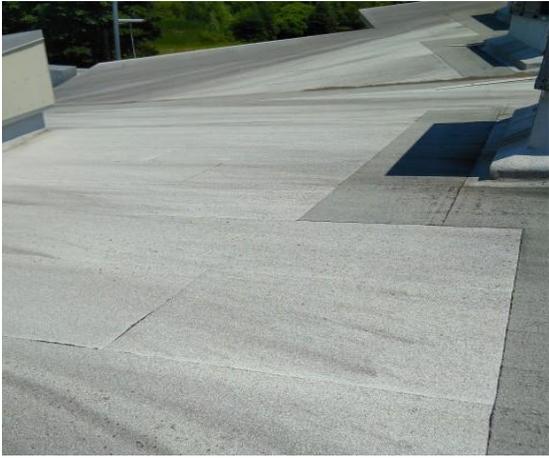
Photo #19 - Blisters and surface degranulation (Roof R2) – July 4, 2019

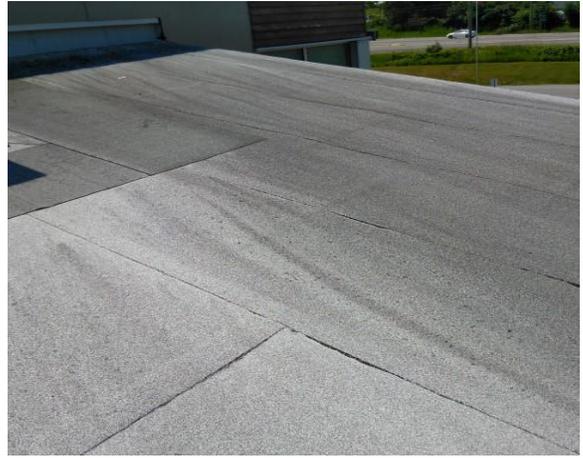
Photo #20 – Blisters and surface degranulation (Roof R2) – July 4, 2019

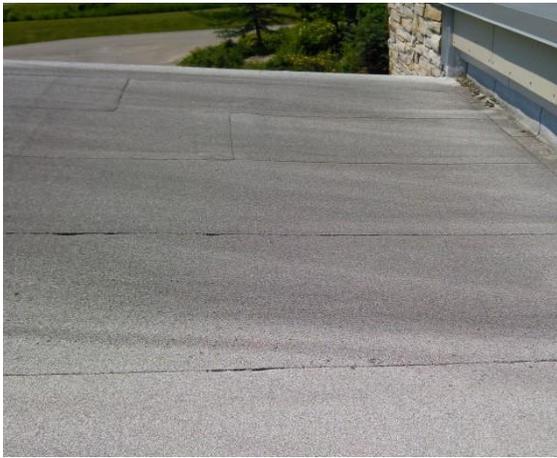
Photo #21 - Blisters and surface degranulation (Roof R2) – July 4, 2019

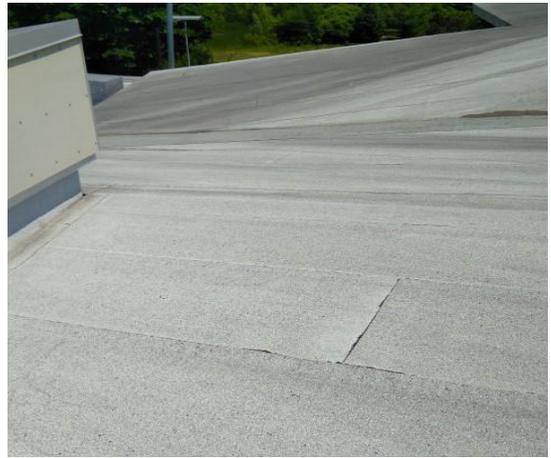
Photo #22 - Blisters and surface degranulation (Roof R2) – July 4, 2019

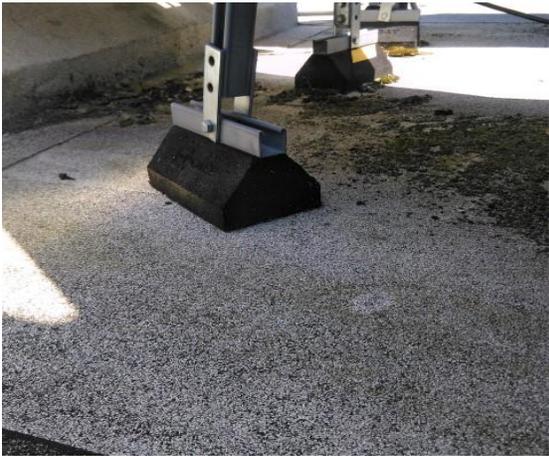
Photo #23 - Moss behind HVAC (Roof R2) – July 4, 2019

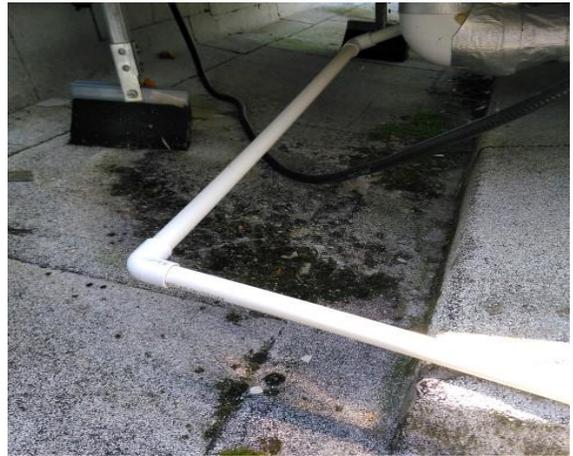
Photo #24 - Moss behind HVAC (Roof R2) – July 4, 2019

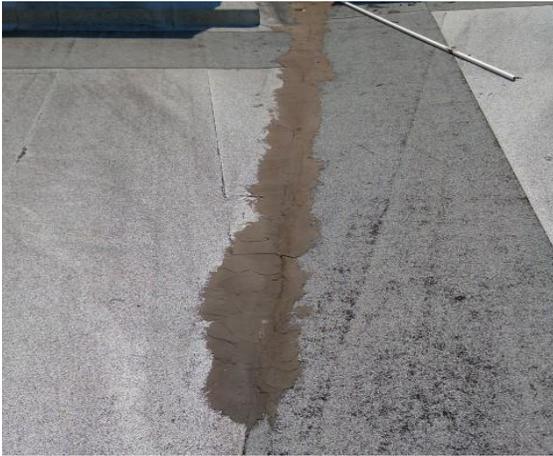
Photo #25 – Repair to be removed between roof Section R2 and R3 – July 4, 2019

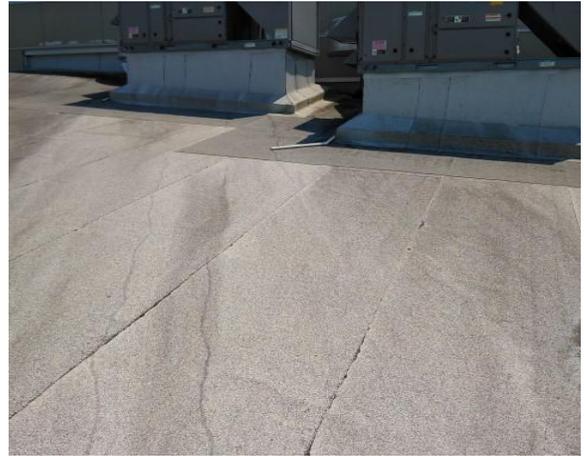
Photo #26 – Blisters and surface degranulation (Roof R3) – July 4, 2019

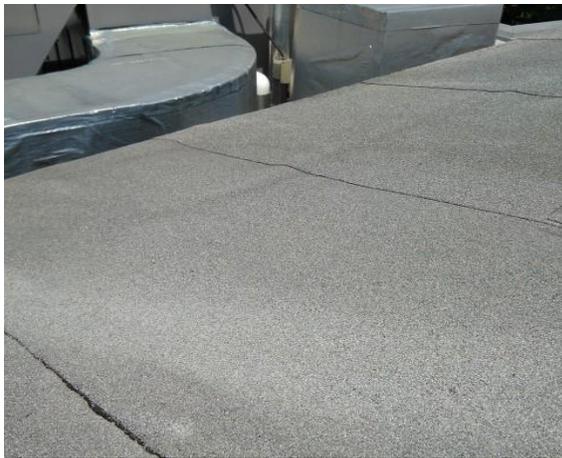
Photo #27 - Blisters and surface degranulation(Roof R3) – July 4, 2019

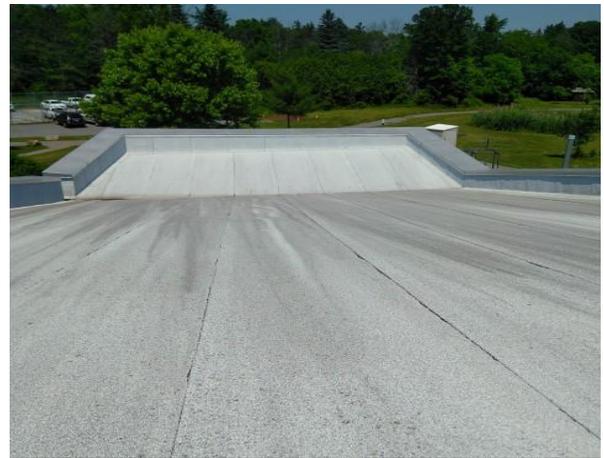
Photo #28 - Blisters and surface degranulation (Roof R4) – July 4, 2019

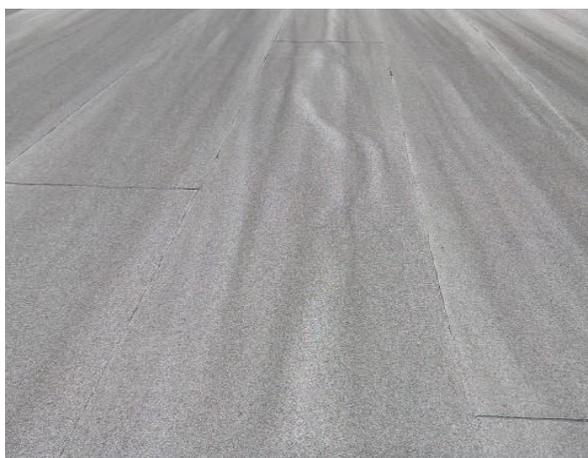
Photo #29 - Blisters and surface degranulation (Roof R4) – July 4, 2019

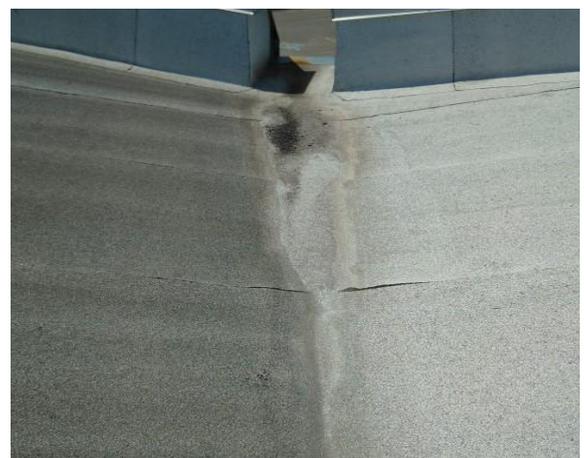
Photo #30 – Granules accumulation by scupper (Roof R4) – July 4, 2019

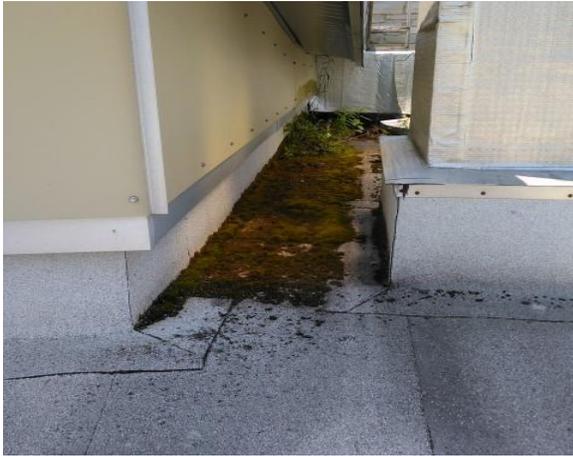
Photo #31 – Moss behind HVAC (Roof R5) – July 4, 2019

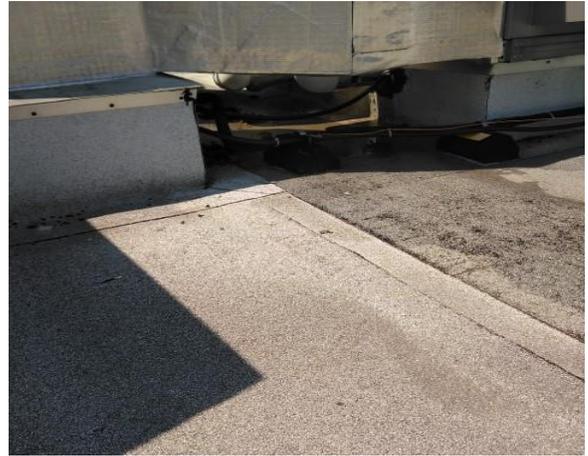
Photo #32 – Moss between HVACs (Roof R5) – July 4, 2019

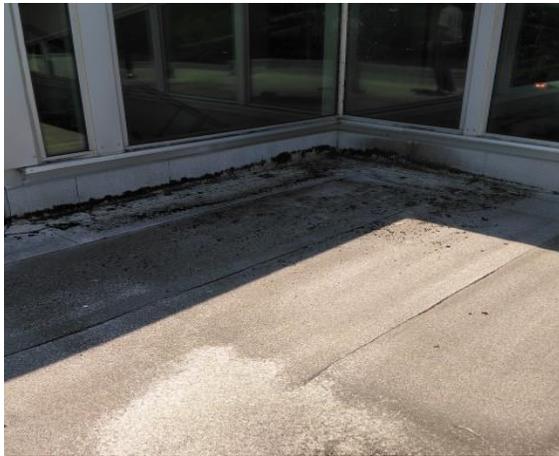
Photo #33 - Moss by windows (Roof R5) – July 4, 2019

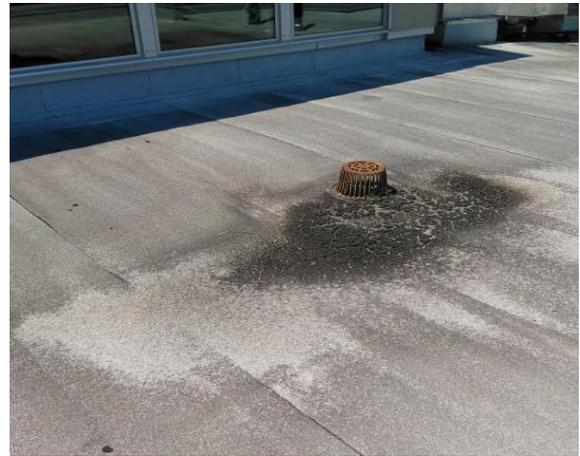
Photo #34 – Drainage deficiency (Roof R5) – July 4, 2019

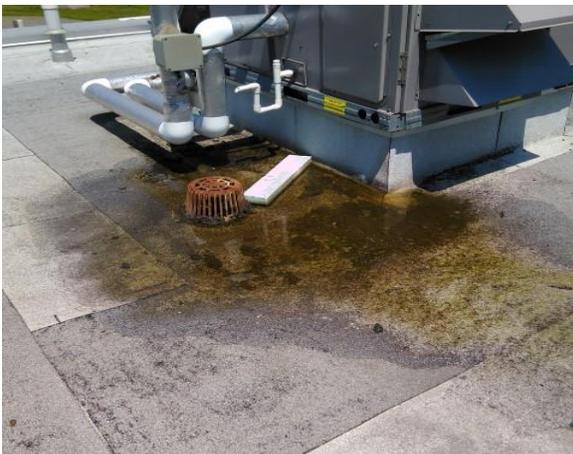
Photo #35 - Drainage deficiency (Roof R5) – July 4, 2019

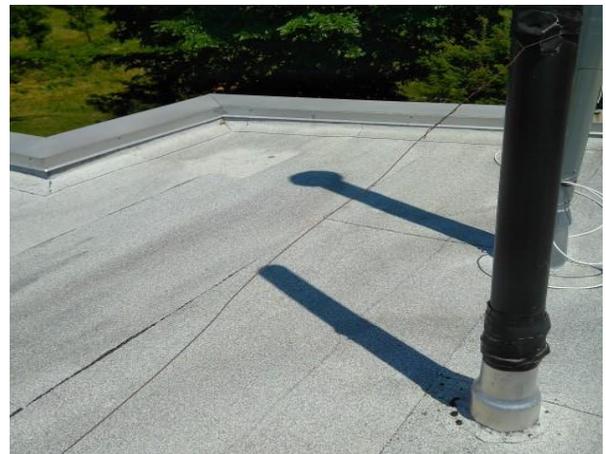
Photo #36 - Blister and surface degradation (Roof R5) – July 4, 2019

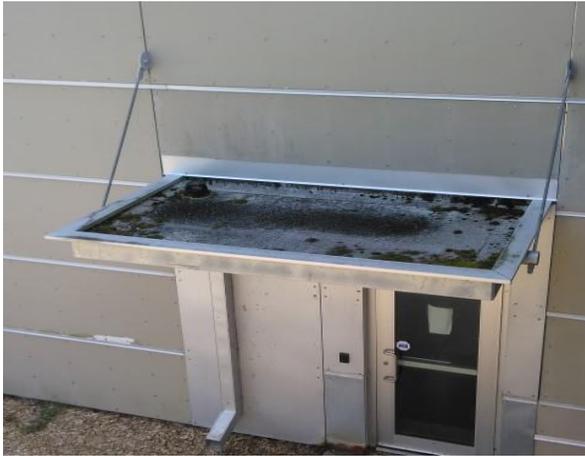
Photo #37 - Moss on Roof R7 – July 4, 2019

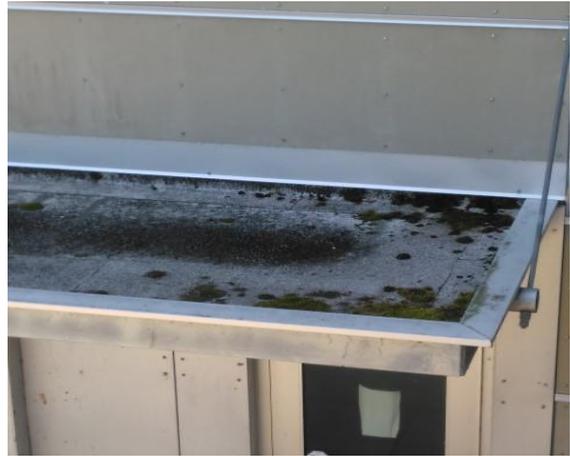
Photo #38 – Closer look of previous picture – July 4, 2019

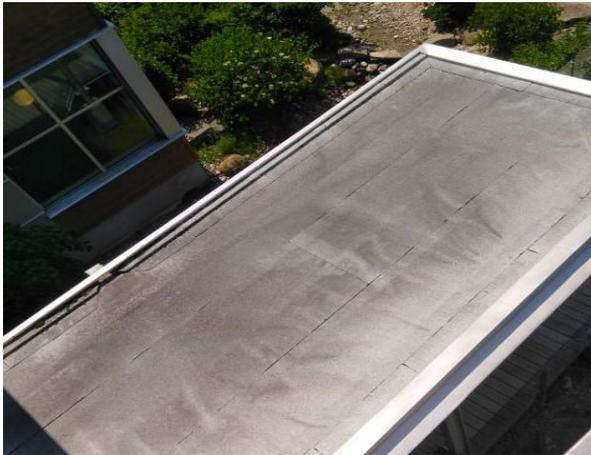
Photo #39 - Blisters and surface degranulation (Roof R8) – July 4, 2019

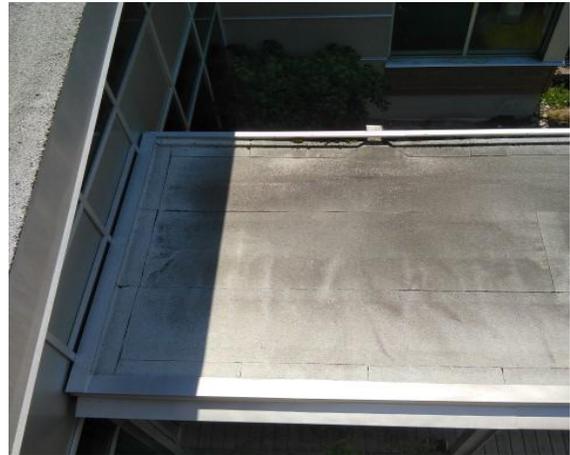
Photo #40 - Blisters and surface degranulation (Roof R8) – July 4, 2019

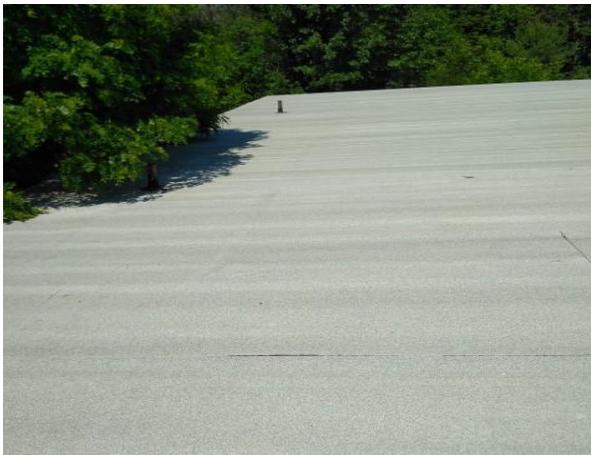
Photo #41 - Blisters and surface degranulation (Roof R9) – July 4, 2019

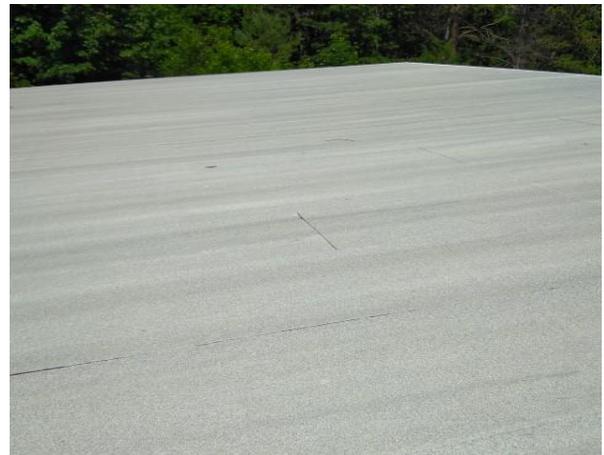
Photo #42 - Blisters and surface degranulation (Roof R9) – July 4, 2019

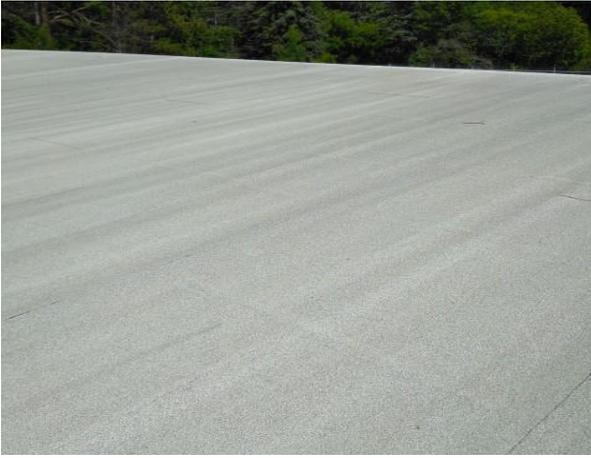
Photo #43 – Surface degranulation (Roof R9) – July 4, 2019

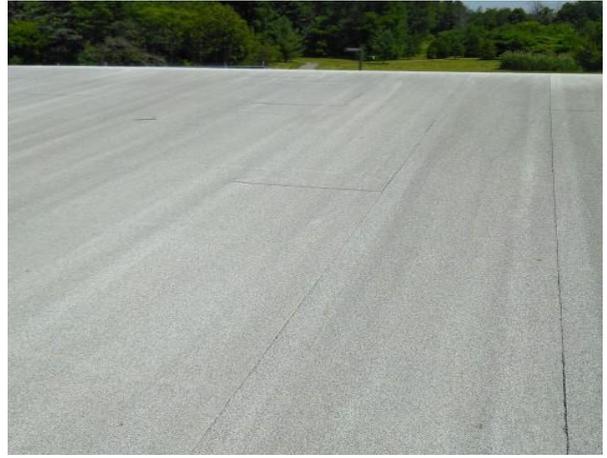
Photo #44 – Blisters and surface degranulation (Roof R9) – July 4, 2019

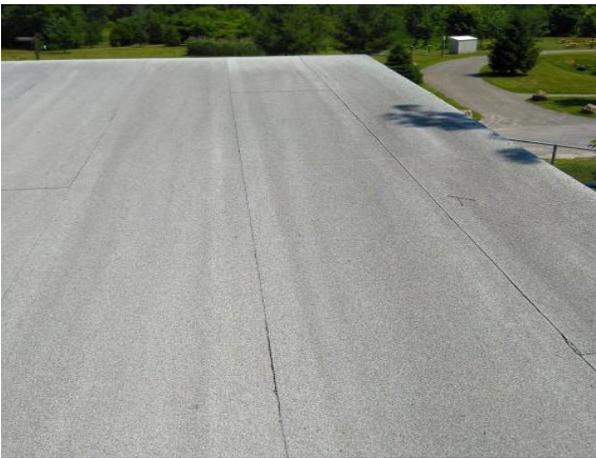
Photo #45 - Blisters and surface degranulation (Roof R9) – July 4, 2019

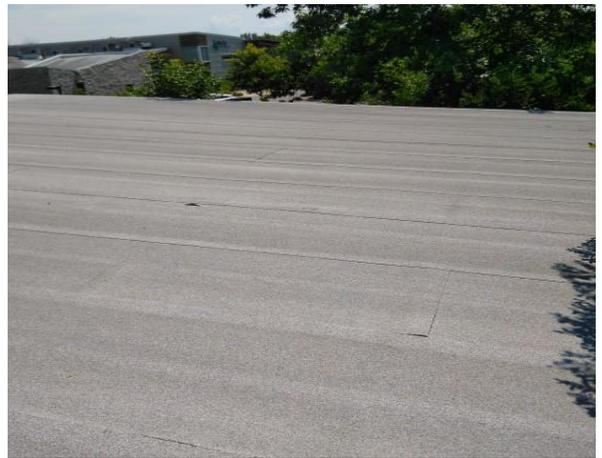
Photo #46 - Blisters and surface degranulation (Roof R9) – July 4, 2019

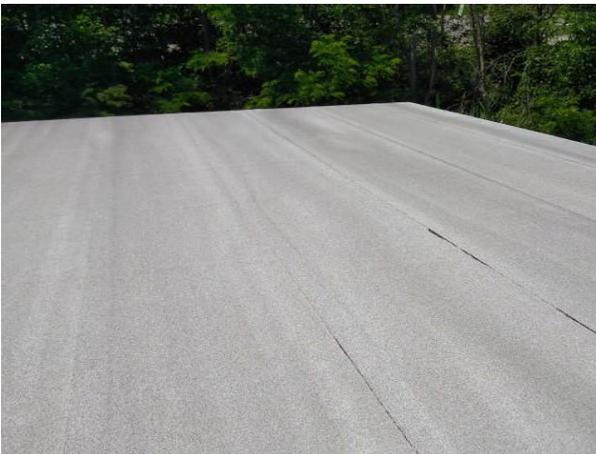
Photo #47 – Surface degranulation (Roof R9) – July 4, 2019

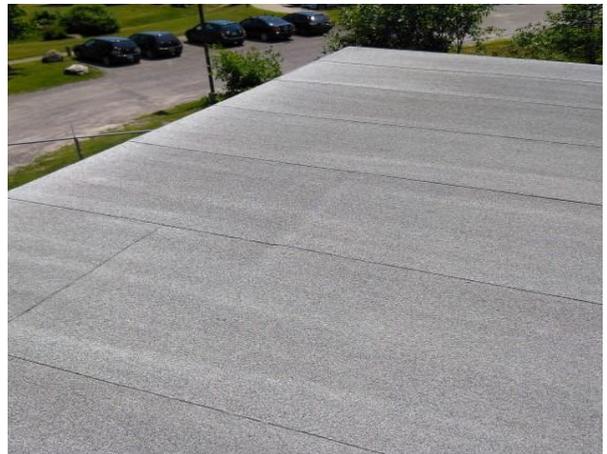
Photo #48 – Blisters and surface degranulation (Roof R9) – July 4, 2019
