The concrete weir and abutments are proposed to be removed and the river bed re-constructed to match the original cross-section.

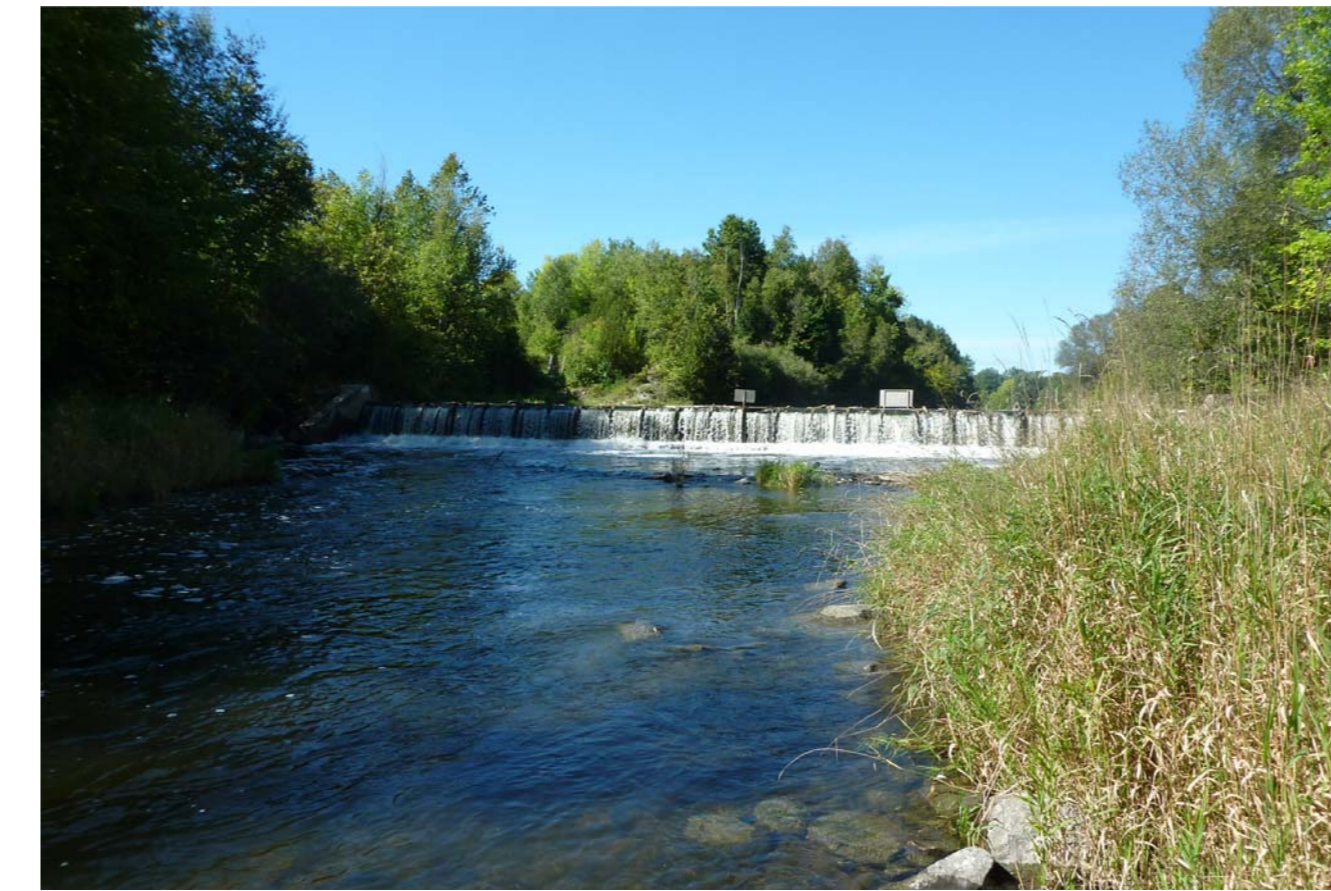
figure 1
View looking up river to the weir.

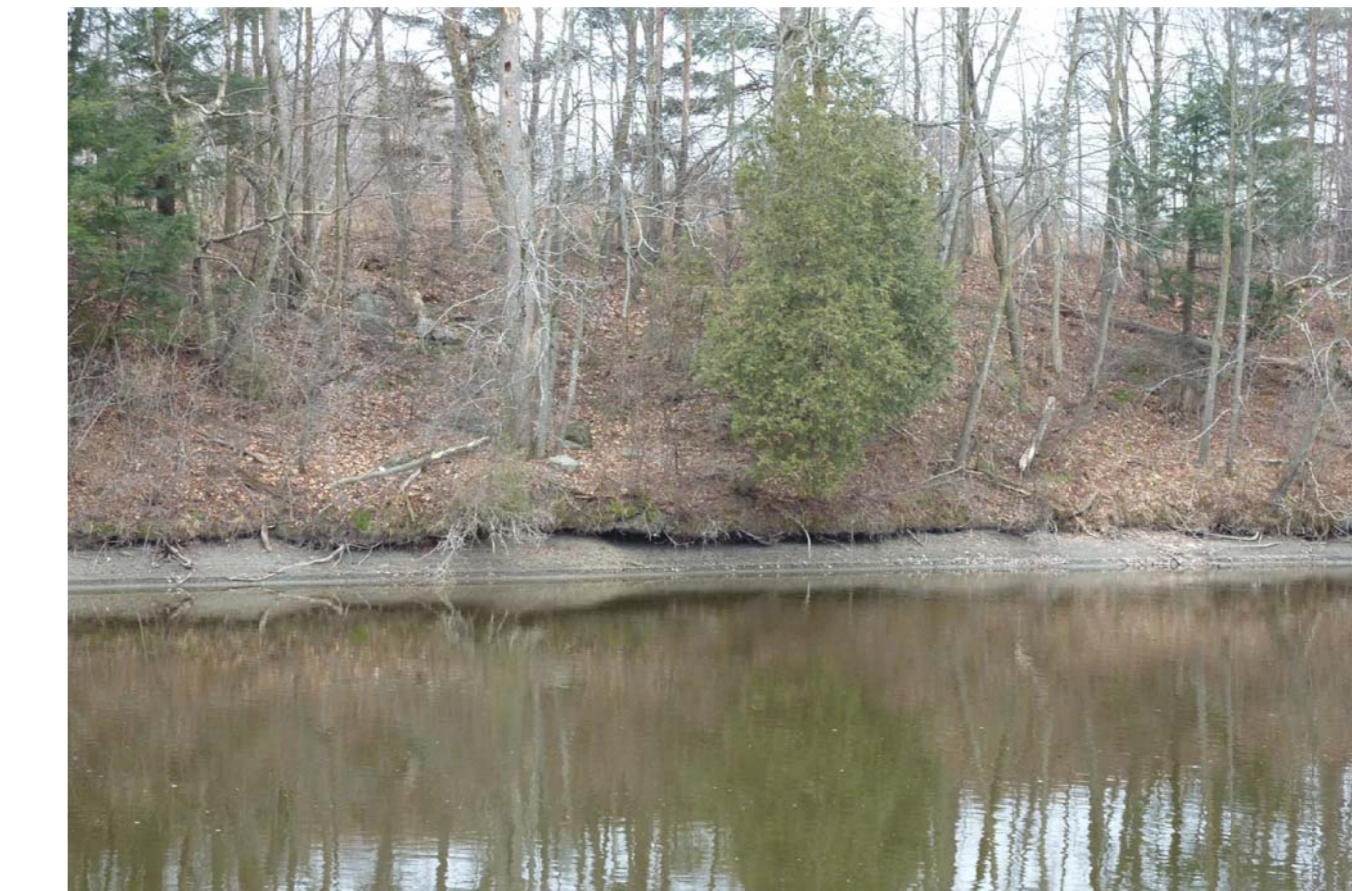
figure 2
View of the southern bank in November (weir out).

The south bank of the river is very steep but well vegetated. While it appears from a distance that the bank is prone to erosion from scour and ice movement, closer investigation reveals that damage of this nature is minimal. A thick, healthy layer of leaf litter blankets the majority of the bank, however in the littoral zone, this organic layer simply floats away with the higher water levels, leaving an exposed band of bare soil.

The re-introduction of native vegetation to the littoral band on this bank is made challenging due to the steepness of the bank and difficult access. A combination of seeding and live stakes are recommended. Both of these methods are recommended to be undertaken, immediately after the weir has been removed and the soil moisture level is optimal for rooting and germination.

Live stakes will consist of native, locally harvested rhizomatous willow and dogwood cuttings. As a general rule, live stakes should measure at least 2cm in diameter by 50cm and be installed at least 80% of the length into the ground or deep enough to be in contact with moist soil during summer drought conditions. There are numerous other horticultural practices for harvesting, handling and installing live stakes that are required to ensure rooting. This technique is illustrated in figures 10 & 11. The spacing and layout of live stakes should be done in such a manner to mimic a natural colonization pattern.

A native seed mix applied to the exposed soil in the littoral zone will help to establish vegetative cover and protect against invasive species. Due to the steepness of the bank, a seed mix, along with with an organic bonded-fibre matrix, should be applied with a hydro-seeder wherever possible. Where restricted truck access prevents this, the seed will need to be carefully sown onto the bank by hand.

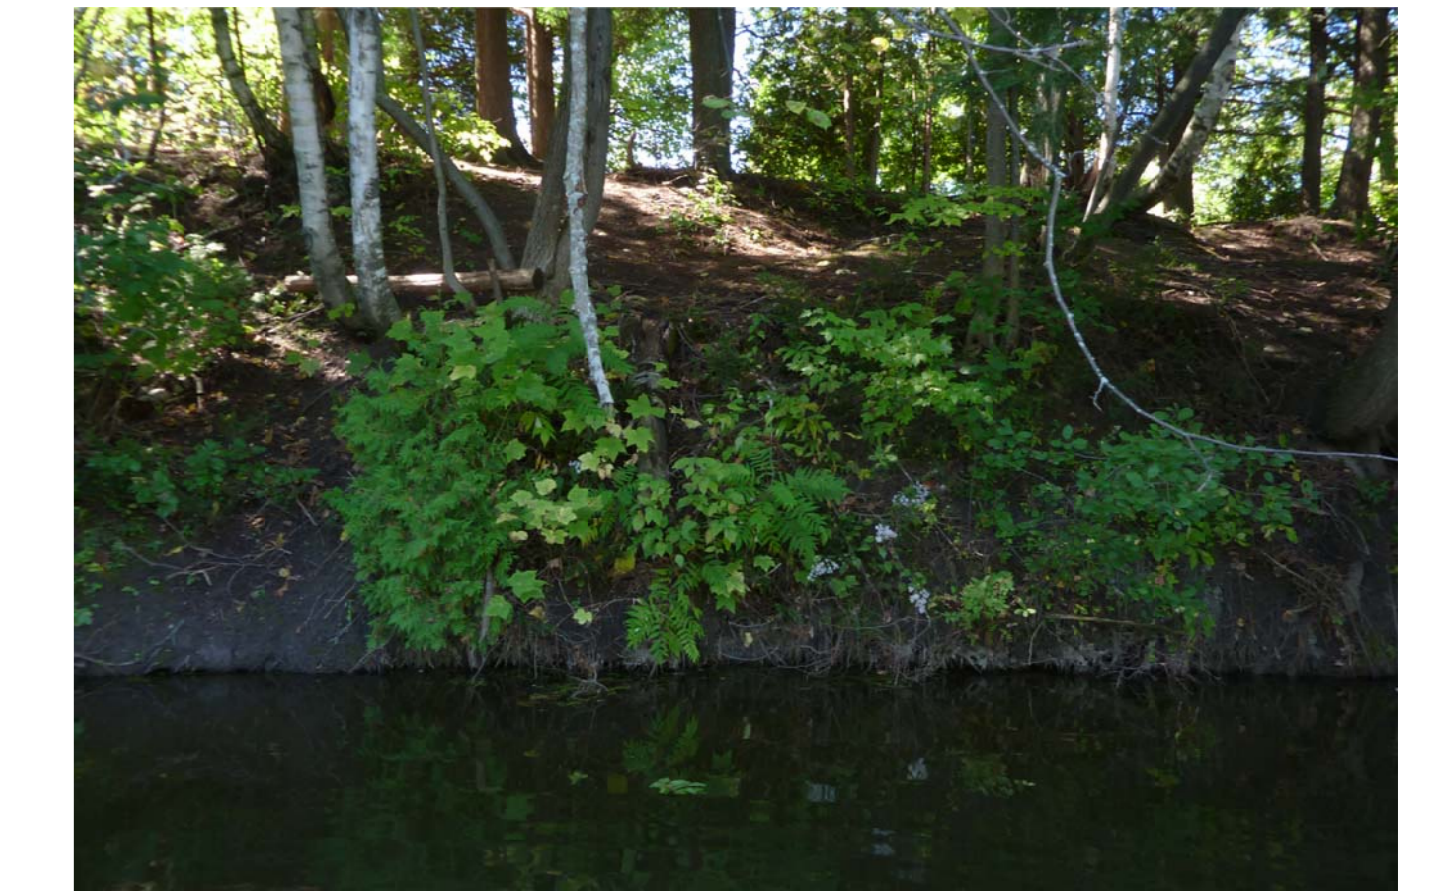
figure 3
View of the typical condition of the southern bank in September (weir in).

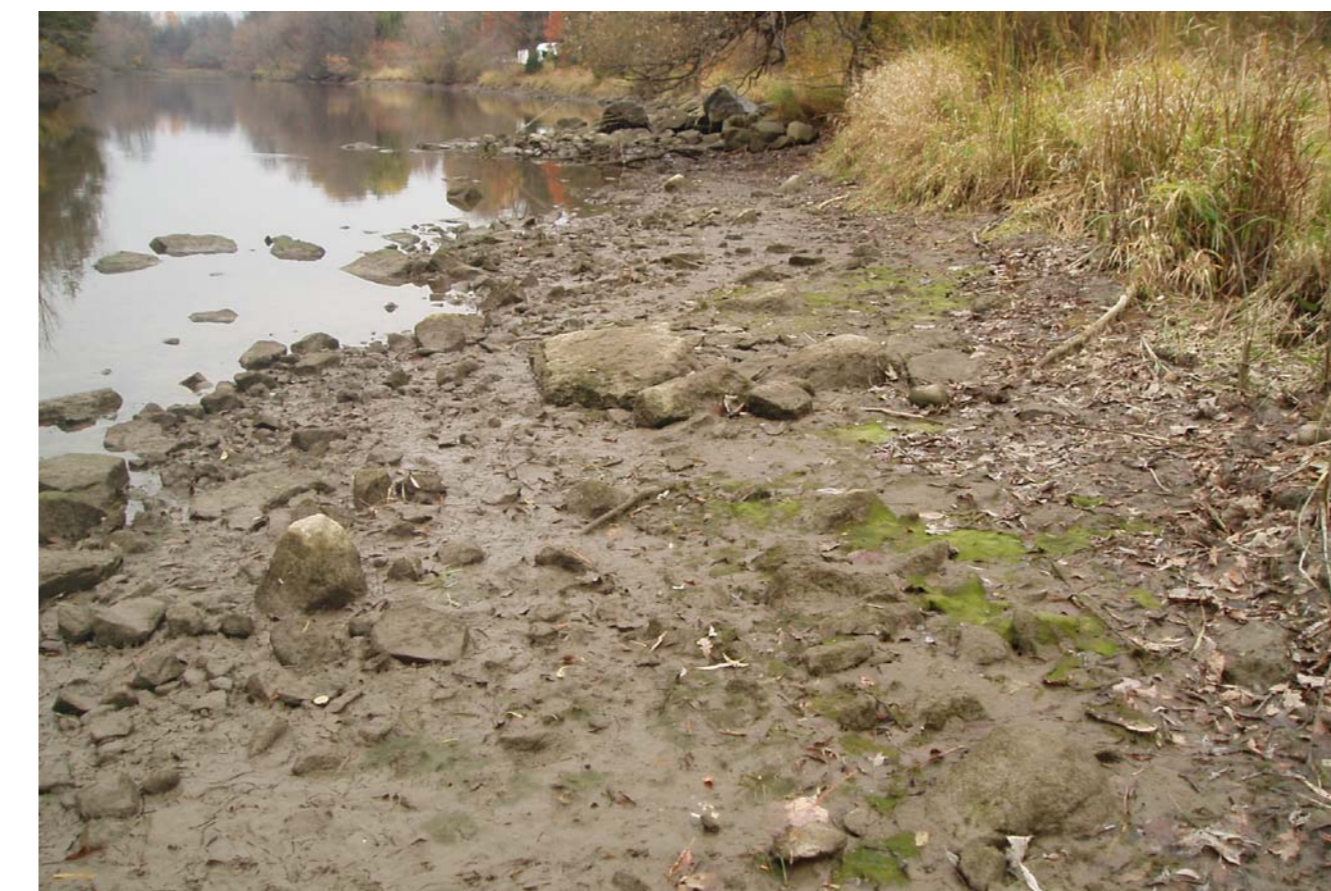
figure 4
View from just above the weir, looking up river along the north bank.

Areas with exposed fine sediments can be effectively seeded with a mix of native grasses, rushes and sedges. Eventually these newly exposed areas will be covered over with vegetation similar to what is shown in the upper right corner of the photo. Establishing native vegetation in these areas will prevent "opportunistic" invasive species, such as Purple Loosestrife from taking over. Soil moisture and temperature are critical factors for successful seed germination and should be a consideration for the proposed timing of the weir removal.

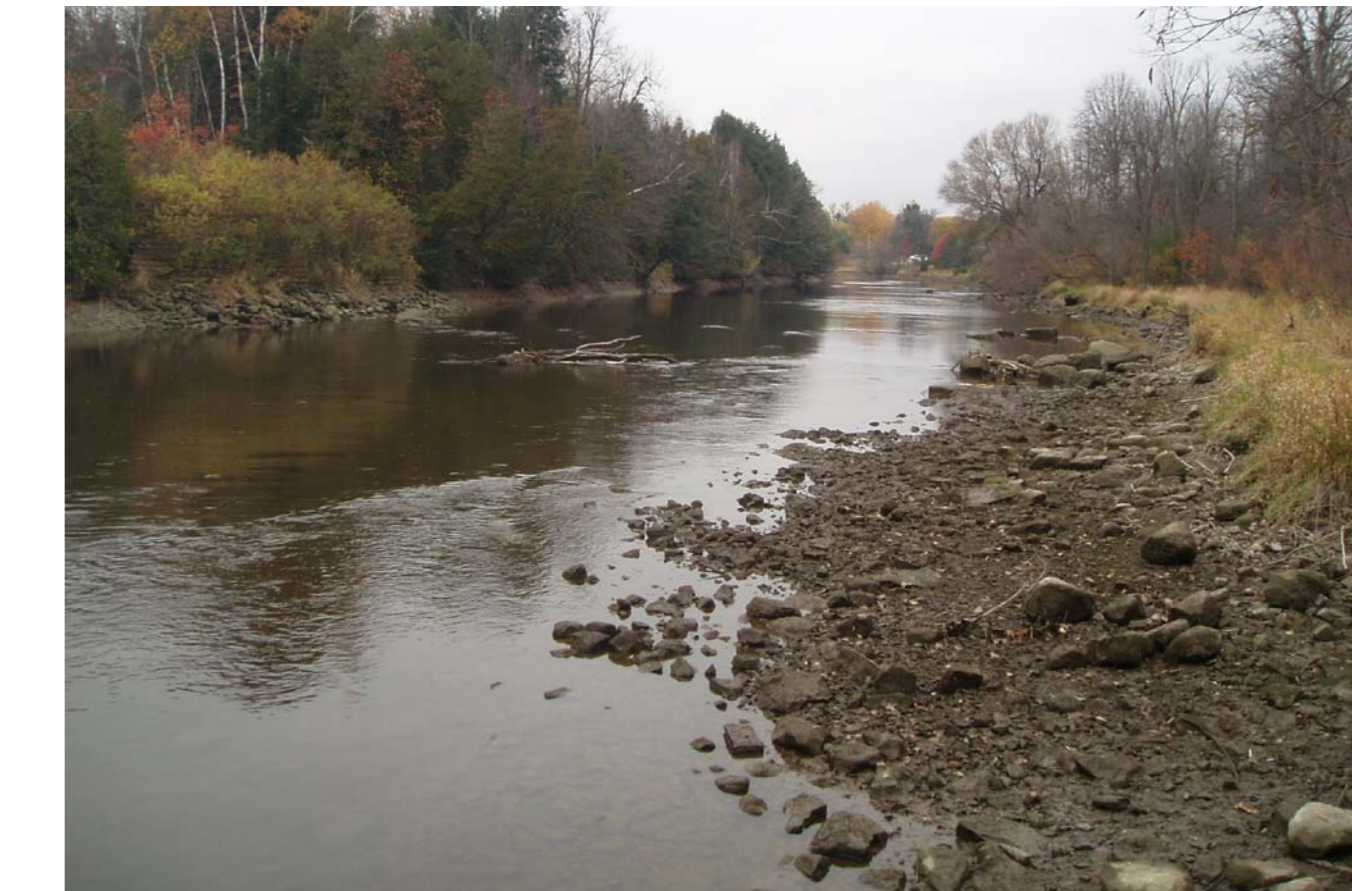
figure 5
View from just above the weir, looking up river along the north bank.

Some of the "flats" will be left as an exposed thin layer (75 to 150mm) of cobbles and gravel. With little to no exposed fine sediment, these areas are not appropriate candidates for broadcast seeding as there is no adequate seed bed. To introduce a native seed source into these zones are pre-empt the establishment of invasive species, potted grasses, rushes and sedges can be manually planted. The gravel and cobbles can be pulled back at each planting location, and a random species mix of 10cm potted stock, can be easily planted in the native soil beneath.

To provide shade at the new water line, clusters of potted or bare root, native, deciduous shrubs and whip stock trees can also be planted in similar fashion. The locations of these clusters should be carefully considered to frame, rather than obstruct residents' views to the river.

Time of year for planting is a consideration, as potted and bare root stock will require supplemental watering in drought conditions, during the establishment period. The stems of woody trees and shrubs should be adequately protected from beaver damage. In the long-term, maintenance and eventual removal of these protection measures should be factored into warranty specifications and long-term operational budgets.

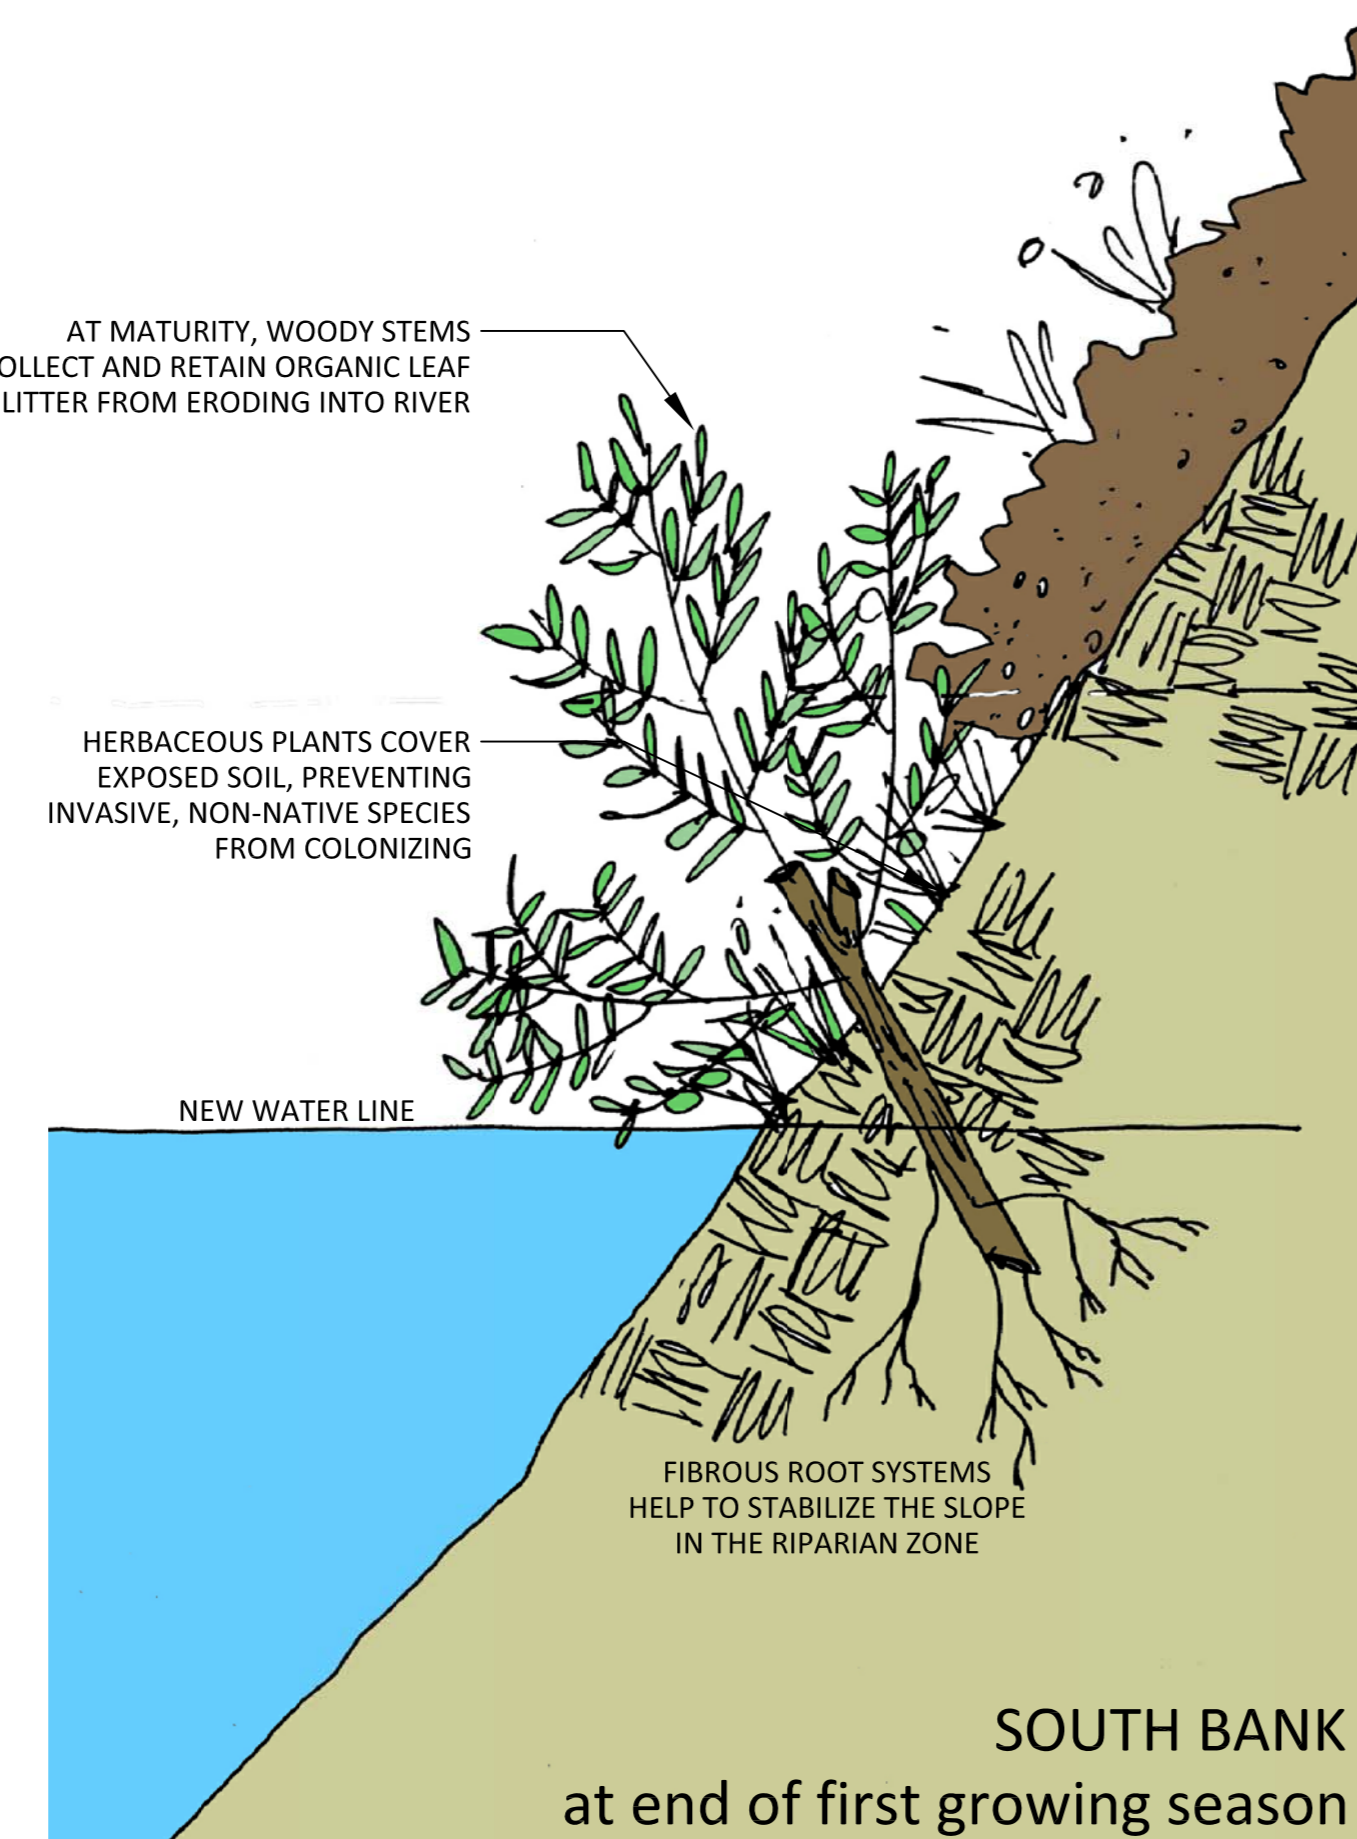
figure 11
Live stake establishment at end of first growing season.

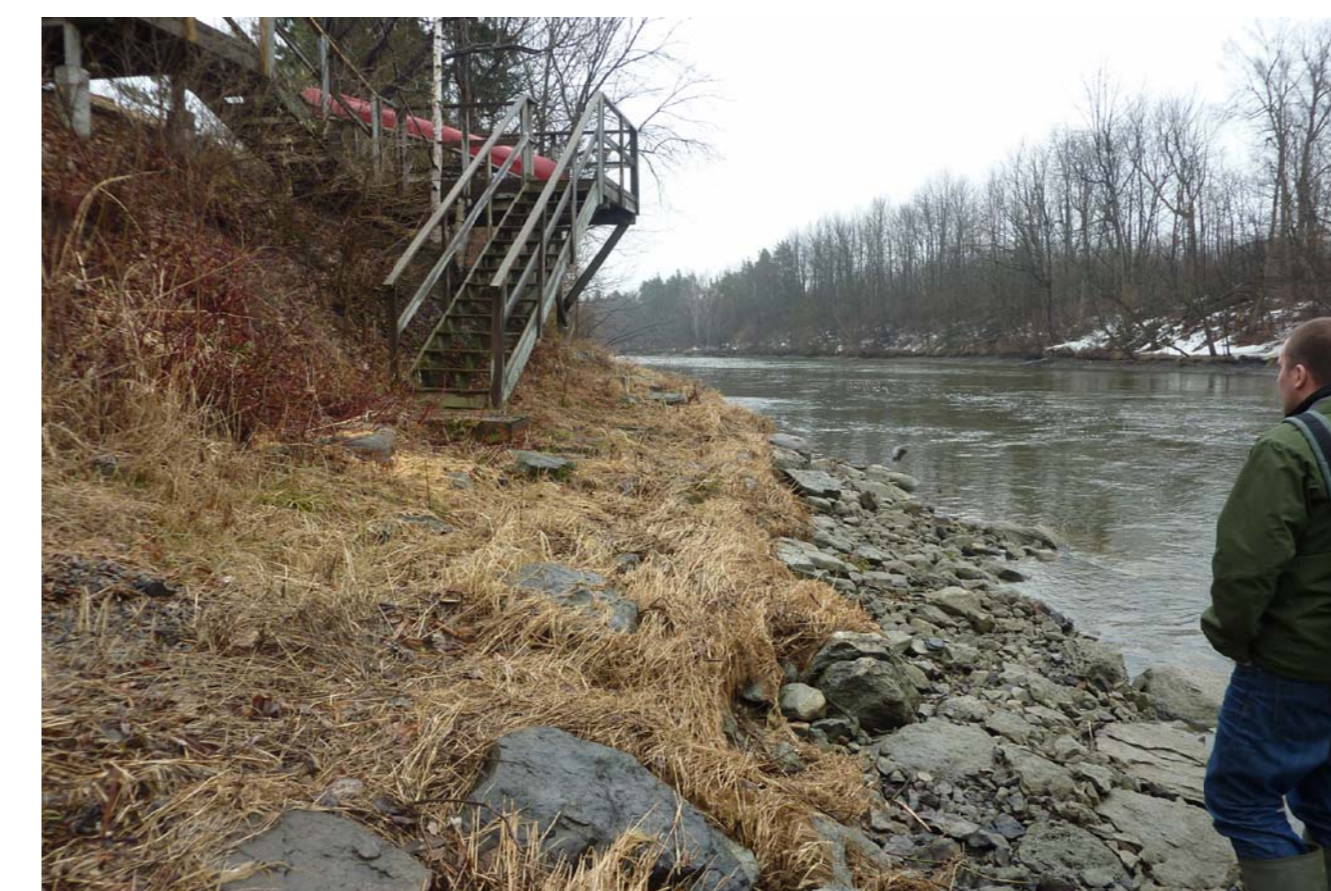
figure 7
View of a homeowner's access on the north bank in April (weir out).

Many of the residents along this stretch of the Jock are concerned about having recreational access to the water eliminated. Flat armour stones, as shown in figure 9, can be placed with little disturbance to the bank, to accommodate access to the adjusted waterline. A similar access point could be created along Goodwood Drive to provide the same opportunity for those not backing directly on the river. Heavy equipment access, for delivery and placement of the stones, is limited. Access to the bank should be considered in planning and during construction staging.

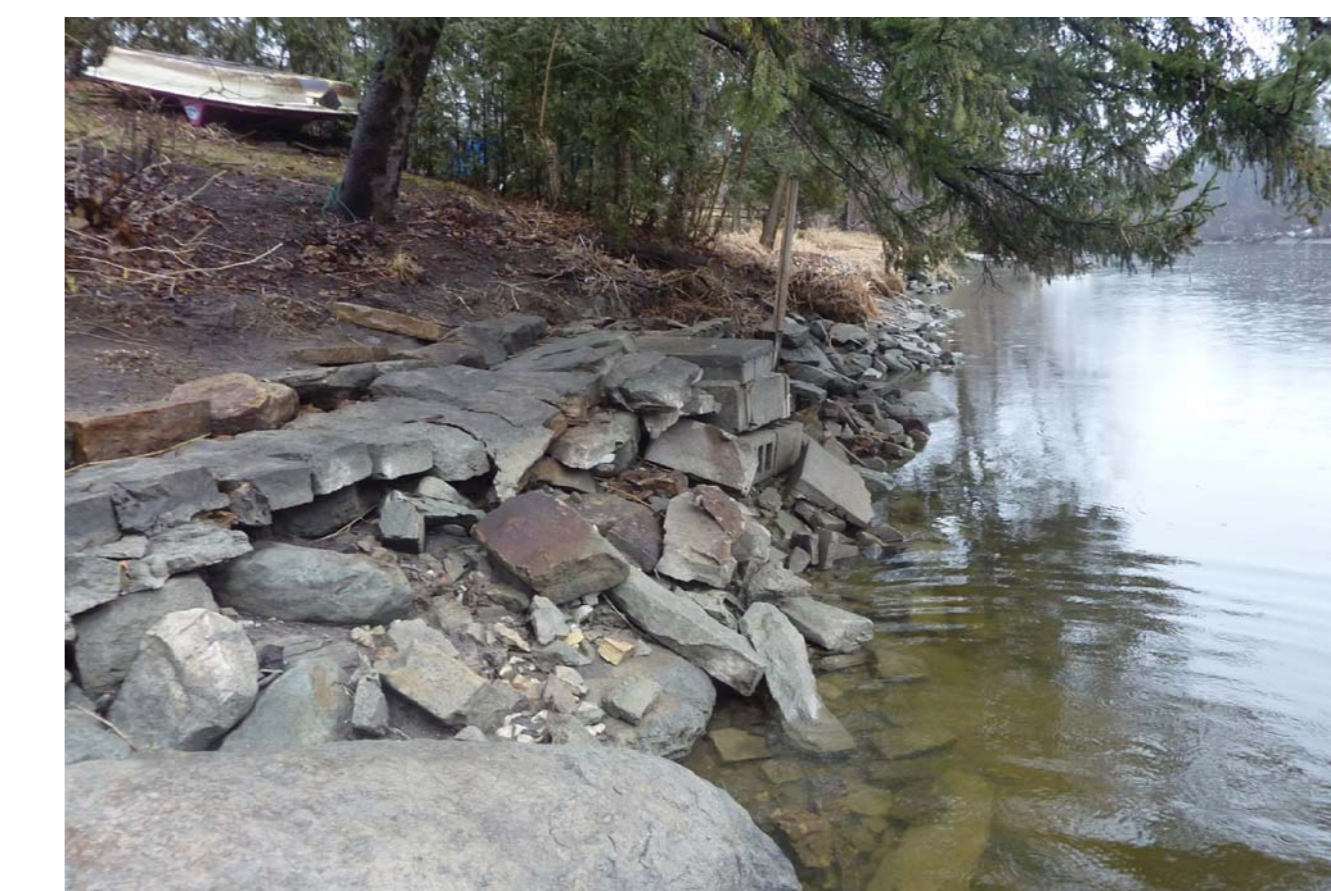
figure 8
View of a homeowner's access on the north bank in April (weir out).

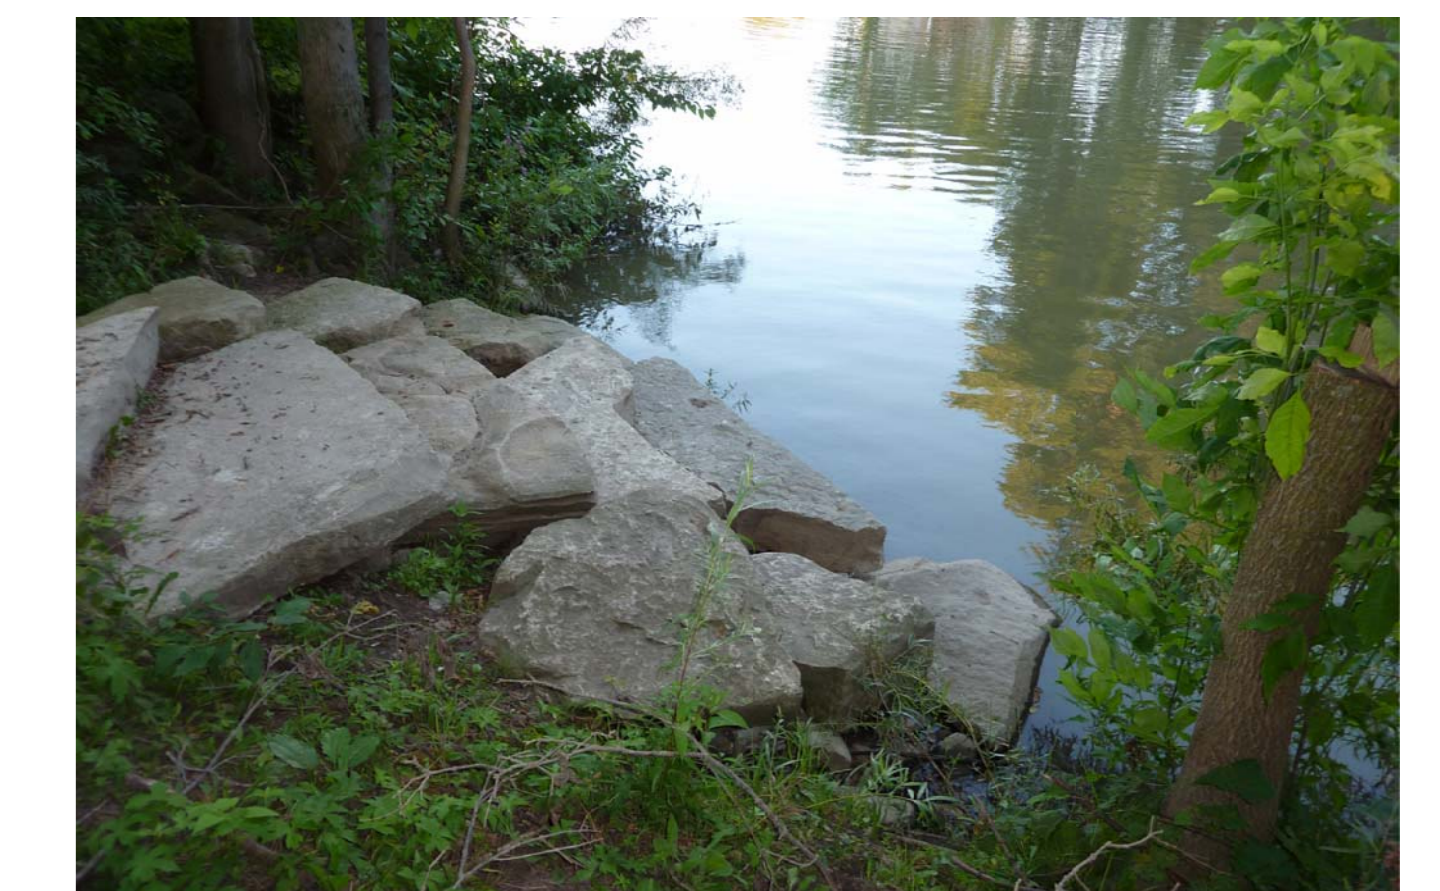
figure 9
An example of low-impact access to a river's edge.

Large armour stones could be placed at each property to permit launching of canoes, kayaks and paddle boats. The dry-laid stones should measure no more than 1.5m wide.
