Mosquito Creek 2023 Catchment Report

In 2023, 77 sections (7.7 km) of Mosquito Creek were surveyed as part of the City Stream Watch monitoring activities. The following is a summary of observations made by staff and volunteers along those 77 sections.

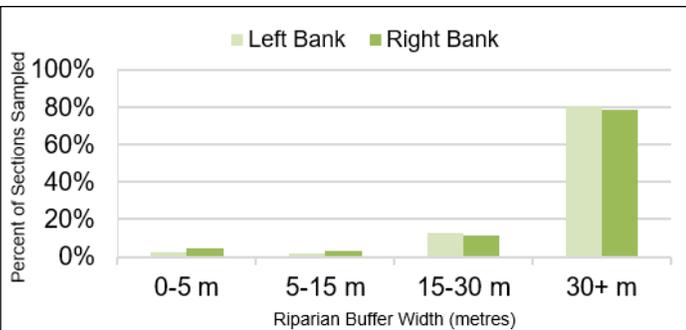
Figure 2 Vegetated buffer width along Mosquito Creek

Figure 2 demonstrates buffer conditions along the left and right banks of the surveyed sections of Mosquito Creek. Buffers greater than 30 meters were present along 81 percent of the left bank and 79 percent of the right bank. A 15 to 30 meter buffer was present along 13 percent of the left bank and 11 percent of the right bank. A five meter buffer or less was present along two percent of the left bank and five percent of the right bank. The buffer width evaluation on the sections surveyed of Mosquito Creek are above the recommended guidelines from Environment and Climate Change Canada.

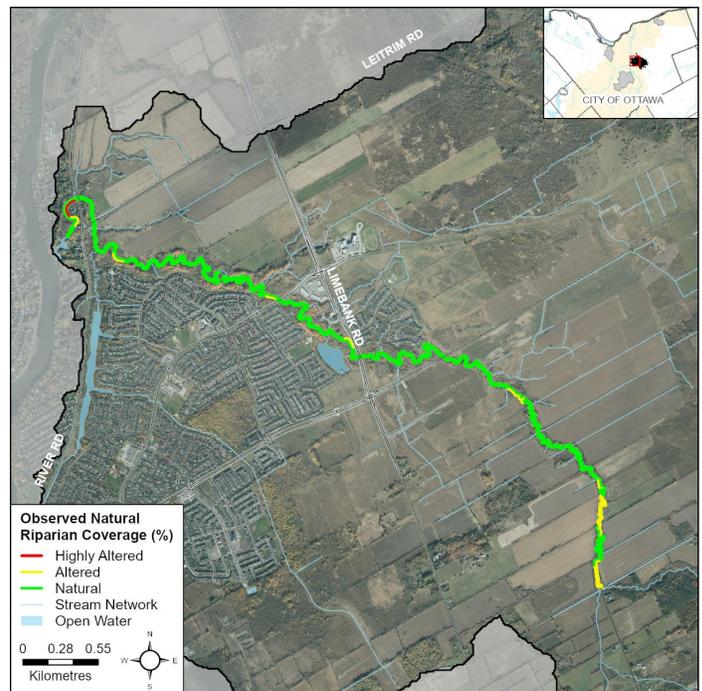
Figure 3 Riparian buffer alterations in Mosquito Creek

Mosquito Creek surveyed riparian zones were primarily natural, with 73 percent of the left and 68 percent of the right bank having dominant natural riparian vegetative communities. Alterations to the riparian buffer accounted for eight percent of the left bank and 11 percent on the right bank; highly altered conditions were observed on two percent of the left bank, and four percent of the right bank. These alterations were associated with infrastructure such as roadways and piping.

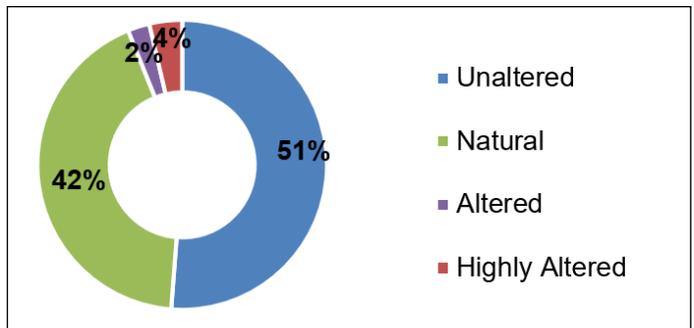
Figure 5 Anthropogenic alterations along Mosquito Creek

Three of the surveyed sections were highly altered. The riparian buffers were less than five meters in width, shoreline alterations were found on most of the sections and storm water outlets were present at road crossings. These sections were mostly found near road and highway infrastructure.

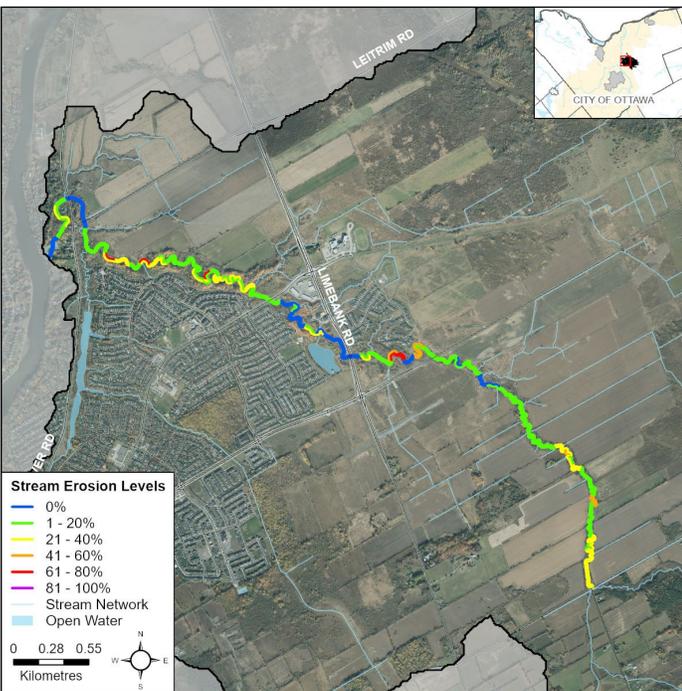
Figure 6 Erosion levels along Mosquito Creek

Figure 6 shows significant erosion was observed across the surveyed portions. Bank instability was observed in 81 percent of the left bank and 86 percent of the right bank of the sections surveyed.

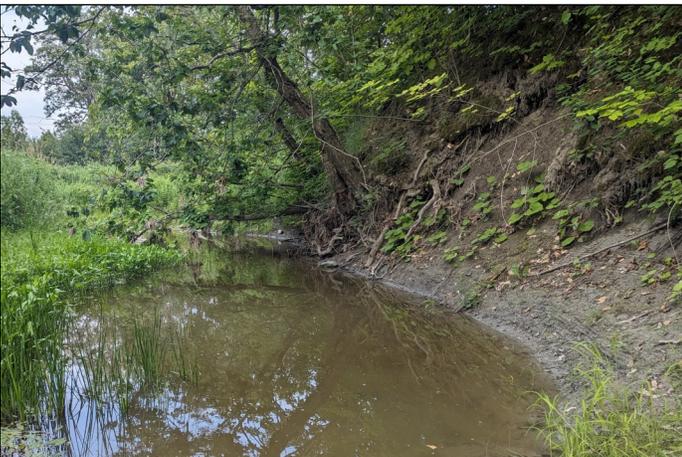
Bank erosion along Mosquito Creek near Limebank Road

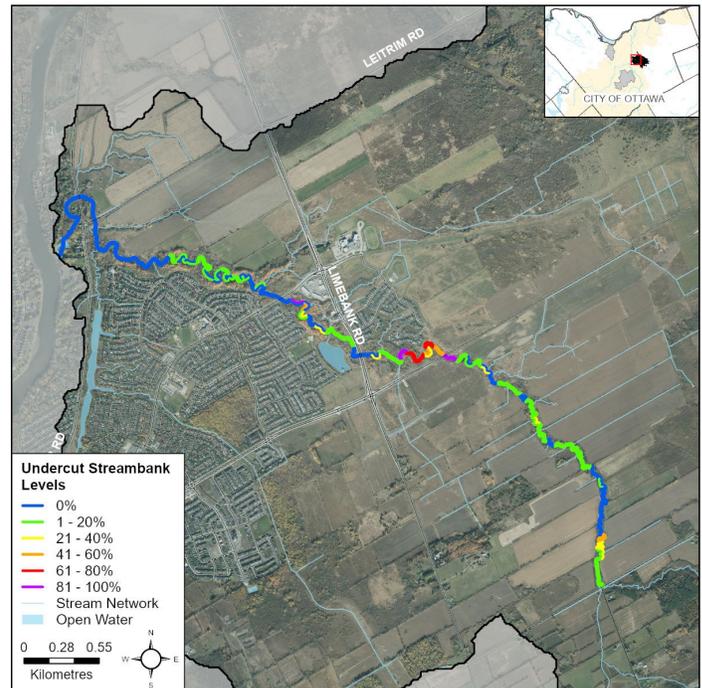
Figure 7 Undercut stream banks along Mosquito Creek

Figure 7 shows where undercut banks were present and to what extent each section contained them in Mosquito Creek. Along the left bank, 51 percent of sections had undercut banks; and the right bank had 58 percent of sections with undercut banks.

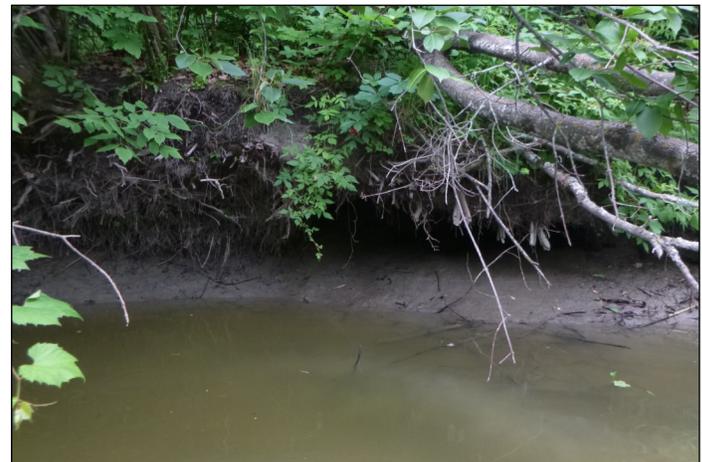
Undercut banks on Mosquito Creek downstream of Spratt Road

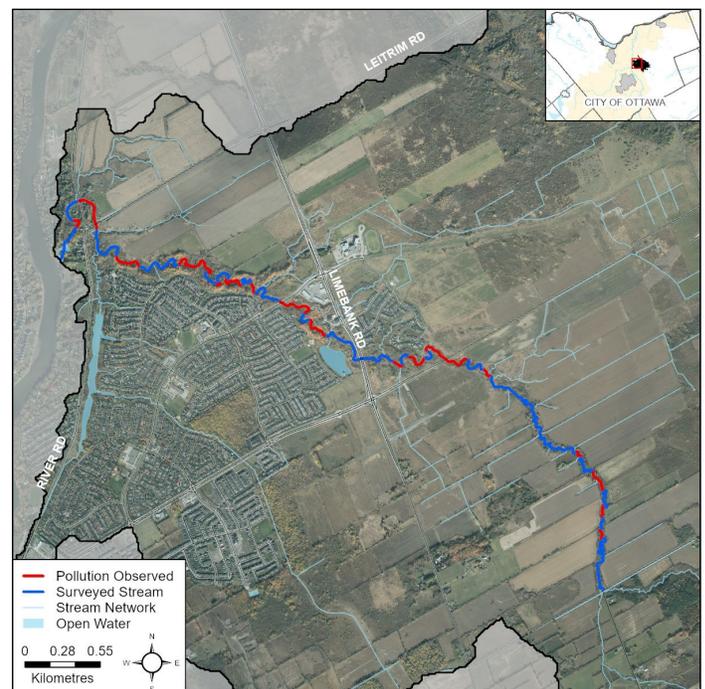
Figure 21 Pollution observed along Mosquito Creek

Figure 21 shows where pollution was observed along Mosquito Creek. The levels of garbage found in the main portion of the stream were low, with 64 percent of sections surveyed containing no garbage. Floating garbage was found in 27 percent of sections surveyed, while garbage on the stream bottom was found in 16 percent. There were no other types of pollution observed within the sections surveyed.

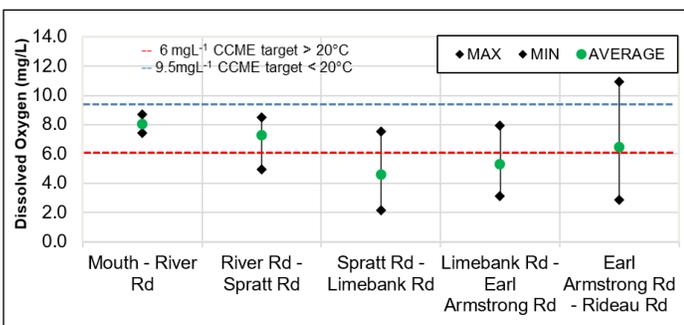
Figure 22 Dissolved oxygen ranges along surveyed sections of Mosquito Creek: Sections 1-83.

Figure 22 shows the concentration levels found in the surveyed portions of Mosquito Creek. The two dashed lines depicted represent the Canadian water quality guidelines. Most of the surveyed portions were found to have oxygen levels within the Canadian water quality guidelines. However, multiple sections near Limebank Road observed oxygen levels below the Canadian water quality guidelines. The sections of Mosquito Creek that contain dissolved oxygen levels above this guideline are sufficient to support warm-water aquatic life. However, any sections with oxygen concentrations that fall below the guideline are likely not sufficient to support aquatic life and may represent impairment. Average concentration levels across the system were 6.5 mg/L.

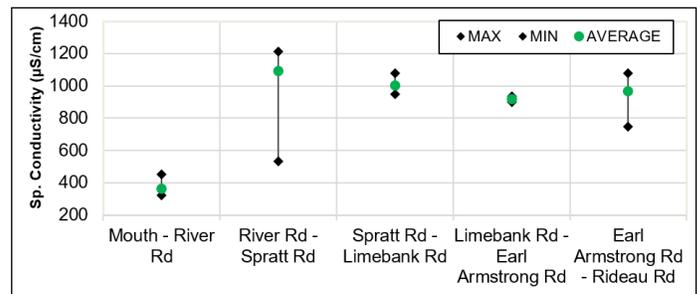
Figure 23 Specific Conductivity ranges along surveyed sections of Mosquito Creek: sections 1-83

The average specific conductivity level in Mosquito Creek is 958.5 $\mu\text{S}/\text{cm}$. Figure 23 shows that conductivity levels were lower in areas approaching the stretch of the creek from the mouth to River Road (sec. 1-6). Higher levels were observed in the remaining sections of the creek (sec.7-83).

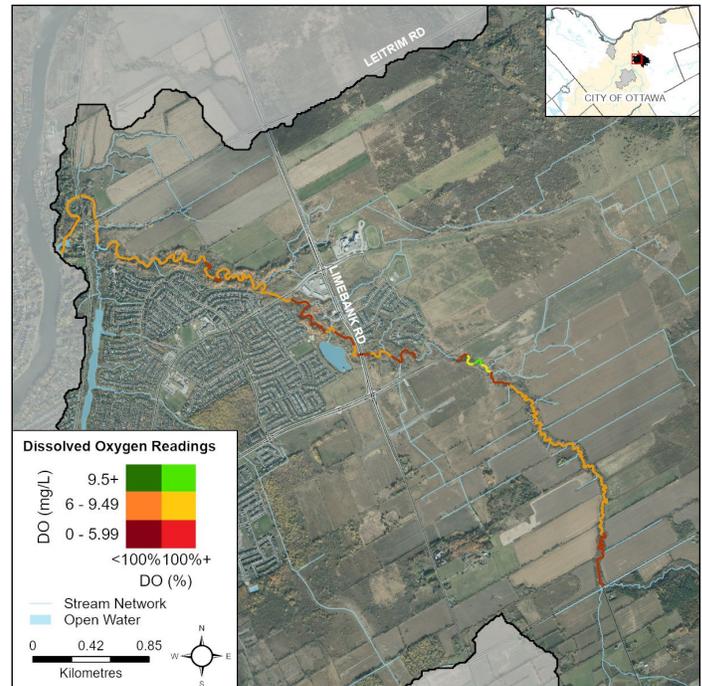
Figure 25 Bivariate assessment of dissolved oxygen concentration (mg/L) and saturation (%) along Mosquito Creek

Figure 25 shows the dissolved oxygen conditions across the areas that were surveyed in 2023. Oxygen levels were not recorded throughout a small section between Limebank and Earl Armstrong Road due to equipment malfunction. Oxygen conditions in Mosquito Creek were sufficient to sustain warm-water biota in areas from the mouth of Mosquito Creek to Spratt Road, and Limebank Road to Rideau Road. Sections shown in dark red in Figure 25, had significant levels of impairment both in concentration and percent saturation. The residential areas near Limebank Road with especially high impairment levels have likely been influenced by the lack of shaded areas and riffle environment. There were also some pockets that contained slightly higher concentrations and saturation conditions just south of Earl Armstrong Road. Even though the average conditions are low in oxygen in these areas, various fish species were observed as the system still contains suitable habitat/refuge. An increase in shading conditions, through riparian planting of trees and shrubs can potentially help cool conditions and possibly increase levels of dissolved oxygen.

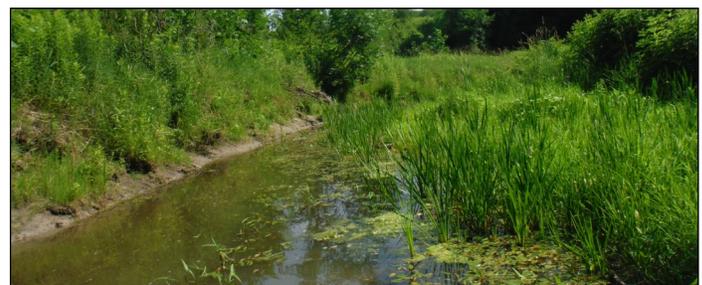
Section on Mosquito Creek south of Spratt Road with **impaired** oxygen conditions for warm-water biota (Dissolved oxygen levels of 2.18 mg/L and 36.8 % saturation)

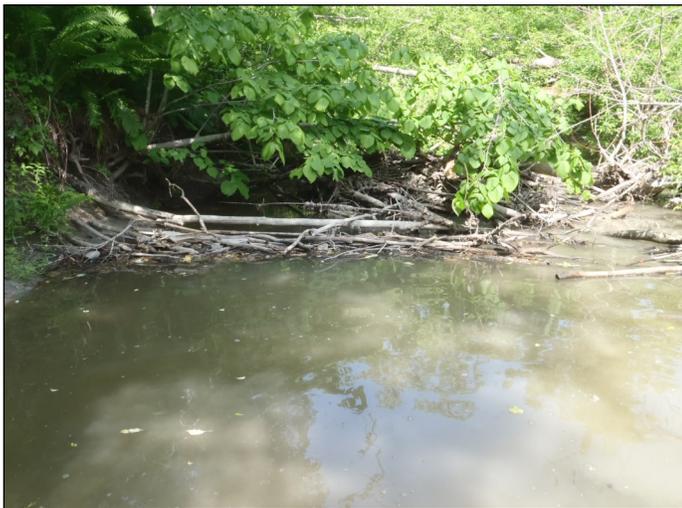
There were three migratory obstructions observed along the surveyed portions of Mosquito Creek. These migratory obstructions observed during stream surveys in 2023 are shown in Figure 31. All of these were debris dams which can become migratory obstructions when water levels are low.

Debris dams in Mosquito Creek create seasonal migratory obstructions.

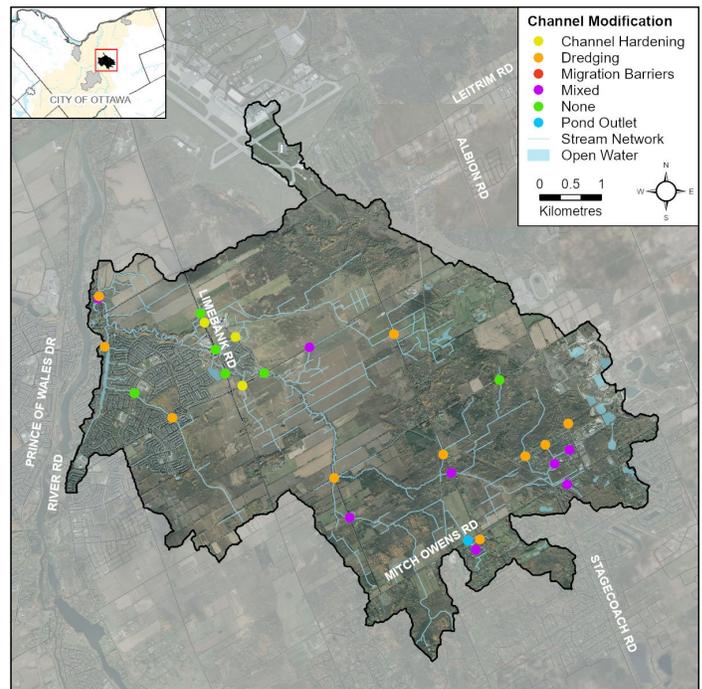
Figure 36 Headwater drainage feature channel modifications in the Mosquito Creek catchment

Figure 36 shows channel modifications observed in Mosquito Creek headwater drainage features. Modifications in this catchment for its headwater drainage features are channel hardening with rip rap, along with channel straightening.

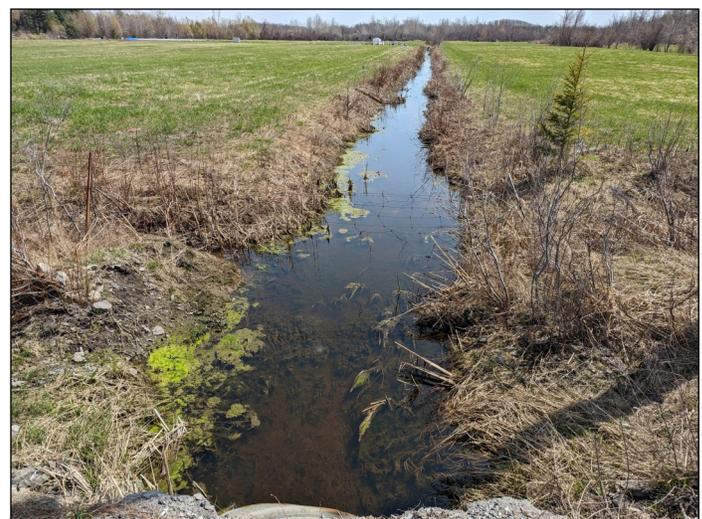
An example of channel straightening on a headwater drainage feature near Mitch Owens Road

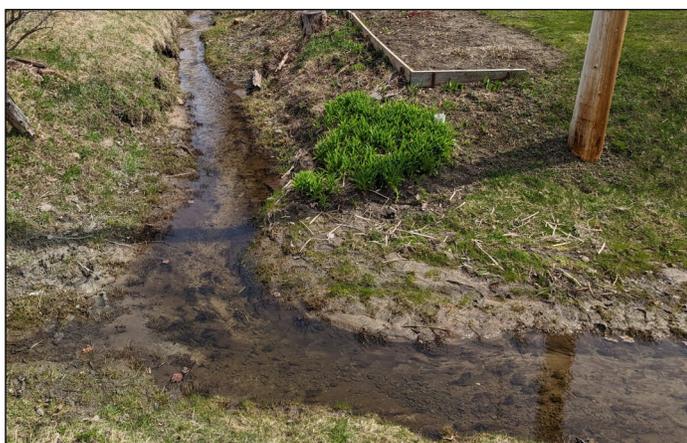
Substantial sediment deposition observed in a headwater drainage feature on Bowsville Road
