Stevens Creek 2017 Catchment Report

The Rideau Valley Conservation Authority, in partnership with six other agencies in Ottawa: City of Ottawa, Ottawa Flyfishers Society, Ottawa Stewardship Council, Rideau Roundtable, Canadian Forces Fish and Game Club, and the National Capital Commission form the 2017 City Stream Watch Collaborative.

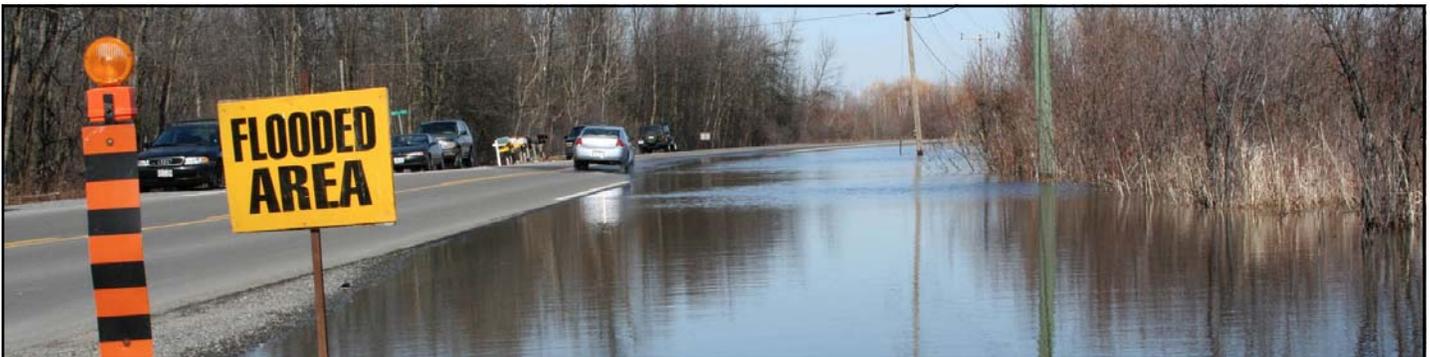
Flooded road section in the Stevens Creek catchment near the Rideau River

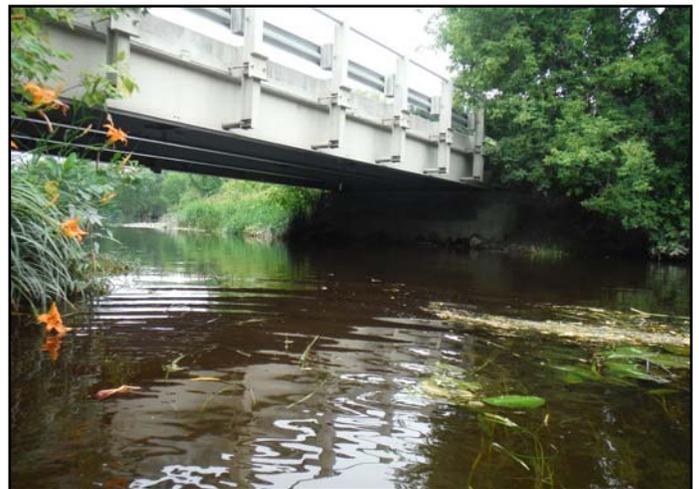
Road crossing altering a section of Stevens Creek

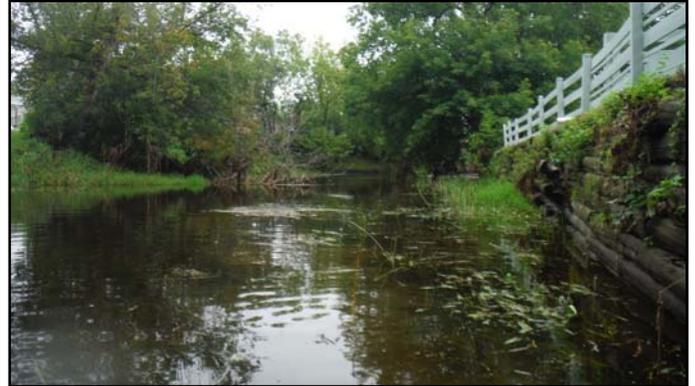
Wooden retaining wall along Stevens Creek

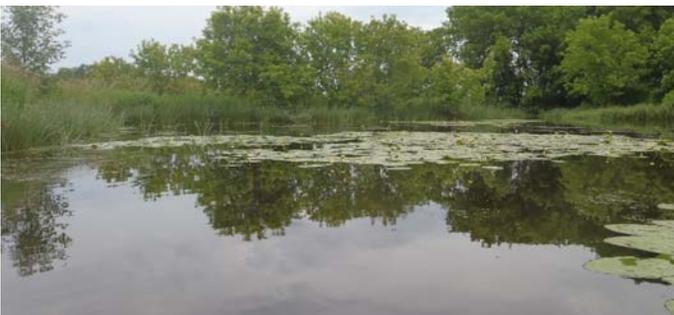
Site on Stevens Creek with **impaired** oxygen conditions (Dissolved oxygen levels of 4.75 mg/L and 53.1% saturation)

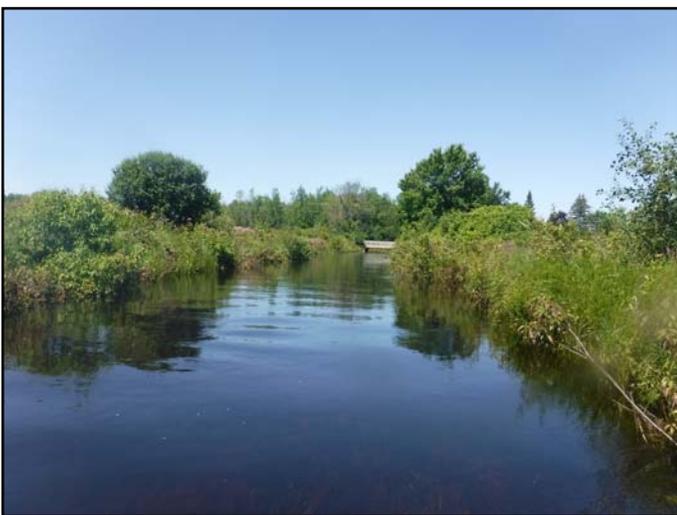
Section of Stevens Creek near Roger Stevens Drive with highly elevated levels of specific conductivity

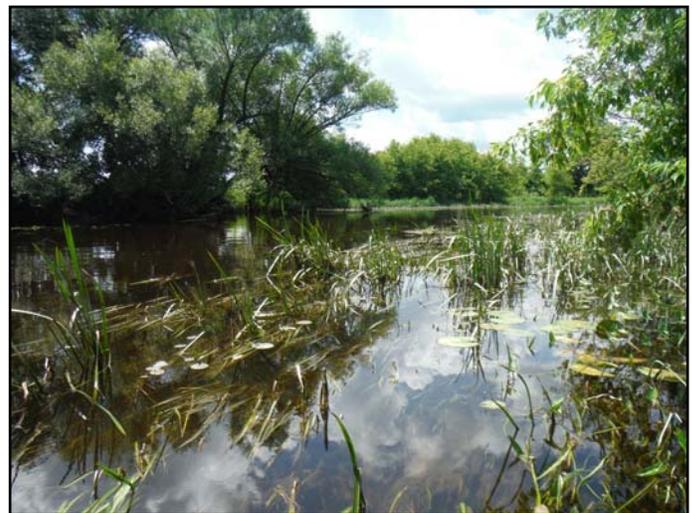
Section of Stevens Creek upstream of highway 416 with moderately elevated levels of specific conductivity

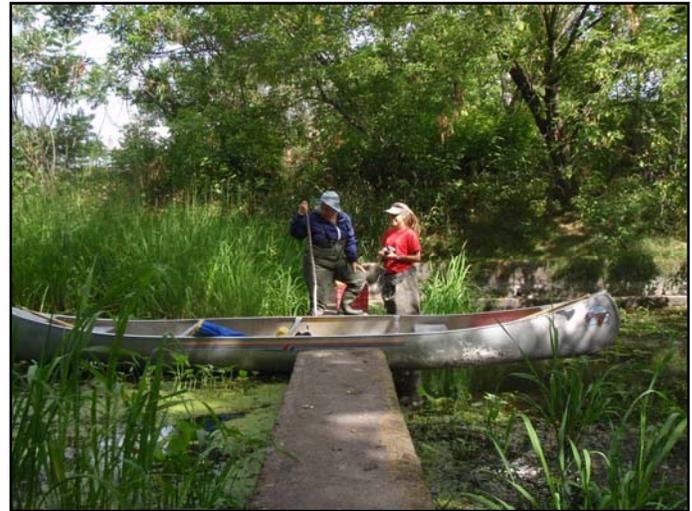
There is a weir located in North Gower and one debris dam was observed upstream of highway 416. This debris accumulated from naturally fallen trees and branches. The locations of migratory obstructions observed during headwater drainage feature assessment and stream surveys in 2017 are shown in Figure 31.

Weir observed along Stevens Creek

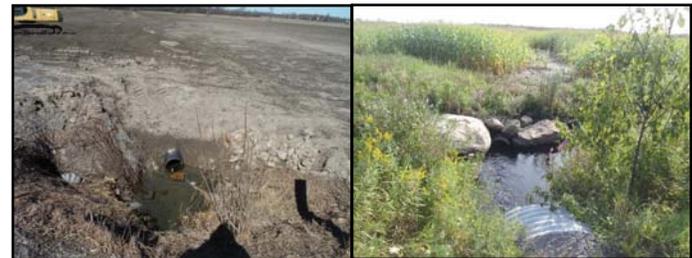
Tiling and other entombments of headwater drainage features can also cause migratory obstructions in the headwater reaches of the catchment. These obstructions lead to loss of important habitat and seasonal spawning grounds for many fish species, including northern pike.

Tiling of headwater drainage features creates fish migratory obstructions and loss of seasonal aquatic habitat

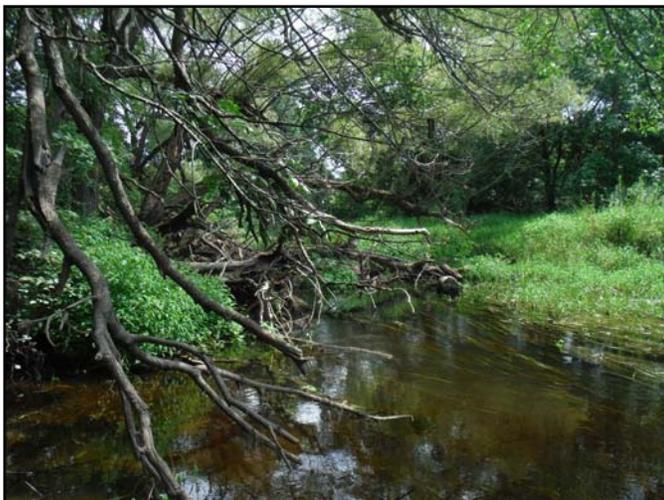
Debris dam observed along Stevens Creek

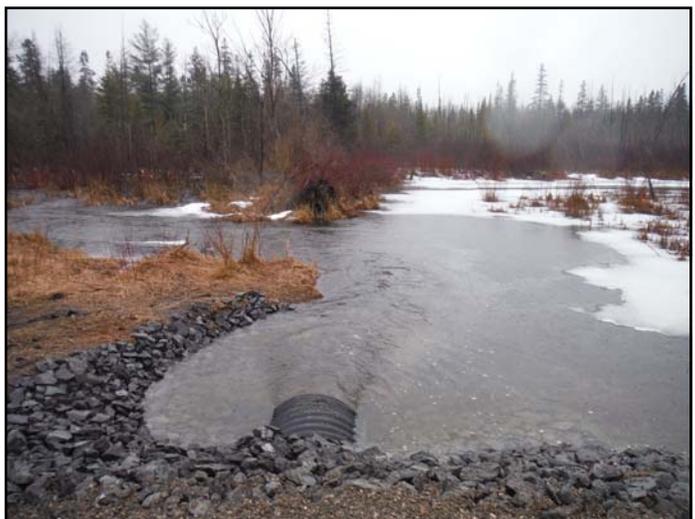
An example of mixed modifications: channel dredging and hardening with rip rap along channel on Roger Stevens Drive

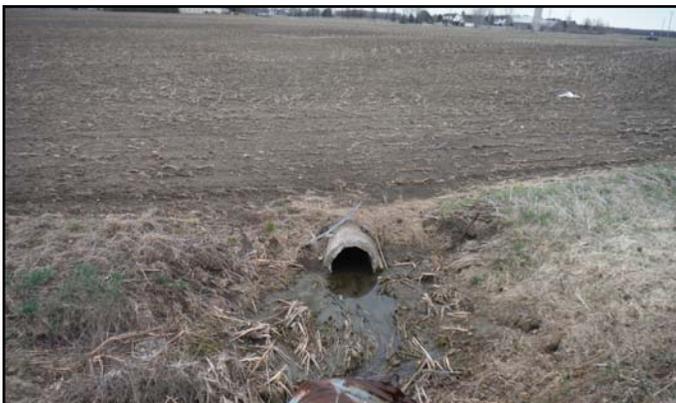
Substantial sediment deposition observed on Malakoff Road

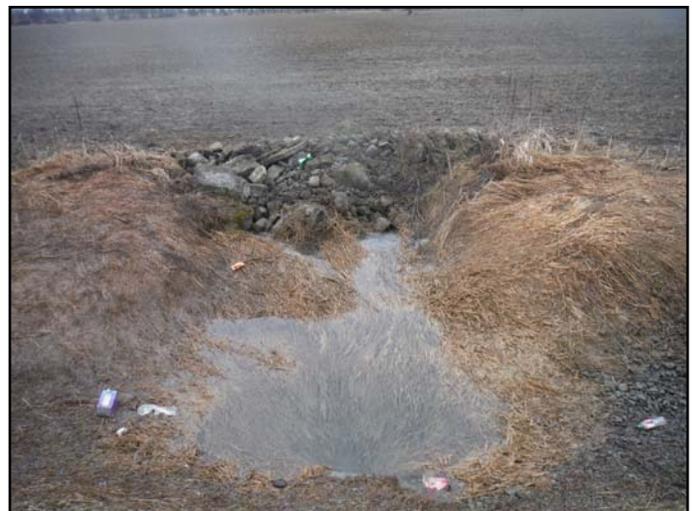
Headwater drainage feature that could benefit from tile outlet control in the Stevens Creek catchment

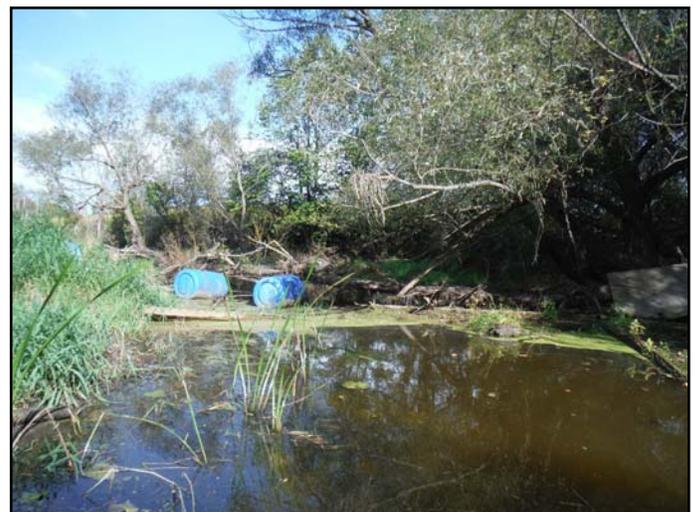
Area with accumulation of large debris, could benefit from a stream clean up.
