Mud Creek 2023 Catchment Report

Introduction

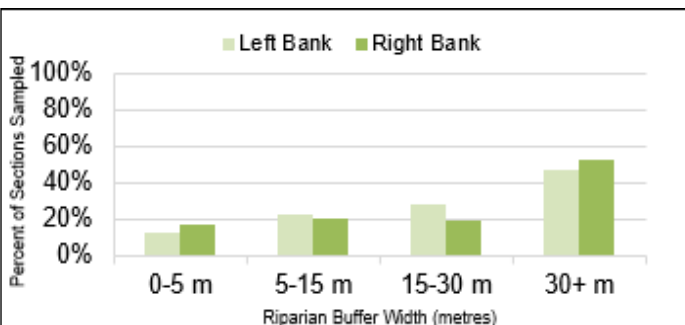
Figure 2 Vegetated buffer width along Mud Creek

Figure 2 demonstrates buffer conditions along the left and right banks of the surveyed sections of Mud Creek. Buffers greater than 30 meters were present along 47 percent of the left bank and 53 percent of the right bank. A 15 to 30 meter buffer was present along 28 percent of the left bank and 20 percent of the right bank. A five to 15 meter buffer was present along 23 percent of the left bank and 21 percent of the right bank. A five meter buffer or less was present along 13 percent of the left bank and 17 percent of the right bank. The buffer width evaluation on the sections surveyed of Mud Creek are below the recommended guidelines from Environment and Climate Change Canada.

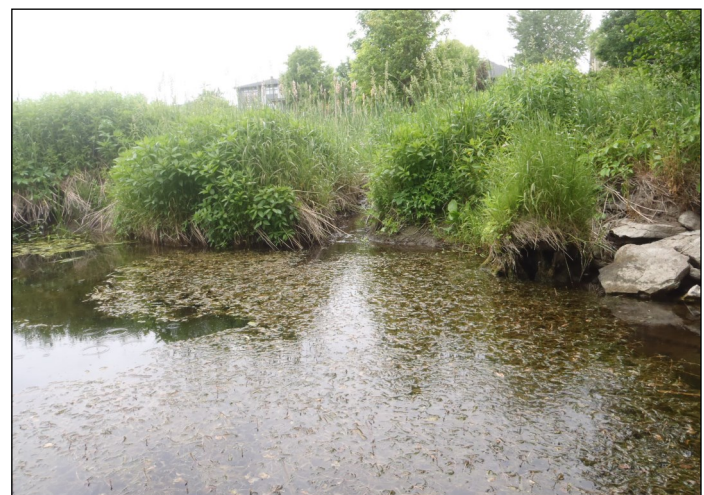
Undercut banks 600 m upstream of the mouth of Mud Creek

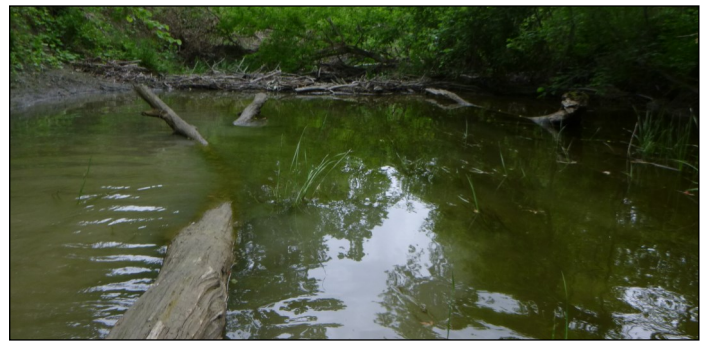
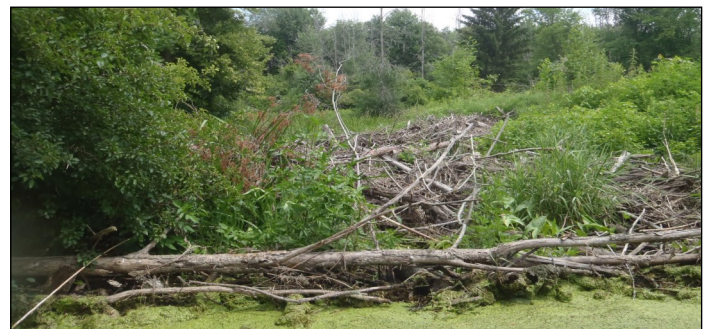
Instream wood structure found along Mud Creek are important for fish a wildlife habitat (above), some can become seasonal migration barriers (below).

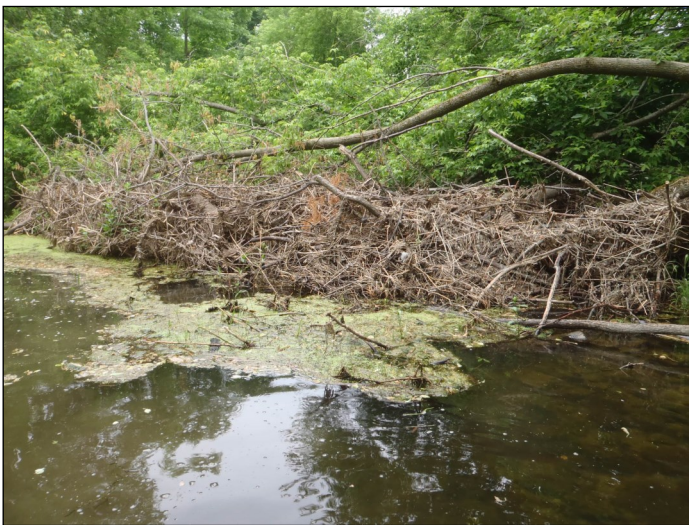
Debris dam create fish migratory obstructions and loss of aquatic habitat and seasonal grounds for many fish species.

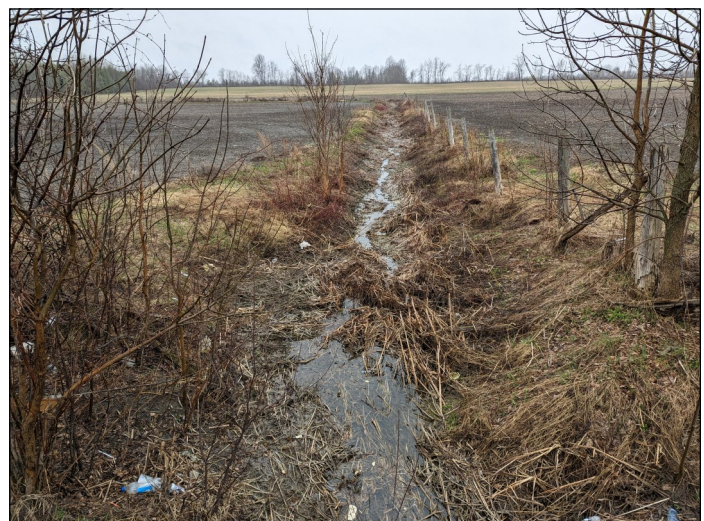
An example of historical channel straightening on a headwater drainage feature near Malakoff Road.

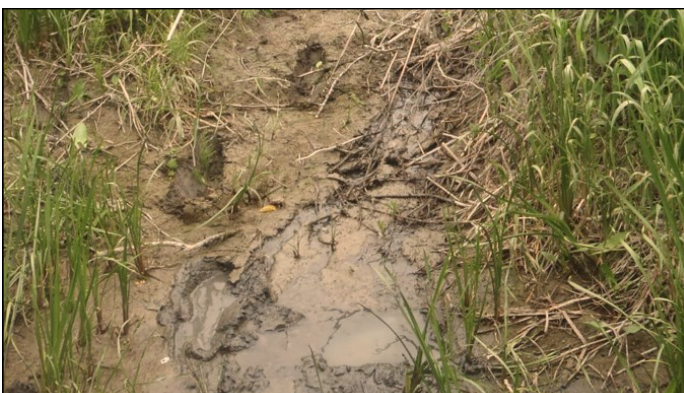
Substantial sediment deposition observed in a headwater drainage feature on Mud Creek.

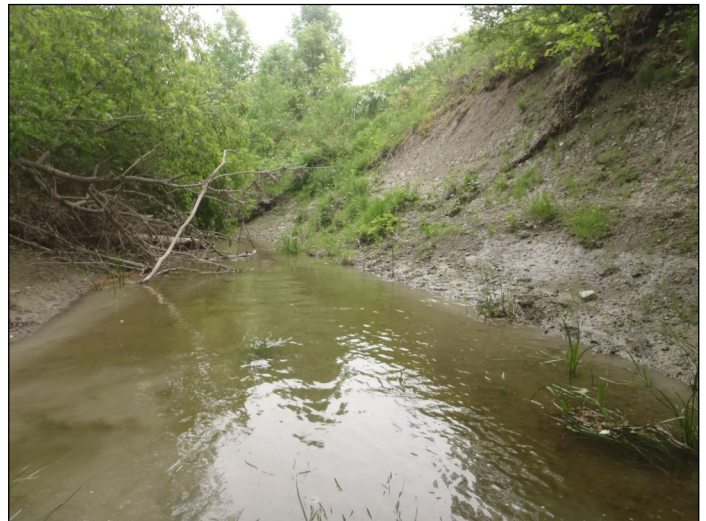
Area of Mud Creek near Rideau Valley Drive that would benefit from riparian planting
