# Stillwater Creek 2023 Catchment Report

In 2023, 108 sections (10.8 km) of Stillwater Creek were surveyed as part of the City Stream Watch monitoring activities. The following is a summary of observations made by staff and volunteers.

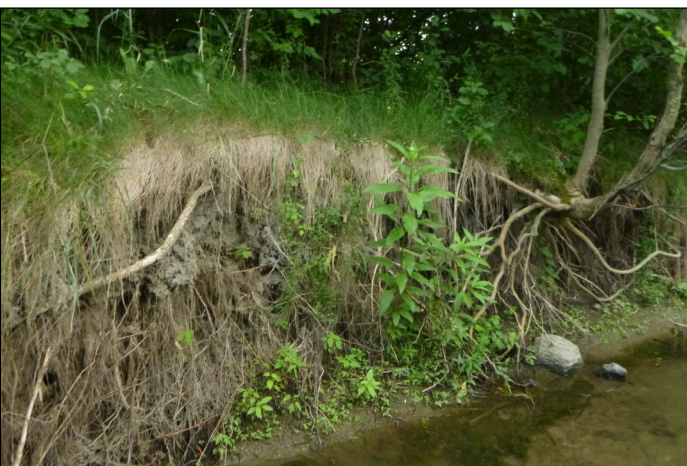
Bank erosion along Stillwater Creek upstream of HWY 417

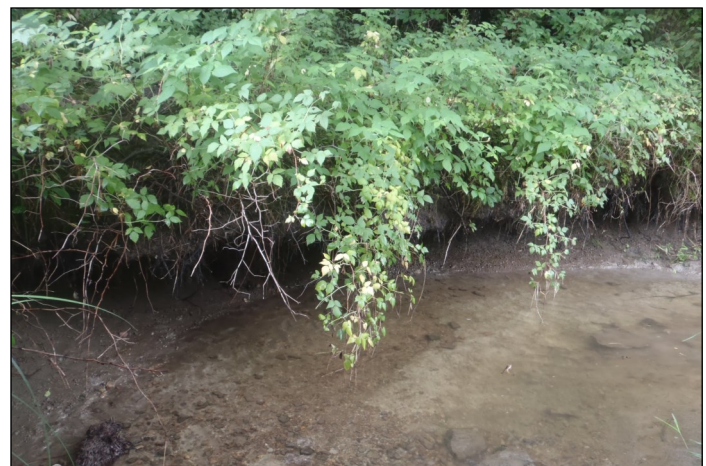
Undercut banks along Stillwater Creek upstream of Timm Drive

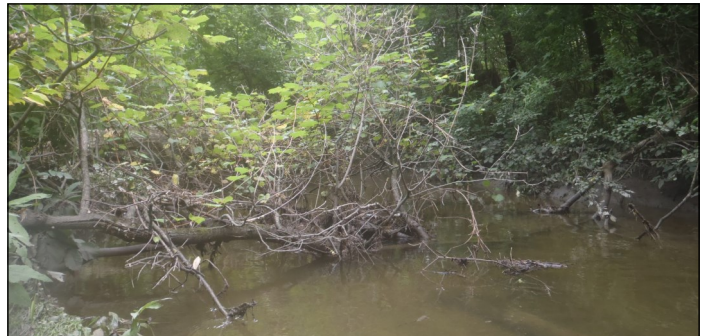
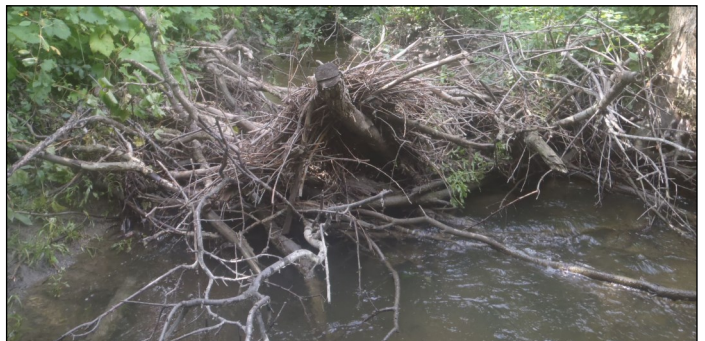
Instream wood structures found along Stillwater Creek are important for fish and wildlife habitat (above), some can become seasonal migration barriers (below)

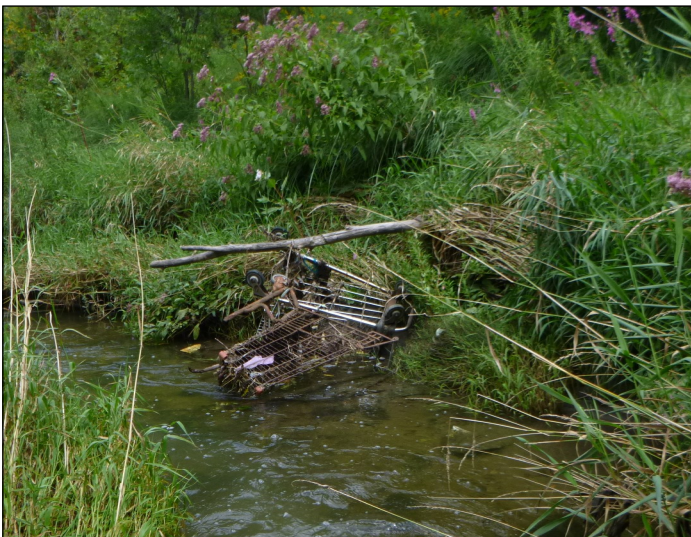
Shopping cart embedded in the bank of Stillwater Creek

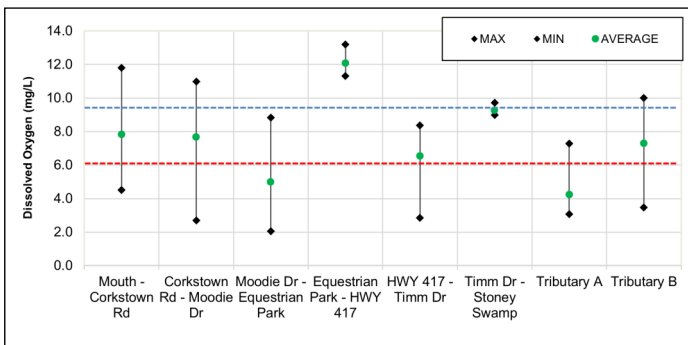
Figure 22 Dissolved oxygen ranges along surveyed sections of Stillwater Creek

Figure 22 shows the concentration levels found in the surveyed portions of Stillwater Creek. The two dashed lines depicted represent the Canadian water quality guidelines. Most of the surveyed portions were found to have oxygen levels within the Canadian water quality guidelines. Lower levels of dissolved oxygen were observed in wetland and agricultural areas along the system. This is typical for wetland habitats as a result of high biological oxygen demand. Average concentration levels across the system were 7.5 mg/L.

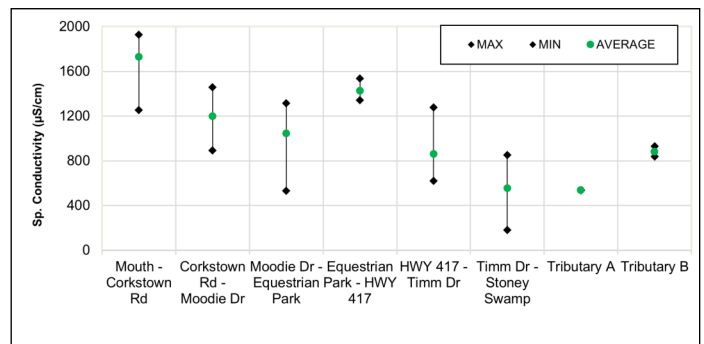
Figure 23 Specific Conductivity ranges along surveyed sections of Stillwater Creek

Figure 23 shows specific conductivity levels in Stillwater Creek. Average conductivity level was measured at 986.4  $\mu\text{S}/\text{cm}$ . Conductivity levels are lower in areas approaching headwater reaches. Higher levels were observed in the sections closer to road infrastructure and the confluence with the Ottawa River.

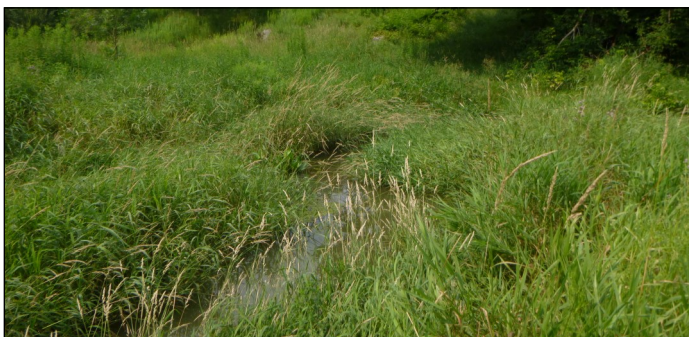
Section on Stillwater Creek west of Moodie Drive with **impaired** oxygen conditions (Dissolved oxygen levels of 2.85 mg/L and 31.5 % saturation)

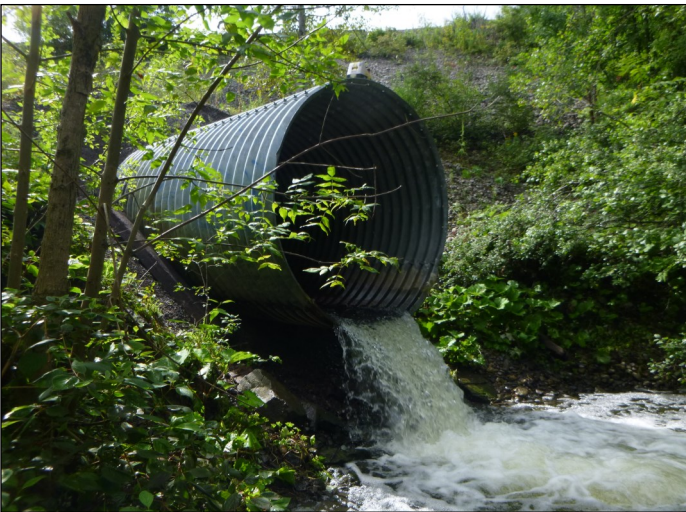
Perched culverts create fish migratory obstructions and loss of aquatic habitat and seasonal grounds for many fish species

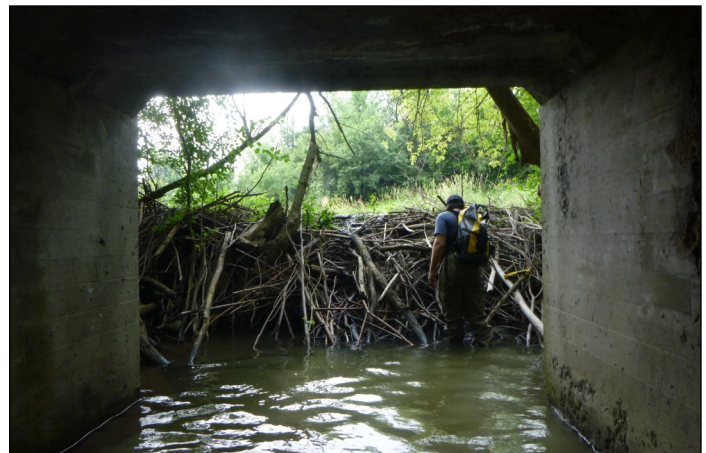
An active beaver dam blocking the culvert under the railway east of Moodie Drive

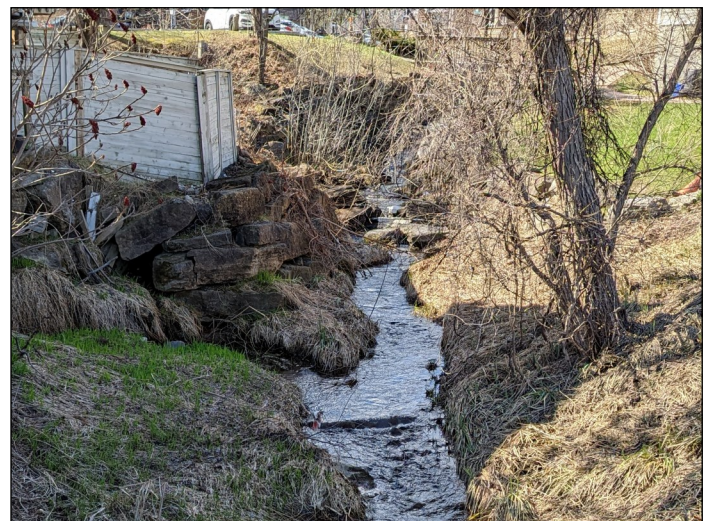
An example of the use of armourstone on a headwater drainage feature on Robertson Road

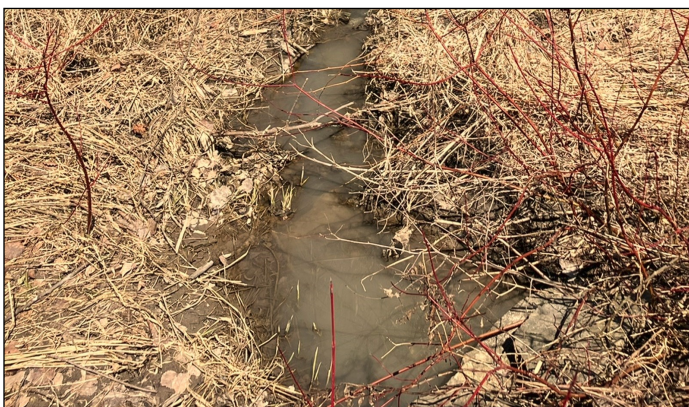
Moderate sediment deposition observed in a headwater drainage feature on Timm Road
