Mud Creek (GCK) 2012 Summary Report

As part of the City Stream Watch monitoring activities in 2012, 61 sections along Mud Creek were surveyed by staff and volunteers. In addition, 26 sections of a tributary of Mud Creek that runs east towards Page road were also surveyed. The results presented in this report include data collected from Mud Creek as well as the tributary that was surveyed.

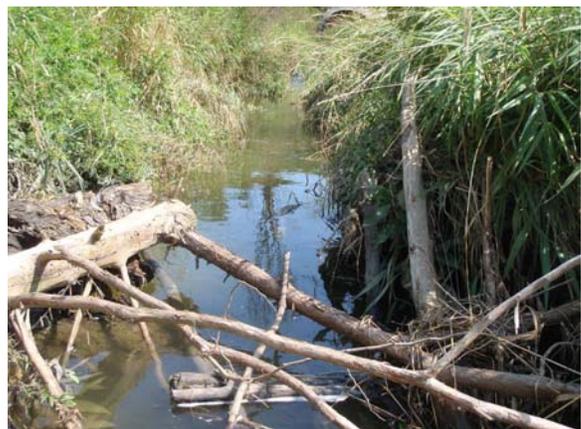
Photo 1. Instream trees and branches on Mud Creek Tributary

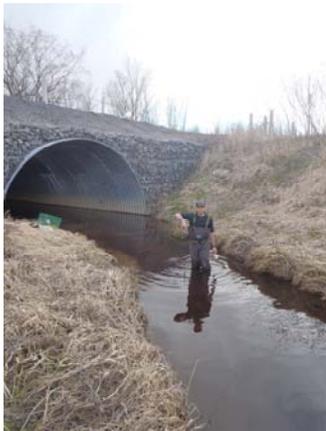
Photo 2. The location where a temperature datalogger was deployed on Mud Creek near Renaud road.

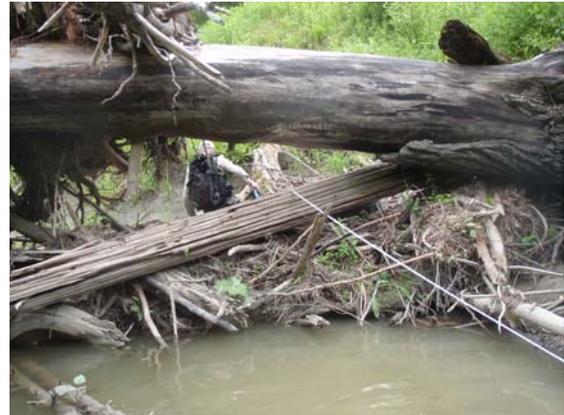
Photo 3. A volunteer measuring across a large debris dam on Mud Creek

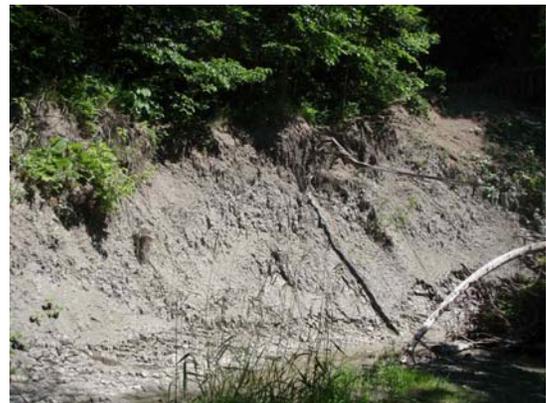
According to observations bank stability has increased overall since 2007. In 2007, 33 percent of the banks were considered stable. In 2012, 63 percent of the left bank is stable and 58 percent of the right bank is stable. It is important to note that although there has been an improvement in erosion levels on Mud Creek overall, there has been an increase in sites with extreme erosion and bank instability.

Photo 4. Erosion and bank instability observed in 2012
