Sawmill Creek 2014 Summary Report

Sawmill Creek is approximately eleven kilometres long and drains 21 square kilometres of land. Beginning in a wetland south of Lester Road, the creek flows north through South Keys and Heron Park before emptying into the Rideau River near the intersection of Bank Street and Riverside Drive. Although Sawmill Creek is one of the last free-flowing coolwater streams left in the urban core of the City of Ottawa, the lower and middle reaches of the creek are highly urbanized and the creek corridor is degraded and confined by development and transportation infrastructure (RVCA 2012). The surficial geology in the subwatershed area is mainly marine clay plains with sand and rock ridges (RVCA, 2008). Due to its location in the City of Ottawa, much of the subwatershed is fairly urbanized, and the vegetation in the subwatershed has been impacted but there remain some more extensive forested areas around Blossom Park, McCarthy Woods and north of Walkley Road along the creek (CH2MHILL, 2003).

In 2014, 110 sections (11 km) of Sawmill Creek were surveyed as part of the City Stream Watch monitoring activities. The following is a summary of observations made by st

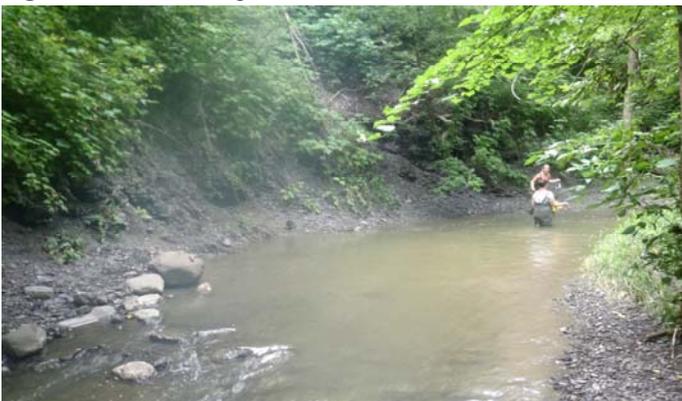
Stream bank erosion along Sawmill Creek

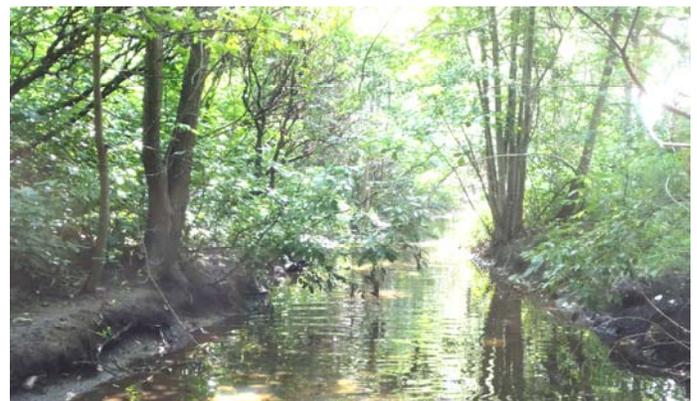
Bank undercutting along Sawmill Creek

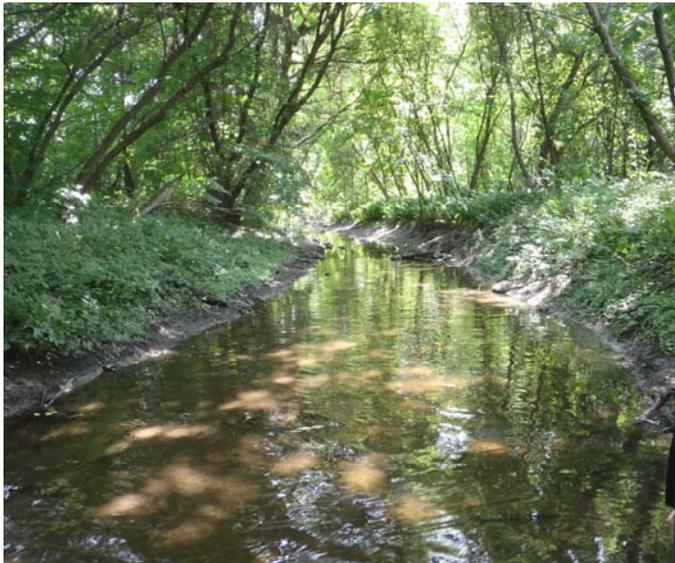
Stream shade along Sawmill Creek

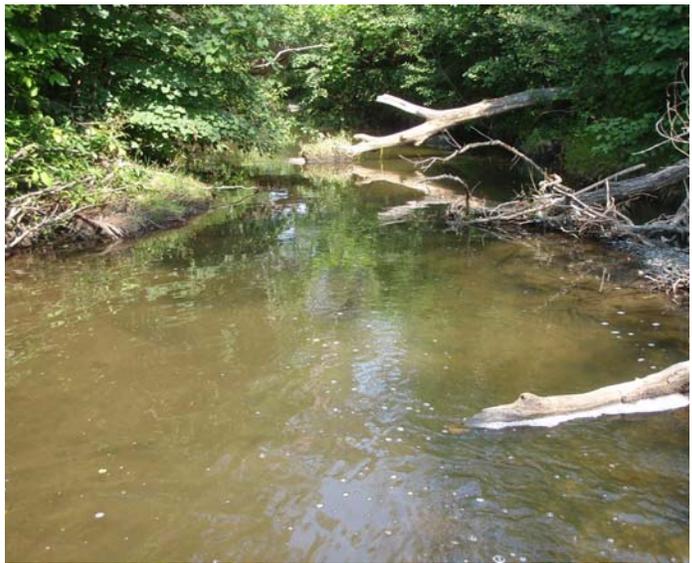
Instream woody debris along Sawmill Creek

Figure 7 shows that overall, the surveyed sections along Sawmill Creek had moderate levels of instream woody debris in the form of branches and trees. Instream woody debris is important for fish and benthic habitat, by providing refuge and feeding areas. Some areas with high levels of instream woody debris were observed downstream of Walkley Road and upstream of Albion Road.

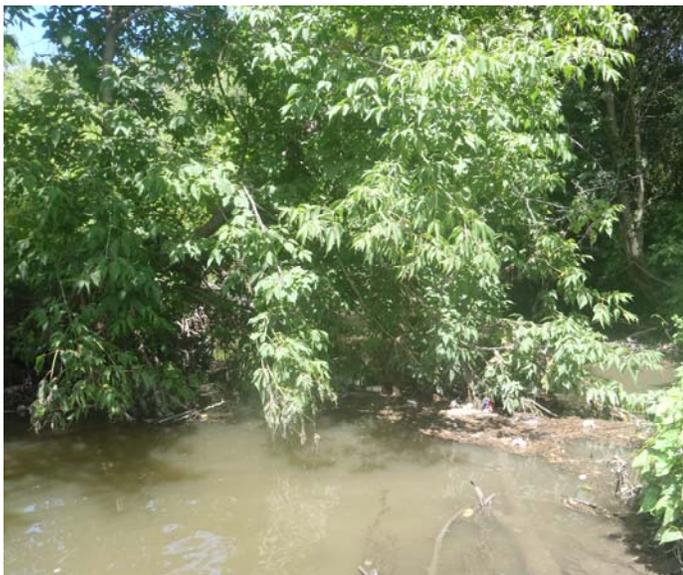
Overhanging trees and branches on Sawmill Creek

Figure 8 shows that overall, Sawmill Creek had moderate to high coverage from overhanging branches and trees. Trees and branches that are less than one meter from the surface of the water are defined as overhanging. At this proximity to the water branches and trees provide a food source, nutrients and shade which helps to moderate instream water temperatures.

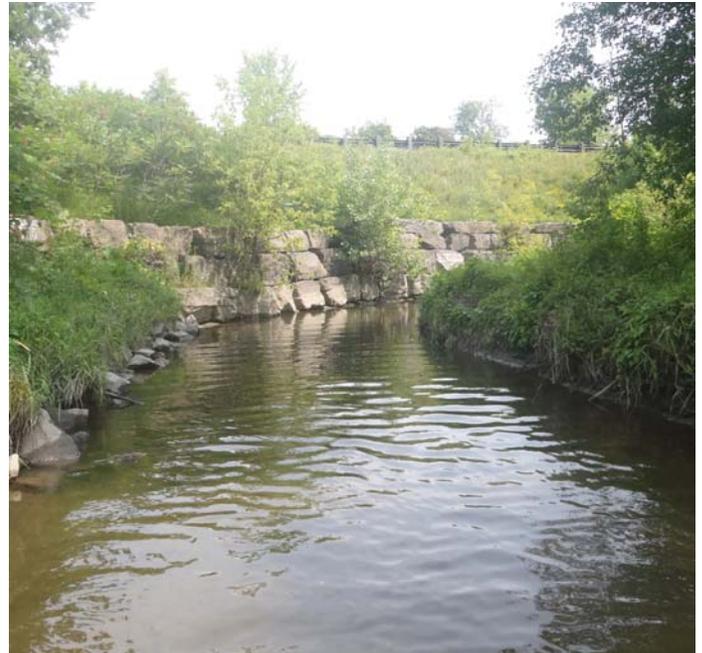
A highly altered section of Sawmill Creek where armour stone has been used to protect urban infrastructure at the top of the bank from the effects of stream erosion

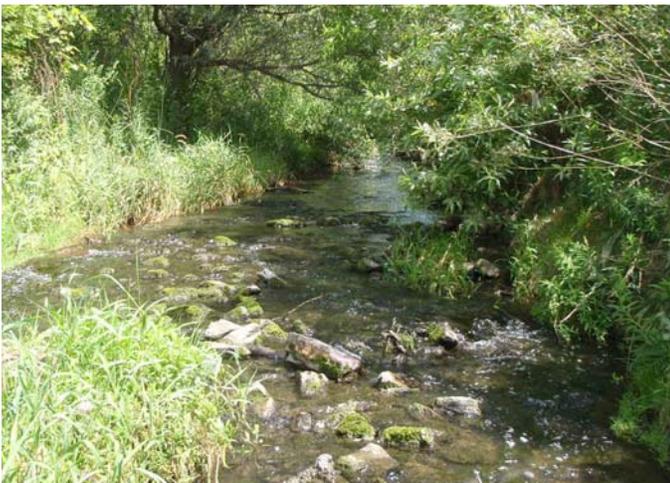
Habitat complexity on Sawmill Creek

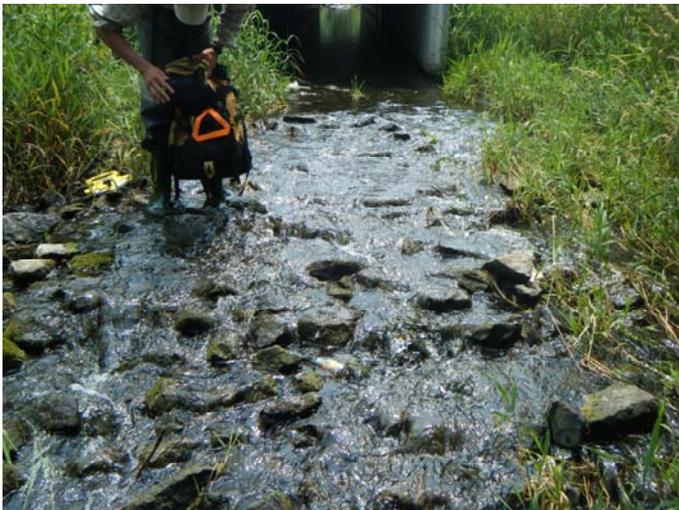
Cobble and boulder habitat observed along Sawmill Creek

Boulders create instream cover and back eddies for large fish to hide and/or rest out of the current. Cobble provides important over-wintering and/or spawning habitat for small or juvenile fish. Cobble can also provide habitat conditions for benthic invertebrates that are a key food source for many fish and wildlife species. Figure 13 shows the distribution of cobble and boulder habitat along Sawmill Creek. Areas of cobble and boulder habitat are found along most of the creek.

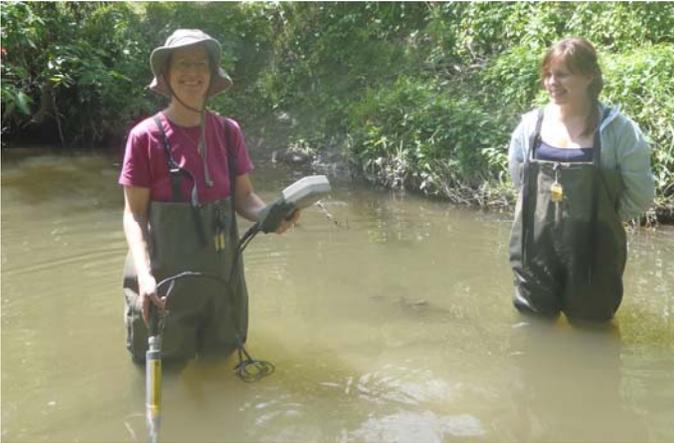
Volunteers measuring water chemistry using a YSI

During the stream characterization survey, a YSI probe is used to collect water chemistry information. Dissolved oxygen, conductivity and pH are measured at the start and end of each section.

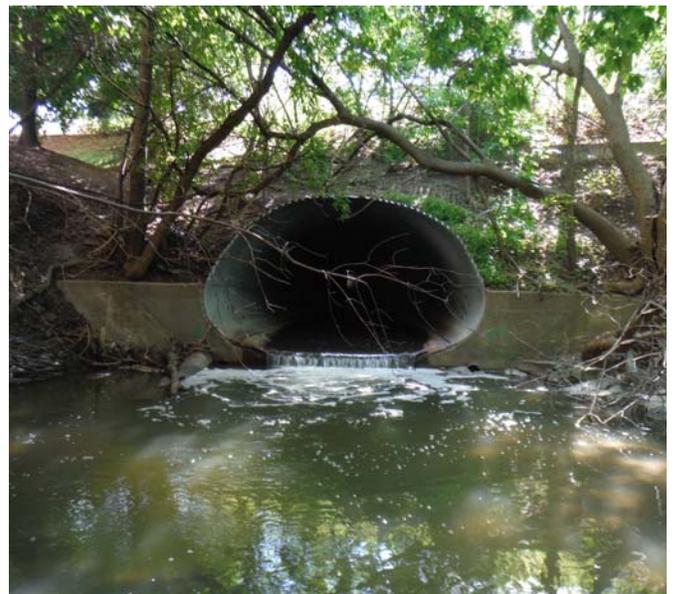
A perched culvert observed along Sawmill Creek at Bank Street

Most of the instream restoration opportunities listed for Sawmill Creek are stream garbage cleanups. There is also a fish habitat enhancement opportunity where there is a perched culvert at Bank Street.

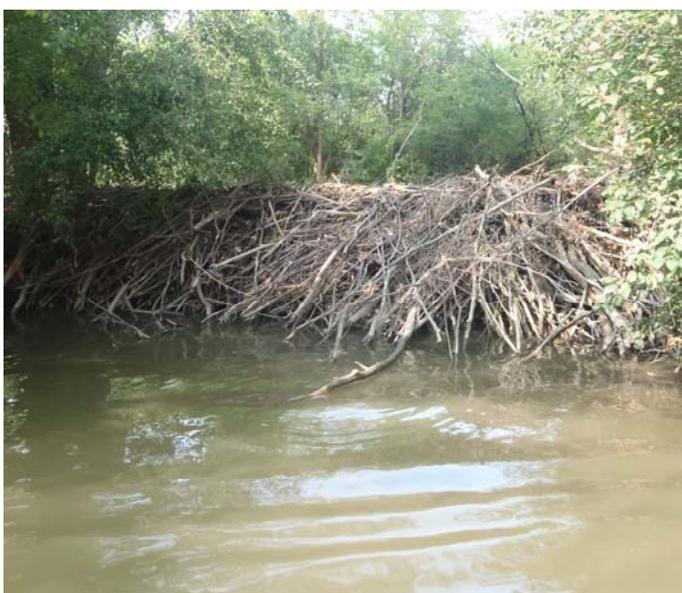
An active beaver dam on Sawmill Creek

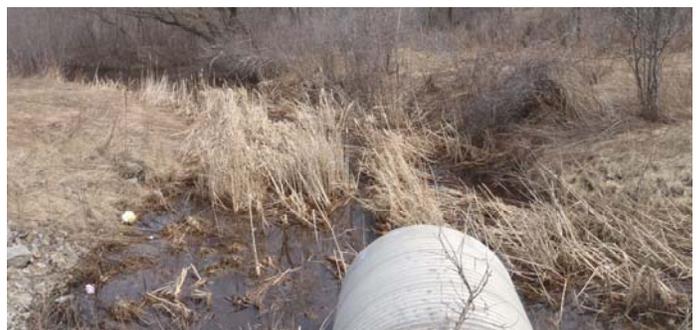
A headwaters site at Uplands Drive

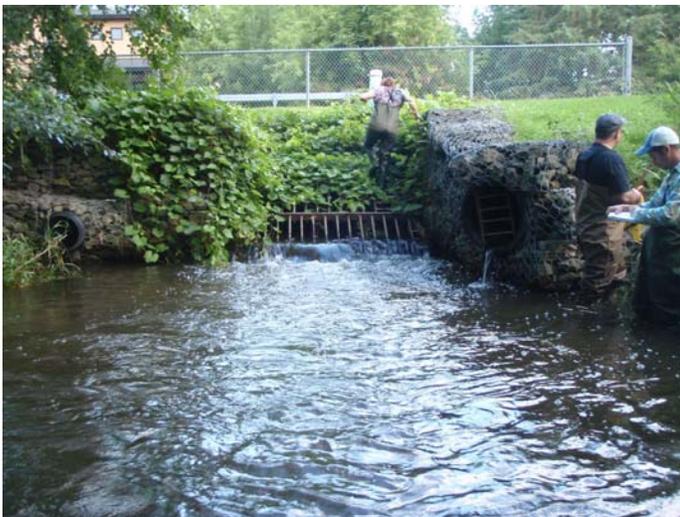
Table 3 shows that between 2008 and 2014 anthropogenic alterations along Sawmill Creek have increased. In 2008, 23 percent of the sections had no anthropogenic alterations, in 2014 that number has decreased to 14 percent. This change may be caused by changes in the stream survey protocol and the classification of channelization. In 2010 anthropogenic alterations were further defined in the protocol, which has caused some land uses to shift categories.

Anthropogenic alterations on Sawmill Creek at Kingsdale Avenue

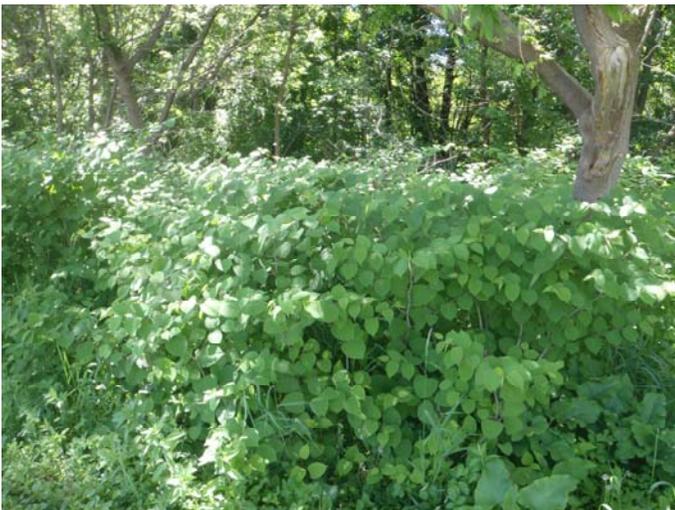
An invasive species removal opportunity where Japanese knotweed was observed along Sawmill Creek

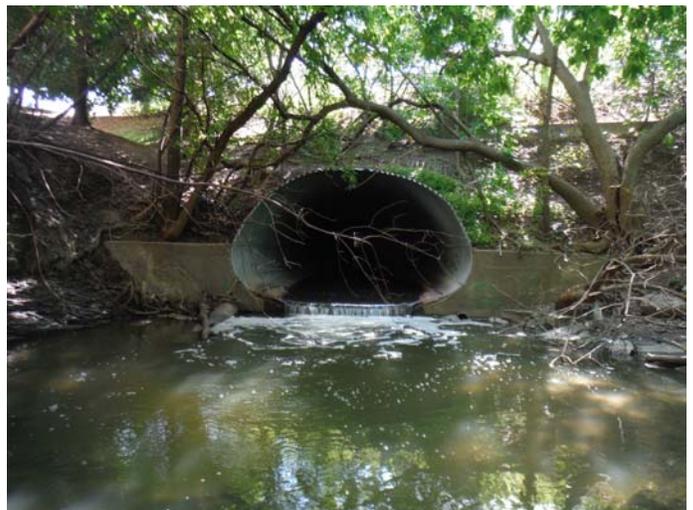
A fish habitat enhancement opportunity where there is a perched culvert on Sawmill Creek at Bank Street
