Voyageur Creek 2013 Summary Report

In 2013, Voyageur Creek was monitored for the first time by the City Stream Watch Program. As part of the City Stream Watch monitoring activities, 59 sections along Voyageur Creek were surveyed by staff and volunteers. The following is a summary of the 59 macro stream assessments carried out on Voyageur Creek.

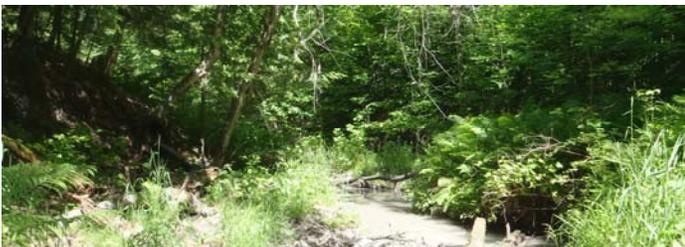
Vegetated buffer along Voyageur Creek

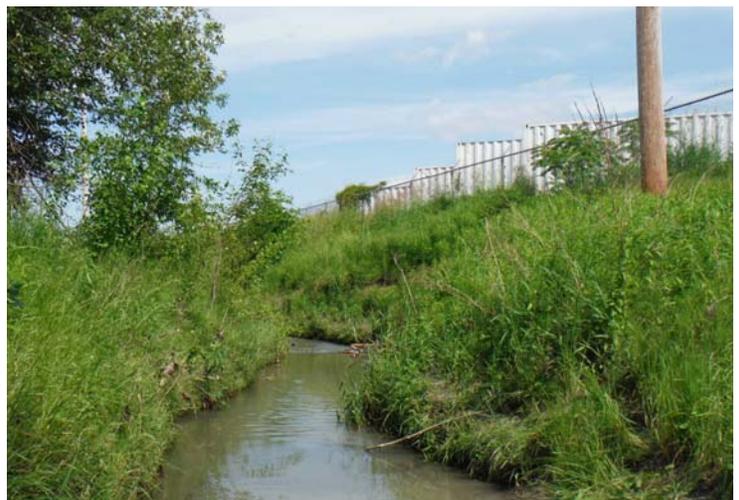
Industrial/commercial land use along Voyageur Creek

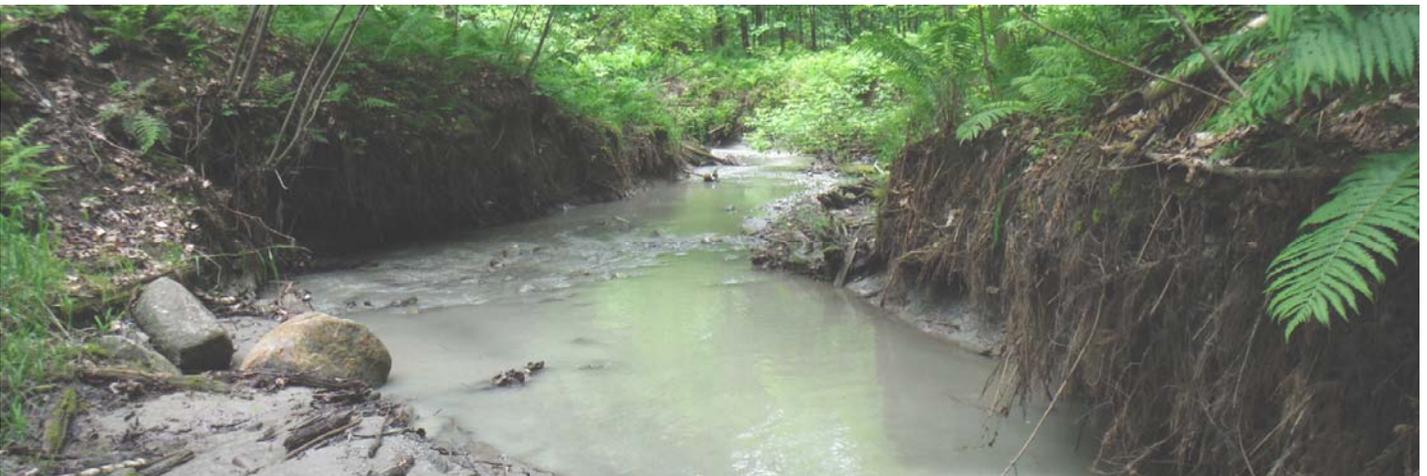
Stream bank undercutting typical along Voyageur Creek

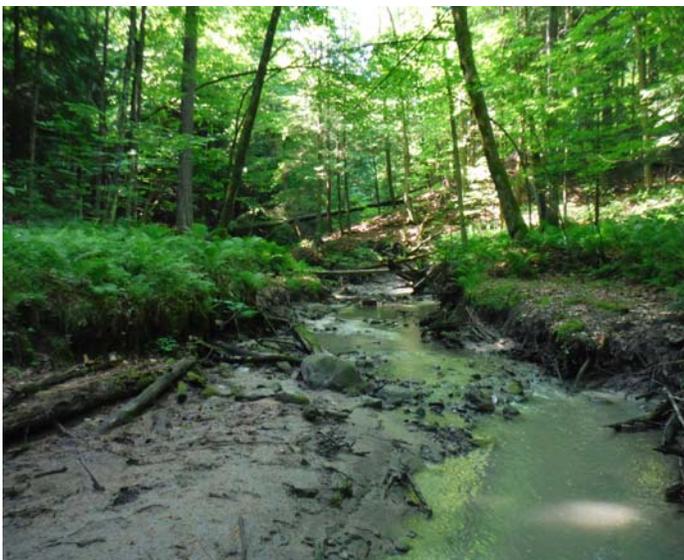
Stream shade along Voyageur Creek

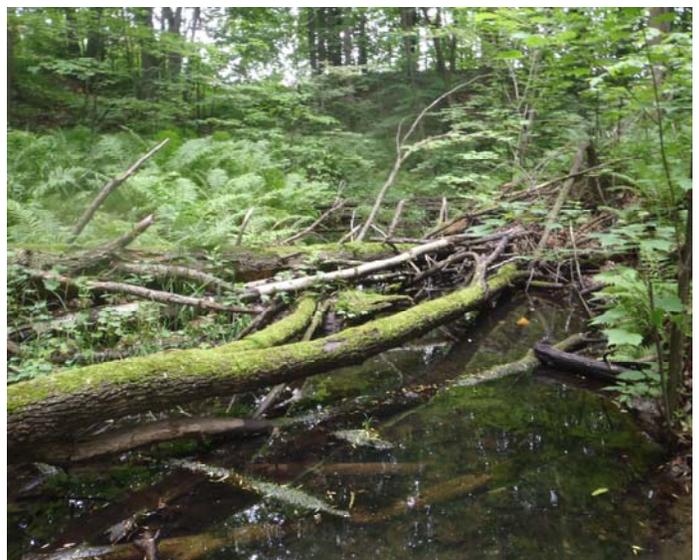
Instream woody debris along Voyageur Creek

Figure 7 shows that the majority of Voyageur Creek had moderate levels of instream woody debris in the form of branches and trees. Instream woody debris is important for fish and benthic habitat, providing refuge and feeding areas.

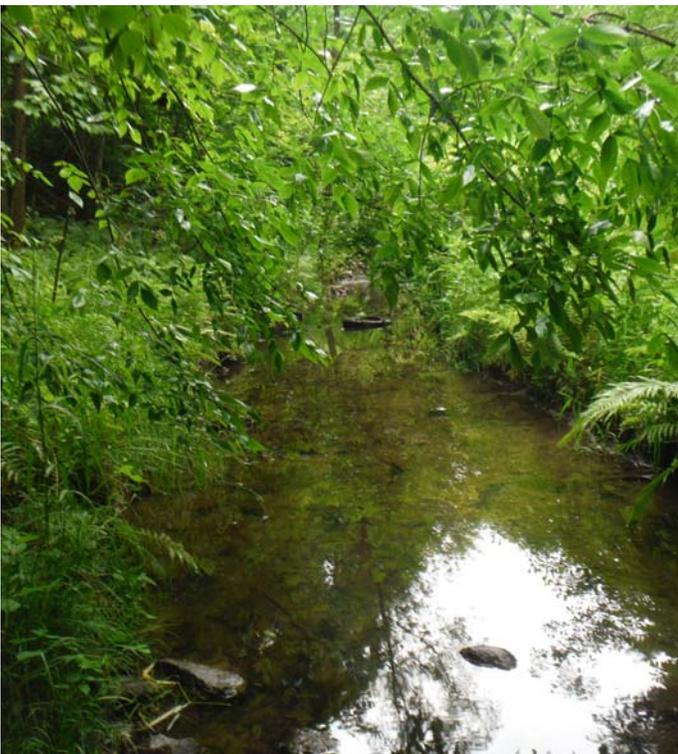
Overhanging trees and branches on Voyageur Creek

Figure 8 shows that the majority of Voyageur Creek had moderate to high levels of overhanging branches and trees. Overhanging branches and trees provide a food source, nutrients and shade which helps to moderate instream water temperatures.

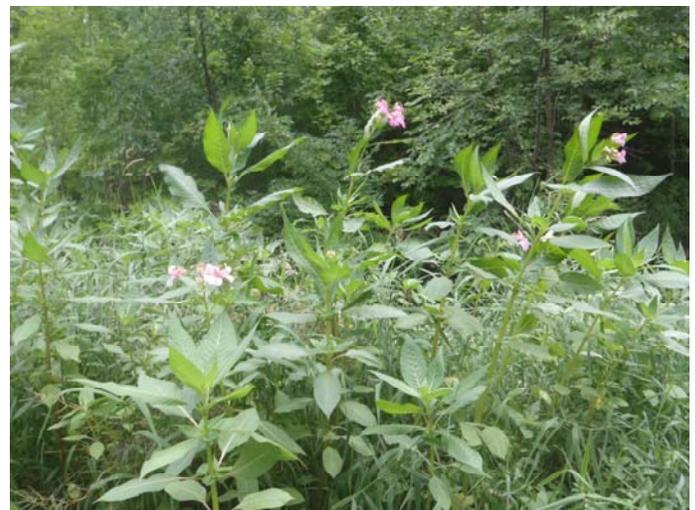
Himalayan Balsam is an invasive species found on Voyageur Creek

Invasive species can have major implications on streams and species diversity. Invasive species are one of the largest threats to ecosystems throughout Ontario. They can outcompete native species, having negative effects on local wildlife, fish and plant populations. Thirty-seven percent of the sections surveyed along Voyageur Creek had invasive species (Figure 16). The invasive species observed along Voyageur Creek were Manitoba maple (*Acer negundo*), purple loosestrife (*Lythrum salicaria*), dog-strangling vine (*Cynanchum rossicum*), Himalayan balsam (*Impatiens glandulifera*) and garlic mustard (*Alliaria petiolata*).

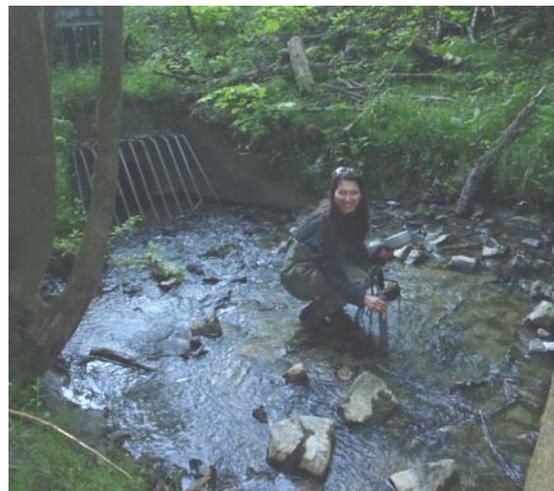
A volunteer using a YSI on Voyageur Creek

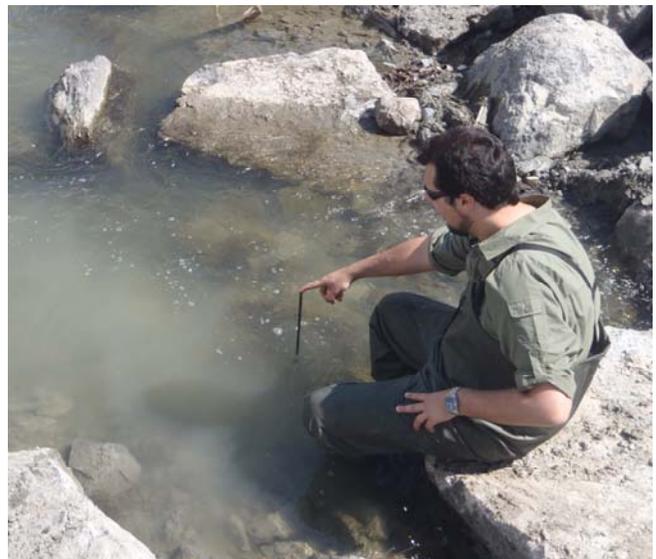
Temperature logger installed near Highway 174

Three temperature loggers were installed on Voyageur Creek: logger one upstream of Rivercrest Drive, logger two East of Forest Valley Drive, and logger three upstream of highway 174 (Figure 18). Logger three at highway 174 was not retrieved because it was washed away or stolen, so only data from the other two loggers is represented in Figure 19 below. Analysis of the data collected indicates that Voyageur Creek is classified as a cool water system. The water temperature of this creek is likely heavily influenced by the substantial amount of shading along most of its length as well as the piped sections of the creek.
