City Stream Watch 2004 Annual Report

November 23, 2004

Executive Summary

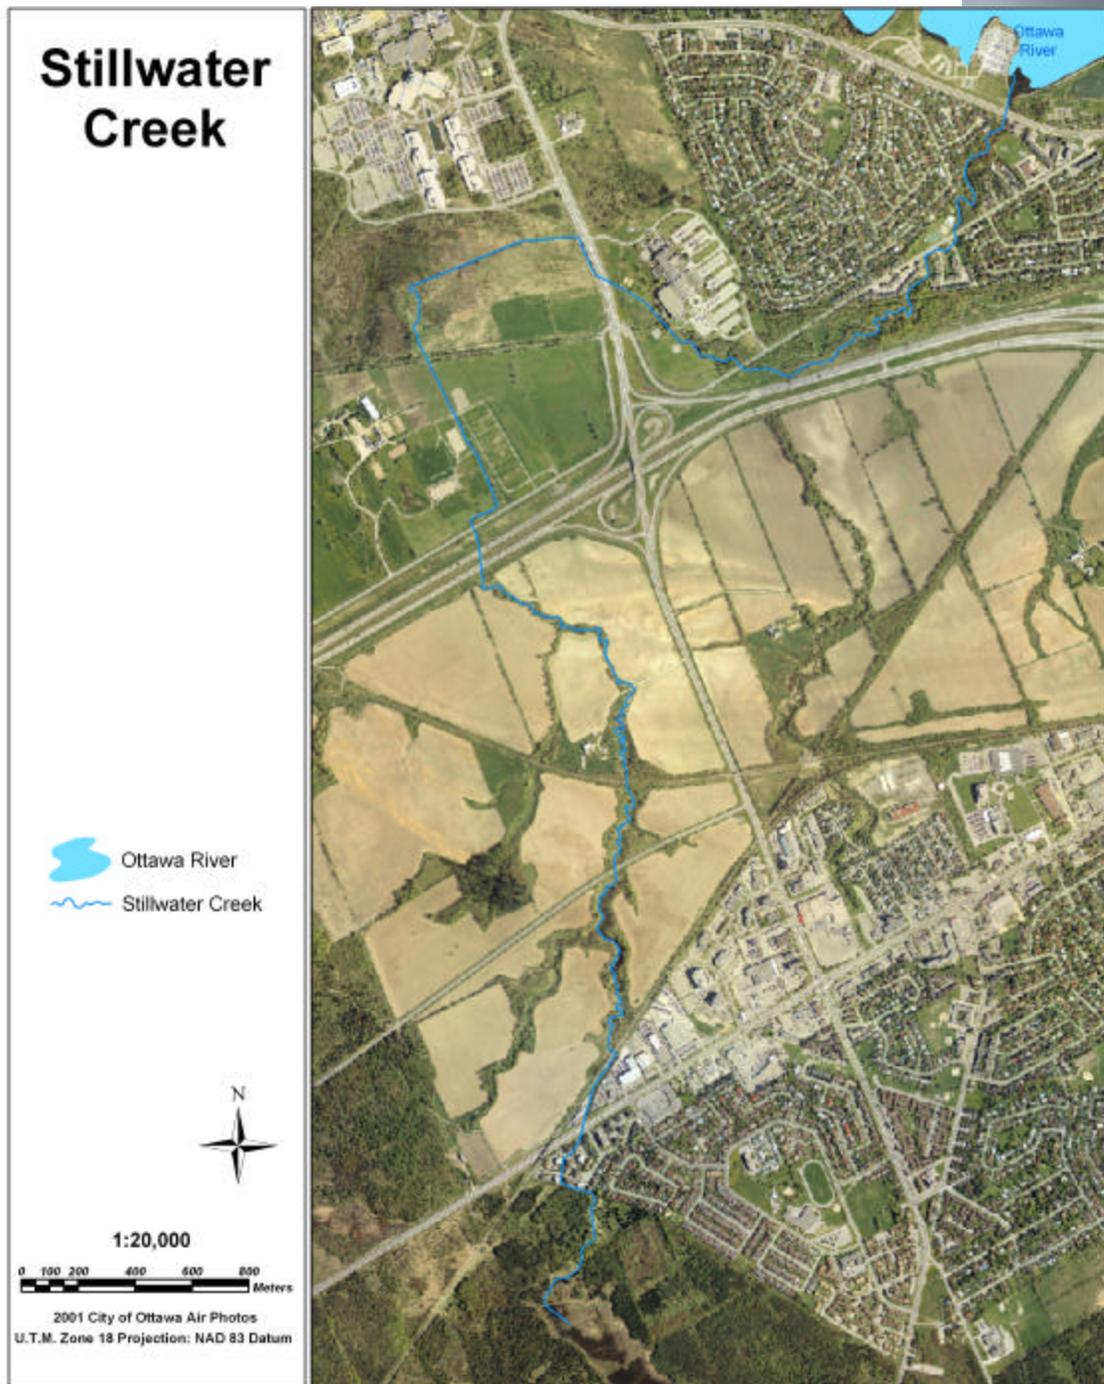
Figure 2. Air photo of Stillwater Creek and surrounding area.

Stillwater Creek is approximately 8.5 kilometres long, flowing from Stoney Swamp north through agricultural, recreational, and urban areas before entering the Ottawa River just east of the Nepean Sailing Club. Figure 2 shows air photos taken of the Stillwater Creek area in 2001.

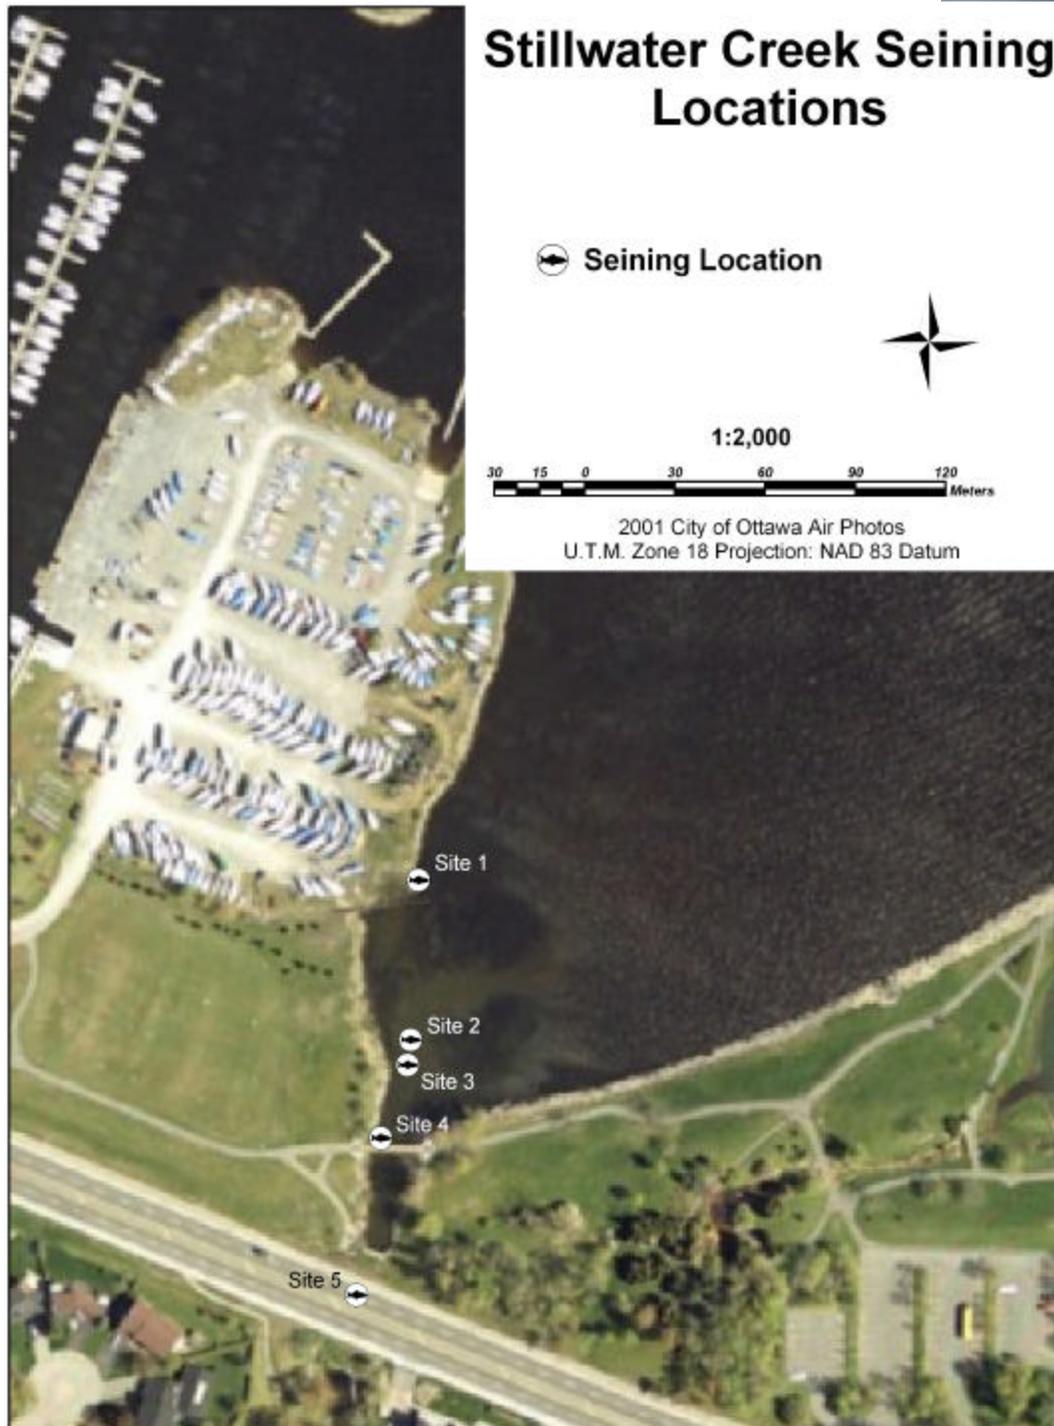
Figure 20. Air photo of the mouth of Stillwater Creek showing 5 seining site locations.

The mouth of Stillwater Creek was sampled five times over two days. Figure 20 shows the locations of the sampling sites, and table 5 is a summary of the fish caught in Stillwater Creek.

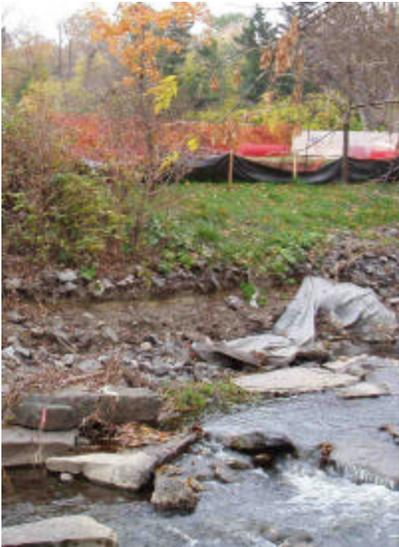
Location	Issue	Picture	Remediation Strategy	Expected Results
<p>The mouth of Sawmill Creek where it empties into the Rideau River near Billings Estate just east of the corner of Bank Street and Riverside Drive. Approximately 150m section of creek not including infrastructure.</p>	<p>The rock rubble that was used to armour the banks has proven to be incompetent due to the steepness of the slope and high flow rates. The banks are exposed and undercut, and much of the geotextile has been naturally removed by flows and is positioned in the channel bed or is exposed. The resulting excavation and deposition of the silty clay material from the banks is causing the deterioration of walleye spawning habitat at the mouth of the creek, which was created as compensation for a past project on sawmill creek.</p>

<p>Utilize existing volunteer base of the City Stream Watch program to participate in this rehabilitation effort. A combination of several bio-engineering systems (live staking, live fascines, bare root shrubs, coco matting, brush mats) should be applied to re-stabilize the slope. Due to periodic high-velocity flows, the toe of the slope requires protection against undercutting and resultant slumping of the existing rock rubble on the steep banks.</p>	<ul style="list-style-type: none"> • Effective streambank protection from erosion; • Community involvement and ownership; • Reduce siltation of existing walleye spawning habitat; • The enhancement of conditions for natural colonization of existing plant community; • Produce streamside fish and wildlife habitat. • Reduction of sediment that negatively impacts benthic invertebrate community. • Overall net gain for the aquatic community

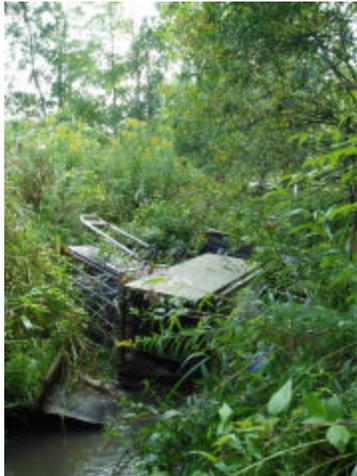
Location	Issue	Picture	Remediation Strategy	Expected Results
<p>Many locations along Sawmill Creek and Bilberry Creek.</p>	<p>The accumulation of garbage and refuse at various sites along both creeks. This has resulted in the degradation of fish and wildlife habitat, the deterioration of water quality, and the deterioration of both creek's aesthetic appeal.</p>

<p>Utilize existing volunteer base of the City Stream Watch program to participate in this rehabilitation effort. Community clean-up days should be organized on both creeks to facilitate the safe and proper removal of human produced material from the creek bed and riparian zones. Natural material should be left undisturbed.</p>	<ul style="list-style-type: none"> • Community involvement and ownership; • Enhancement of fish and wildlife habitat; • Enhancement of the creek's aesthetic qualities.

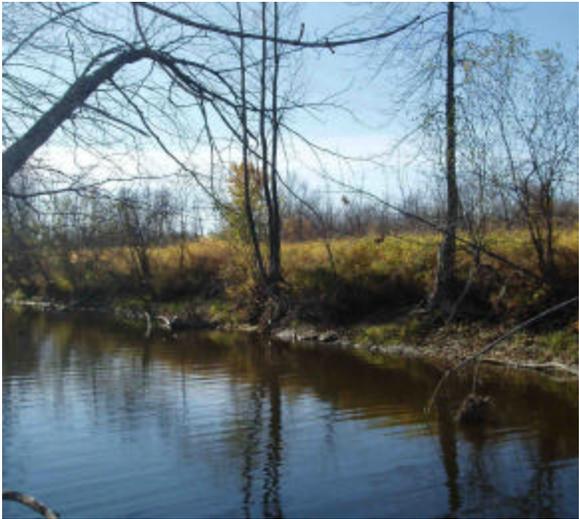
Location	Issue	Picture	Remediation Strategy	Expected Results
The mouth of Bilberry Creek where it empties into the Ottawa River.	A lack of shallow, back water areas suitable for spawning and nursery habitat for certain fish species (yellow perch, northern pike, and muskellunge).

Utilize existing volunteer base of the City Stream Watch program to participate in this rehabilitation effort. Construct a small embayment off of the main creek channel, creating additional aquatic habitat (including but not limited to fish spawning and nursery habitat).	<ul style="list-style-type: none"> • Community involvement and ownership; • Enhancement of aquatic habitat, in particular yellow perch, northern pike, and muskellunge spawning and nursery habitat. • Creation of quality habitat for amphibians.
Location	Issue	Picture	Remediation Strategy	Expected Results
Locations along Stillwater Creek and Bilberry Creek.	Un-vegetated unstable banks along both creeks. As a result, the excavation of material from the banks and the deposition of this material in the stream bed are having negative impacts on fish habitat and the benthic invertebrate community.
