Ottawa West Tributaries 2017 Catchment Report

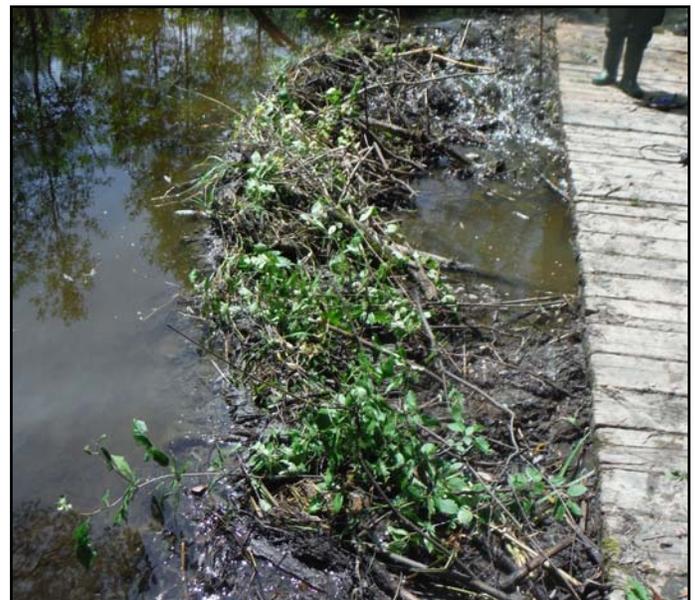
Breached beaver dam along Ottawa West Tributary 1

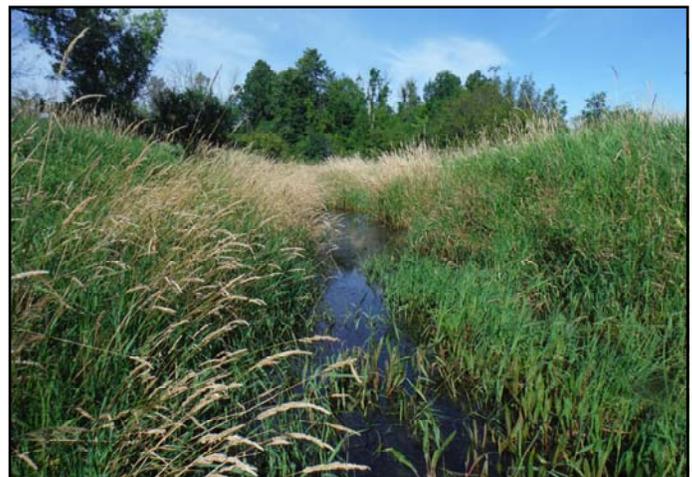
Section of Ottawa West Tributary 1 that would benefit from fish habitat enhancement.

The Ottawa West Tributary 1 has an area identified for having potential for fish habitat enhancement (Figure 30). This area could benefit from increased heterogeneity in the stream by creation of riffles along that section. Riffle creation would also contribute to increase the oxygen levels which are currently impaired in that area.
