Becketts Creek 2017 Catchment Report

Becketts Creek is a tributary of the Ottawa River located in the East end of the City of Ottawa. The 28 kilometer stream flows from the southern portion of Sarsfield to its confluence into the River at Baie Lafontaine in Cumberland. Adjacent to the confluence there is also a 184 hectare migratory bird sanctuary.

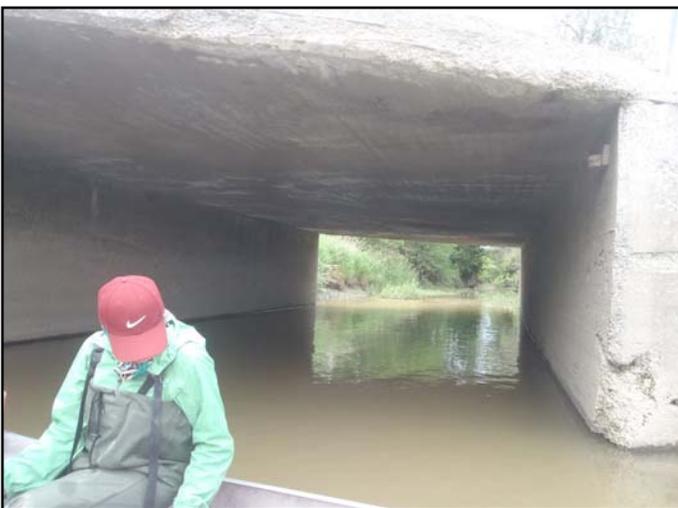
Road crossing altering riparian zones along Becketts Creek

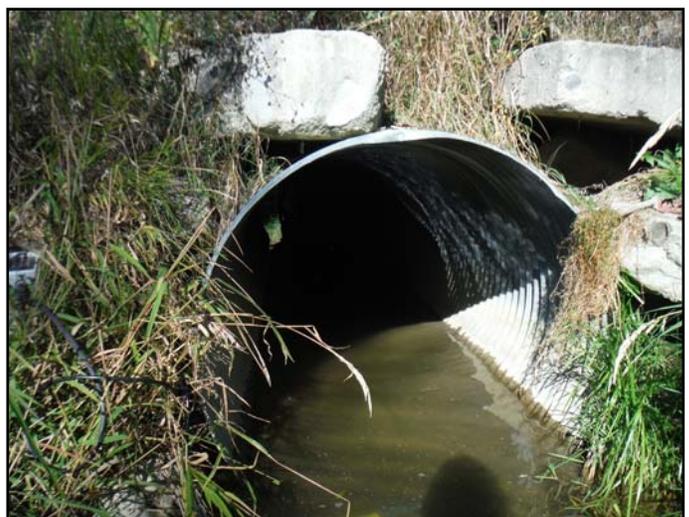
A highly altered stream section flowing through a culvert

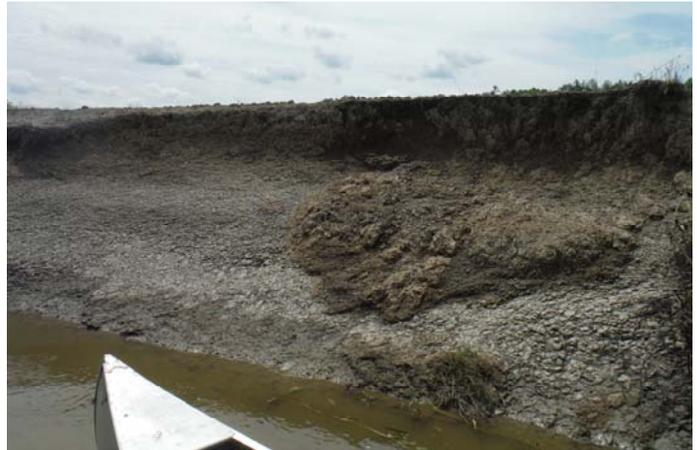
Near the mouth and in many other reaches of Becketts Creek, the system is dominated by steep forested slopes and leda clay that makes them unstable. In the upper reaches of the system, certain agricultural areas have unstable banks with exposed soils, lack of vegetation and undercutting.

Stream bank erosion with visible soils and lack of vegetation

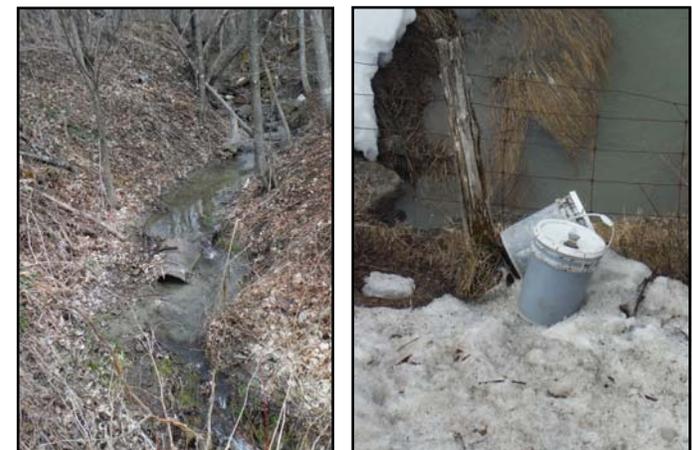
In the headwater portions of the catchment garbage and dumping was also observed. The images below show examples of dumping and oil spills near roads.

Pollution observed along headwater areas of Becketts Creek: metal drums and pails of unknown fluids

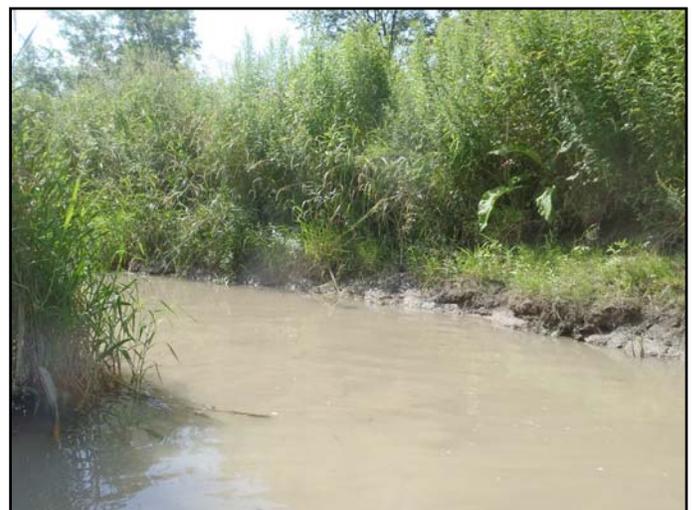
Site on Becketts Creek with **impaired** oxygen conditions

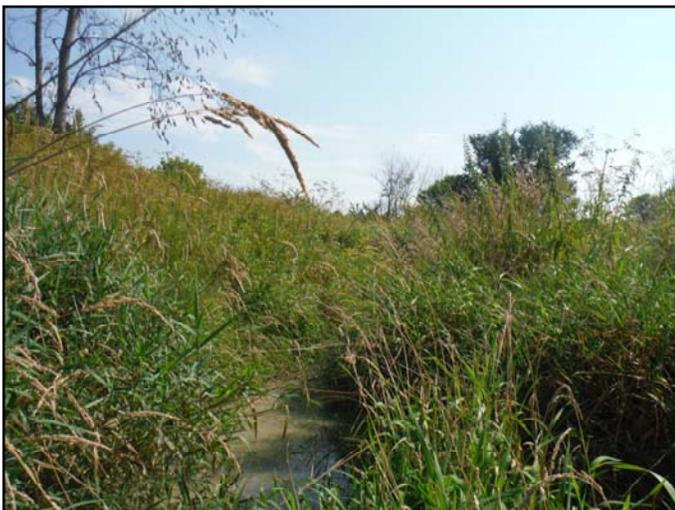
Section of Becketts Creek upstream of Sarsfield Road with highly elevated conductivity levels

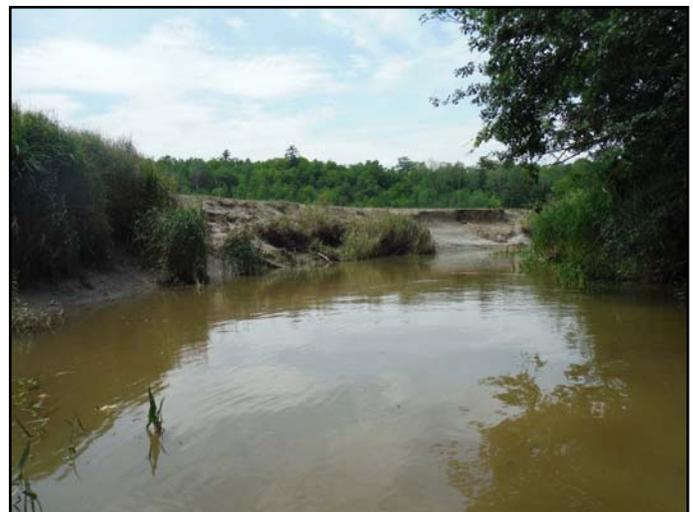
Section of Becketts Creek upstream of Birchgrove Road that would benefit from buffer enhancement to improve shoreline conditions and water quality.

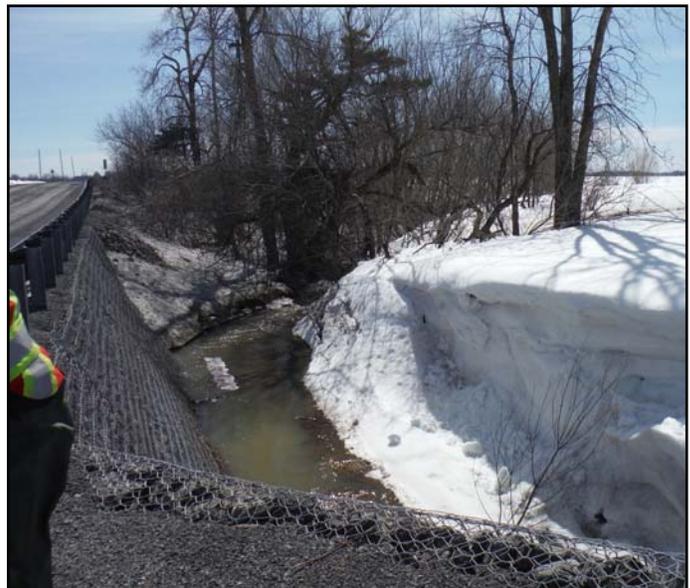
An example of mixed modifications: channel straightening and hardening with gabion baskets on Birchgrove Road

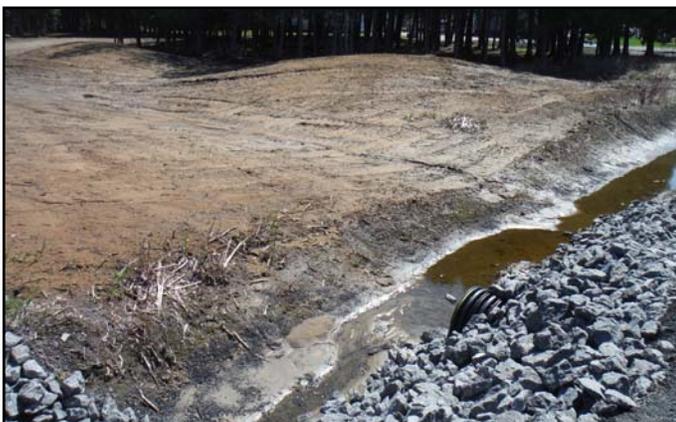
Extensive sediment deposition observed on Joannise Road
