# Stillwater Creek 2009 Summary Report

## City Stream Watch Report, 2009

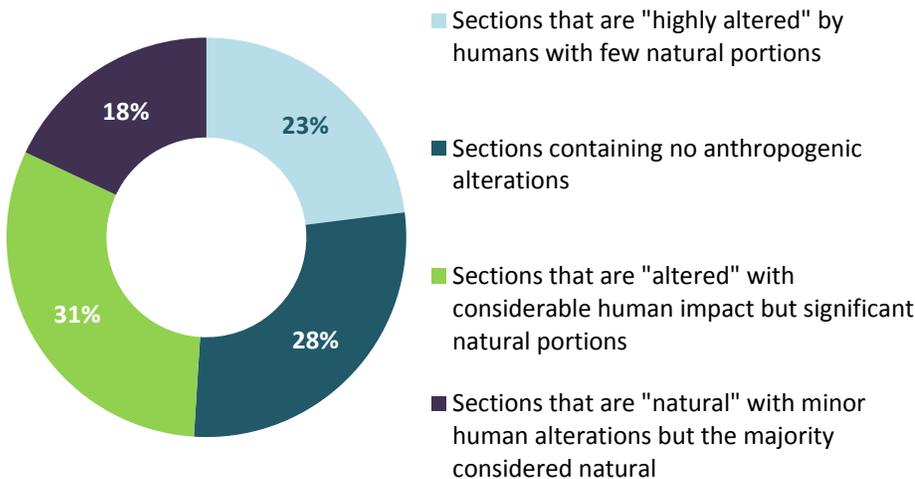
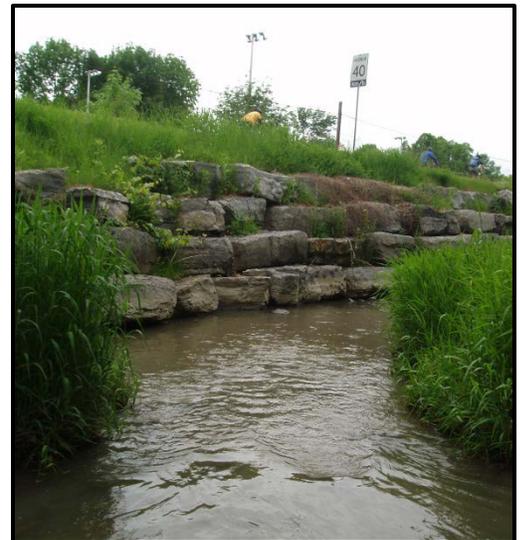
Figure 2. Shoreline alteration along Stillwater Creek

Of the 79 sections of stream surveyed, volunteers identified that 28 percent displayed no human alterations or disturbances. These areas include the headwaters in Stony Swamp and the large wetland west of Moodie Drive. Of the remaining sections, 18 percent were considered natural with some human alteration. 31 percent of the creek was considered altered but with some natural portions. The remaining 23 percent was considered highly altered with few natural portions. These areas were sections of Stillwater that had been straightened, armoured or had little or no buffer. The altered and highly altered areas include the sections downstream of Stony Swamp across Robertson Road, the Highway 417 crossing, the Equestrian Park and the area adjacent to Abbott Laboratories.

#### Anthropogenic Alterations to Stillwater Creek

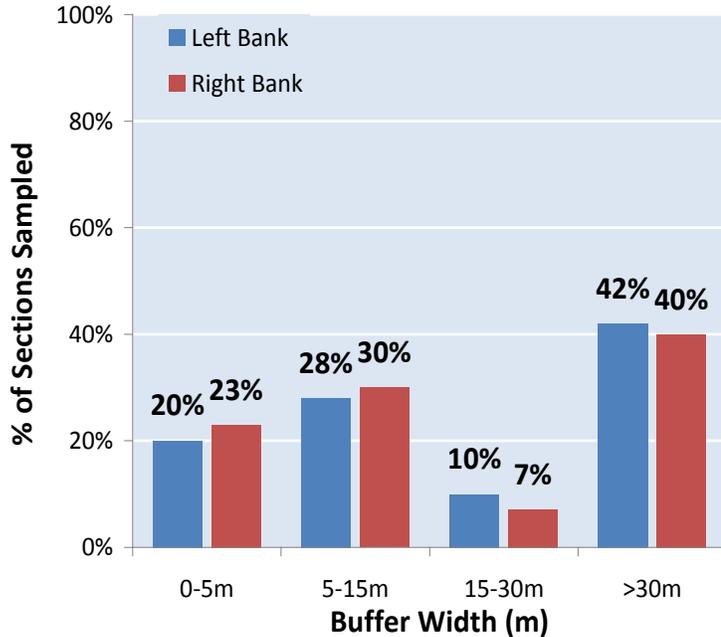
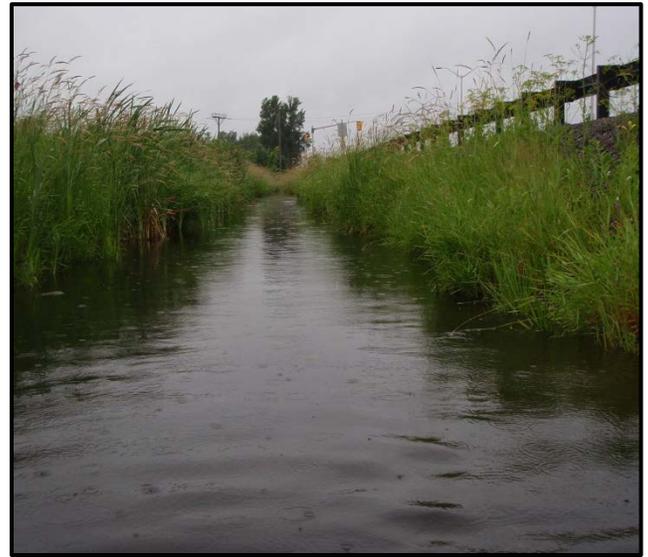
Figure 4. Alterations to the natural buffer alongside Stillwater Creek

Natural buffers are extremely important for filtering excess nutrients running into the creek, infiltrating rainwater, maintaining bank stability, maintaining baseflow levels, keeping water temperatures cool and providing wildlife habitat. According to the document *How Much Habitat Is Enough*, a stream should have riparian areas of 30 metres minimum or more, depending on the site conditions. Stillwater only meets this requirement for 40-42 percent of its stream length. Twenty percent of the left bank and 23 percent of the right bank had a buffer of only zero to five metres, 28-30 percent had a buffer of five to 15 metres and seven to ten percent had 15 – 30 metres.

### Buffer Evaluation of Stillwater Creek

TYPE OF PROJECT	DESCRIPTION
<b>Stream Garbage Cleanups</b>	Regular garbage cleanups could be held on Stillwater Creek to ensure that fish and wildlife habitat is not being negatively impacted and that stream aesthetics are not being affected.
<b>Riparian Planting/Buffer Enhancements</b>	Riparian Plantings and buffer improvements could be implemented in several locations. The mouth of Stillwater Creek is part of Andrew Haydon Park and has very little buffer downstream of Carling Avenue, and shrubs and trees could be planted in this area. Buffer areas along the Equestrian Park and areas between Highway 417 and Robertson Road need to be enhanced.
<b>Bioengineering</b>	Many parts of Stillwater Creek were stable; however, the mouth of Stillwater Creek has had erosion issues. Bioengineering could be installed at this site, along with additional shrub and tree plantings to improve the stream habitat in this area. Because it is part of Andrew Haydon Park, it would be an excellent location for a buffer demonstration area.

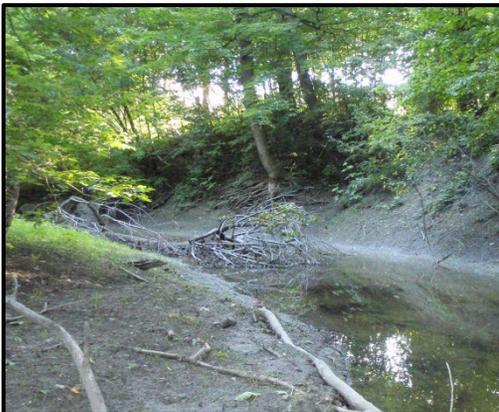
Figure 5. Eroded shoreline along Stillwater Creek

Erosion is a normal, important stream process and may not affect actual bank stability; however, excessive erosion and deposition of sediment within a stream can have detrimental effects to important fish and wildlife habitat. City Stream Watch has recorded bank stability separately for left and right banks to obtain greater detail on the areas experiencing erosion. The majority of Stillwater Creek was stable (90 percent), and left and right banks were equal overall. Although active erosion was observed in many areas, it did not appear to be threatening bank stability. The mouth of Stillwater Creek is experiencing erosion, and it would be a good site to apply bioengineering methods to help mitigate those effects.

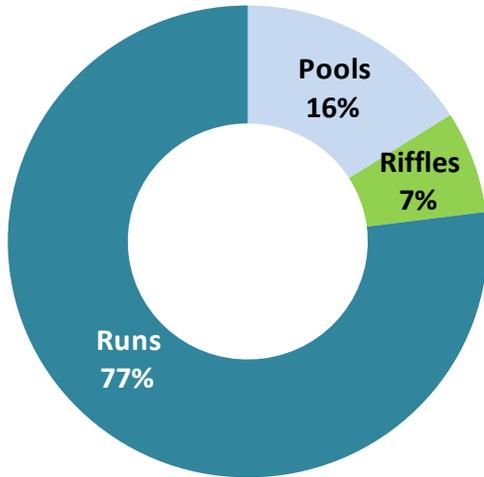
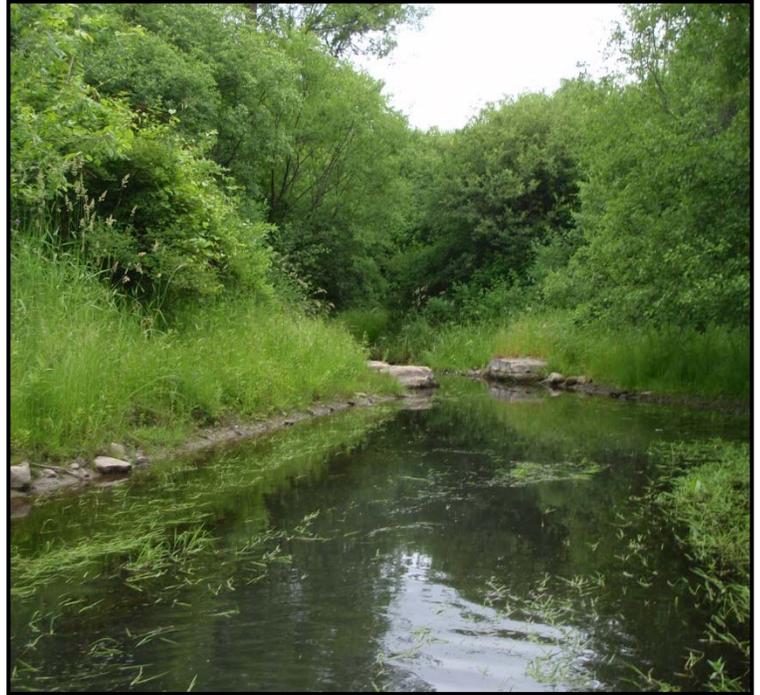
Figure 6. Instream morphology along a section of a Stillwater Creek

Pools and riffles are important features for fish habitat. Riffles contribute higher dissolved oxygen to the stream and act as spawning substrate for some species of fish and pools provide shelter for fish and can be refuge areas. Runs are usually moderately shallow, with unagitated surfaces of water, and areas where the thalweg (deepest part of the channel) is in the center of the channel. Instream morphology along Stillwater Creek is fairly homogeneous, consisting of large runs with 16 percent pools and seven percent riffles.

### Instream Morphology of Stillwater Creek

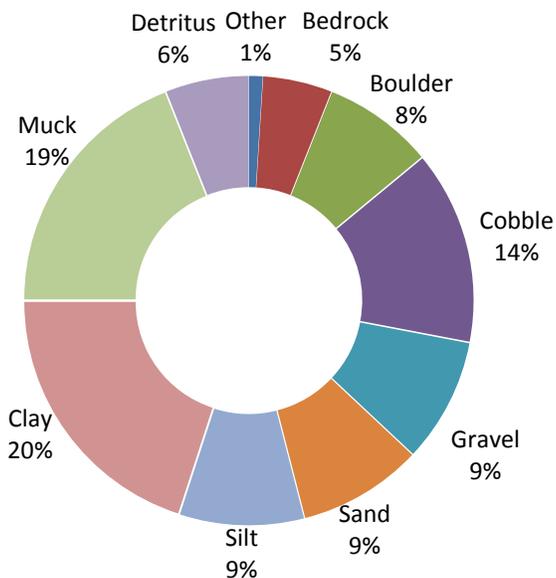
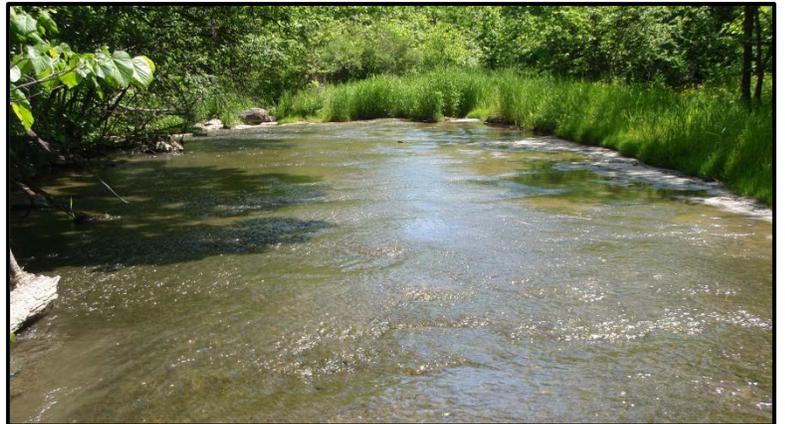
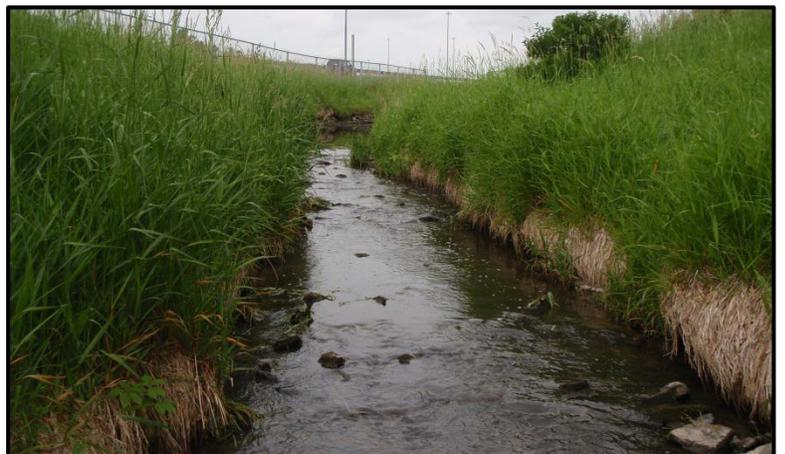
Diverse substrate is important for fish and benthic macroinvertebrate habitat for spawning, resting, over wintering and feeding. A variety of substrate can be found instream along Stillwater Creek. Clay and muck were observed along many parts of Stillwater Creek, and muck was abundant in the sections surveyed in the wetland adjacent to Moodie Drive. Bedrock was observed in the section running north of Highway 417 and south of Corkstown Road. The "other" substrate noted was metal culvert, on which there was no other substrate deposited.

Figure 7. Various substrate types found throughout Stillwater Creek (Top: Bedrock - Bottom: Gravel/Cobble)

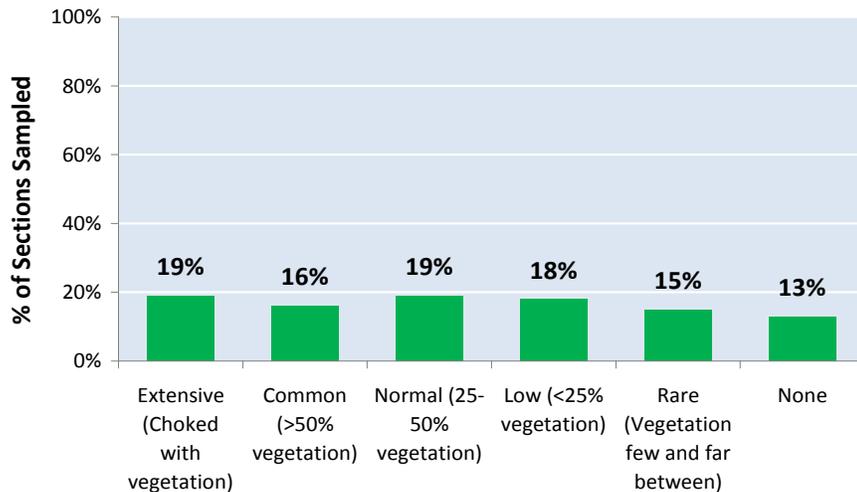
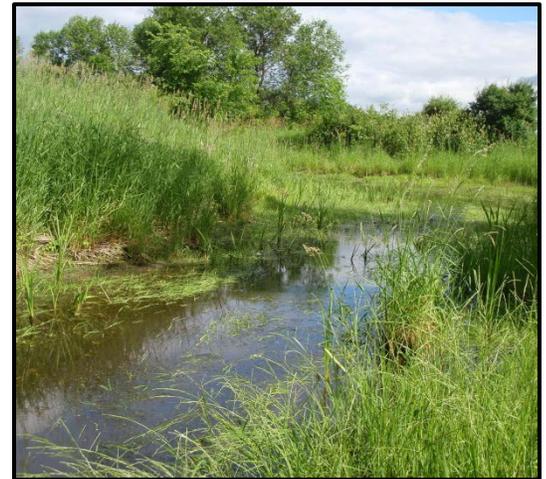
Figure 8. Instream vegetation along a section of Stillwater Creek

Instream vegetation is an important factor for a healthy stream ecosystem; it helps to remove contaminants, contributes oxygen and provides habitat for fish and wildlife, although extensive vegetation can have negative impacts. Stillwater Creek does not appear to have a healthy variety of instream vegetation and very few types were found. The majority Stillwater Creek did not have a healthy amount or variety of instream vegetation. Instream vegetation was categorized as being common for 16 percent of the stream and 19 percent normal. Low vegetation made up 18 percent of the creek. For 15 percent of the sections surveyed, vegetation was rare, and in 13 percent there was none. Nineteen percent of the creek was considered to have extensive vegetation; this occurred at one of the Corkstown Road crossings and in the wetland adjacent to Moodie Drive.

#### Instream Vegetation of Stillwater Creek

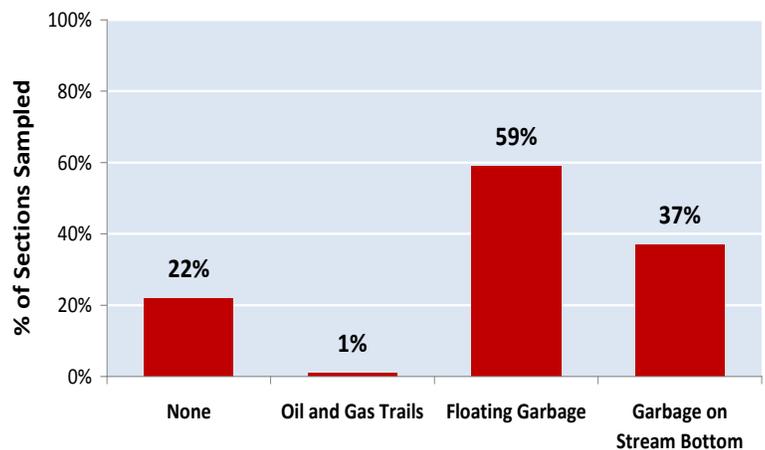
#### Pollution Observed in Stillwater Creek

Pollution and garbage along Stillwater Creek was assessed visually and noted for each section where it was observed. Only twenty-two percent of Stillwater did not have the occurrence of garbage. Oil and gas trails were recorded for one percent of the sections surveyed. On many surveys, both floating garbage and garbage on the stream bottom were observed. A wide variety of pollution was recorded along Stillwater Creek, although the most abundant was plastic. A cleanup was organized for the fall as part of the TD Great Canadian Shoreline Cleanup, and some of the worst areas were addressed.

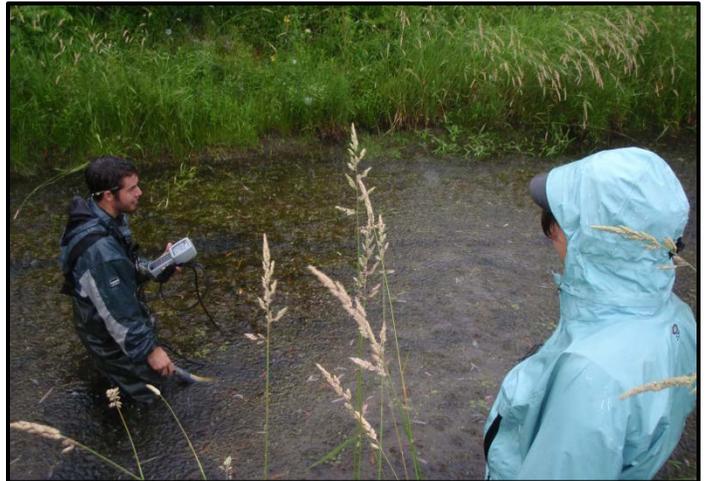
Figure 10. Water chemistry sampling along a section of Stillwater Creek

During the surveys, a YSI probe was used to collect values on dissolved oxygen, conductivity and pH. The data from the 2009 season is summarized in the following chart.

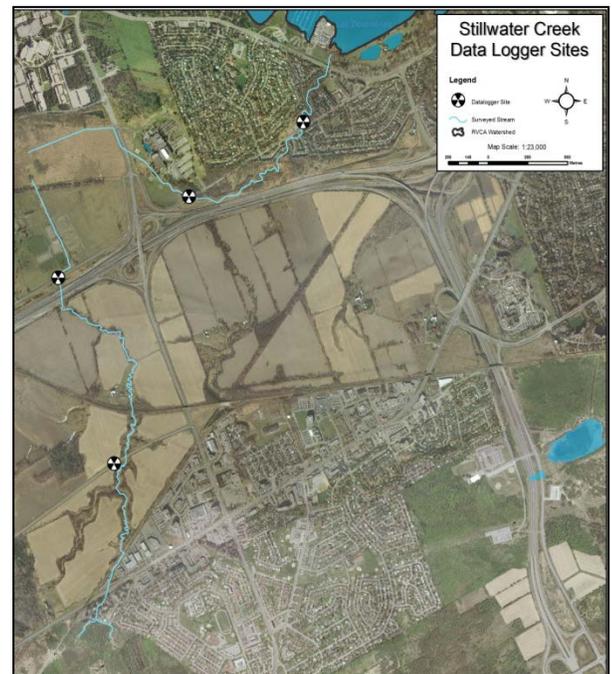
Blue values represent coldwater (<19°C), green values coolwater (19-25°C) and red values (>25°C) warm water temperatures

\*Likely that water levels dropped below the temperature datalogger, and air temperature was being recorded

\*\*Temperature loggers were removed September 22, therefore temperatures recorded do not include the entire month

Temperature is an important parameter in streams as it influences many aspects of physical, chemical and biological health. Four temperature dataloggers were placed in Stillwater Creek at the three crossings of Corkstown Road and one was placed at Timm Road. Water temperature values from July, August and September are colour coded for cold, cool and warm water classification and are listed in the chart under "max". Classification is based on the Ontario Stream Assessment Protocol, for which the temperature data is taken between 4 and 4:30pm, anywhere between July 1 and September 10, on days where maximum air temperature exceeds 24.5 C and after two previous days without precipitation and temperatures surpassing 24.5 C. Based on water temperature and fish community data, it appears that Stillwater Creek is a cool water stream with cold water reaches. Only one warm water species was captured on Stillwater.
