Mud Creek 2014 Summary Report

Introduction

In 2014, permission was granted to survey 78 sections (7.8 km) of Mud Creek as part of the City Stream Watch monitoring activities. The following is a summary of observations made by staff and volunteers along those 78 sections.

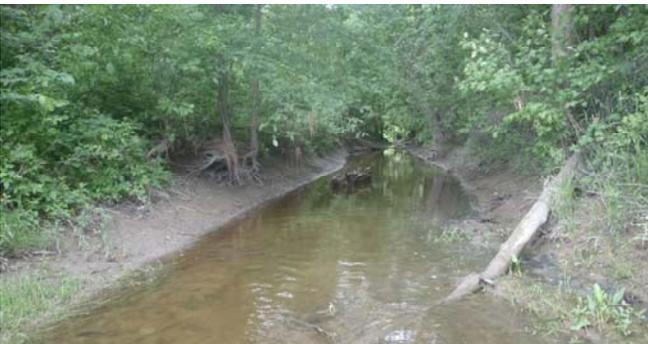
Stream bank erosion along Mud Creek near Third Line Road

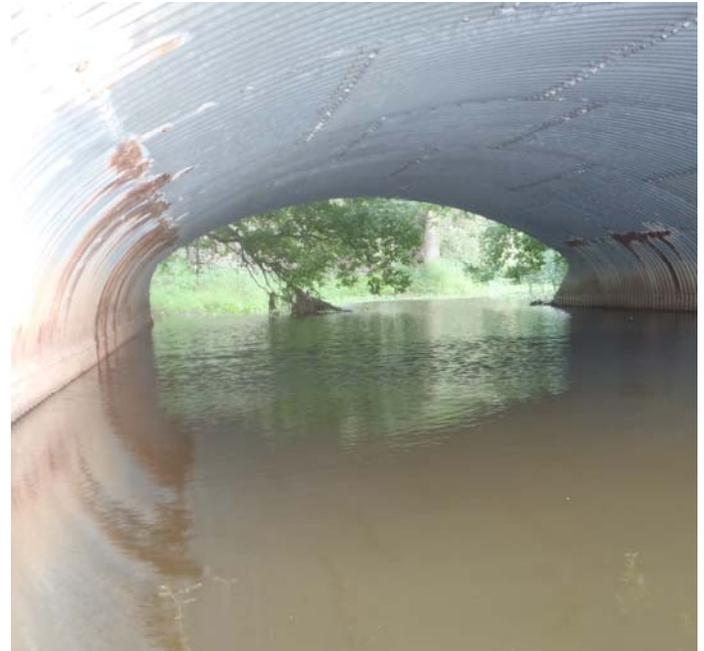
A highly altered section of Mud Creek which runs through a culvert

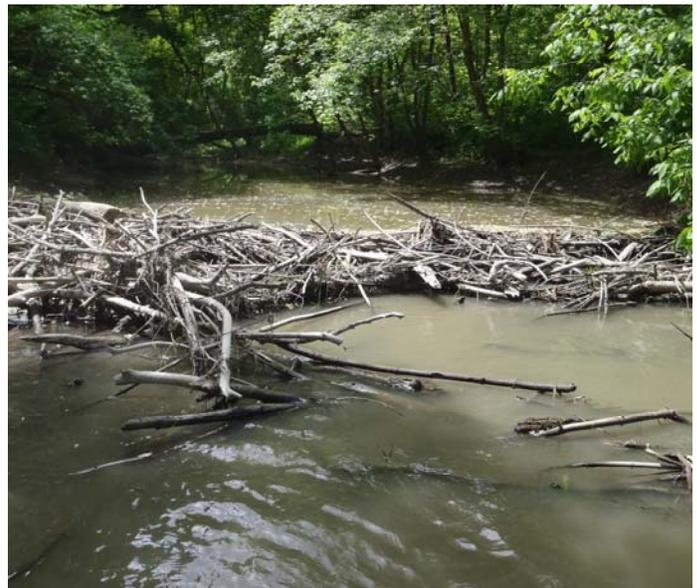
An abandoned beaver dam observed on Mud Creek

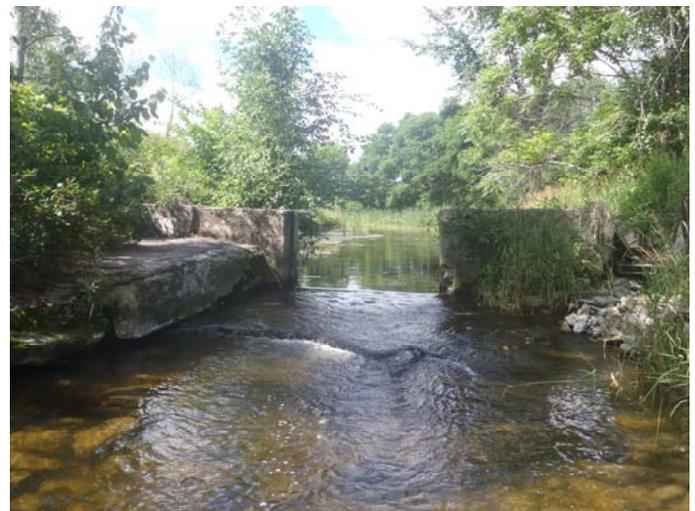
An area along Mud Creek where fish habitat would be enhanced by removing a seasonal migratory obstruction
