# CITY STREAM WATCH 2007

# **City Stream Watch 2007 Annual Report**

January 11, 2008

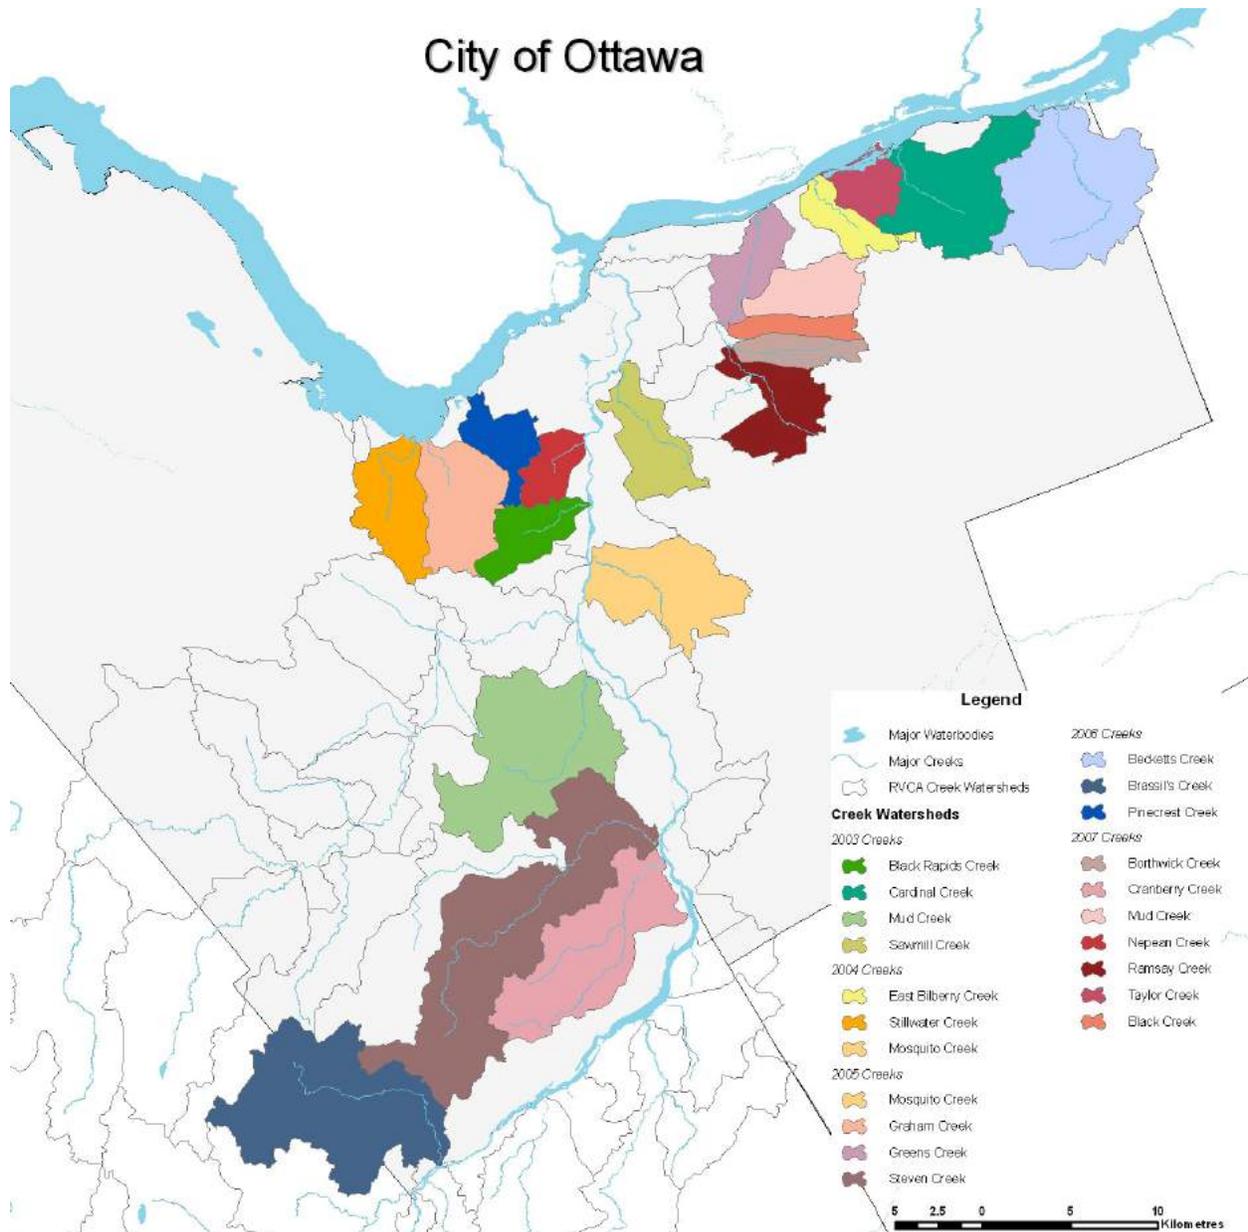
Figure 1. Locations of Streams and Their Watersheds Sampled From 2003 to 2007.

In 2007 seven streams were chosen to be sampled based on community interest as well as need for current information. Nepean Creek, Cranberry Creek, Taylor Creek and four important tributaries, which make up Greens Creek: Black, Mud, Borthwick and Ramsay Creek were selected. Figure 1 shows the locations of the 2007 sample streams as well as all streams sampled from 2003 to 2006.

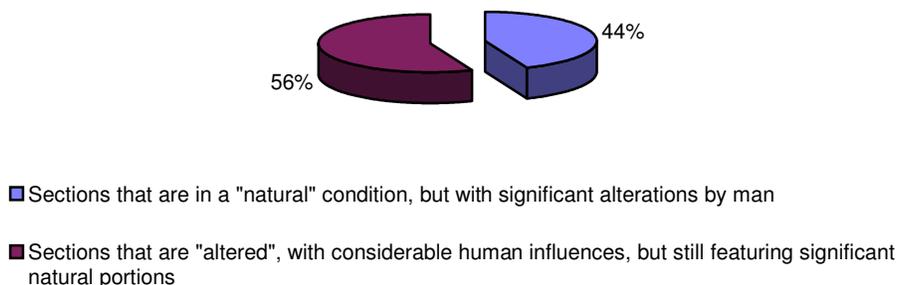
**Figure 3. Classes of Anthropogenic Alterations Occurring Along Nepean Creek.**

Figure 3 illustrates the classes of anthropogenic alterations observed by volunteers along Nepean Creek. Of the 18 sections of stream sampled, there were no sections of stream that were without human alterations of some kind. Sections that remained in a natural condition with some man-made alterations made up 56% of the stream. Stretches considered altered made up the remaining 44% of stream. These

altered areas coincided with low to rare aquatic vegetation and were associated with man-made structures. Three altered sections were found in the lower reaches of Nepean Creek where it meets the Rideau River. This area had alterations which included stormwater pond control structures and a concrete bridge under Prince of Wales Dr. Seven sections in the upper reaches of stream were altered due to a residential development and a parking area on its north bank which had no buffer between it and the stream.

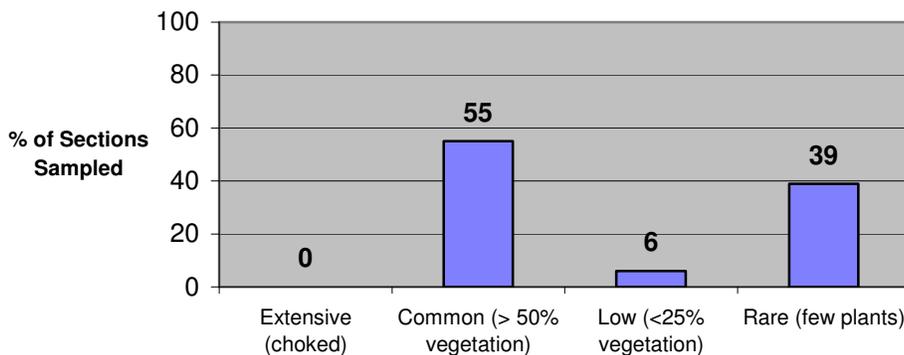
Figure 5. Frequency of Instream Vegetation in Nepean Creek.

The instream vegetation in Nepean Creek varied by location throughout the stream. In 55% of sections sampled vegetation was found to be common and this coincided with areas that are in a “natural” condition. The remaining sections (45%) were classified as low or rare. Areas in an “altered” state coincided with areas of little to no instream vegetation.

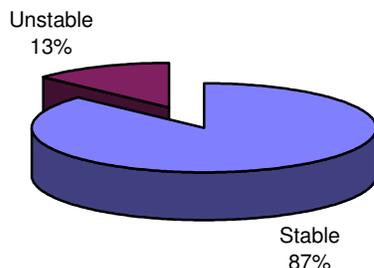
Figure 6. Bank Stability of Nepean Creek.

Figure 6 shows the overall bank stability of Nepean Creek. In 87% of sections sampled by volunteers, the stream banks were identified as being stable. The stability of the banks can be attributed to a healthy buffer of trees and vegetation between the residential development and the stream. Eroded sections were identified in 13% of surveyed sections. Erosion along this stream was moderate and does not pose a risk to overall stream health. A small amount of undercutting was observed but appeared to result from a woody debris jam. This unnatural deflector caused the water to change its natural course, eroding a small section of bank downstream of the debris jam. It is not known how long this debris has been in the stream although at the time of sampling it appeared to be the cause.

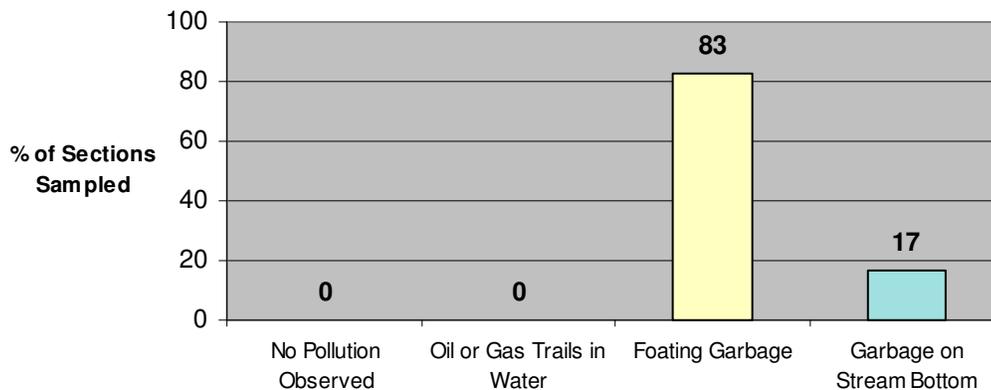
Figure 7. Frequency of Pollution Occurring in Nepean Creek.

Figure 7 demonstrates the incidence of pollution in Nepean Creek. Pollution in the stream is assessed visually and noted for each section where it is observed. At least one piece of garbage (floating or on the stream bottom) was found in each of the 18 sections surveyed. Garbage did not occur in large quantities or accumulate in large amounts, but there was scattered debris in all sections surveyed.

Pollution observed includes garbage in the stream and along its banks. Much of it likely results in trash blowing in from the sports fields, recreational pathways, neighbouring residential areas and the construction sites.

Floating garbage found in the stream consisted of plastic bags, styrofoam and pop bottles. Garbage found on the stream bottom included scrap metal, plastic (fencing), glass bottles, cans, PVC piping, shopping carts, bicycle parts and tires. A community cleanup was held in 2007 by a Boy Scout troop as part of the Great Canadian Shoreline Cleanup. Nepean Creek would benefit from annual cleanups where members from the community walk the stream and remove all un-natural debris from the stream channel and banks.

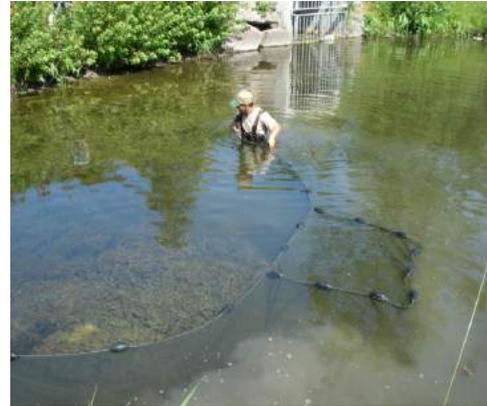
Figure 8. Air photo of Nepean Creek Showing Seining Sites.

Five seine netting sites were completed along Nepean Creek on July 3, 2007. Figure 8 shows the locations of the sampling sites, and Table 4 is a summary of the fish caught.

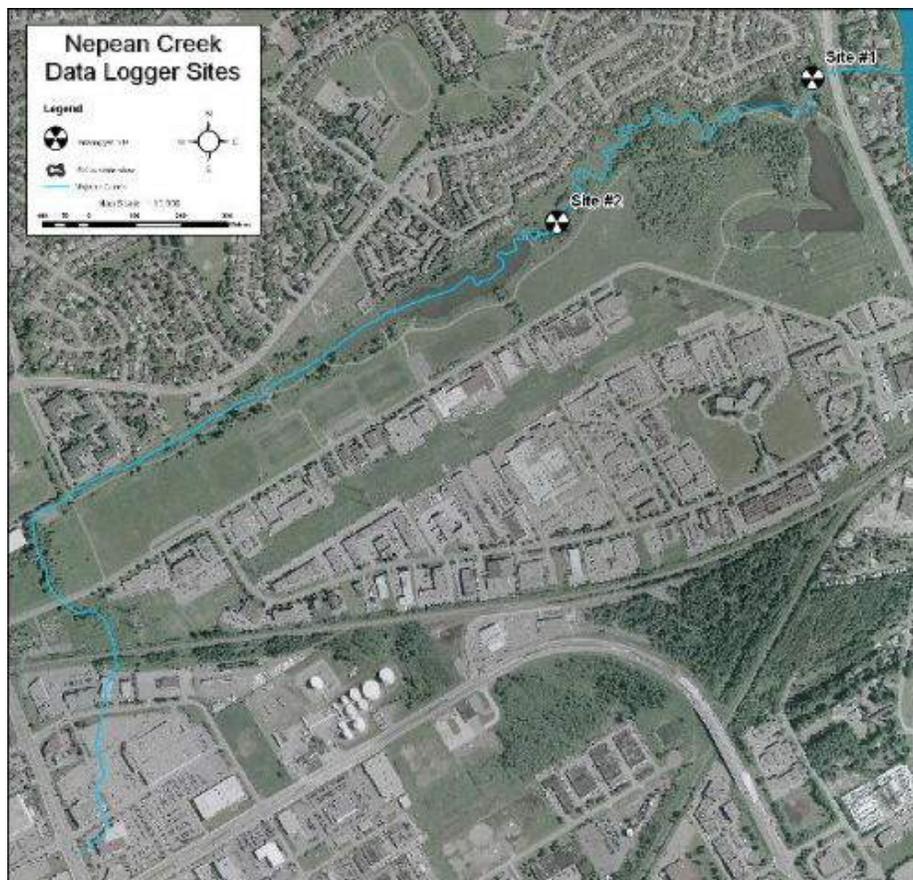
Figure 10. Datalogger Locations Along Nepean Creek.

Two temperature dataloggers were set in Nepean Creek for a 100-day period. Readings began on June 13 and the dataloggers were removed September 20, 2007. Figure 10 shows the locations of dataloggers in Nepean Creek.

Dataloggers were set in two different locations along the stream to give a representative sample of how temperature fluctuates and differs throughout the course of the stream. One was set in the lower reaches,

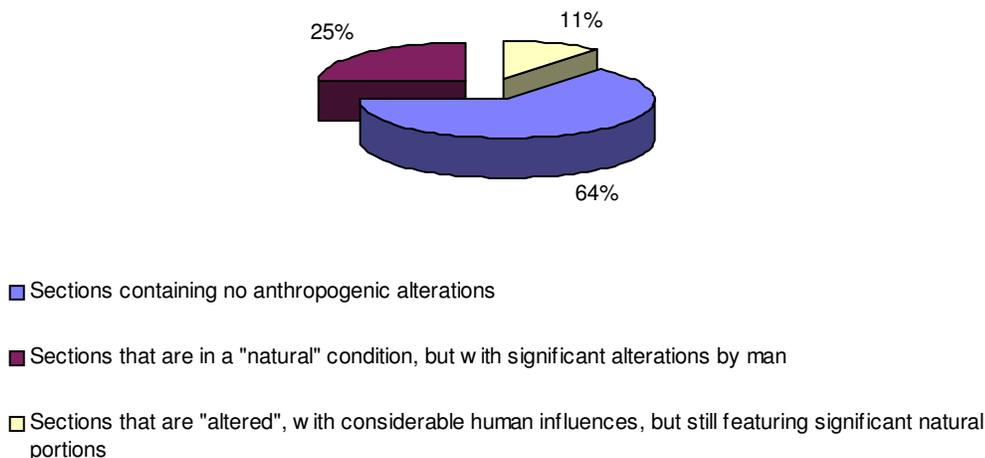
**Figure 13. Classes of Anthropogenic Alterations Occurring Along Cranberry Creek.**

Figure 13 illustrates the classes of anthropogenic alterations observed by volunteers along Cranberry Creek. Of the 61 sections of stream surveyed, volunteers identified 39 sections that displayed no human alterations or disturbances. Much of Cranberry Creek's land use is made up of natural wetland areas and is isolated from developmental pressures. Of the remaining sections, 15 were considered natural with some human alteration. These minor alterations to land use included active and abandoned agricultural fields and cleared powerline areas. The remaining 7 sections were considered altered and this was due to culverts and bridges for roadways such as Highway 416 and other road crossings. Some active agriculture along the banks was classed as altered as well. There were no areas considered highly altered along the sections sampled.

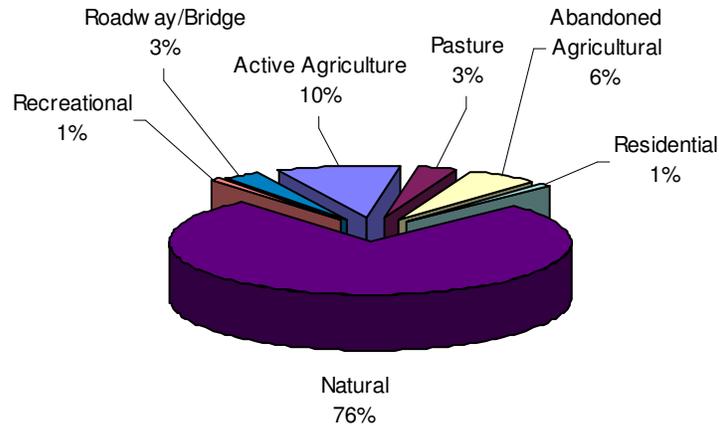
Figure 14. Land Use Identified by Volunteers Along Cranberry Creek.

Figure 14 demonstrates the seven different land uses adjacent to Cranberry Creek observed by volunteers. Natural areas exist along 76% of the creek, while active agriculture made up 10% of the stream. Agricultural impacts were minimal for most of the stream as grazing pasture made up 3% of sampled sections and abandoned agricultural fields made up 6%. Cattle access to the stream was not observed and the only

disturbances observed to the stream were agricultural drains. Roadways and bridges where the stream passes under major road crossings such as Highway 416, Rideau Valley Drive and McCordick Road made up 3% of land use along Cranberry Creek. Recreational and residential land use occurred along 2% of the stream, where the stream emptied into the Rideau River. It should also be noted that parts of the Cranberry Creek system are classified as a municipal drain.

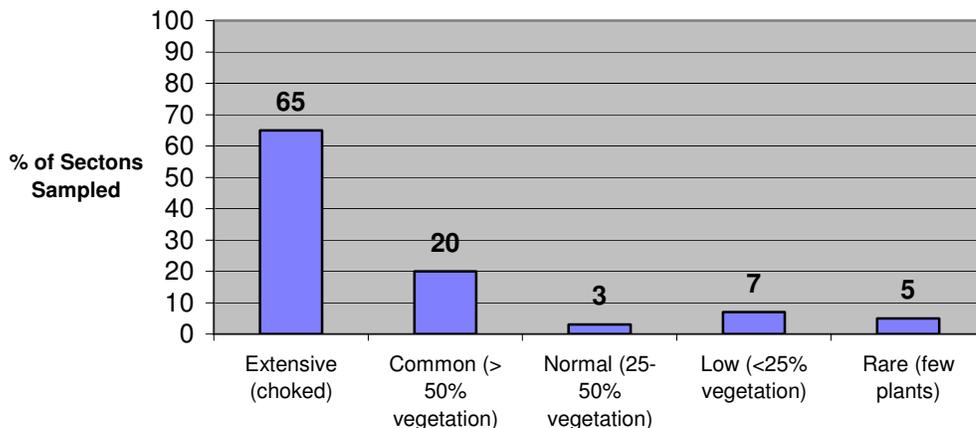
**Figure 15. Frequency of Instream Vegetation in Cranberry Creek.**

Figure 15 demonstrates the incidence of instream vegetation in Cranberry Creek. Instream vegetation was categorized as being common to normal for 23% of the stream. Low vegetation made up 7% of sampled sections and very little or rare vegetation was found in 5%. Extensive vegetation was found to be quite high in Cranberry Creek. In areas such as the wetlands which exist along the stream it is common for there to be thick growth of macrophytes although extensive growth was found throughout the stream. Extensive vegetation can have negative affects on the stream such as biological oxygen demand (BOD), which reduces the amount of dissolved oxygen in the system. Choked vegetation also can impact the mobility and migration of aquatic organisms as well as affects the feeding patterns of fish.

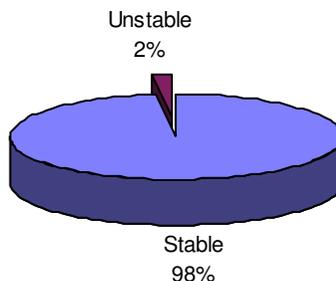
**Figure 16. Bank Stability of Cranberry Creek.**

Figure 16 demonstrates the overall bank stability of Cranberry Creek. Evidence of erosion from the bank was observed in only 2% of the shoreline. These areas of bank instability were found in altered sections, downstream of man-made structures such as culverts for driveways and road crossings.

Cranberry Creek is a rural stream that is isolated from development and other urban pressures. Most often, urban streams exhibit excessive erosion due to the removal of buffer zones, accelerated runoff from developed areas, and channel modification. The banks of Cranberry Creek support a healthy vegetative community of hardwood forests and wetland areas. For this reason very little erosion was observed along this stream.

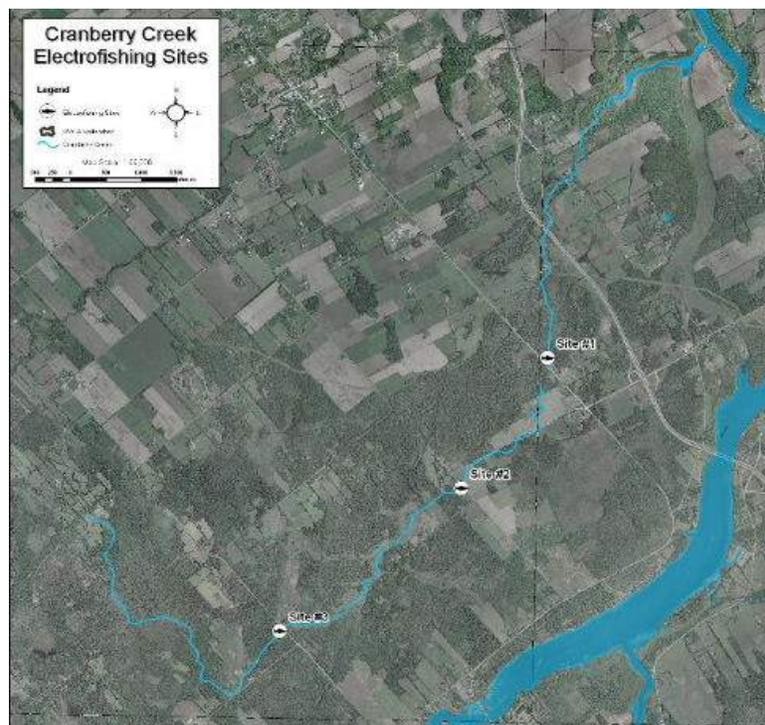
**Figure 19. Air photo of Cranberry Creek Showing Electrofishing Sites.**

Cranberry Creek was electrofished by RVCA staff on July 12, 2007. A total of three sites, each made up of approximately 50m, were sampled. A total of seven different species were identified. (See discussion at 3.2.1 for a description of electrofishing).

Figure 19 shows the locations of the electrofishing sites along Cranberry Creek.

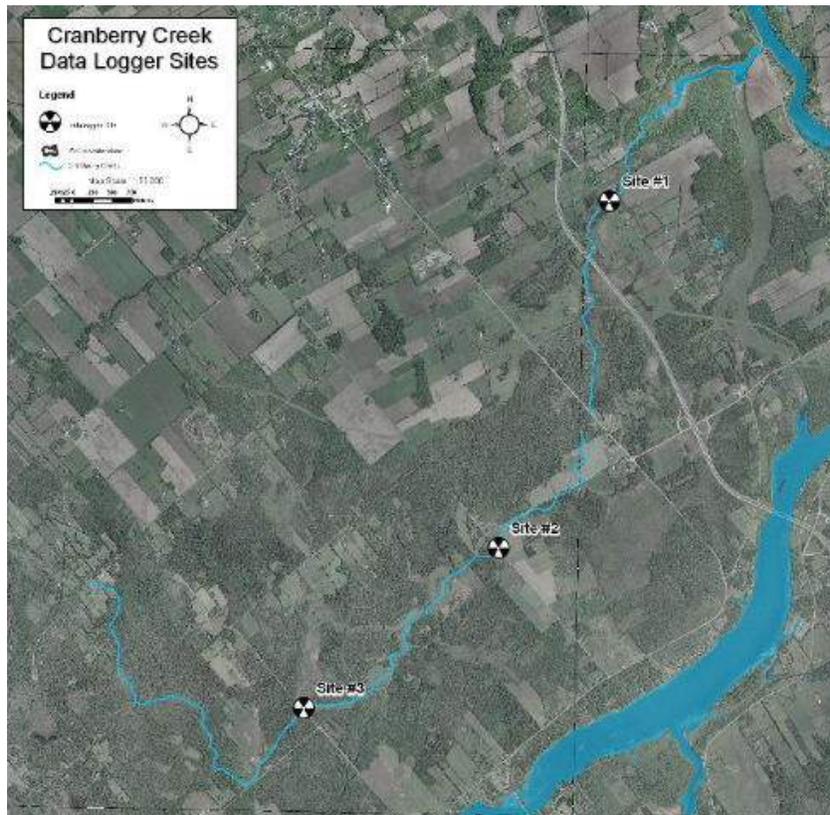
**Figure 21. Datalogger Locations Along Cranberry Creek**

Three temperature dataloggers were set in Cranberry Creek for a 90-day period beginning on June 12 and removed on September 9, 2006. Datalogger 1 was not recovered therefore temperature data is only available for sites 2 and 3. Figure 21 shows the locations of dataloggers in Cranberry Creek.

Dataloggers were set in three different locations along the stream to give a representative sample of how temperature fluctuates and differs throughout the course of the stream. Sites begin at the furthest downstream site and were placed in order upstream. Datalogger 1 was set just downstream of Third Line Drive South. This logger was damaged and the data could not be retrieved. Datalogger 2 was set close to midway through the system, just downstream of McCordick Road. Datalogger 3 was set downstream of Malakoff Road.

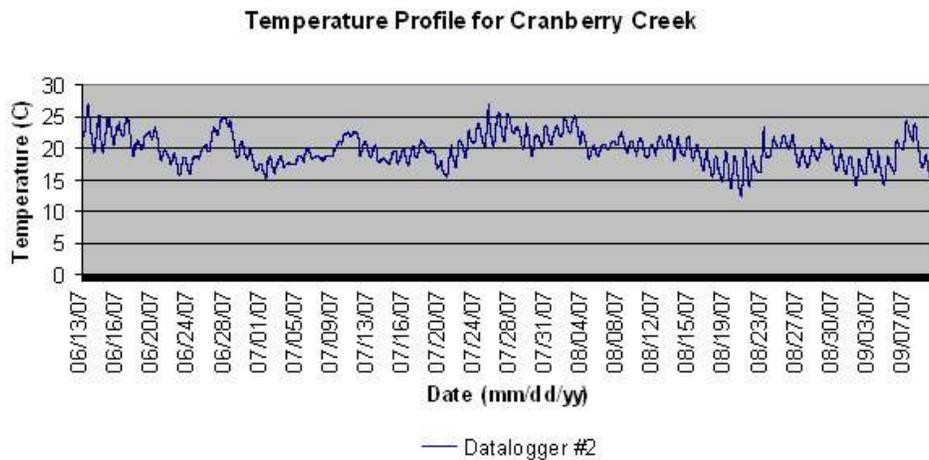
Figure 22. Temperature Profile for Datalogger 2 in Cranberry Creek.

Datalogger 3 was set differently than the other two and recorded temperature every four minutes instead of every five minutes. For this reason the two temperature profiles cannot be compared on the same graph. Figure 22 and 23 show the results from datalogger 2 and 3.

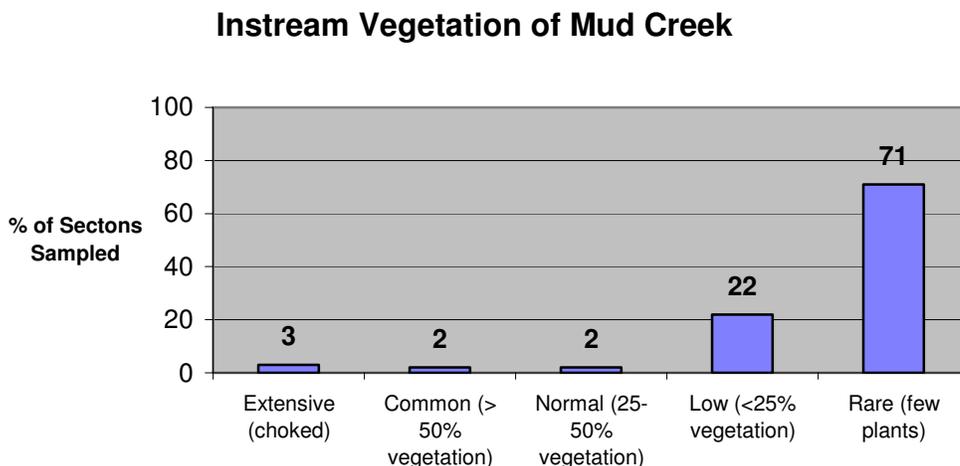
**Figure 41. Frequency of Instream Vegetation in Mud Creek.**

Normal, common and excessive vegetation combined to make up 6% of the stream. Sections where instream vegetation was found were in the headwater area where the stream begins at Mer Bleue wetland. Stream morphology in this area was slow, sometimes with water being backed up from beaver dams, making wetland areas where conditions for vegetation growth are more suitable.

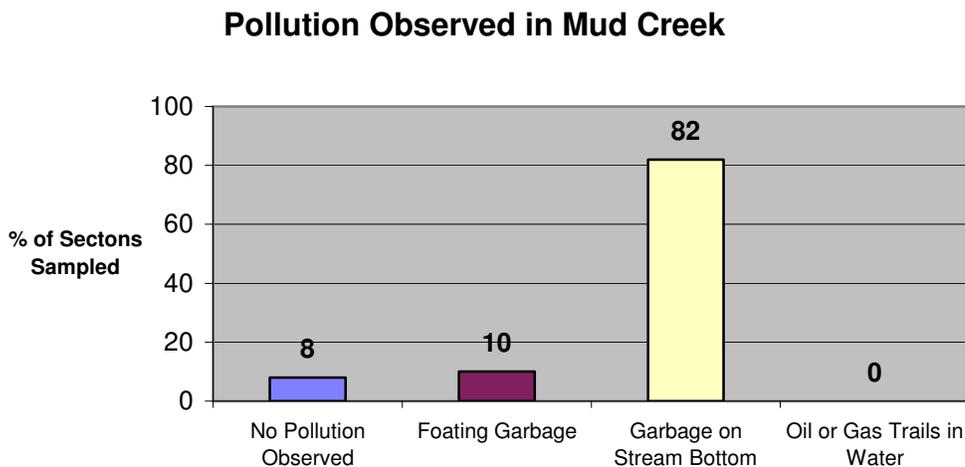
**Figure 43. Frequency of Pollution Occurring in Mud Creek.**

Figure 43 demonstrates the incidence of pollution in Mud Creek. Pollution was observed in 92% of sampled sections. This high abundance of pollution can be attributed to debris being blown and washed into the stream by littering from roadways and flowing downstream. Many items have been in the stream for some time and can be a result of historical work done in and around the stream.

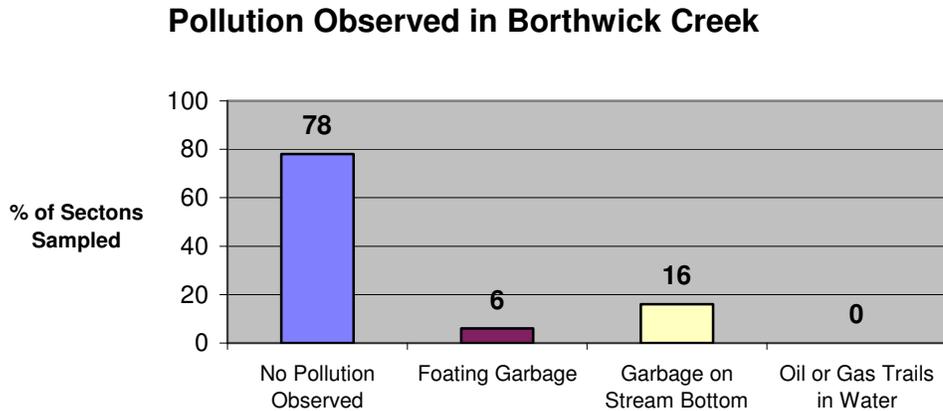
Figure 51. Frequency of Pollution Occurring in Borthwick Creek

Figure 51 demonstrates the incidence of pollution in Borthwick Creek. Floating debris and garbage on the stream bottom was observed in 22% of surveyed sections. The frequency of the garbage in these sections was quite low and unnatural pollution is not a major problem in this stream. Although the majority of the stream is natural and isolated from development, pollution can still make its way into the stream from littering by passing motorists. The majority of pollution observed was in the vicinity of, or downstream from road crossings. The garbage found consisted of styrofoam, scrap metal, tires, plastic, food wrappers, and plastic bags.

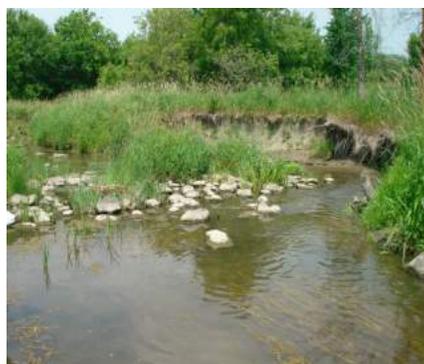
**Figure 59. Bank Stability of RamsayCreek.**

Figure 59 shows the overall bank stability of Ramsay Creek. Evidence of erosion from the stream bank was observed along 54% of the shoreline, coinciding with areas of little or no vegetation. Areas of erosion were found in 90% of sections surveyed although in many sections it only occurred in isolated areas. Stable banks were observed in 46% of the sections. Some areas identified as being stable were due to artificial features such as concrete bridge structures and rip rap stone. Erosion is a natural stream process though it is often accelerated by human alterations to the stream channel and adjacent land use. Much of the erosion observed can be considered natural, though the clearing of streamside vegetation for the installation of railroad tracks, roadways and large concrete bridges do contribute to accelerated erosion along the stream.

Areas of erosion have been identified on an aerial photo of Ramsay Creek and can be found in Appendix G.

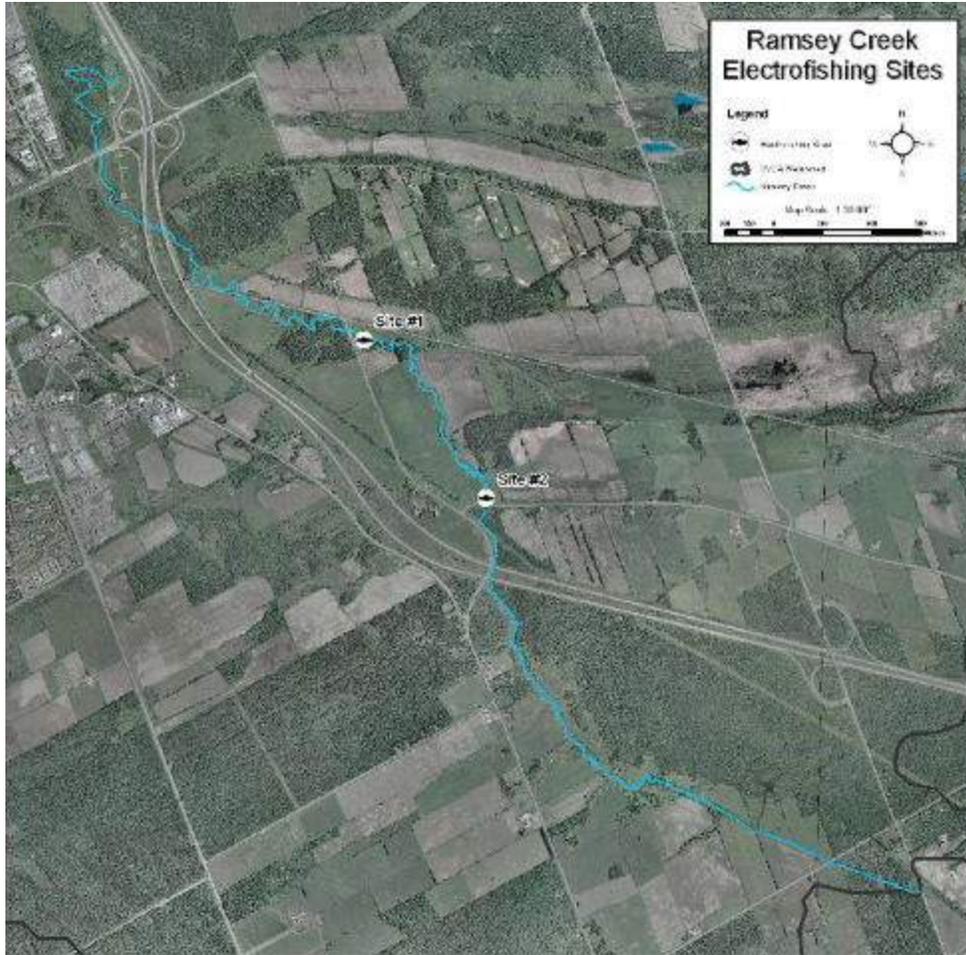
Figure 61. Air photo of Ramsay Creek Showing Electrofishing Sites.

RVCA staff electrofished two sites along Ramsay Creek on July 11, 2007. A total of eleven different species were identified. Some cyprinid (minnow) species could not be identified. Figure 61 shows the locations of the electrofishing sites.

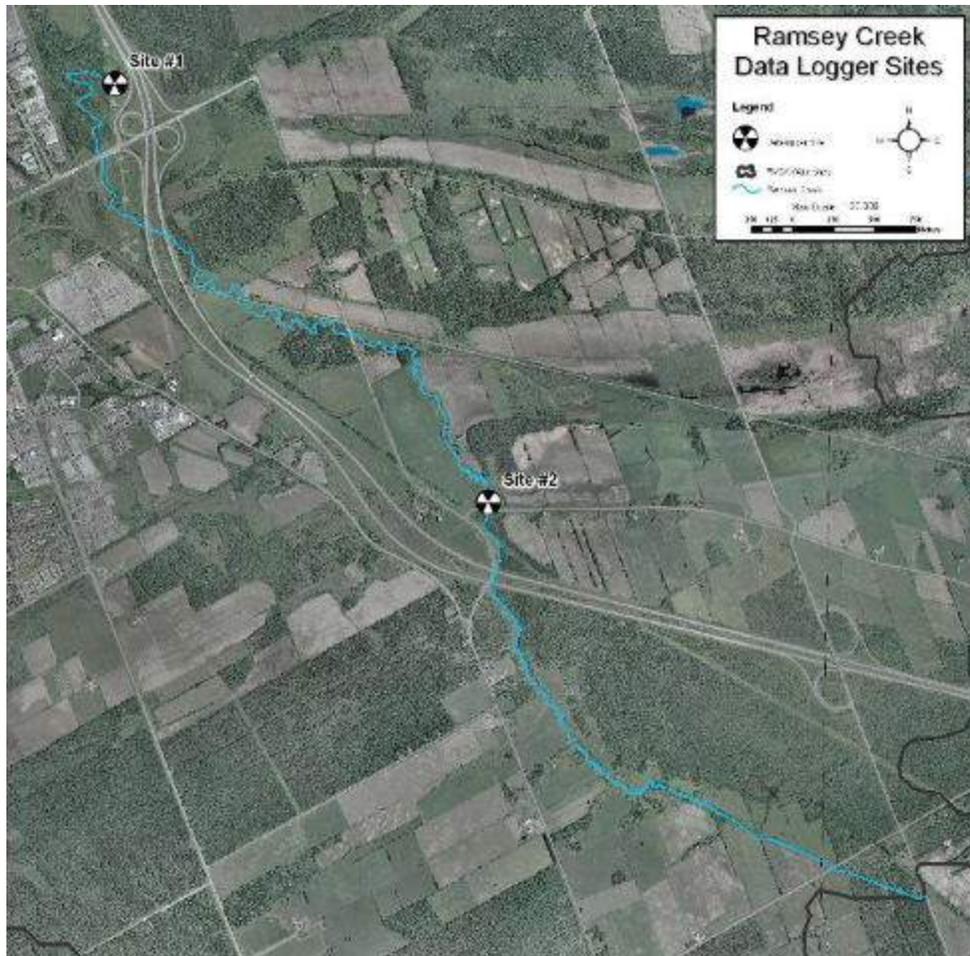
**Figure 62. Datalogger Locations Along Ramsay Creek.**

Two temperature dataloggers were set in Ramsay Creek for a 100-day period beginning on June 13 and ending on September 20, 2007. Figure 62 shows the locations of dataloggers in Ramsay Creek.

Dataloggers were set in two different locations along the stream to give a representative sample of how temperature fluctuates and differs throughout the course of the stream. Datalogger 1 was placed approximately .50 metres upstream of where Borthwick Creek empties into Ramsay Creek. Datalogger 2 was set approximately .50 metres downstream of the Russell Road culvert. Datalogger 2 was damaged and temperature readings could not be retrieved. Temperature classifications are based on Datalogger 1 only and temperatures which were recorded at the time of stream surveys.

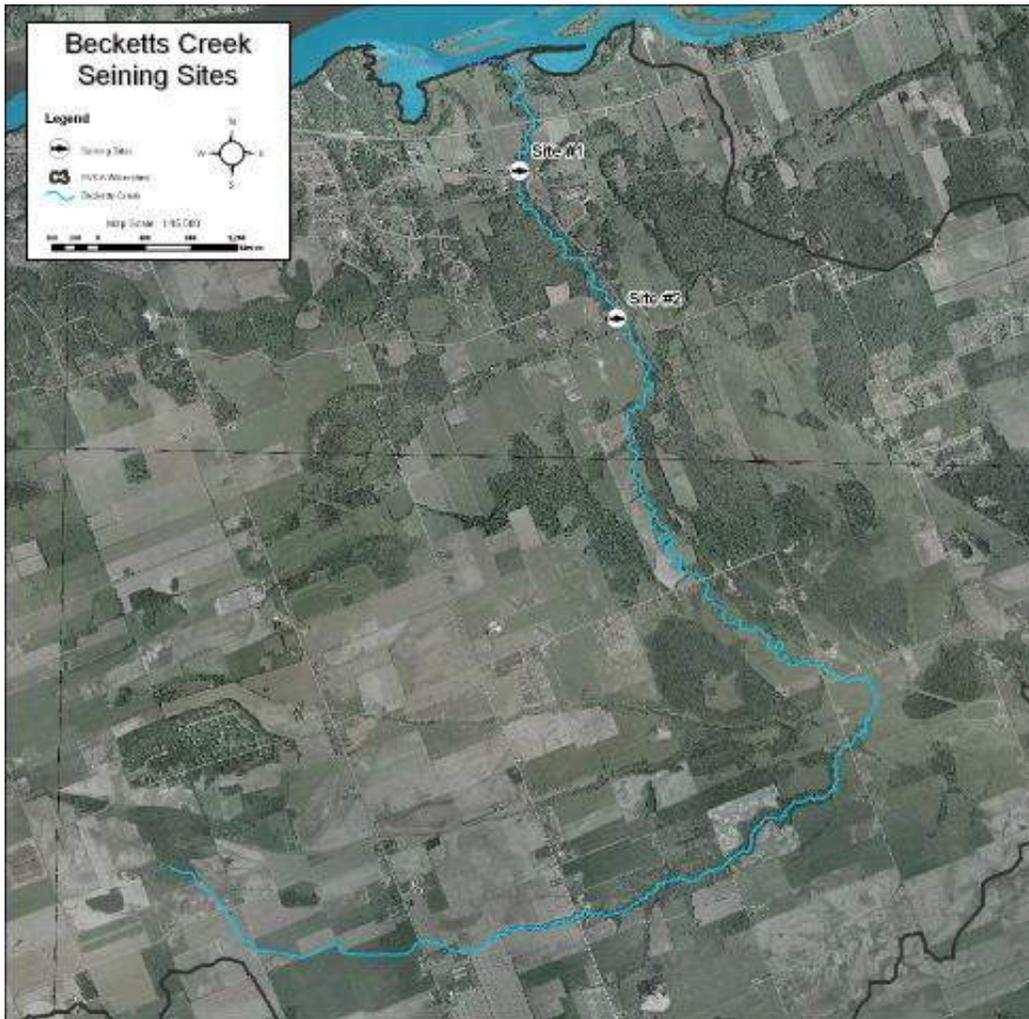
Figure 64. Air photo of Becketts Creek Showing Seining Sites.

Figure 64 shows the locations of the sampling sites, and Table 36 is a summary of the fish caught seining in Becketts Creek.

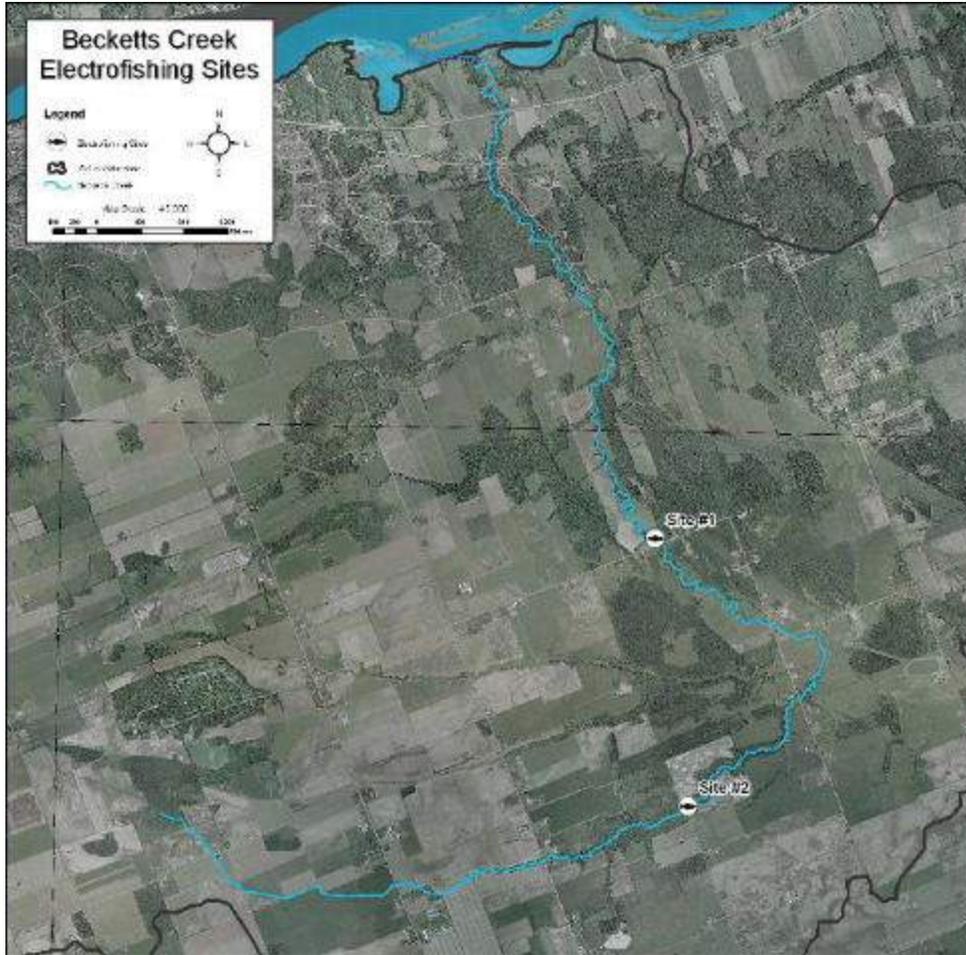
Figure 65. Air Photo of Becketts Creek Showing Electrofishing Sites.

RVCA staff electrofished two sites along Becketts Creek on July 26, 2007. Figure 65 shows the locations of the electrofishing sites.

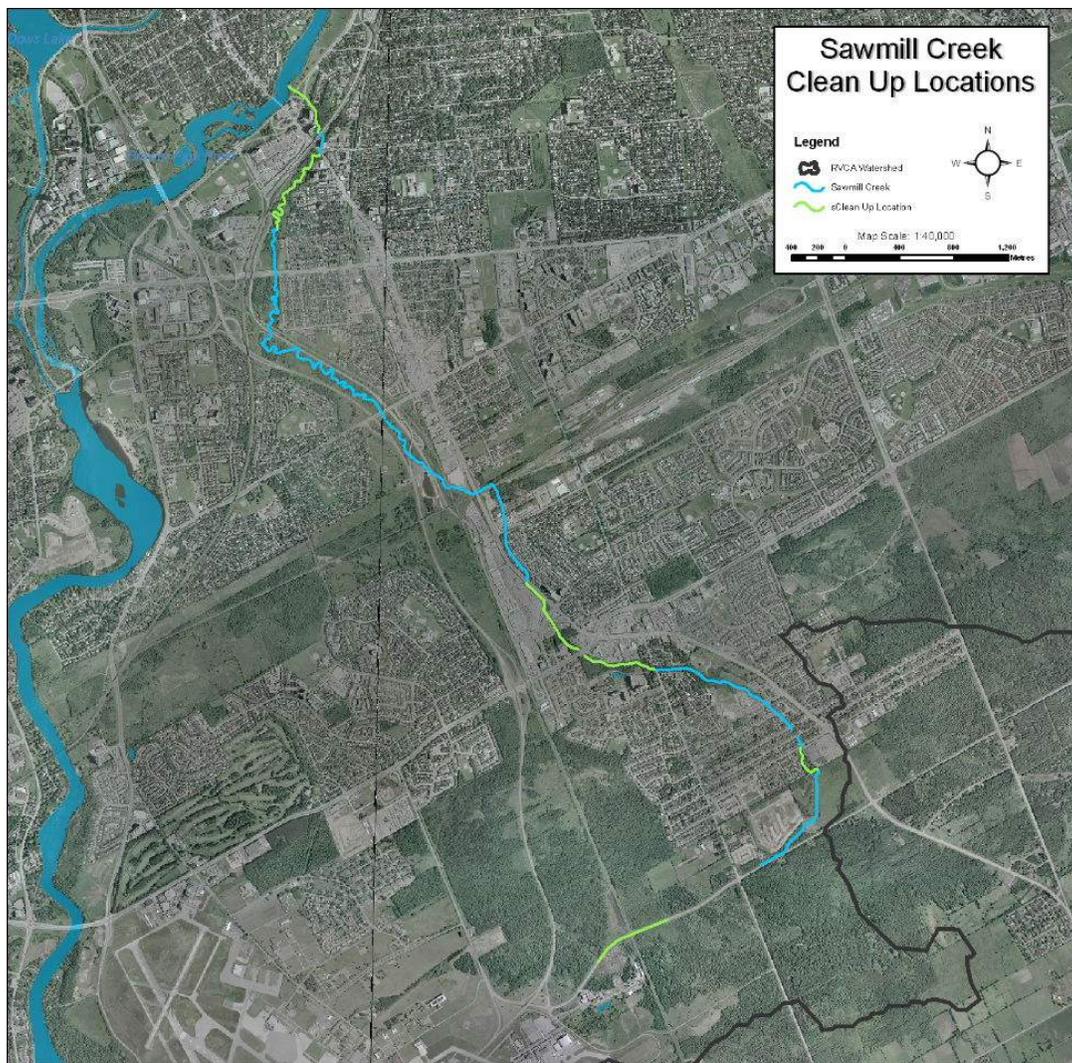
Figure 66. Map of Sawmill Creek Showing Sections Cleaned in 2007.

On September 23<sup>rd</sup>, City Stream Watch volunteers teamed up with members of Heron Park Community Association and National Defence Headquarters Fish and Game Club to cleanup Sawmill Creek as part of TD Canada Trust – Great Canadian Shoreline Cleanup. The Vancouver Aquarium started the Great Canadian Shoreline Cleanup over 12 years ago, and with support from the TD Canada Trust, the program has grown from a local beach cleanup to a national program with participants in every province and territory. Each September, hundreds of thousands of participants from around the world join Canadians to clean up their shorelines. Figure 66 shows the stretches of creek that were successfully cleaned by the volunteers at the Great Canadian Shoreline Cleanup (GCSC).

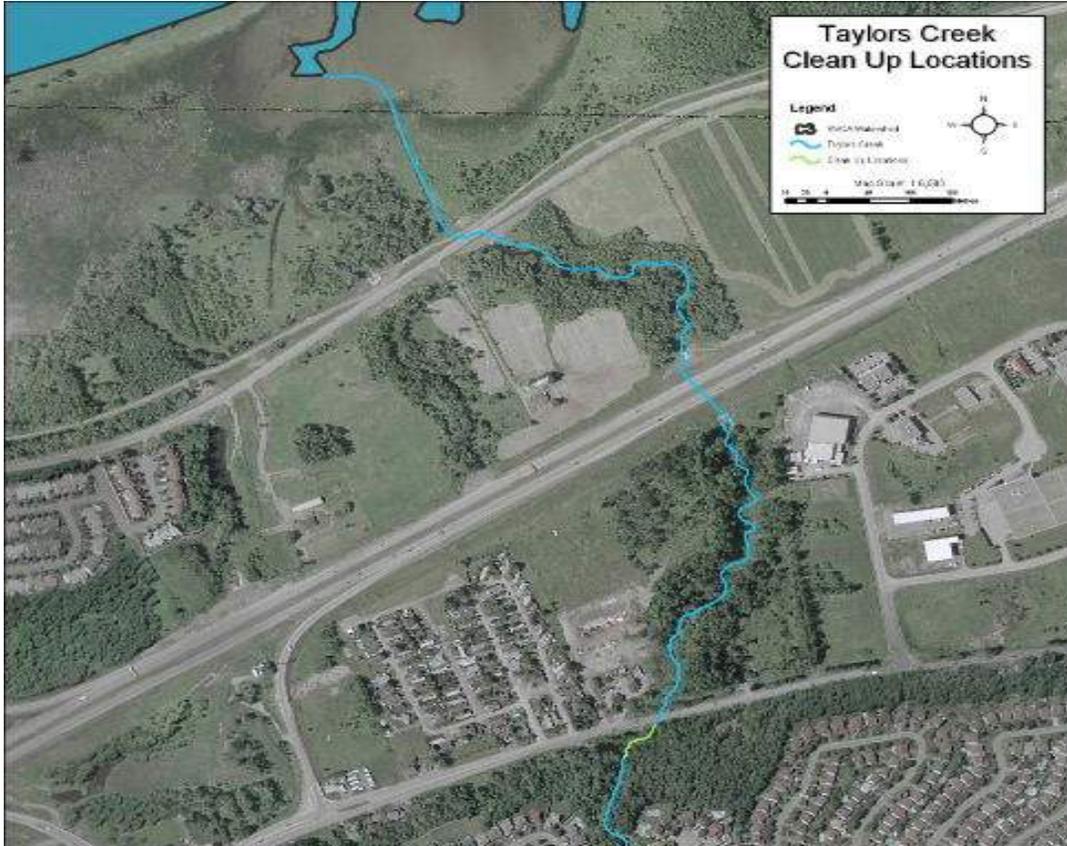
Figure 67. Map of Taylor Creek Showing Sections Cleaned in 2007.

City Stream Watch joined forces with the Fallingbrook 4<sup>th</sup> Orleans Scouts on October 13 to clean up a section of Taylor Creek from St. Joseph Blvd. to Princess Louise Falls (green).

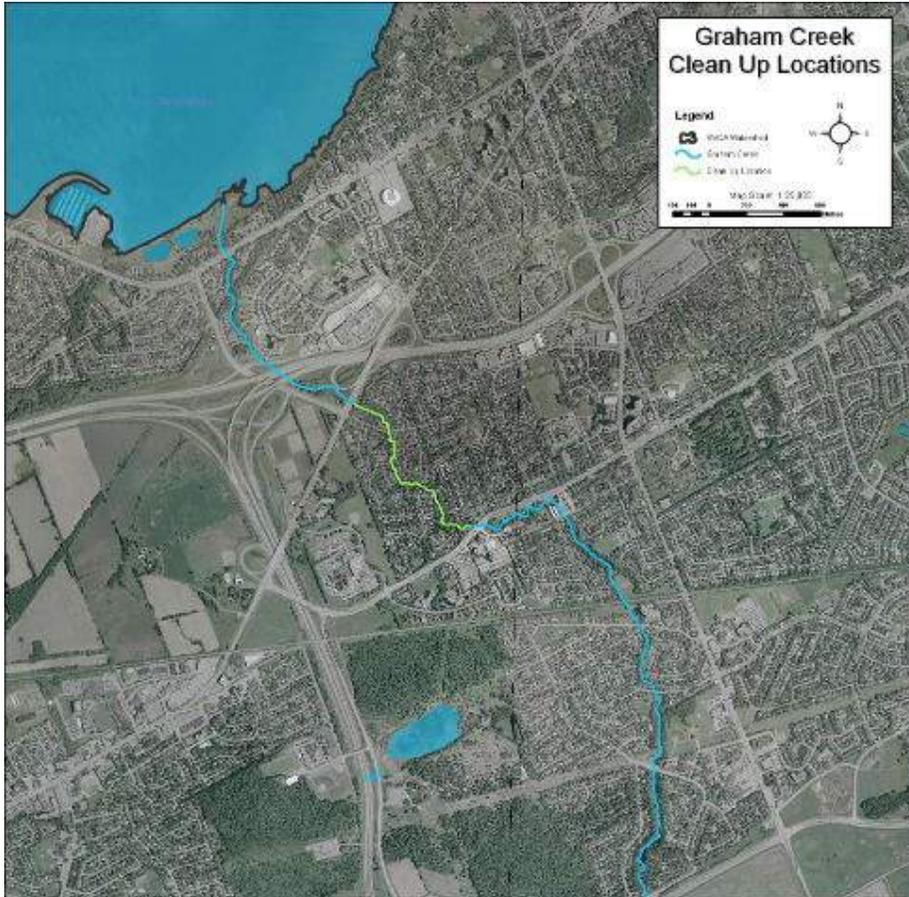
Figure 68. Map of Graham Creek Showing Sections Cleaned in 2007.

On October 20, the 19<sup>th</sup> Nepean-Briargreen Scouts waded through Graham Creek in the west end to help clean approximately a one-kilometre stretch from Richmond Road to Baseline Road in the Nanaimo Park area.

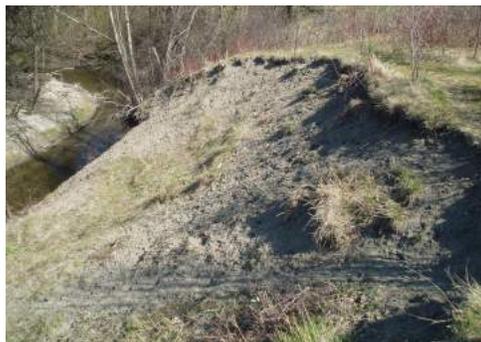
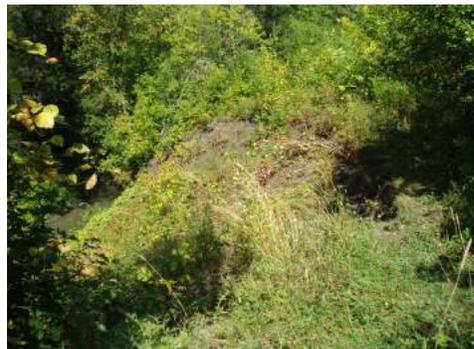
**Figure 69- Sawmill Creek Planting Site in Heron Park.**

City Stream Watch, in cooperation with Heron Park Community Association has completed two phases of a shoreline rehabilitation project on Sawmill Creek. The goal of this project is to restore a failed bank on the east side of the stream just north of Heron Road. Phase I planting was done in 2005 where 350 small shrubs were planted along a failed bank to help re-vegetate the lower areas of the bank failure near the stream. Phase II was completed in the spring of 2006 with the planting of 600 more trees along the upper sections of the bank failure and in areas where more planting was necessary.

2005 Pre-planting - Prior to Phase I Planting

2006 Post-planting – Phase II Complete

This site will be monitored and a Phase III planting may be initiated if erosion has continued or if damage has occurred to the young trees.

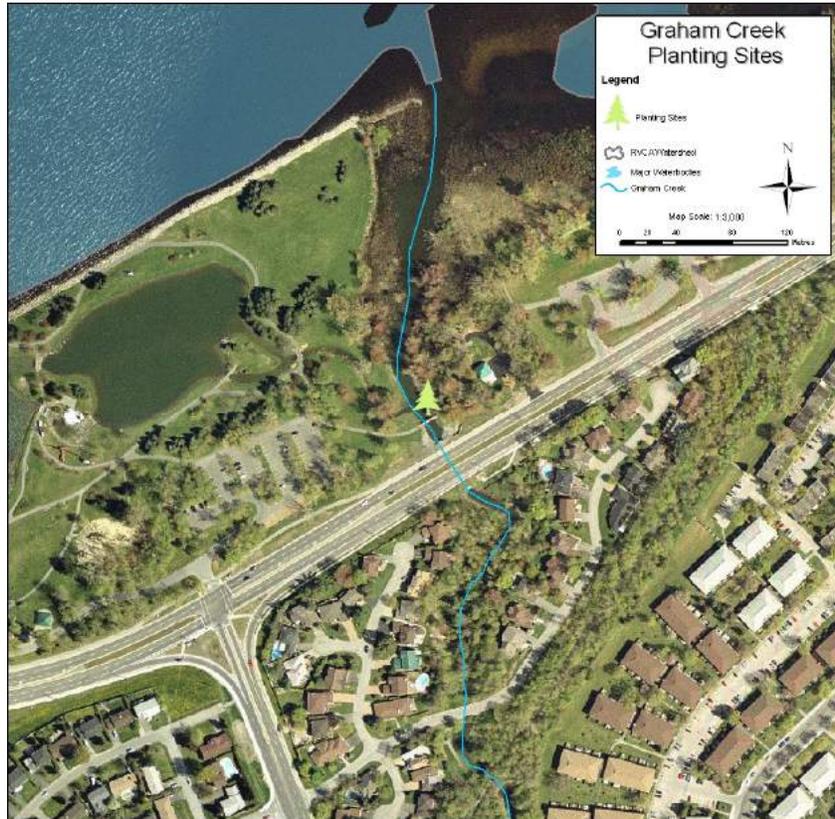
**Figure 70- Air Photo of Graham Creek Planting Site in Andrew Haydon Park.**

Based on recommendations in the 2006 Annual Report, Phase II of a riparian planting project was carried out in the spring of 2007 on an eroded bank on Graham Creek. Figure 70 shows where Phase II of this planting project was completed.

In 2006, 50 small shrubs were planted along the bank. Due to storm events in the spring and fall some plants were damaged. Phase II of the planting project was undertaken in 2007. The goal was to further rehabilitate the eroded section along the stream in Andrew Haydon Park. Two volunteers from the program successfully planted 100 red osier, white spruce and highbush cranberry along the bank on the east side of the stream. Planting efforts were completed on May 17, 2007.

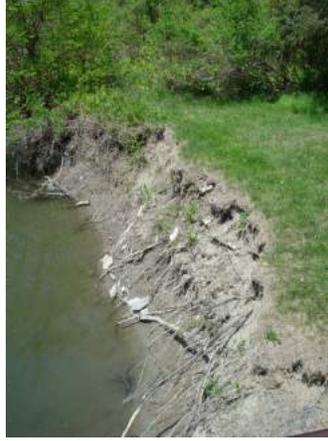
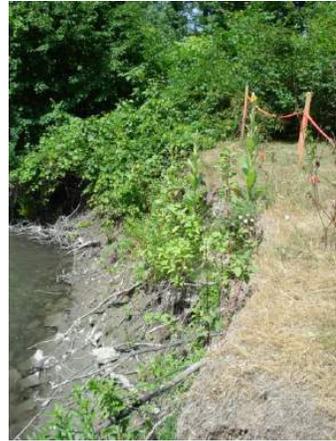
**Figure 71- Graham Creek Planting Site in Andrew Haydon Park.**

2006 Pre-planting

2007 Post-planting

This stream section is found in a well-used city park and some grass areas are cut close to the stream, thereby reducing riparian buffers. After discussion with park maintenance crews, an area above the eroded bank is now blocked off and will no longer be cut. This will allow natural regeneration of plant species to supplement our planting efforts. The Graham Creek planting site will be monitored and accessed for impacts or evidence of further erosion. New rehabilitation efforts will be initiated if necessary.

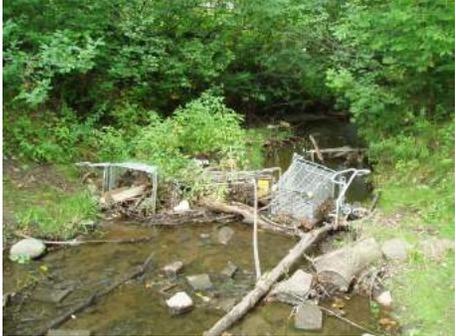
Location	Issue	Picture	Remediation Strategy	Expected Results
<p>Many sections of Sawmill Creek (South Keys Shopping Area of primary concern)</p>	<p>The accumulation of garbage and refuse along various stretches of Sawmill Creek is a ongoing problem. Not only does man-made pollution take away from the aesthetic quality of the stream but it limits and degrades the quality of fish and wildlife habitat.</p>

<p>Utilize existing volunteer base of the City Stream Watch to participate in annual cleanup efforts. Sawmill Creek cleanup days should be carried out in the summer and fall to facilitate the removal of garbage and to rid the stream and riparian areas of unnatural debris.</p>	<ul style="list-style-type: none"> <li>• Community involvement;</li> <li>• Enhancement of fish and wildlife habitat;</li> <li>• Enhancement of the creek's aesthetic qualities.</li> </ul>
Location	Issue	Picture	Remediation Strategy	Expected Results

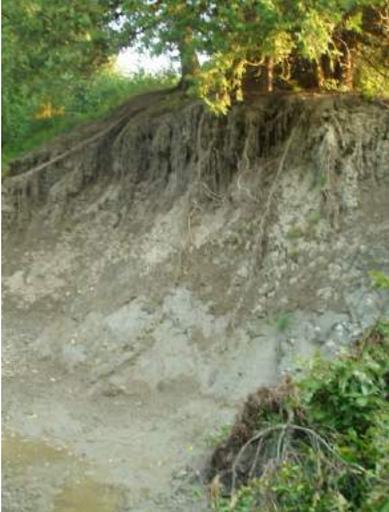
<p>Mud Creek (Greens Trib) – Various Locations</p>	<p>Erosion of stream banks along Mud Creek is common problem along the system. There is little disturbance along the stream although a lot of erosion was observed throughout sampling. Mud Creek would benefit from planting along its banks and in some areas the clearing of wood debris jams.</p>

<p>Utilize existing volunteer base of the City Stream Watch program and recruit volunteers from neighbouring communities to participate in this rehabilitation effort.</p>	<ul style="list-style-type: none"> <li>• Community involvement</li> <li>• Effective stream bank protection;</li> <li>• Reduce siltation of fish spawning habitat;</li> <li>• The enhancement of conditions for natural colonization of existing plant community;</li> <li>• Produce streamside wildlife habitat.</li> </ul>

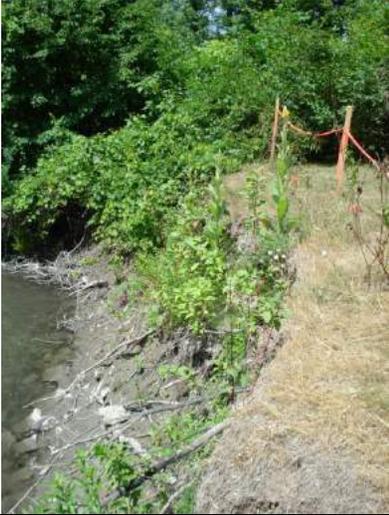
Location	Issue	Picture	Remediation Strategy	Expected Results
<p>Graham Creek at Andrew Haydon Park. On right bank just downstream from bridge.</p>	<p>The planting site on Graham Creek in Andrew Haydon Park needs to be continually monitored. It is important that a small buffer is left from grass cutting operations to help the bank re-establish a plant community.</p>

<p>Phase I and II of planting along this section have been completed. It is important to monitor the site to ensure plants continue to grow. If plant die-off is observed or damage is done to the site new planting initiatives will be initiated.</p>	<ul style="list-style-type: none"> <li>• Effective stream bank protection;</li> <li>• Reduce siltation of fish spawning habitat;</li> <li>• Enhance conditions for natural colonization of existing plant community;</li> <li>• Produce streamside wildlife habitat.</li> <li>• Enhancement of the creek's aesthetic qualities.</li> </ul>

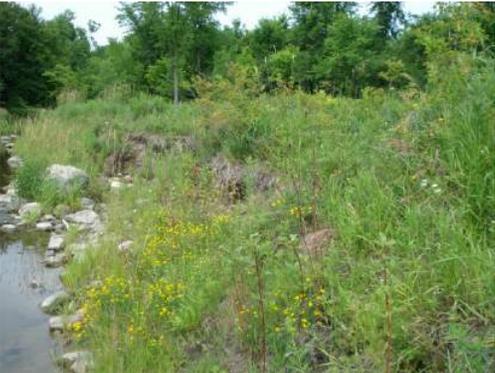
Location	Issue	Picture	Remediation Strategy	Expected Results
<p>Mosquito Creek downstream of Spratt Road in the Riverside South Subdivision</p>	<p>Erosion of stream banks along Mosquito Creek is a problem. Heavy development over the past few years along with creation of roads, bridges, and residential properties has increased runoff and caused significant erosion along the stream. Planting is completed and continued monitoring is important.</p>

<p>Phase I and II of planting along this section have been completed. It is important to monitor the site to ensure plants continue to grow. If plant die-off is observed or damage is done to the site new planting initiatives will be initiated.</p>	<ul style="list-style-type: none"> <li>• Enhance fish and wildlife habitat;</li> <li>• Enhance the creek's aesthetic qualities.</li> <li>• Protect stream bank.</li> <li>• Erosion control.</li> </ul>
