# CITY STREAM WATCH 2007

# **City Stream Watch 2007 Annual Report**

January 11, 2008

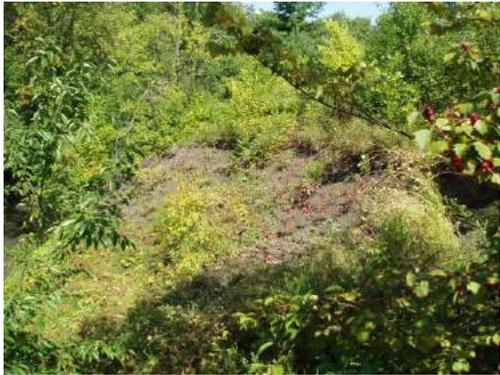
Location	Issue	Picture	Remediation Strategy	Expected Results
<p>Sawmill Creek just North of Heron Park Community Centre (Heron Rd.).</p>	<p>Phase I and Phase II planting took place on in 2005 and 2006 to help rehabilitate a failed bank on Sawmill Creek. Planting work has been successful although monitoring needs to be done often to ensure planting communities are successful. If trampling and further erosion are noticed, more planting may be needed.</p>

<p>Utilize existing volunteer base of the City Stream Watch program and residents from the Heron Park community to monitor success of planting site and report back to the coordinator with updates.</p>	<ul style="list-style-type: none"> <li>• Promote community involvement in rehabilitation projects</li> <li>• Enhance fish and wildlife habitat;</li> <li>• Enhance the creek's aesthetic qualities.</li> <li>• Erosion control</li> </ul>
Location	Issue	Picture	Remediation Strategy	Expected Results

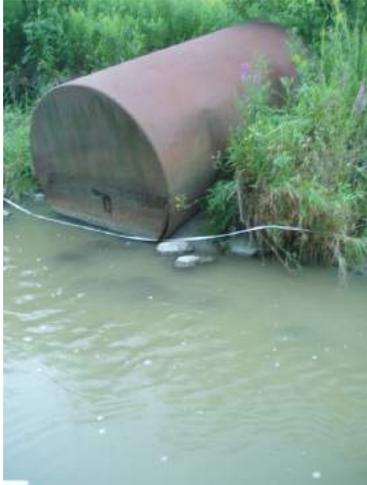
<p>Mud Creek (Greens Trib) – Various Locations</p>	<p>There are areas where the accumulation of garbage and debris has collected in debris jams along Mud Creek. Some pollution is large and has been in and around the stream for a long time. Man-made pollution takes away from the aesthetic quality of the stream and also limits and degrades the quality of fish and wildlife habitat.</p>

<p>Utilize existing volunteer base of the City Stream Watch to participate in annual cleanup efforts. Sawmill Creek cleanup days should be carried out in the summer and fall to facilitate the removal of garbage and to rid the stream and riparian areas of unnatural debris.</p>	<ul style="list-style-type: none"> <li>• Community involvement;</li> <li>• Enhancement of fish and wildlife habitat;</li> <li>• Enhancement of the creek's aesthetic qualities.</li> </ul>
