# Barrhaven Creek 2015 Summary Report

In 2015, 15 sections (1.5 km) of Barrhaven Creek were surveyed as part of the City Stream Watch monitoring activities. The following is a summary of observations made by staff and volunteers along those 15 sections.

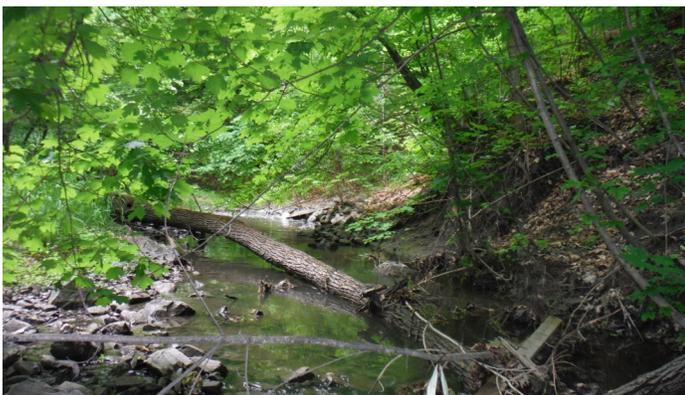
Stream bank erosion along the right bank of Barrhaven Creek

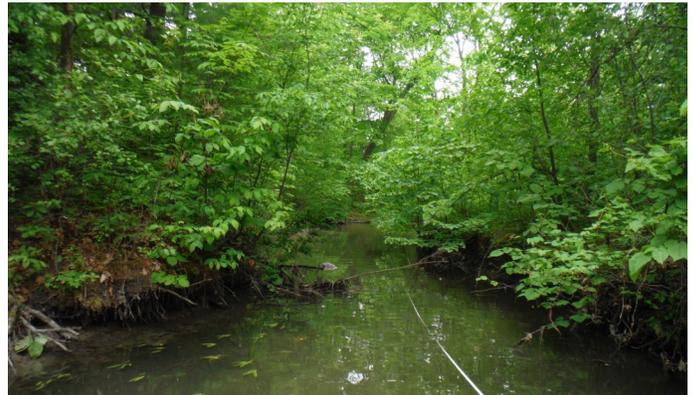
Bank undercutting along Barrhaven Creek

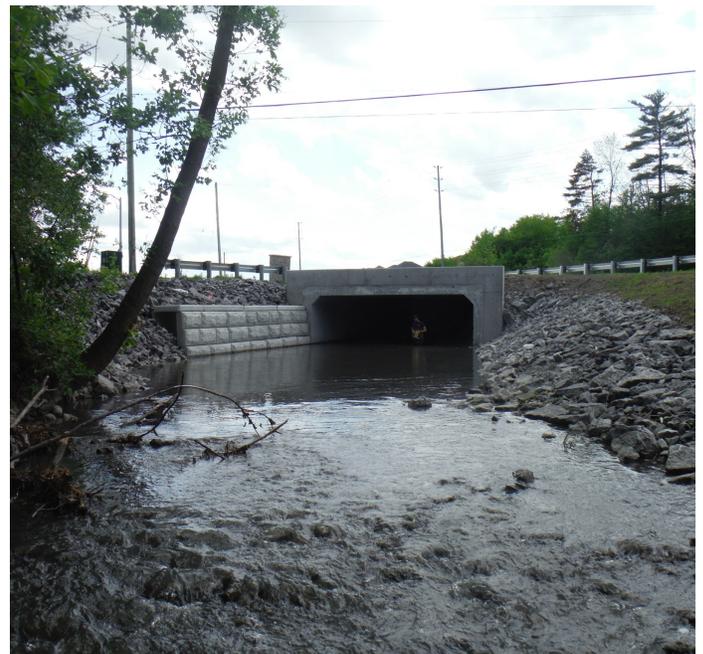
A highly altered section of Barrhaven Creek at Prince of Wales Drive

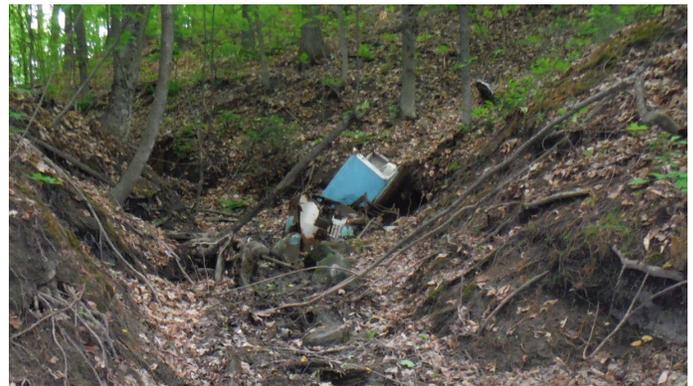
Abandoned car parts observed along Barrhaven Creek

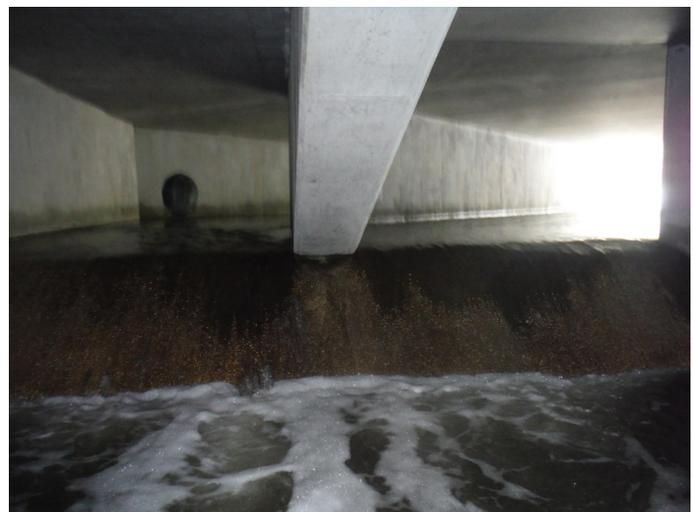
Grade barrier observed within the culvert at Prince of Wales Dr.

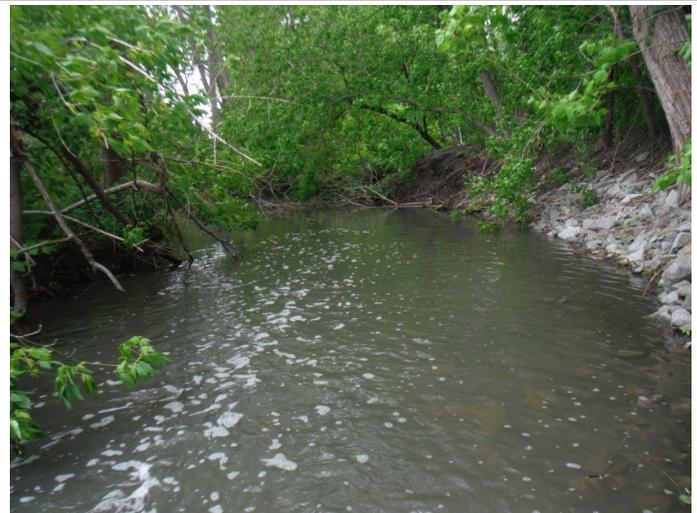
Erosion control opportunity near the mouth of the creek

Two opportunities were listed for Barrhaven Creek; erosion control near the mouth of the creek and wildlife habitat creation upstream of the stormwater pond.
