# Bilberry Creek 2015 Summary Report

In 2015, 71 sections (7.1 km) of Bilberry Creek were surveyed as part of the City Stream Watch monitoring activities. Surveying in 2015 included both branches of the creek north of Innes Road. The following is a summary of observations made by staff and volunteers along those 71 sections.

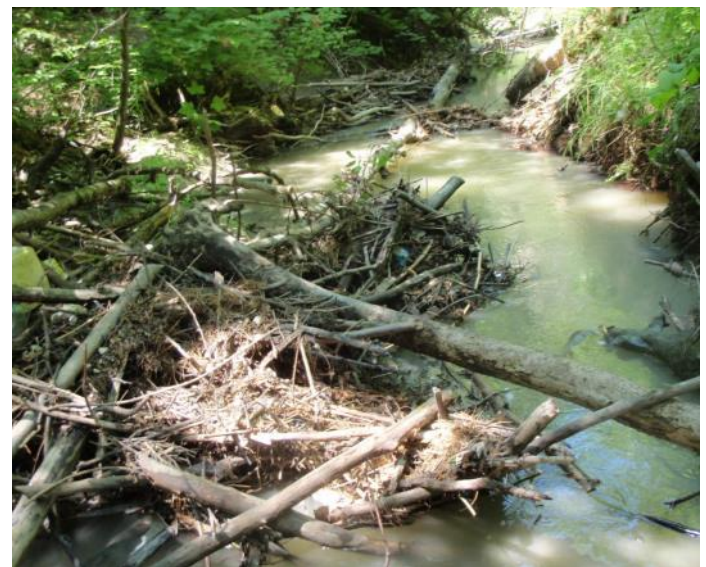
Figure 7 Instream woody debris along Bilberry Creek

Figure 7 shows that overall, the surveyed sections along Bilberry Creek had moderate levels of instream woody debris in the form of branches and trees. High levels of woody debris were observed in areas where erosion has led to fallen trees accumulating in the creek. Instream woody debris is important for fish and benthic habitat, by providing refuge and feeding areas but large accumulations of woody debris resulting from erosion can lead to debris dams that may affect fish migration.

High levels of Instream woody debris along Bilberry Creek

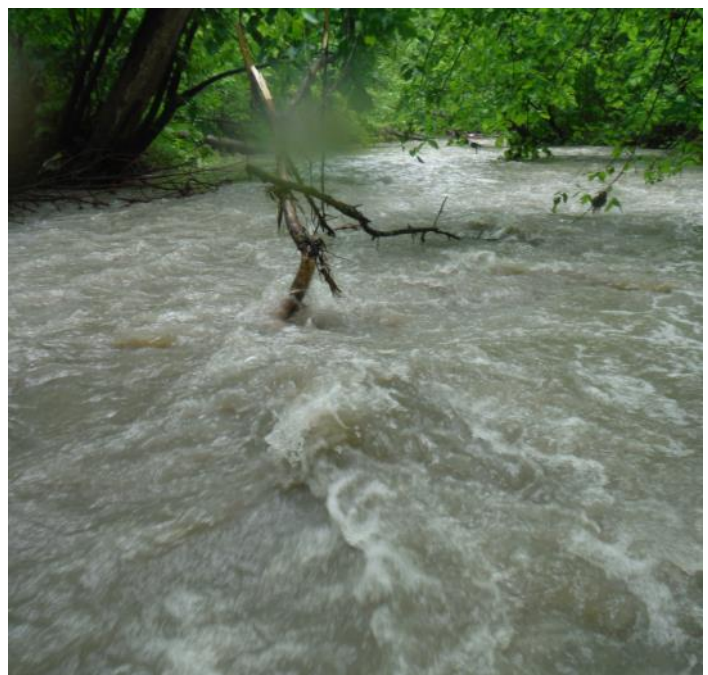
Instream vegetation is an important factor for a healthy stream ecosystem. Vegetation helps to remove contaminants from the water, contributes oxygen to the stream, and provides habitat for fish and wildlife. Too much vegetation can also be detrimental. Figure 18 demonstrates that overall Bilberry Creek had extremely low levels of instream vegetation. Areas of no vegetation accounted for 18 percent, rare levels accounted for 58 percent, low levels accounted for 23 percent and the remaining one percent were common levels. The low levels of vegetation on Bilberry Creek are the result of substrates dominated by clay and extreme fluctuations in water levels after rain events due to storm water runoff. Most types of vegetation, other than algae, have trouble establishing in these conditions.

Extremely high water levels observed after a rain event

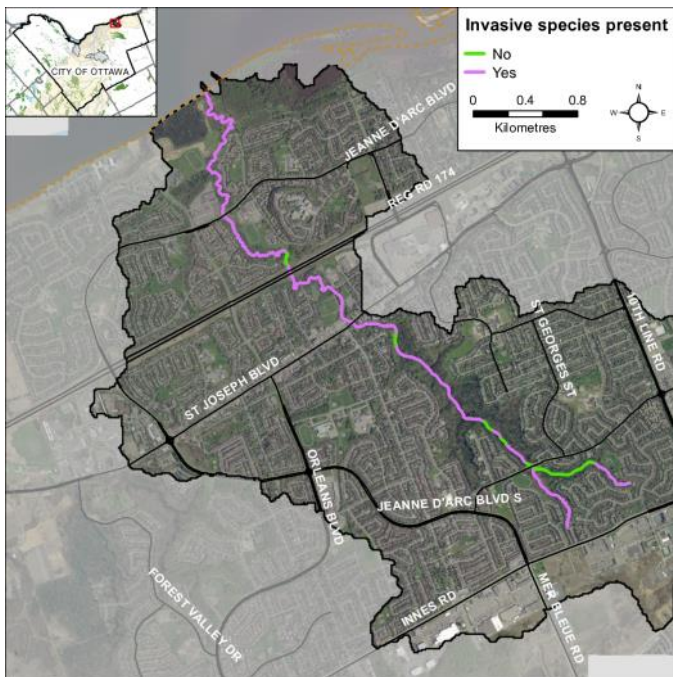
**Figure 19** Presence of invasive species along Bilberry Creek

Invasive species can have major implications on streams and species diversity. Invasive species are one of the largest threats to ecosystems throughout Ontario and can outcompete native species, having negative effects on local wildlife, fish and plant populations. Invasive species were observed along 87 percent of the sections surveyed along Bilberry Creek (Figure 19). Figure 20 shows the variety of invasive species observed along Bilberry Creek. The invasive species that were observed most often were Manitoba maple (*Acer negundo*), purple loosestrife (*Lythrum salicaria*), common buckthorn (*Rhamnus cathartica*), Himalayan balsam (*Impatiens glandulifera*), and garlic mustard (*Alliaria petiolate*).

The majority of the opportunities listed were invasive species control riparian planting and erosion control. The areas highlighted for invasive species control were where the species Himalayan balsam was observed. The areas highlighted for erosion control were downstream of highway 174 and downstream of Bilberry Drive towards the mouth of the creek.

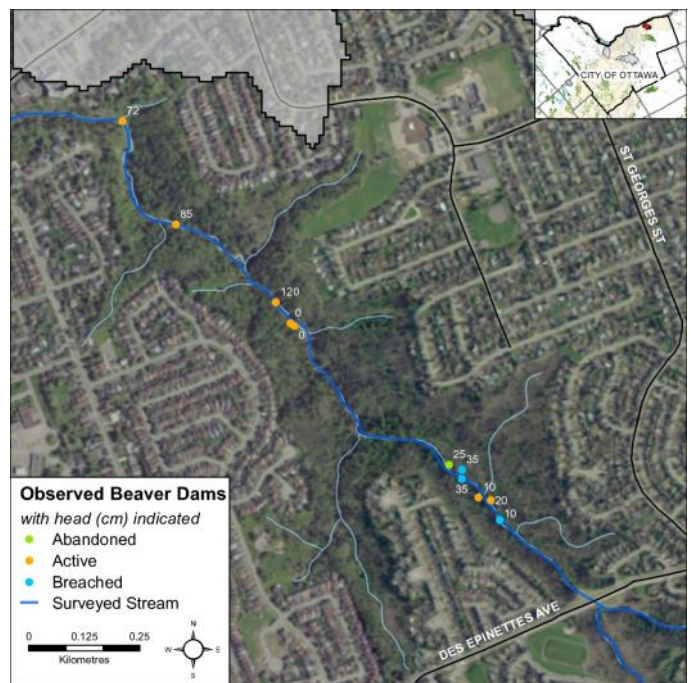
**Figure 30** Beaver dams observed on Bilberry Creek

Beaver dams can also act as obstructions to fish migration. Figure 30 shows that in total 11 beaver dams were observed on Bilberry Creek all located between St. Joseph Boulevard and Des Epinettes Avenue. Seven of the beaver dams were active, four had been breached and one was abandoned. The head, or difference between the water level up and down stream, of the beaver dams ranged from 0 cm to 120 cm.

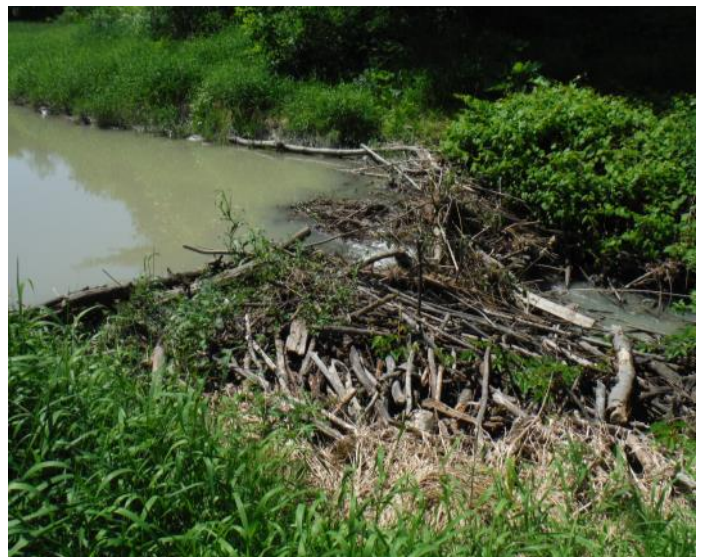
A beaver dam observed on Bilberry Creek

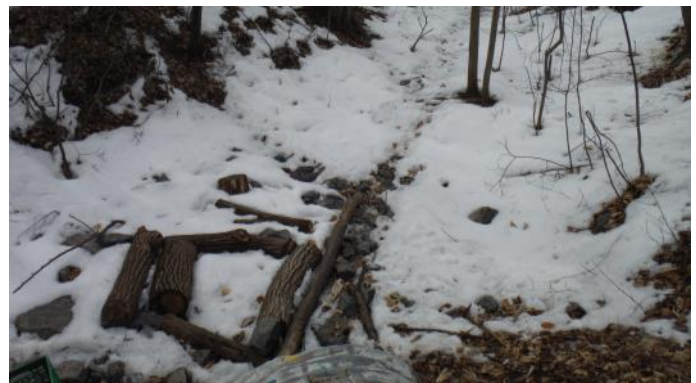
Undefined HDF feature upstream of Des Epinettes Avenue

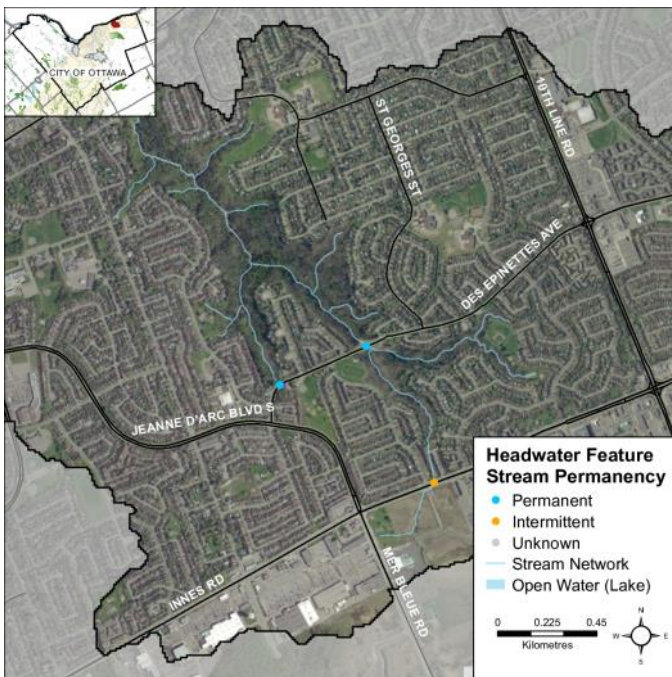
Figure 33 Bilberry Creek HDF flow conditions

The observed flow condition within headwater drainage features can be highly variable depending on timing relative to the spring freshet, recent rainfall, soil moisture, etc. Flow conditions are assessed in the spring and in the summer to determine if features are perennial and flow year round, if they are intermittent and dry up during the summer months or if they are ephemeral systems that do not flow regularly and generally respond to specific rainstorm events or snowmelt. Flow conditions in headwater systems can change from year to year depending on local precipitation patterns. Figure 33 shows the observed flow conditions at the sampling locations in the Bilberry Creek catchment. The sampling sites on Des Epinettes Ave were permanent features, whereas the feature on Innes Rd was intermittent.

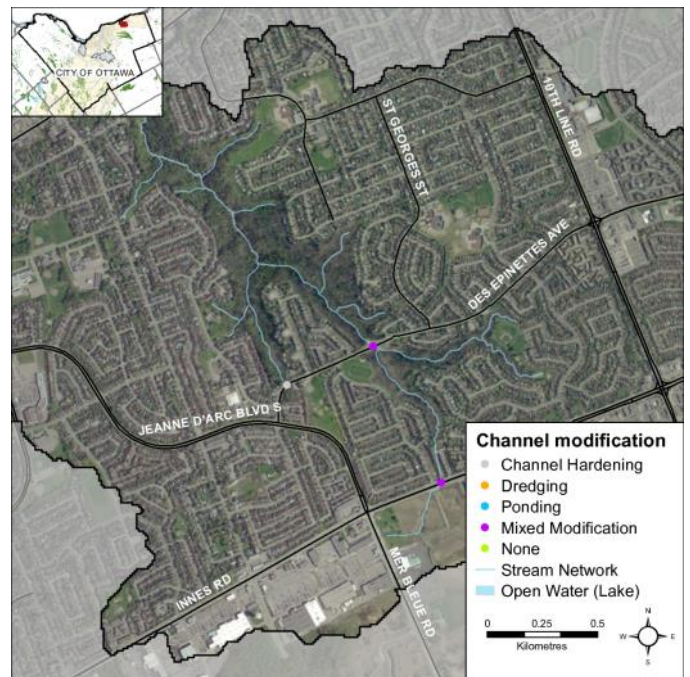
Figure 34 Bilberry Creek HDF channel modifications

Channel modifications were assessed at each headwater drainage feature sampling location. Modifications include channelization, dredging, hardening and realignments. All of the sampling locations in the Bilberry Creek catchment were classified as having channel modifications. The sampling site closest to Jeanne D'Arc Blvd was classified as having channel hardening in the form of rip rap. The feature farther east along Des Epinettes Ave was classified as having mixed modifications in the form channel hardening, straightening, and barriers in close proximity. Finally, the site on Innes Road was classified as having mixed modifications. Figure 34 shows the channel modifications observed at the sampling locations for Bilberry Creek.

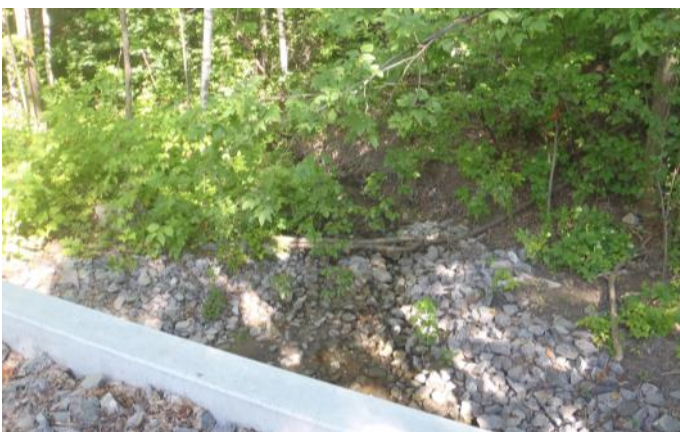
Permanent HDF sampling site with observable flow in July

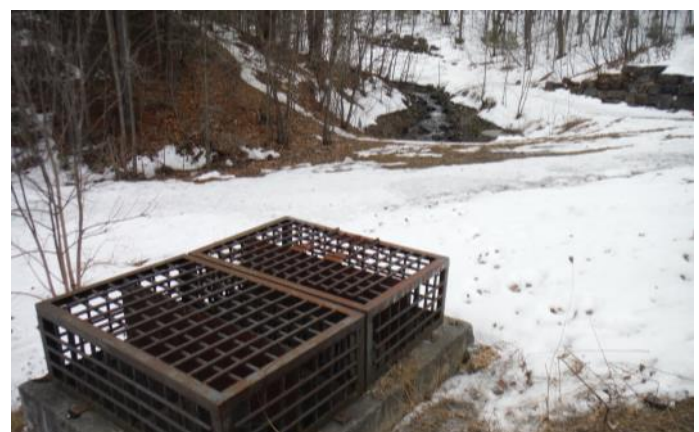
A stormwater feature forming part of the mixed modifications observed at an HDF site on Bilberry Creek

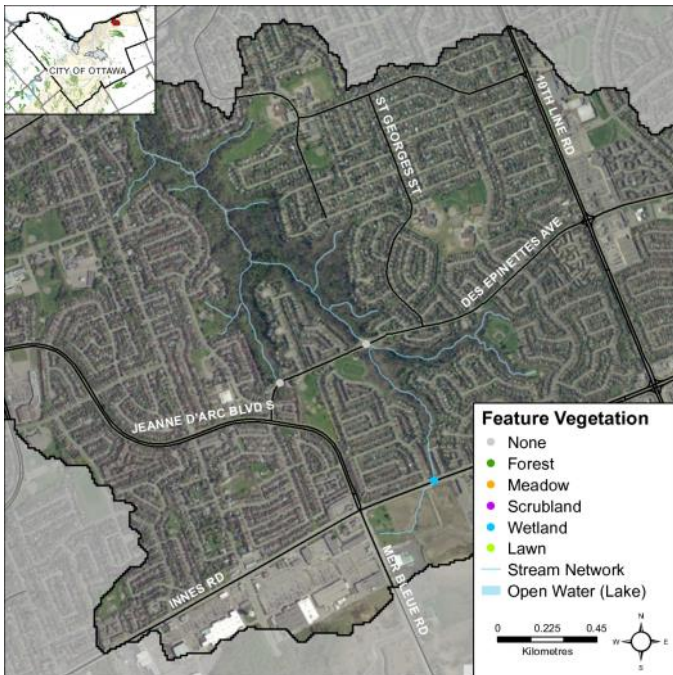
Figure 35 Bilberry Creek HDF feature vegetation

Headwater feature vegetation evaluates the type of vegetation that is found within the drainage feature. The type of vegetation within the channel influences the aquatic and terrestrial ecosystem values that the feature provides. For some types of headwater features the vegetation within the feature plays a very important role in flow and sediment movement and provides wildlife habitat. The following classifications are evaluated: no vegetation, lawn, wetland, meadow, scrubland and forest. Figure 35 depicts the dominant vegetation type observed at both sampled headwater sites along Des Epinettes Ave was no vegetation due to the channel hardening which extended into the channel of both features. The site on Innes Rd was classified as having wetland feature vegetation.

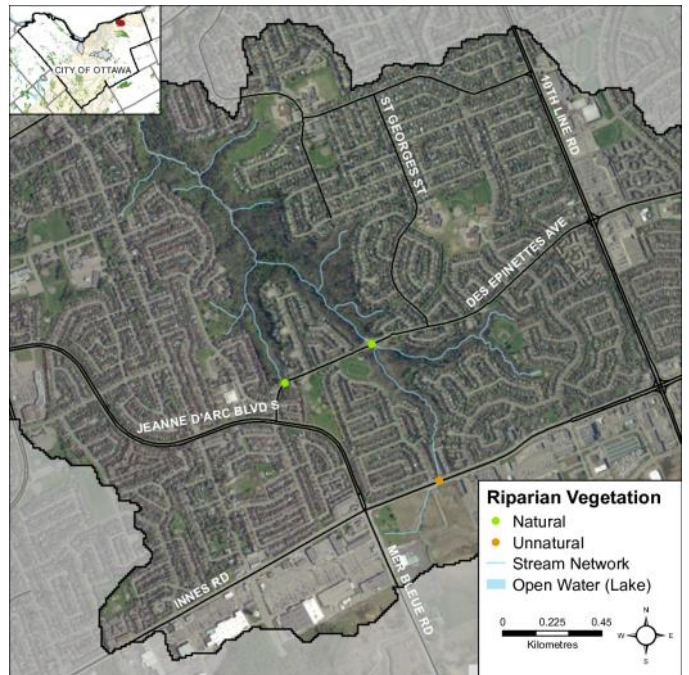
Figure 36 Bilberry Creek HDF riparian vegetation

Headwater riparian vegetation evaluates the type of vegetation that is found along the headwater drainage feature. The type of vegetation within the riparian corridor influences the aquatic and terrestrial ecosystem values that the feature provides to the watershed. Although impacted by development in close proximity, the riparian vegetation at the sample locations along Des Epinettes Ave were dominated by natural vegetation in the form of forest as a result of the forested buffer maintained around that section of Bilberry Creek. The site on Innes Rd was heavily impacted by recent commercial development as was classified as having unnatural riparian vegetation. Figure 36 depicts the type of riparian vegetation observed at the sampled headwater sites in the Bilberry Creek catchment.

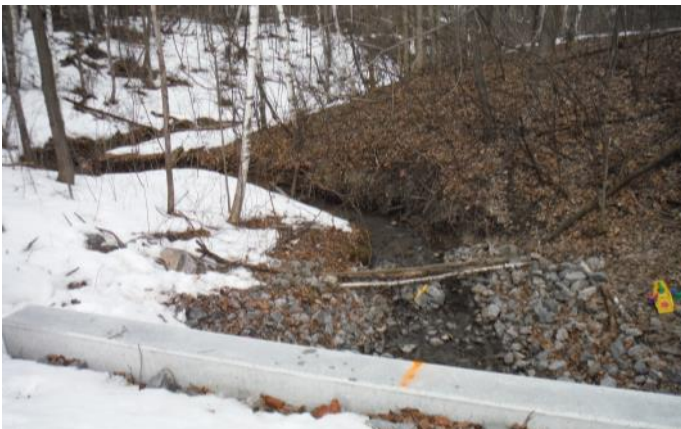
HDF with no vegetation due to rip rap in the channel

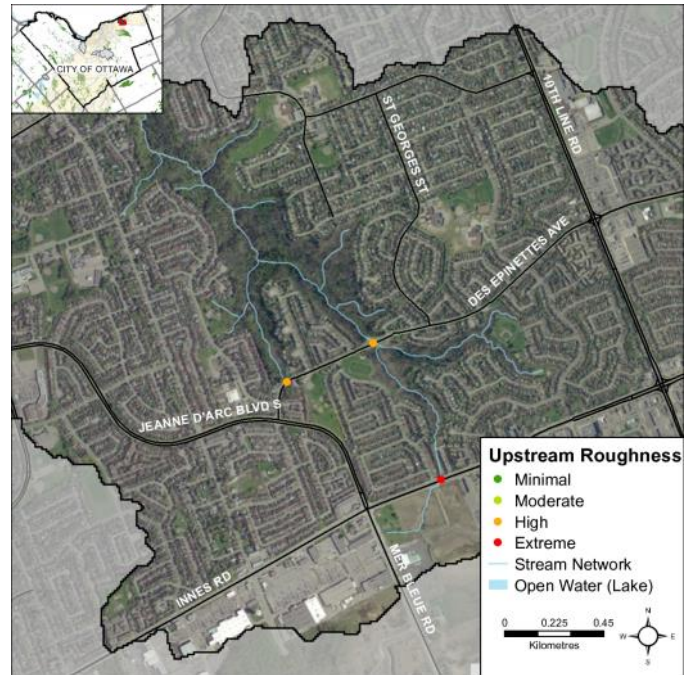
Figure 38 Bilberry Creek HDF feature roughness

Feature roughness will provide a measure of the amount of materials within the bankfull channel that could slow down the velocity of water flowing within the headwater feature (OSAP, 2013). Materials on the channel bottom that provide roughness include vegetation, woody debris and boulders/cobble substrates. Roughness can provide benefits in mitigating downstream erosion on the headwater drainage feature and the receiving watercourse by reducing velocities. Roughness also provides important habitat conditions to aquatic organisms. Both samples locations along Des Epinettes Ave exhibited high feature roughness, and the site on Innes Rd exhibited extreme roughness. Figure 38 shows the feature roughness conditions at the sampling locations in the Bilberry Creek catchment.

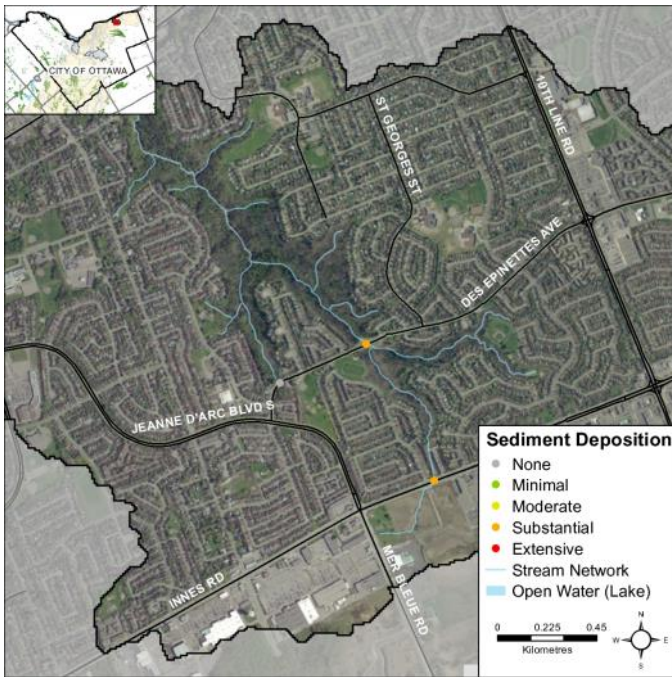
Figure 37 Bilberry Creek HDF sediment deposition

Assessing the amount of recent sediment deposited in a channel provides an index of the degree to which the feature could be transporting sediment to downstream reaches (OSAP, 2013). Evidence of excessive sediment deposition might indicate the requirement to follow up with more detailed targeted assessments upstream of the site location to identify potential best management practices to be implemented. One site sampled in the Bilberry Creek catchment had no sediment deposition since the feature was entombed upstream, whereas the other features had substantial sediment deposition. Figure 37 depicts the degree of sediment deposition observed at the sampled headwater sites in the Bilberry Creek catchment.

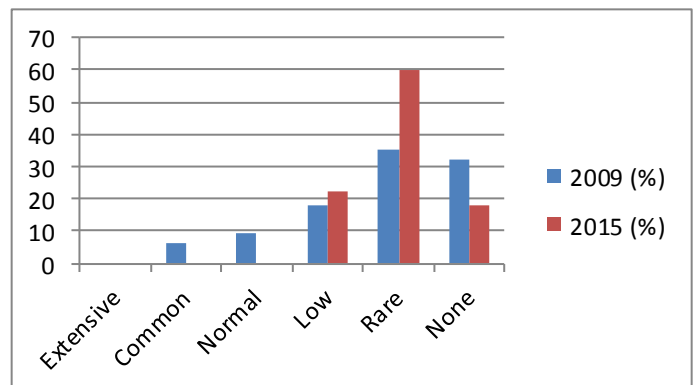
**Figure 39** Comparison of instream vegetation levels

Figure 39 shows that there has been an overall decrease in instream vegetation in Bilberry Creek since 2009. The amount of common levels of vegetation totaled 6 percent in 2009, and that number has decreased to zero in 2015. In addition, the amount of normal levels of vegetation totaled nine percent in 2009 and decreased to zero in 2015. Finally, the number of areas classified as having rare levels of vegetation or no vegetation has increased from 67 percent in 2009 to 78 percent in 2015. The decrease in instream vegetation may be in part attributed to stormwater influence on the system over time, but vegetation growth is also dependent on climatic variables as well as the stage of the growing season when observations took place.
