Executive Committee Meeting

STAFF REPORT

Application # RV3-59/23

File RV3-5923, Proposed Armor Stone Retaining Wall & Landscaping, 6079 James
Bell, Manotick, ON

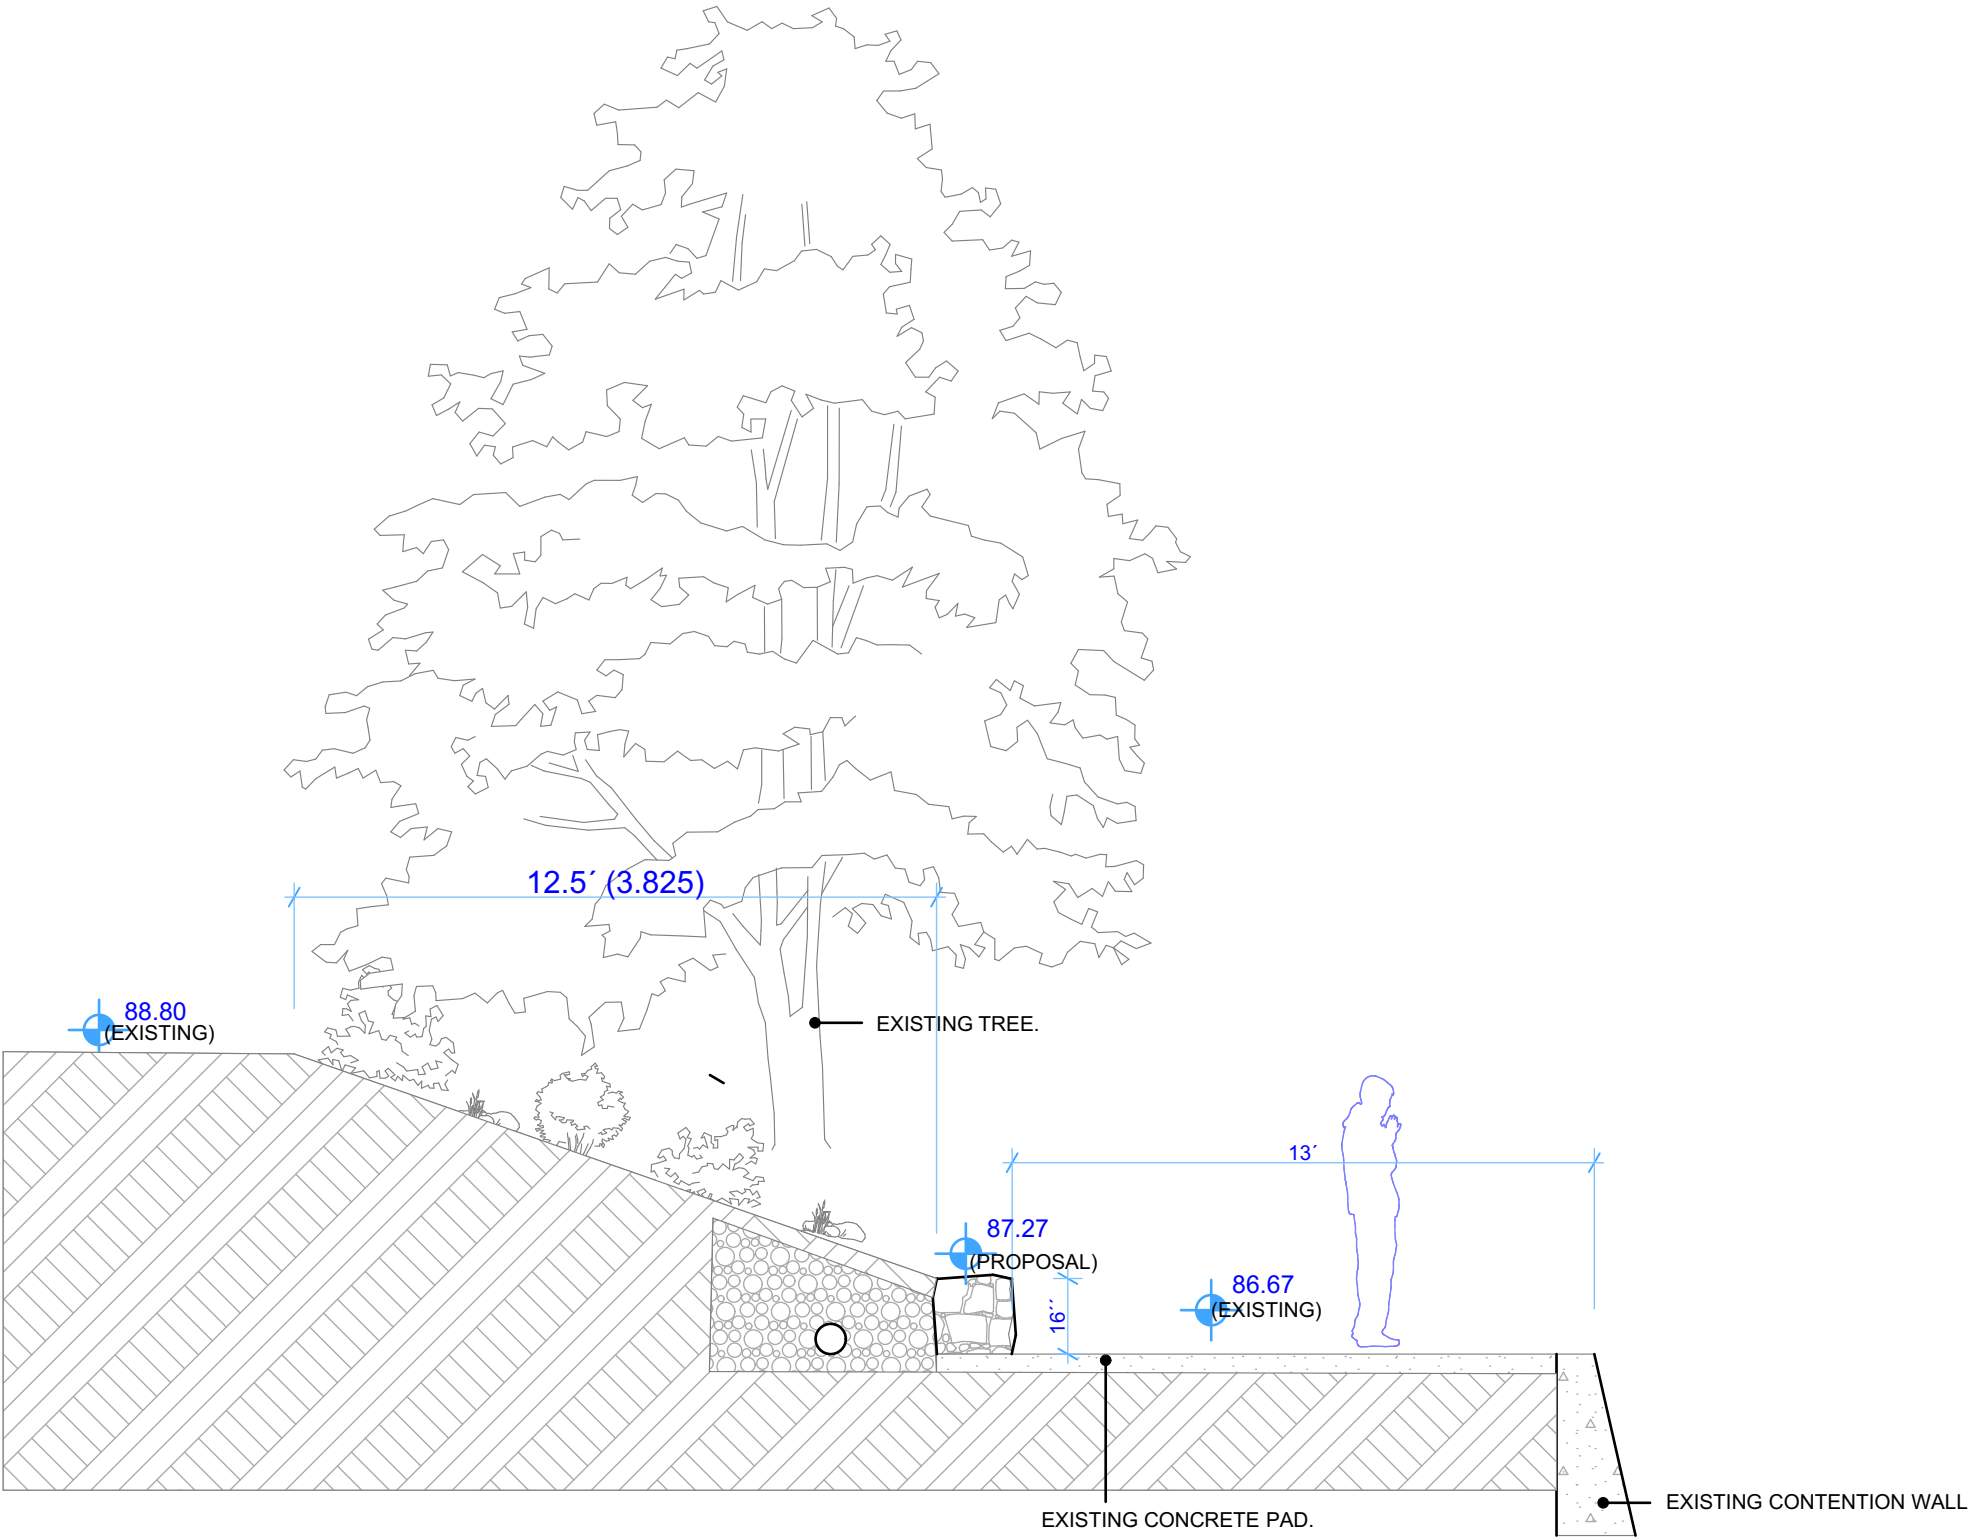
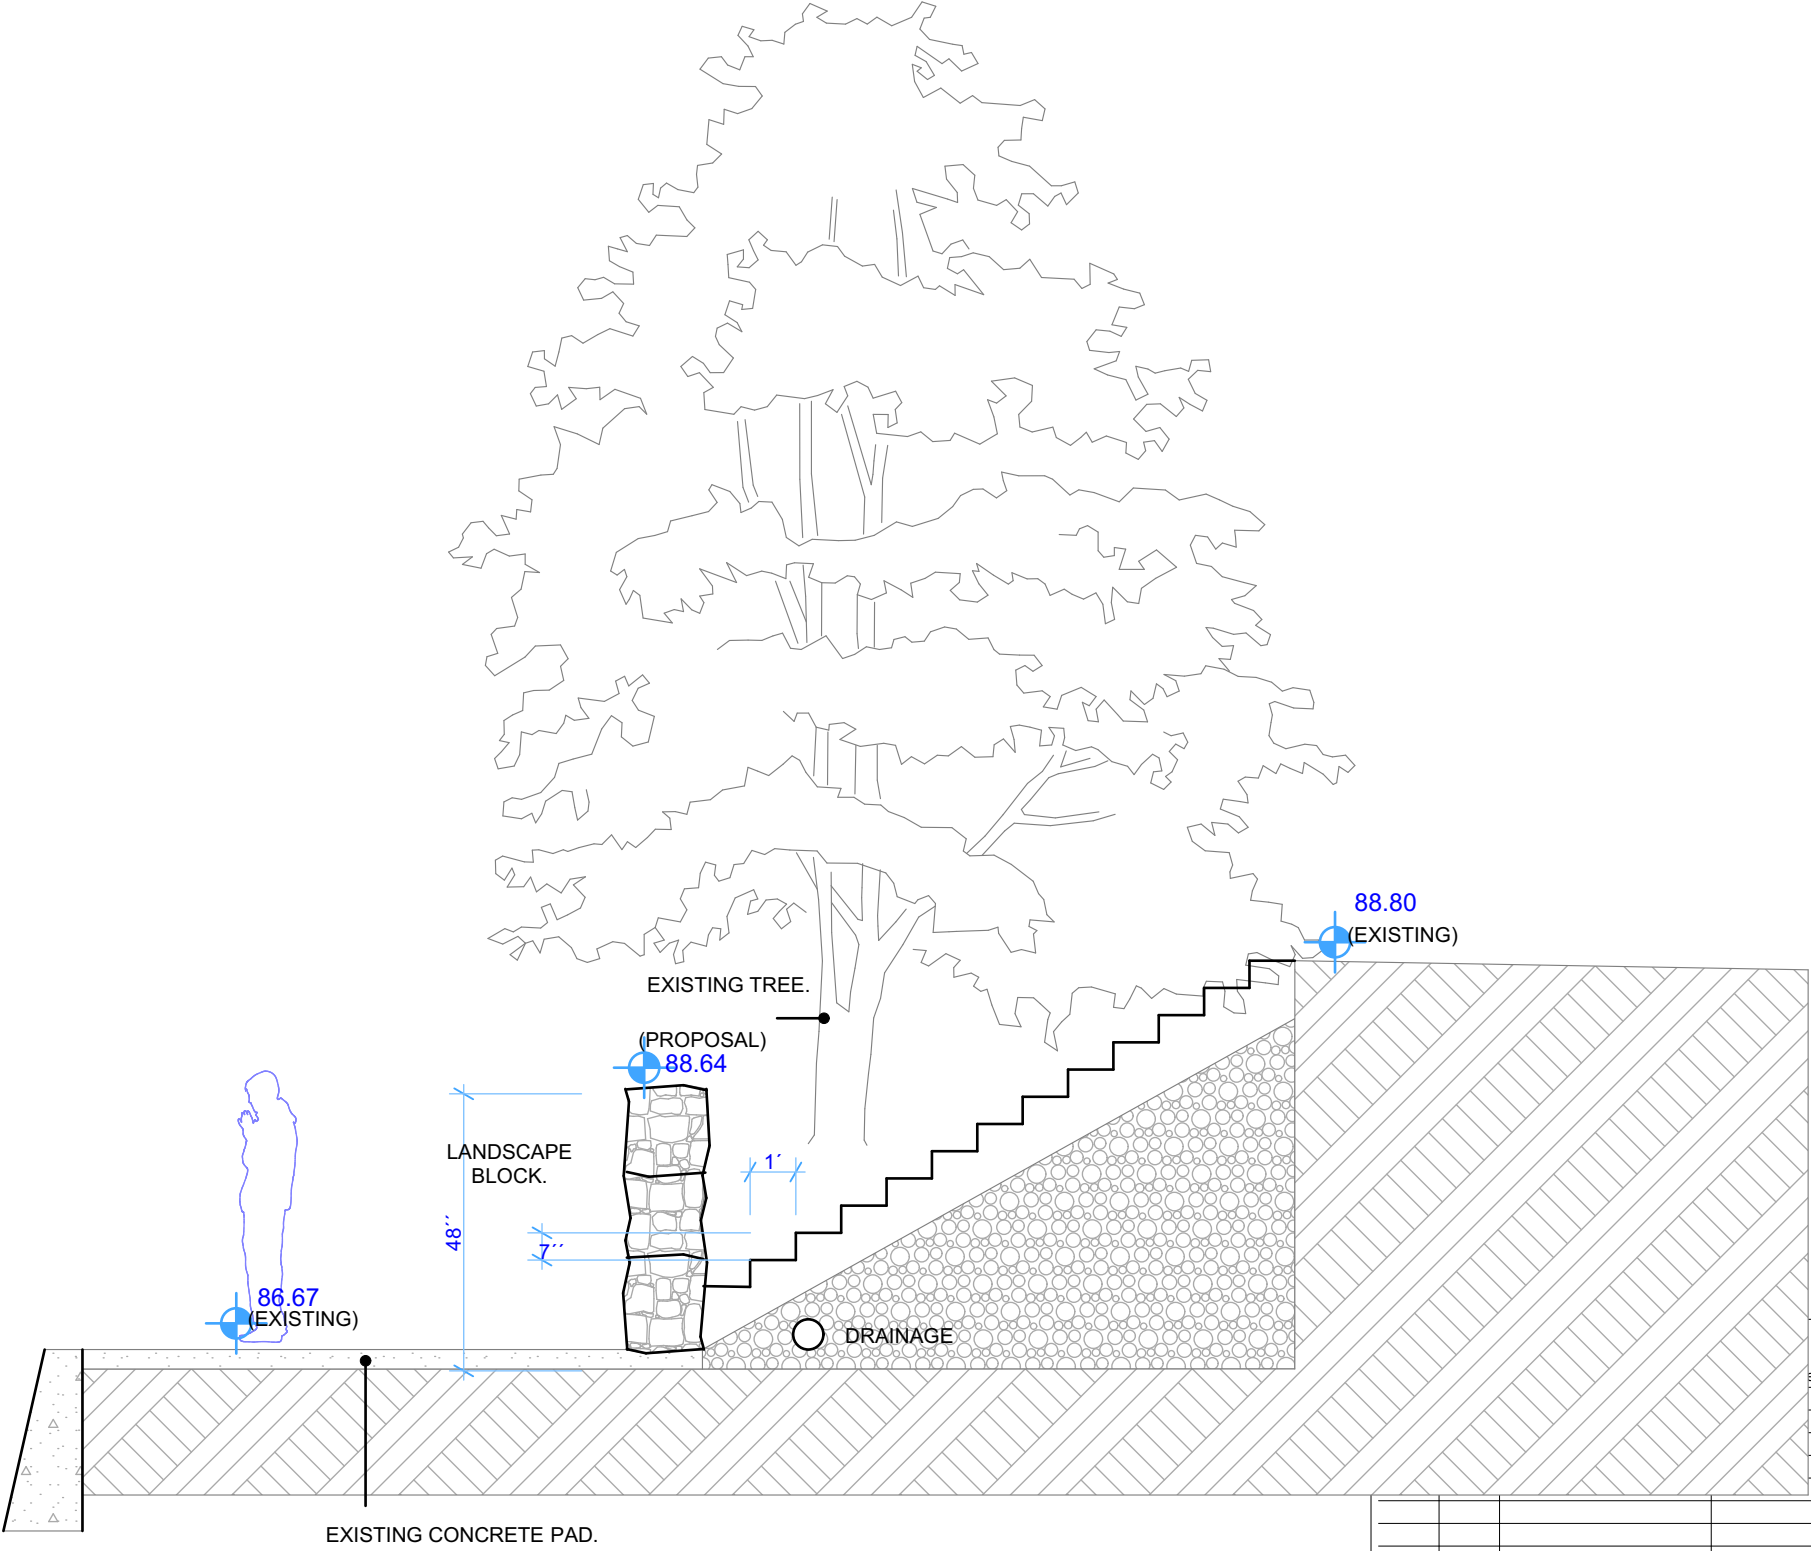
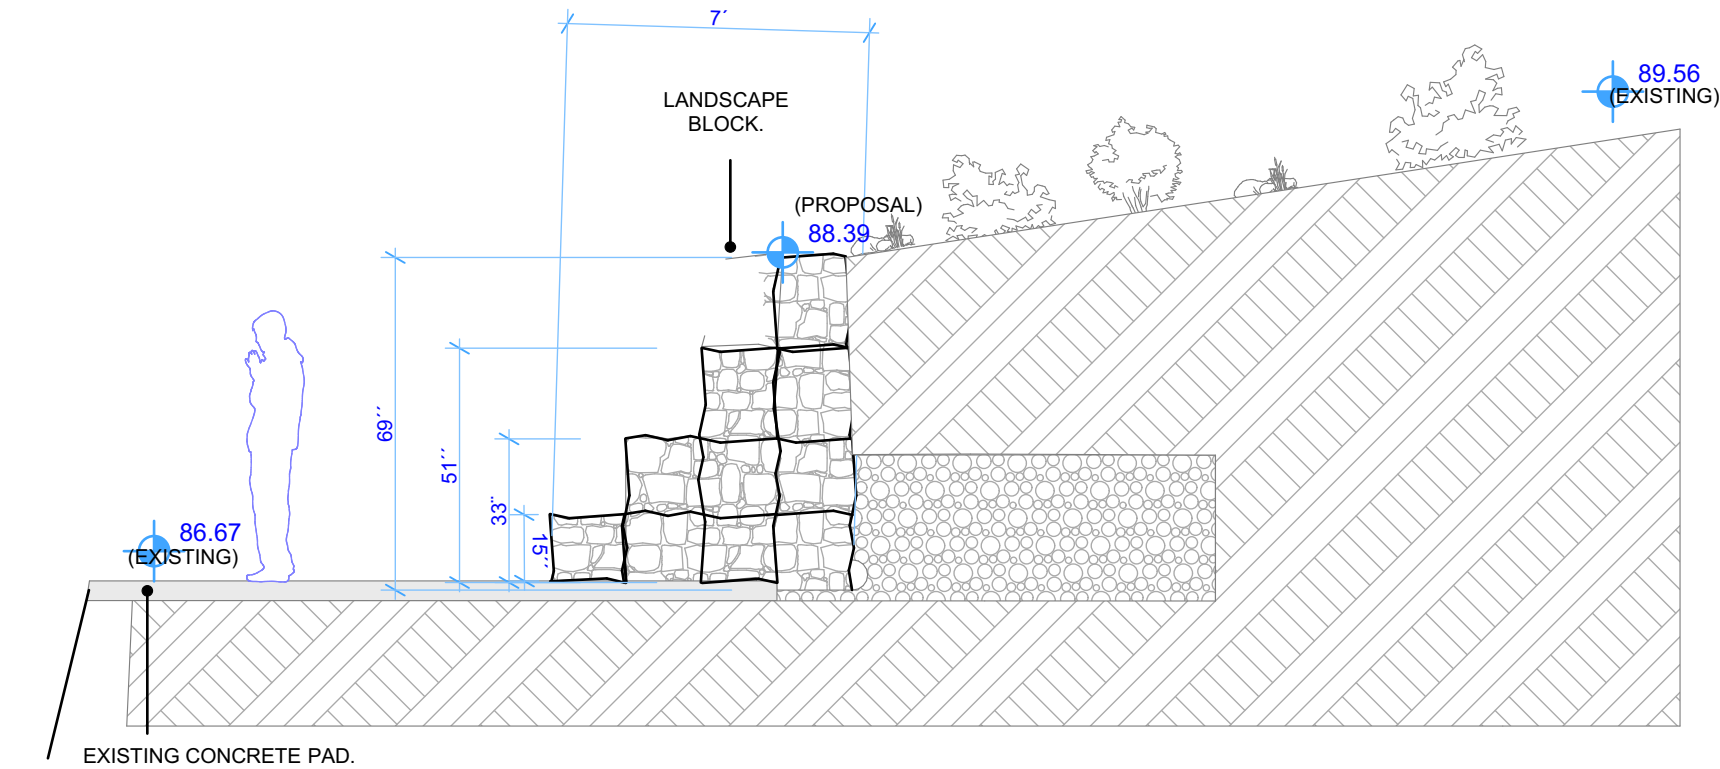
Existing Conditions as of August 2023, before development began:

- Property is 1356.27 m² or 0.34 of an acre on the west shore of the Rideau River.
- Property has approximately 37 metre (121.4 feet) of shoreline in length. The shoreline is fully developed with an approx. 73 m² rectangular concrete pad. The pad is cracked in a few places.

- Shoreline is a vertical concrete wall.
- The 1:100-year floodplain at this site is 86.86 metres geodetic and the development regulation applies approximately 15 metres from the 86.86 metres elevation, based on the OMNRF Guidelines for hazard mapping. The 1:100-year floodplain elevation is located on top of the concrete pad towards the rear/toe of slope.

- Concrete stairs to the west of a mature tree provided access to the concrete pad.
- There was an existing brick crib built around the base of the tree. The brick crib was in poor condition.

- The slope was partially vegetated with non-manicured vegetation and minor erosion of fines was observed where vegetation was lacking.
- Interlock & brick landscaping was in place beginning at the front of the dwelling, wrapping around the north side of the dwelling before ending at the eastern end of the dwelling.

- There was an existing brick garden wall along the edge of the garden on the south side of the property.
