Bilberry Creek 2023 Catchment Report

Introduction

Bilberry Creek was previously surveyed in 2015 under the City Stream Watch program. In 2023, 71 sections (7.1km) were surveyed as a part of the City Stream Watch monitoring activities. The following is a summary of observations made by staff and volunteers along those 71 sections.

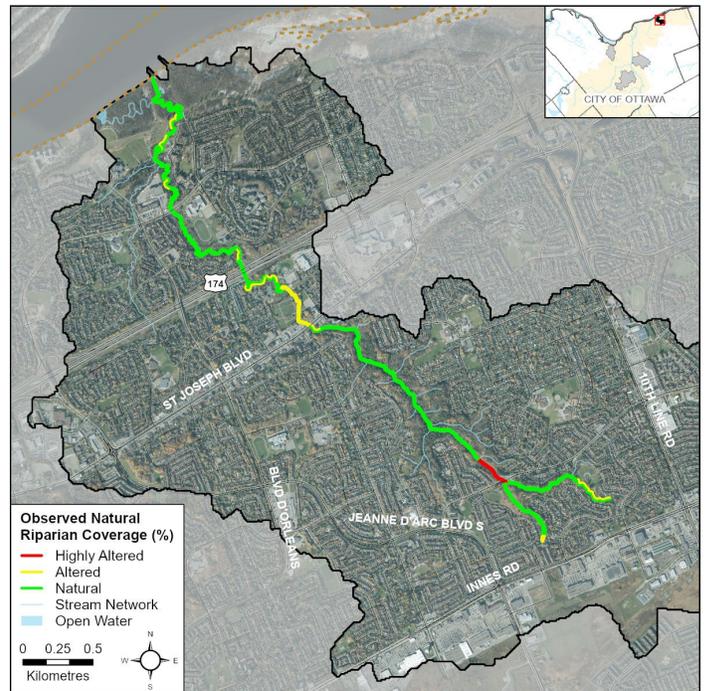
Figure 3 Riparian buffer alterations in Bilberry Creek

Bilberry Creek surveyed riparian zones were mostly natural, with 56 and 57 percent of the right and left banks having dominant natural riparian vegetative communities. Alterations to the riparian buffer accounted for 11 percent of the right bank and 10 percent on the left bank; highly altered conditions were observed on four percent of each the right and left banks. These alterations were associated with infrastructure such as roadways and piping.

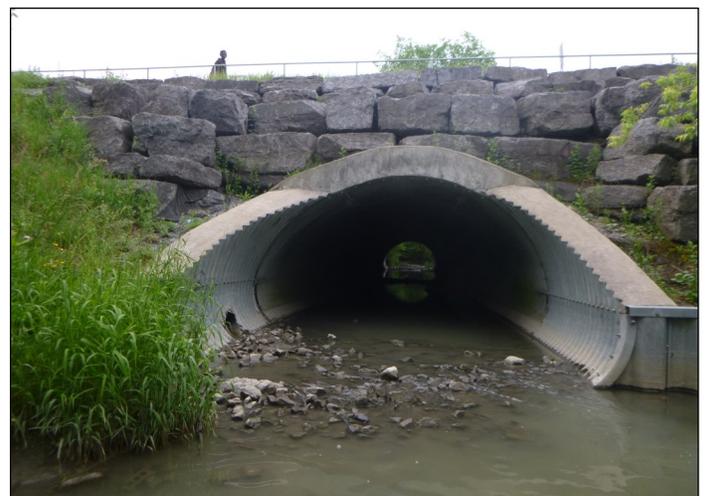
Roadway infrastructure on Jeanne D'Arc Blvd along Bilberry Creek

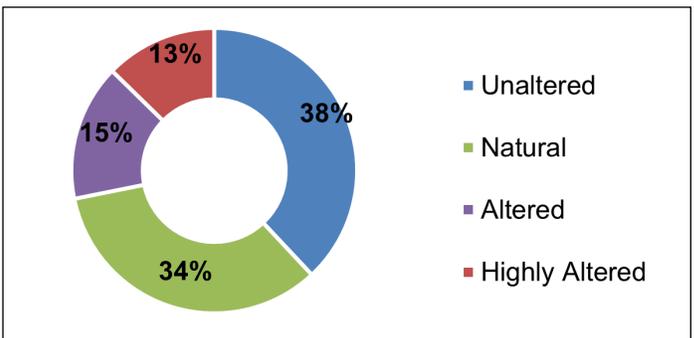
Figure 5 Anthropogenic alterations along Bilberry Creek

Figure 5 shows the level of anthropogenic alterations for the 71 sections surveyed in the Bilberry Creek catchment, with 38 sections remaining without any human alteration. Of the areas surveyed, 34 sections fell in the classification of natural. Natural sections had a riparian buffer greater than 15 meters in width and natural shorelines.

Ten sections were classified as altered. They contained straightened sections and riparian buffers of five to 15 meters in width. Shoreline alterations included concrete bridges and culverts.

Nine of the surveyed sections were highly altered. The riparian buffers were less than five meters in width and shoreline alterations were found on most of the sections. This included rip rap and storm water outlets which were present at road crossings. These sections were mostly found near road and highway infrastructure.

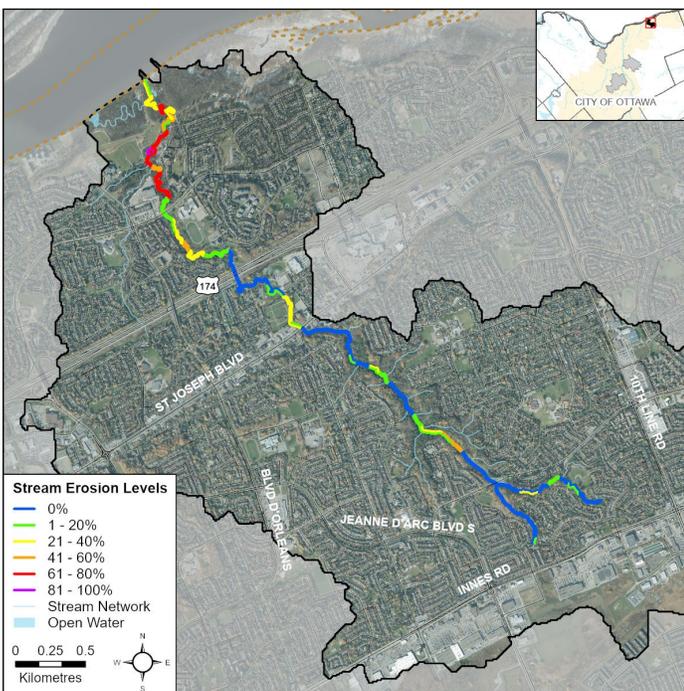
Figure 6 Erosion levels along Bilberry Creek

Figure 6 shows significant erosion was observed across the surveyed portions. Bank instability was observed in 51 percent of the left bank and 56 percent of the right bank of the sections surveyed.

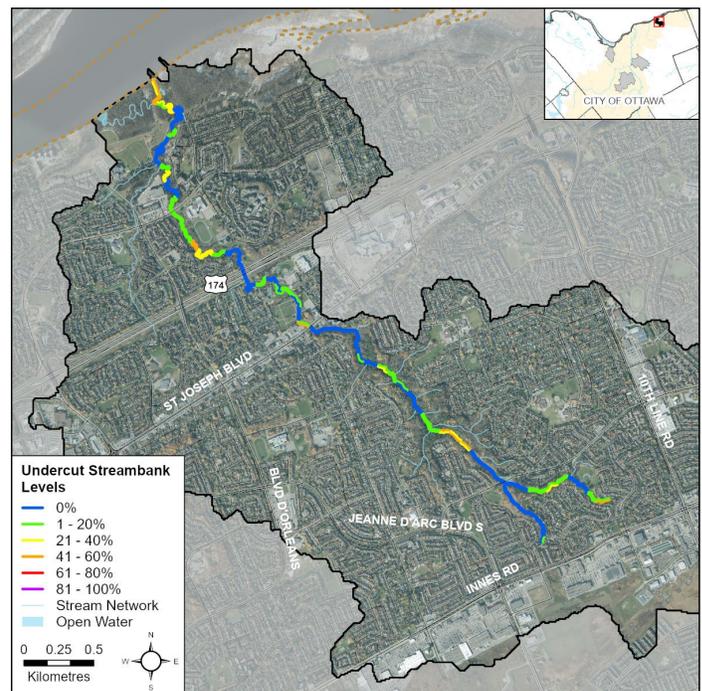
Figure 7 Undercut stream banks along Bilberry Creek

Figure 7 shows where undercut banks were present and to what extent each section contained them in Bilberry Creek. Along the left bank, 46 percent of sections had undercut banks; and the right bank had 45 percent of sections with undercut banks.

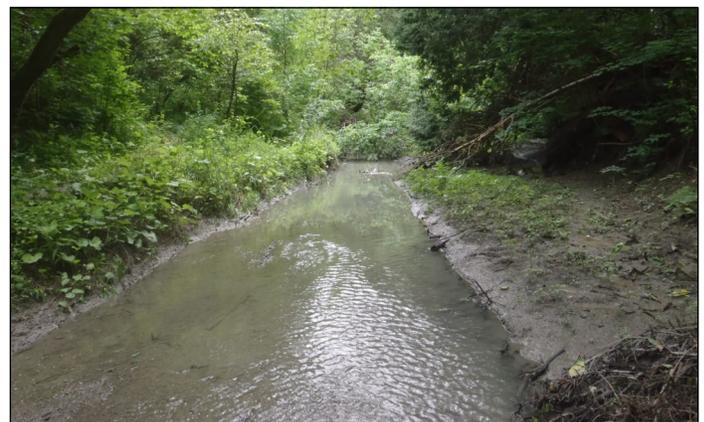
The low levels of vegetation on Bilberry Creek are the result of substrates dominated by clay and extreme fluctuations in water levels after rain events due to storm water runoff. Most types of vegetation, other than algae, have trouble establishing in these conditions.

Section of Bilberry Creek dominated by clay with no instream vegetation near Lacroix Ave

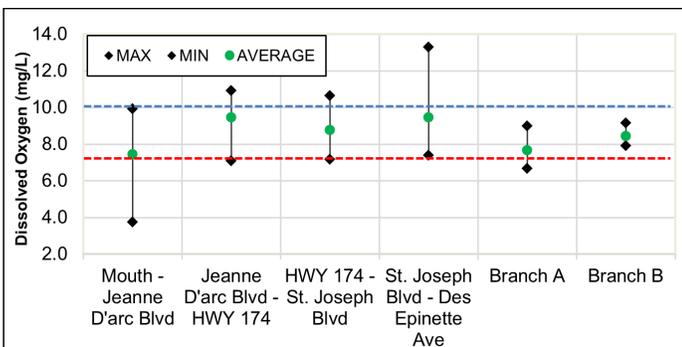
Figure 21 Dissolved oxygen ranges along Bilberry Creek

Figure 21 shows the concentration levels found in the surveyed portions of Bilberry Creek. The Canadian Environmental Quality Guidelines of the Canadian Council of Ministers of the Environment (CCME) suggest that for the protection of aquatic life the lowest acceptable dissolved oxygen concentration should be 6 mg/L for warmwater biota (red line in Figure 19) and 9.5 mg/L for coldwater biota (blue line in Figure 19) (CCME, 1999). Most of the surveyed portions were found to have oxygen levels above the Canadian water quality guidelines for warmwater biota. Average concentration levels across the system were 8.5 mg/L.

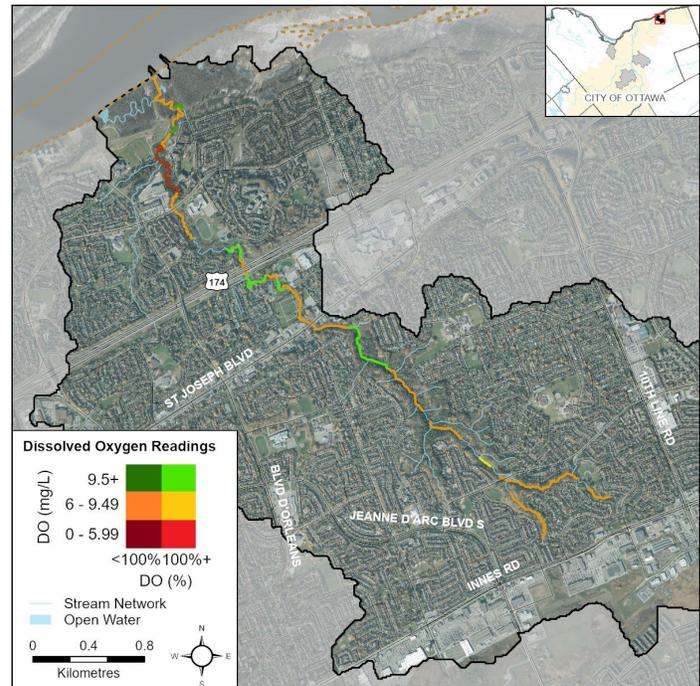
Figure 24 Bivariate assessment of dissolved oxygen concentration (mg/L) and saturation (%) along Bilberry Creek

Figure 24 shows the oxygen conditions across the areas that were surveyed in 2023. Dissolved oxygen conditions in Bilberry Creek were sufficient to sustain warm-water biota in the creek upstream of Jeanne D'Arc Blvd. In the sections between Jeanne D'Arc Blvd and Bilberry Drive, there were significant levels of impairment both in concentration and percent saturation. This area is dominated by clay and had little to no vegetation. There is very little riffle habitat which provides increased oxygen levels in streams. An increase in instream vegetation and riffle habitat would increase levels of oxygen in this area, as well as across the system.

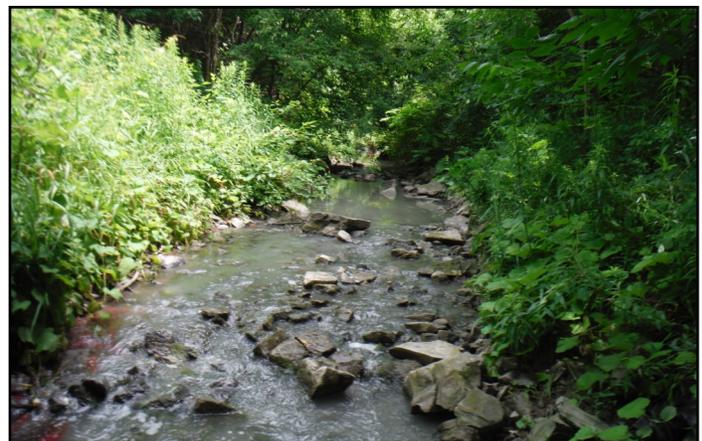
Section on Bilberry Creek upstream of St. Joseph Blvd with **optimal** oxygen conditions for warm-water biota (Dissolved oxygen levels of 10.9 mg/L and 112.7 % saturation)

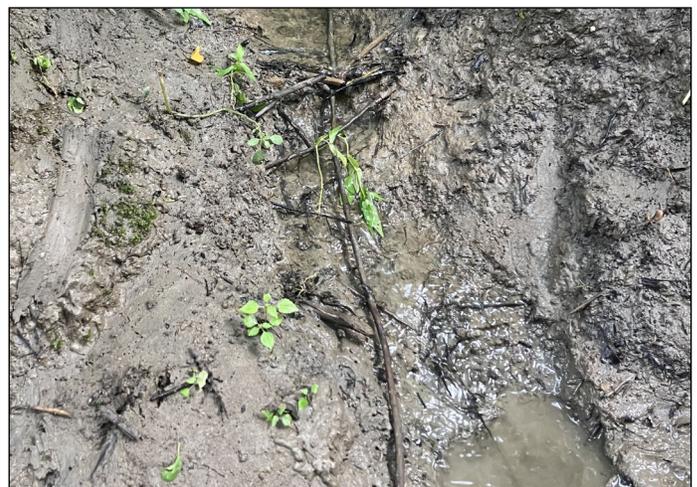
Visible seep observed branches in the upper reaches of Bilberry Creek

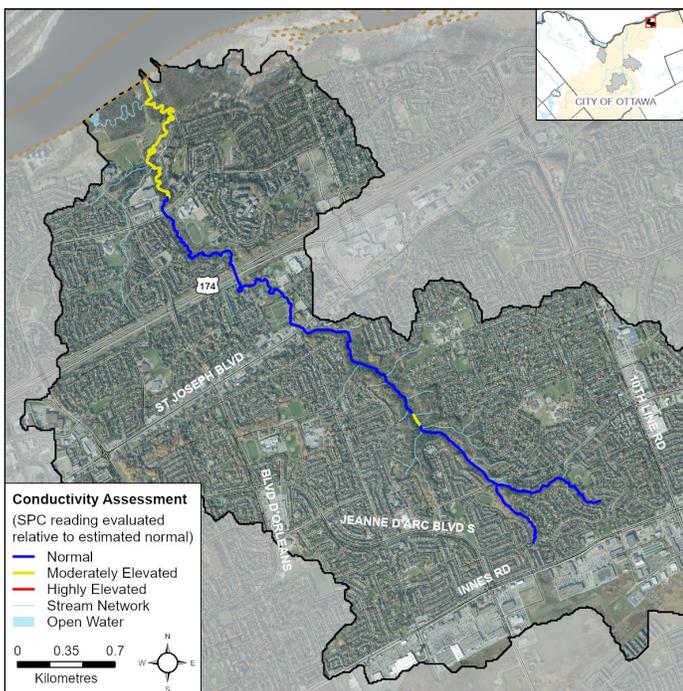
Figure 25 Relative specific conductivity levels along Bilberry Creek

Figure 25 shows relative specific conductivity levels in Bilberry Creek. Normal levels were maintained for most of the surveyed portions. Moderately elevated conditions were observed in sections downstream of Jeanne D'Arc Blvd. This area is highly influenced by stormwater from adjacent urban areas. This was also observed in sections directly downstream from where the creek is piped near Epinettes Ave.

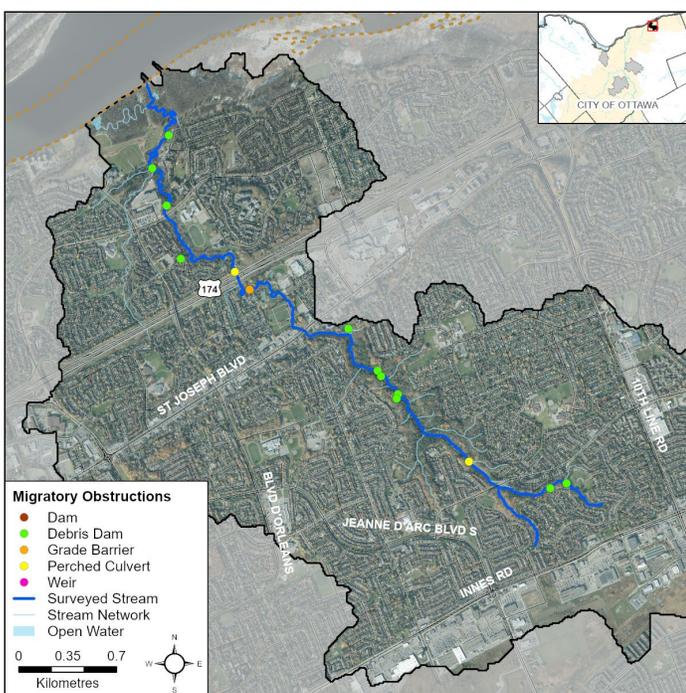
Figure 31 Locations of migratory obstructions along Bilberry Creek

There were several migratory obstructions observed along the surveyed portions of Bilberry Creek. The migratory obstructions observed during stream surveys in 2023 are shown in Figure 31. Most were debris dams, which can be a result of high levels of erosion in this area, causing trees and debris to fall into the creek. Perched culverts, which are classified as grade barriers, were observed in two sections along Bilberry Creek.

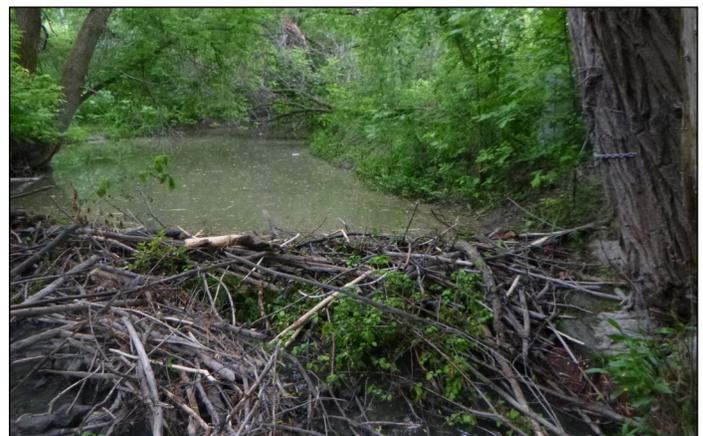
An active beaver dam along Bilberry Creek west of Bilberry Drive

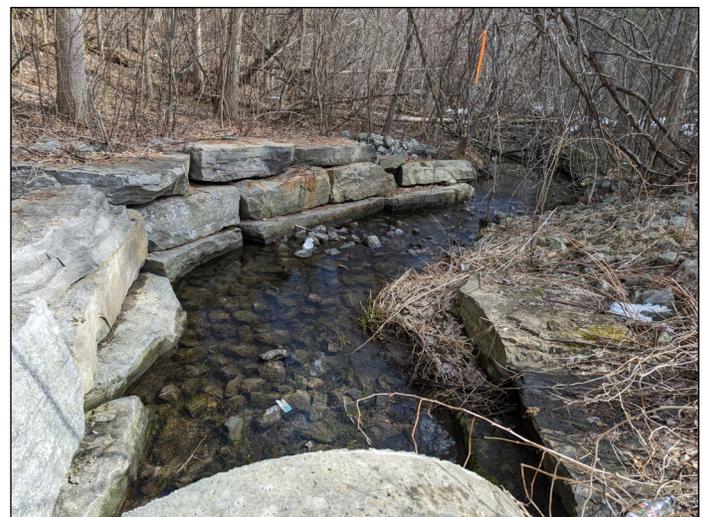
An example of the use of armourstone on a headwater drainage feature on Orleans Blvd

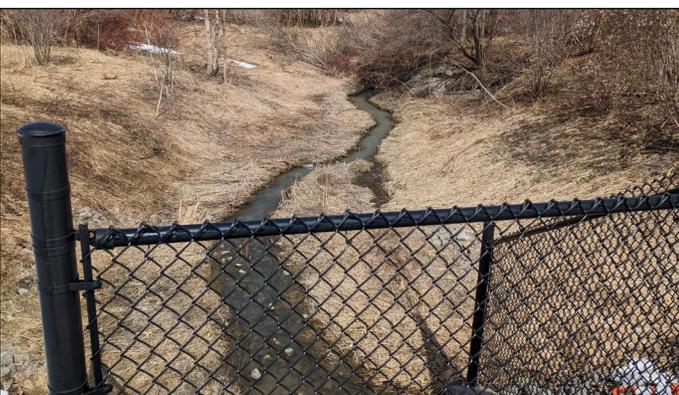
No feature vegetation within a headwater drainage feature west of Orleans Blvd

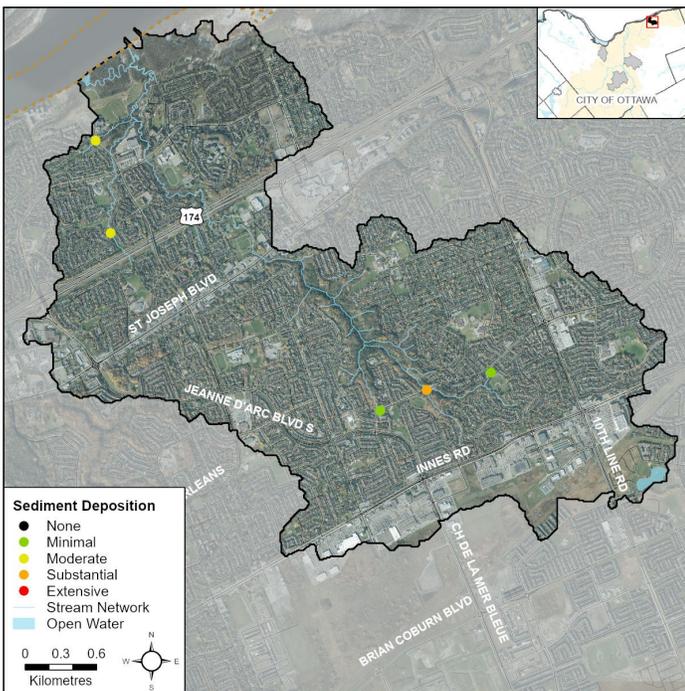
Figure 39 Headwater drainage feature sediment deposition in the Bilberry Creek catchment

From the features assessed, sediment deposition ranged from minimal to substantial. Two features had evidence of minimal deposition levels and two features had moderate deposition levels. One feature had substantial amounts of deposition. Figure 39 shows the levels of sediment deposition observed in the catchment headwaters.

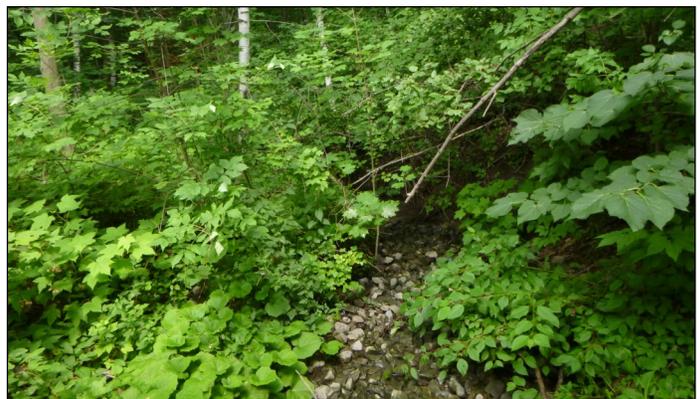
Extreme roughness due to low presence of vegetation and coarse substrate that diffuse flow

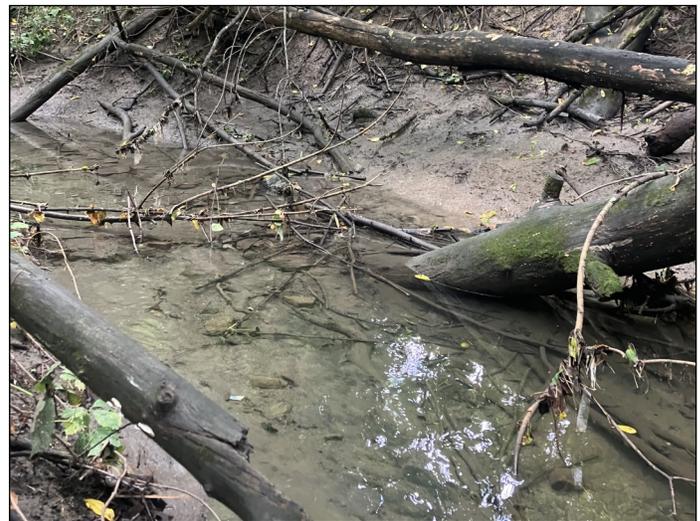
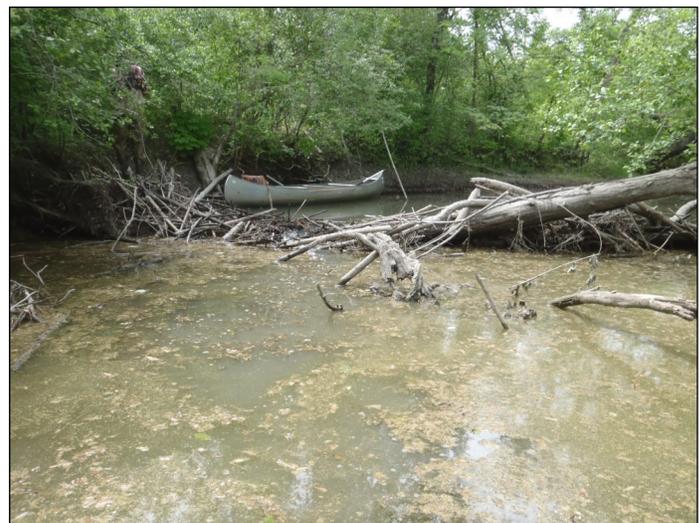
In both cycle years, most sections either had very little or no vegetation (above) or had abundant algae (below)

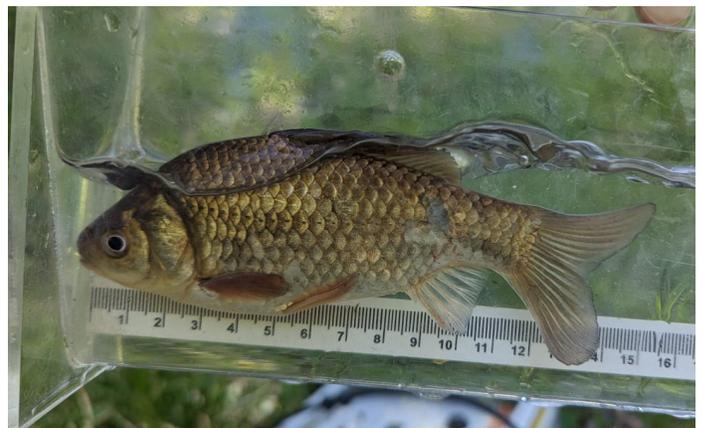
An invasive goldfish, observed for the first time in 2023

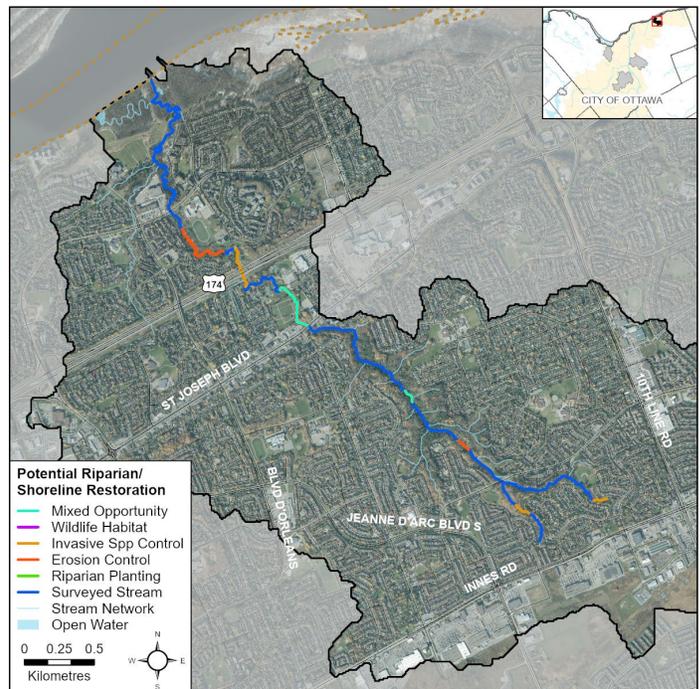
Figure 41 Potential riparian/shoreline restoration opportunities along Bilberry Creek and its headwater reaches

Riparian restoration opportunities include potential enhancement through riparian planting. Opportunities were identified along Bilberry Creek surveyed areas (Figure 41).
