Taylor Creek 2018 Catchment Report

In 2018, the City Stream Watch program surveyed fourteen 100 meter sections of Taylor Creek. Four sites were sampled for fish community composition.

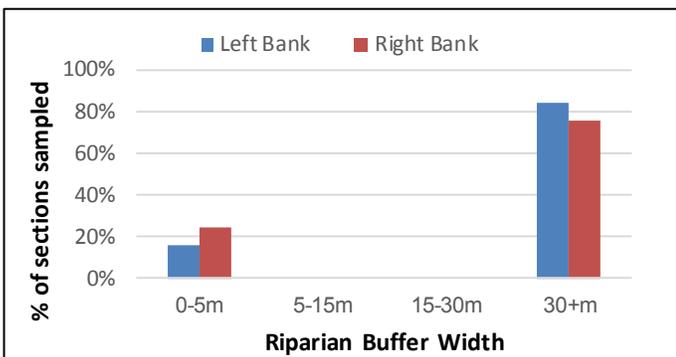
Figure 2 Vegetated buffer width along Taylor Creek

Figure 2 demonstrates buffer conditions along the left and right banks of Taylor Creek. Buffers greater than 30 meters were present along 84 percent of the left bank and 75 percent of the right bank. A five meter buffer or less was present along 16 percent of the left banks and 25 percent of the right bank. These sections with reduced buffer width were found in the last few sections downstream and upstream of St. Joseph Boulevard.

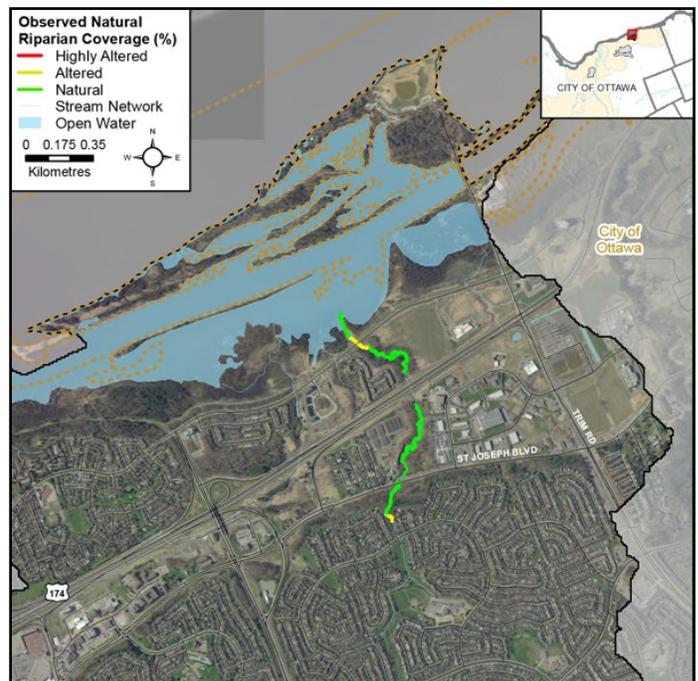
Figure 3 Riparian buffer alterations in Taylor Creek

Taylor Creek riparian zones have primarily natural vegetative communities; alterations are associated with channel straightening and infrastructure, including roadways, and pedestrian pathway crossings.

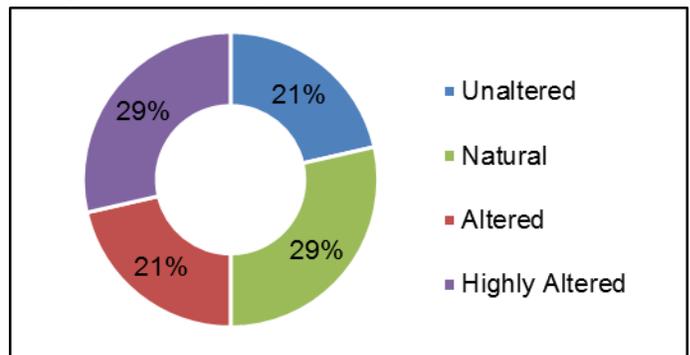
Figure 5 Anthropogenic alterations along Taylor Creek

Figure 5 shows the level of anthropogenic alterations for Taylor Creek, with 21 percent remaining without any human alteration. Of the sections surveyed, 29 percent fall in the classification of natural. Natural sections have not been straightened or diverted, have a riparian buffer greater than 15 meters, contain few lawns, ornamental gardens, beaches, rip rap or constructed wooden structures.

Altered sections account for 21 percent of surveyed areas, they may contain diverted or straightened sections and riparian buffers of five to 15 meters.

Highly altered sections account for 29 percent of surveyed sections. These sections pass through culverts, have multiple storm water outlets are straightened and a riparian buffer less than 5 meters.

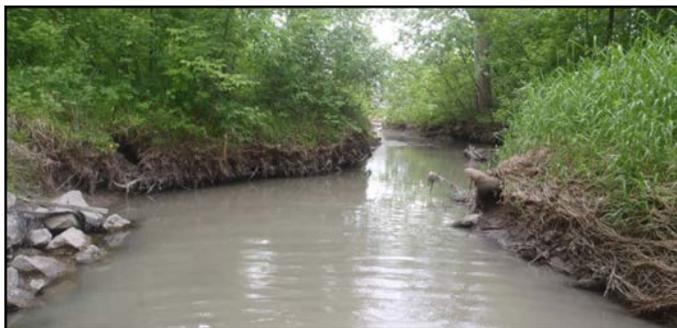
Erosion was observed in 50 percent of the surveyed portions of Taylor Creek. The majority of these sections showed low levels of erosion. Higher levels of erosion were observed downstream of Highway 174 and downstream of Princess Louise Falls at St. Joseph Blvd.

Bank erosion observations along Taylor Creek

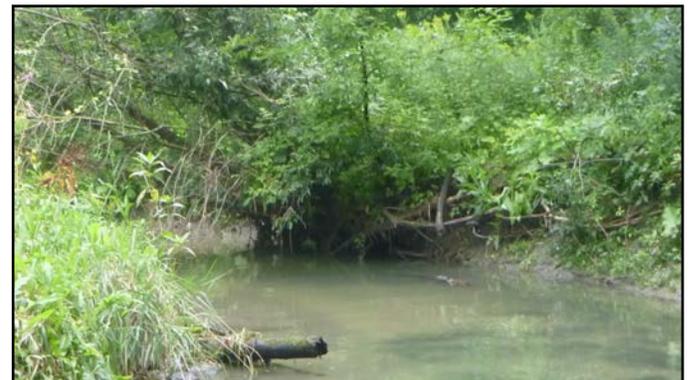
Figure 7 shows that undercut banks were present in over half of the sections surveyed in Taylor Creek. Sixty-four percent of the sections had undercutting in the left bank and 57 percent of the right bank.

Undercutting along Taylor Creek

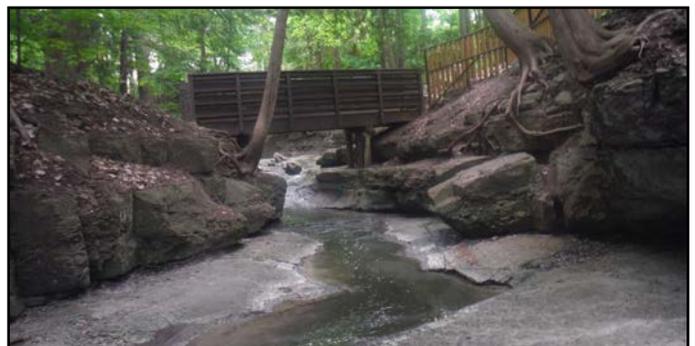
Section of Taylor Creek with no vegetation due to bedrock substrate

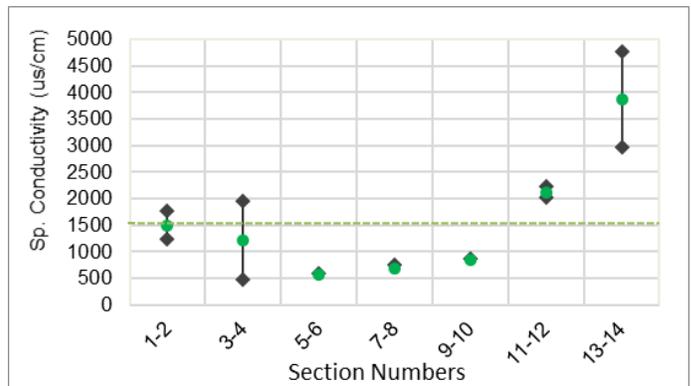
Figure 23 Conductivity ranges along sections of Taylor Creek

Figure 23 shows specific conductivity levels in Taylor Creek, the average level is depicted by the dashed line (1546 $\mu\text{S}/\text{cm}$). Notable variability was observed in the upper reaches of the creek from downstream of St. Joseph Blvd. to Princess Louise Drive (sections 11-14).

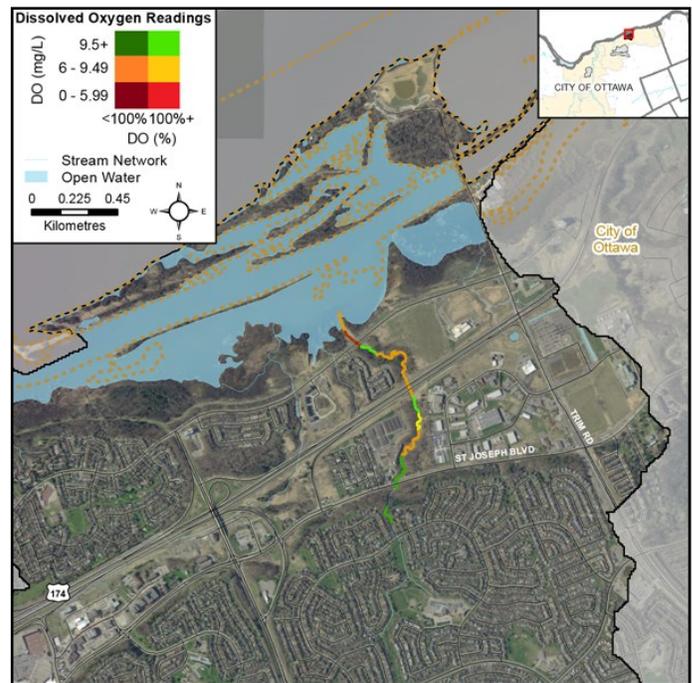
Figure 25 Bivariate assessment of dissolved oxygen concentration (mg/L) and saturation (%) along Taylor Creek

Figure 25 shows the oxygen conditions across the areas that were surveyed in 2018. Overall dissolved oxygen conditions in Taylor Creek are sufficient to sustain warm-water biota in areas near the confluence to the Ottawa River, downstream of Highway 174 and between Highway 174 and St. Joseph Blvd. Sections downstream of Jeanne D'Arc Blvd., shown in dark red Figure 25, have levels of impairment both in concentration and percent saturation. These areas have wetland features that have naturally lower oxygen levels, however these can be further limited by extensive vegetation growth of invasive species, and anthropogenic nutrient input. In the upper reaches near Princess Louise Falls and upstream of Highway 174, there are conditions sufficient to support cold-water biota. These areas are shaded and contain riffle habitat that is conducive to oxygenation.

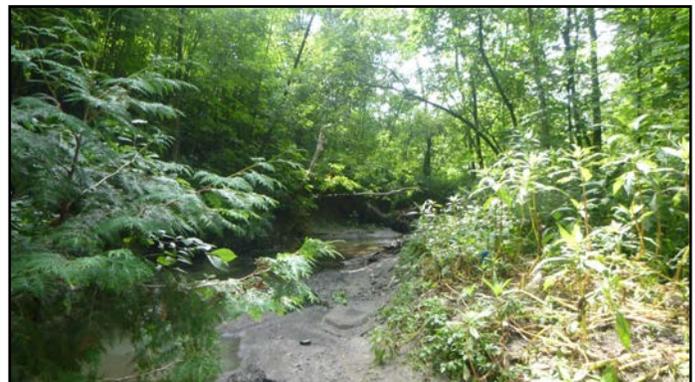
Site on Taylor Creek with **optimal** oxygen conditions (Dissolved oxygen levels of 10.17 mg/L and 100.6% saturation)

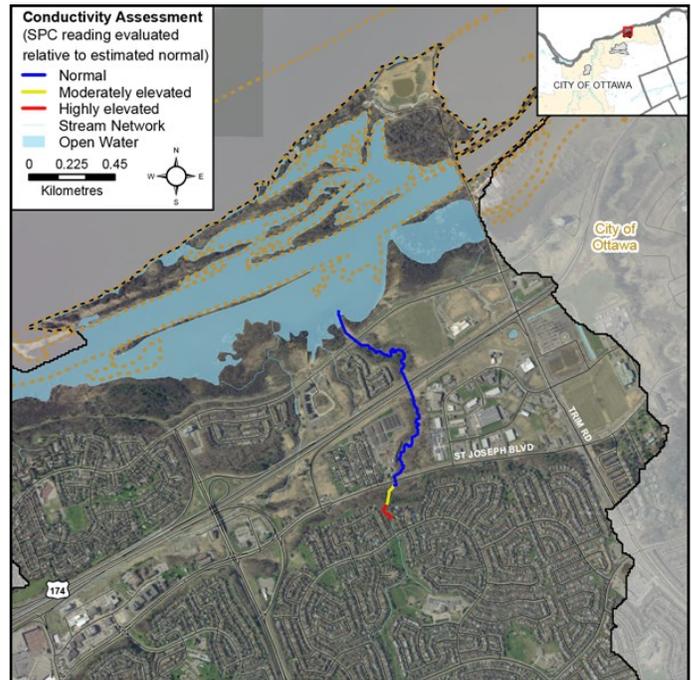
Figure 26 Relative specific conductivity levels along Taylor Creek

Figure 26 shows relative specific conductivity levels in Taylor Creek. Normal levels were maintained for most of the surveyed portions. Moderately elevated conditions were observed upstream of the waterfall where there is high levels of input from stormwater. Highly elevated conditions were present in the upper reaches of the creek, directly downstream of a stormwater outlet that feeds the creek.

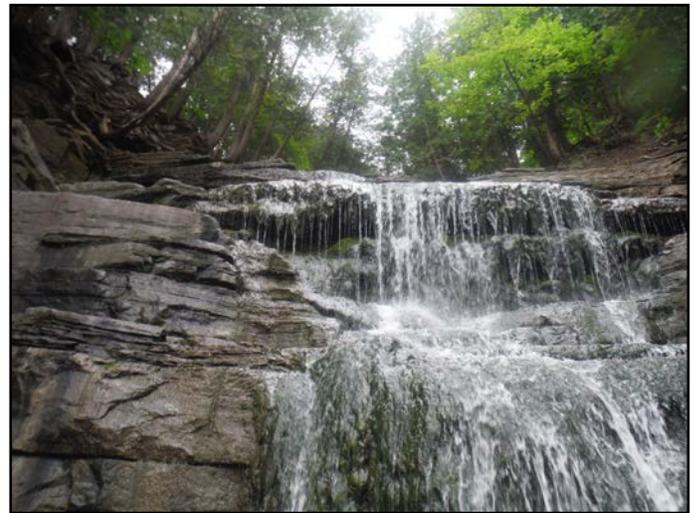
Princess Louise Falls, a natural grade barrier on Taylor Creek

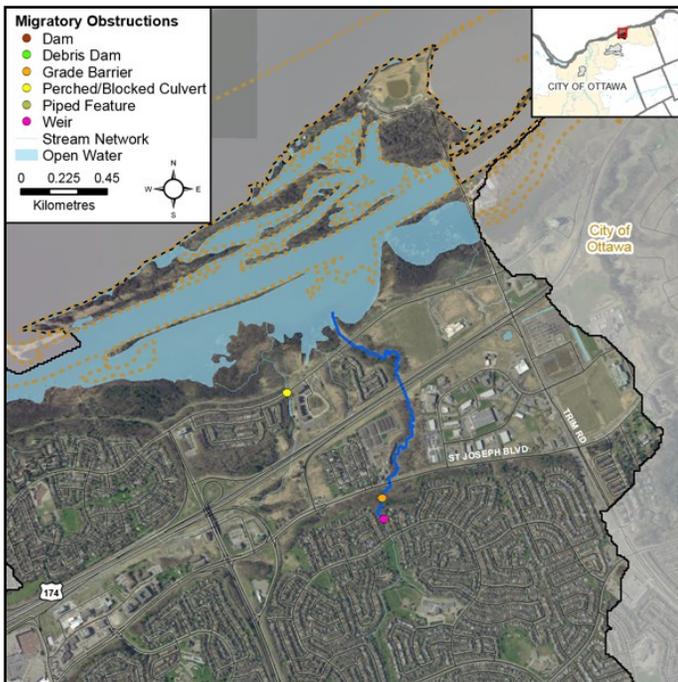
Figure 31 Locations of migratory obstructions along Taylor Creek

There is a natural grade barrier in Taylor Creek which results in the Princess Louise Falls, a small waterfall downstream of Princess Louise Dr. There is also a weir just upstream of the waterfall, directing stormwater flow downstream. There was also a perched culvert observed during headwater drainage feature assessments. The locations of migratory obstructions observed during headwater drainage feature assessment and stream surveys in 2018 are shown in Figure 31.

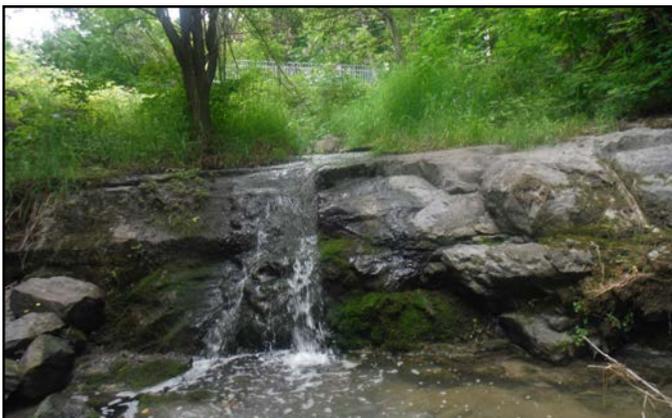
Natural grade barrier observed along Taylor Creek

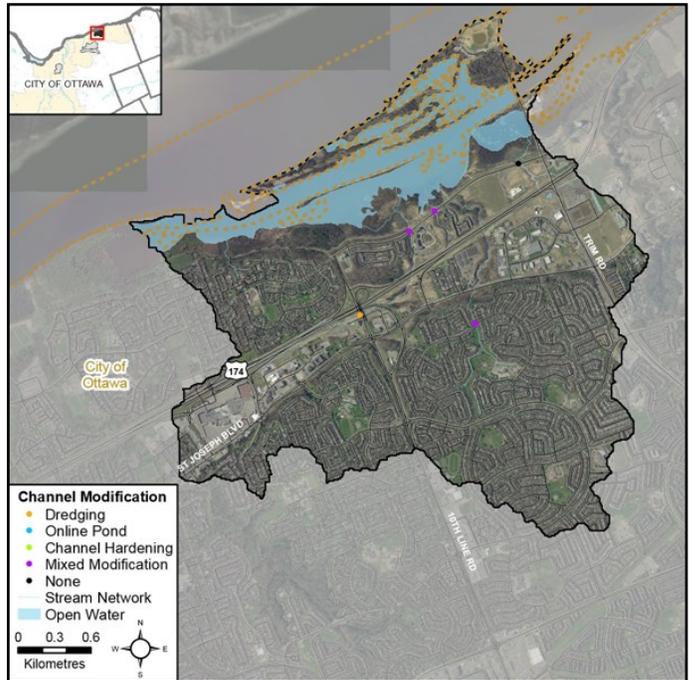
Figure 35 Headwater feature channel modifications in the Taylor Creek catchment

Figure 35 shows channel modifications observed in Taylor Creek headwater drainage features. Most modifications in this catchment for headwater drainage features are mixed modifications. These features were mixed between dredging and hardening. In one case, this also included an upstream online stormwater pond.

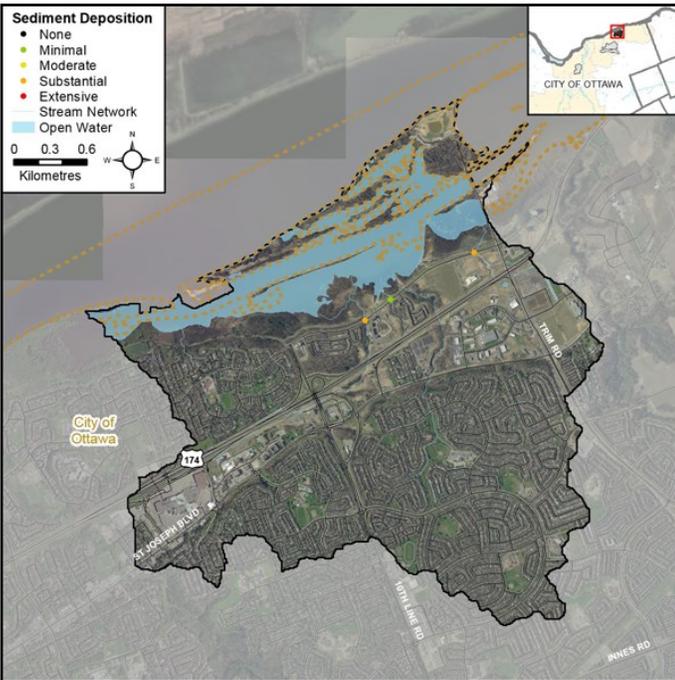
Figure 38 Headwater feature sediment deposition in the Taylor Creek catchment

From the upstream features assessed, sediment deposition ranged from minimal to substantial. One feature had evidence of minimal deposition and two had substantial levels. Two sites were not measured, one had site access restrictions. Figure 38 shows the levels of sediment deposition in the catchment.

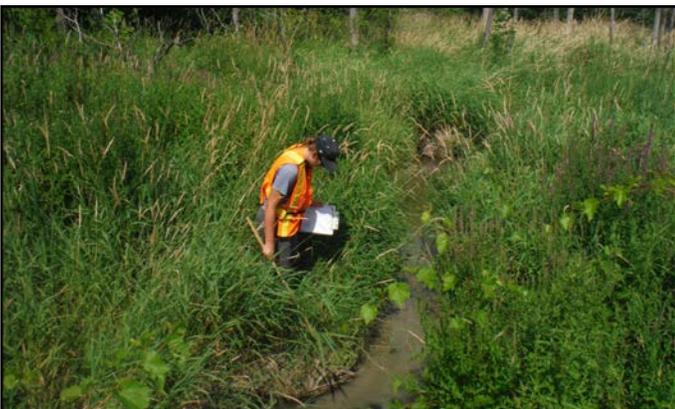
Headwater drainage feature site with substantial level of sediment deposition off Jeanne D'Arc Boulevard

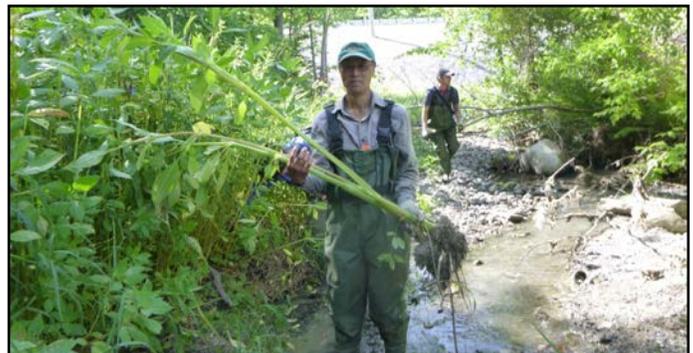
Invasive Himalayan balsam plant on Taylor Creek

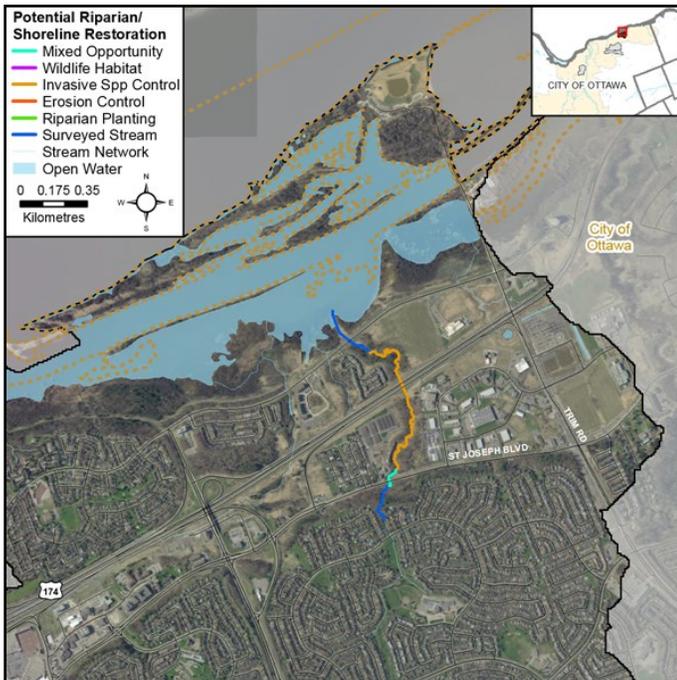
Figure 40 Potential riparian/shoreline restoration opportunities along Taylor Creek

These sections show potential for multiple restoration opportunities. This includes invasive species control, and erosion control directly downstream of the Princess Louise Falls.

Riparian restoration opportunities were assessed in the field and include potential enhancement through riparian planting, erosion control, invasive species management and/or wildlife habitat creation (Figure 40).

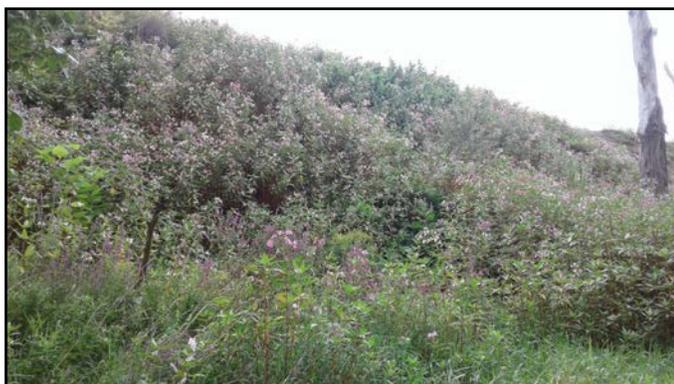
Area dominated by Himalayan balsam that would benefit from invasive species control

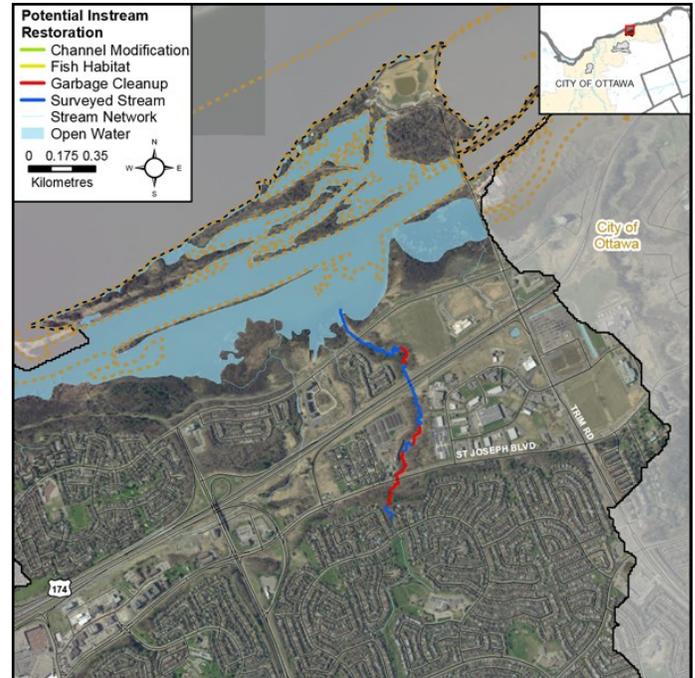
Figure 41 Potential instream restoration opportunities in Taylor

Taylor Creek would benefit from a garbage clean up in the areas shown in Figure 41. Pollution is likely due to stormwater input upstream of the creek. The system can benefit from more frequent stream and shoreline cleanups along the highlighted areas in Figure 41.

Garbage clean up
