# Hunt Club Creek 2019 Catchment Report

## Introduction

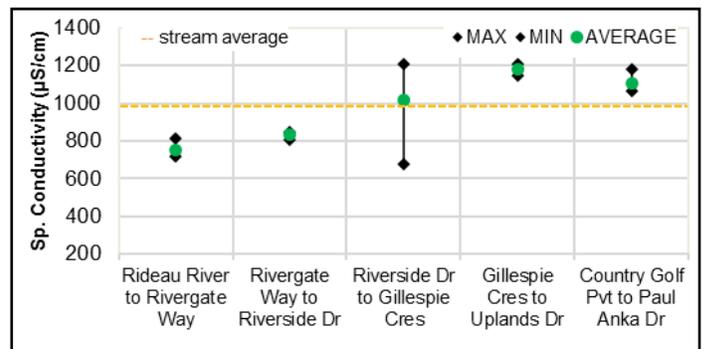
Figure 23 Specific Conductivity ranges along surveyed sections of Hunt Club Creek

Figure 23 shows specific conductivity levels in Hunt Club Creek, the average level is depicted by the dashed line (985.2  $\mu\text{S}/\text{cm}$ ). Conductivity levels are lower in areas approaching the confluence with the Rideau River. Higher levels were observed in the upper sections of the creek. An increase is observed from Riverside Crescent, as land use changes from the McCarthy Woods to residential areas with unmitigated storm water.

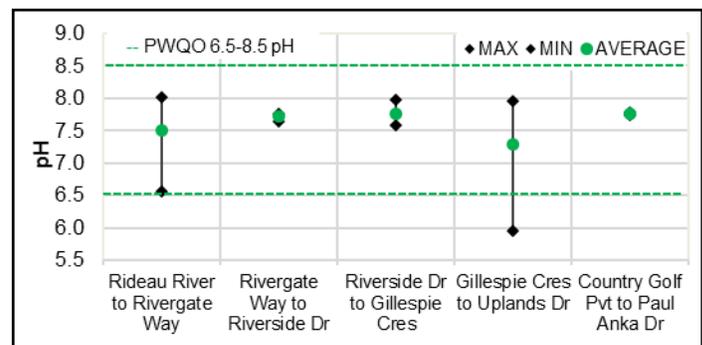
Figure 24 pH ranges along surveyed sections of Hunt Club Creek

Figure 24 shows Hunt Club Creek had mostly pH levels that meet the PWQO. Across the system average pH was 7.62.

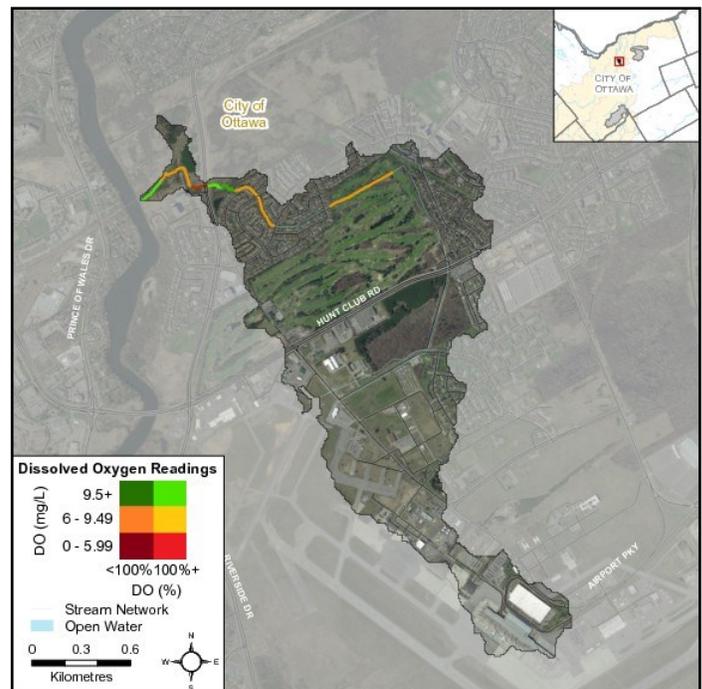
**Figure 25** Bivariate assessment of dissolved oxygen concentration (mg/L) and saturation (%) along Hunt Club Creek

Figure 25 shows the oxygen conditions across the areas that were surveyed in 2019. Dissolved oxygen conditions in Hunt Club Creek were sufficient to sustain cold and warm-water biota. In areas near the confluence to the Rideau River, and just upstream of Riverside Drive, there were high levels of dissolved oxygen concentration and saturation. Near the confluence, there was a series of bedrock formations and waterfalls that allowed water to be well oxygenated. Sections shown in dark red and orange in Figure 25, had lower levels both in concentration and percent saturation. Some of these areas had wetland features that have naturally lower oxygen levels downstream of Riverside Drive. However dissolved oxygen levels can be further limited by anthropogenic input, as seen in residential areas and through the golf course.

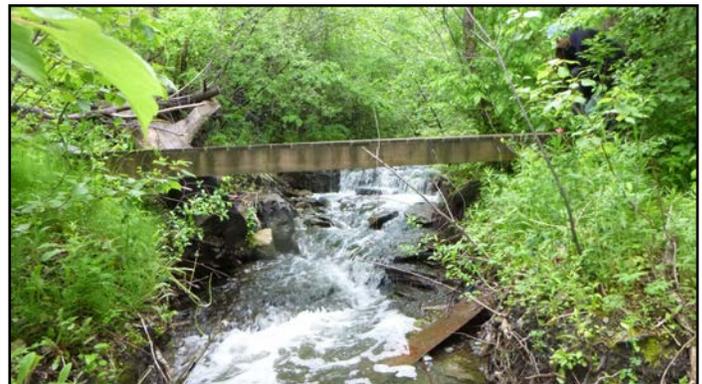
Section on Hunt Club Creek at the confluence with the Rideau River with **optimal** oxygen conditions for cold-water biota (Dissolved oxygen levels of 10.5 mg/L and 100.0 % saturation)

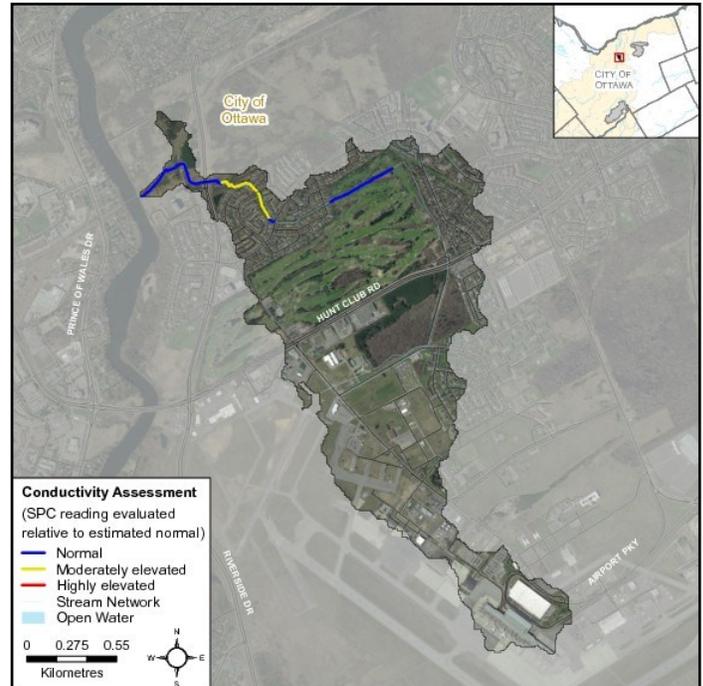
**Figure 26** Relative specific conductivity levels along Hunt Club Creek

Average levels of specific conductivity measured in the surveyed portions of Hunt Club Creek (985.2 µS/cm) were above guidelines (500 µS/cm) used for the Canadian Environmental Performance Index (Environment Canada 2011).

Figure 26 shows relative specific conductivity levels in Hunt Club Creek. Normal levels were maintained for most of the surveyed portions. Moderately elevated conditions were observed from Uplands Road to Gillespie Crescent. This area is highly urbanized and was upstream of the stormwater management pond. The creek receives unmitigated stormwater in this location. Treatment within the pond enables the system to regain a lower conductivity level downstream of Riverside Drive.

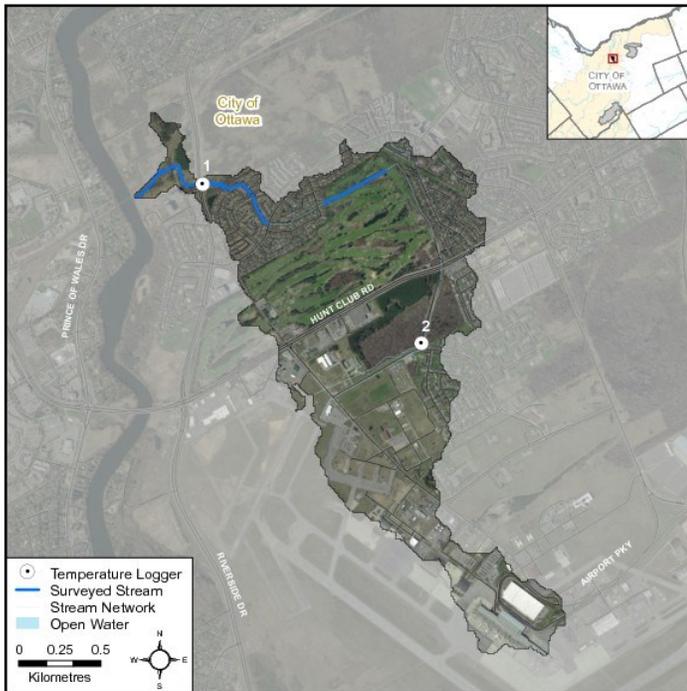
Figure 27 Temperature logger locations on Hunt Club Creek

Figure 27 shows where thermal sampling sites were located. Due to instrument malfunction, only data from one logger at Riverside Drive (#1) was retrieved. Analysis of data from one logger (using the Stoneman

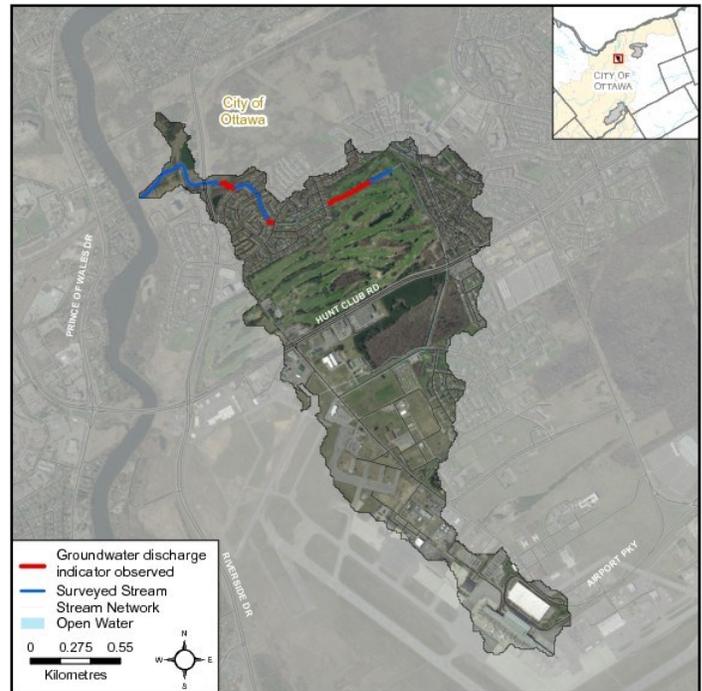
Figure 29 Groundwater indicators observed in Hunt Club Creek

Groundwater discharge areas can influence stream temperature, contribute nutrients, and provide important stream habitat for fish and other biota. During stream surveys and HDF assessments, indicators of groundwater discharge were noted when observed (Figure 29). Indicators included: springs/seeps, watercress, iron staining, significant temperature changes and rainbow mineral film.

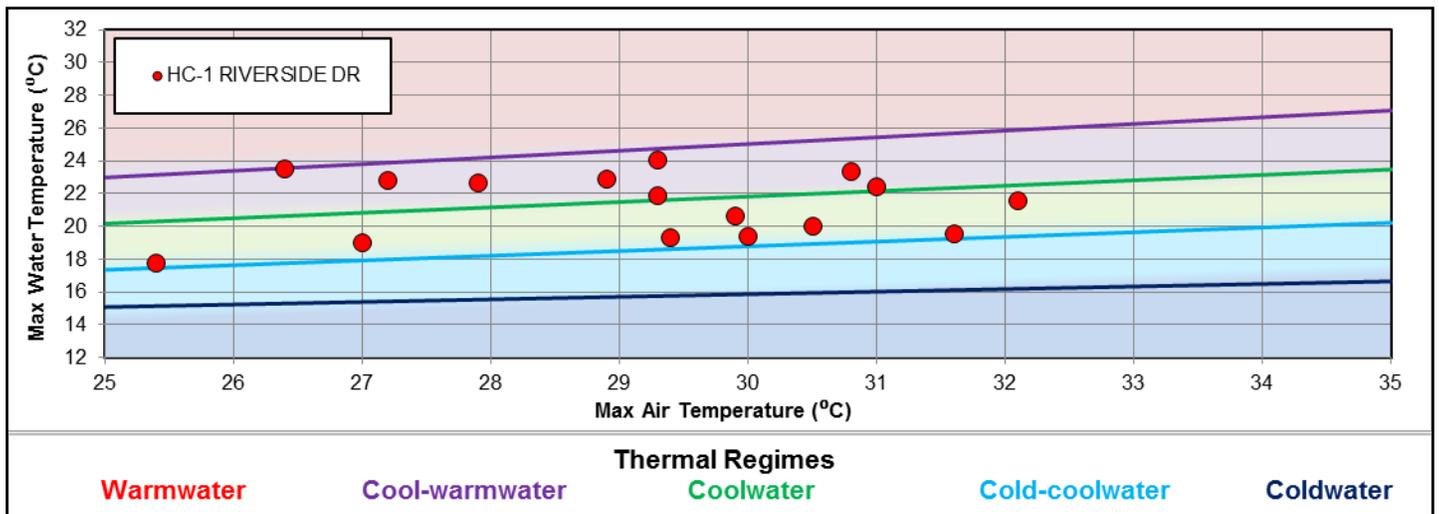
Figure 28 Thermal Classification for Hunt Club Creek with the five thermal regimes adapted from Stoneman and Jones (1996) by Chu et al. (2009): **coolwater** category for one site sampled on Hunt Club Creek

and Jones, 1996, method adapted by Chu et al., 2009), indicated Hunt Club Creek was classified as **coolwater** at the Riverside Drive location (Figure 28). Fish species observed in that area have thermal preferences from warm to cool as indicated by Cocker et al. (2001).

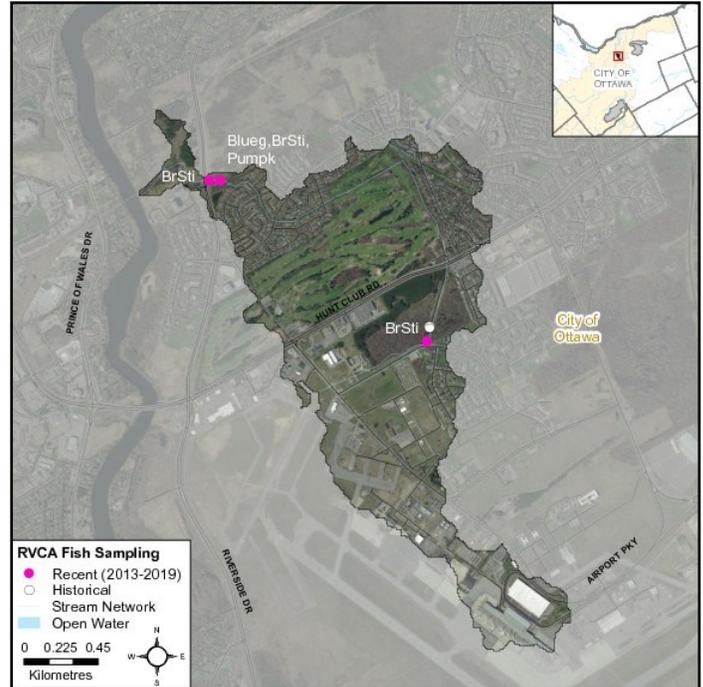
**Figure 30** Hunt Club Creek fish sampling locations and fish species observations from 2013 - 2019

Three species were captured in 2019, they are listed in Table 2 along with their thermal classification preferences (Coker et al., 2001) and MNR species codes. Hunt Club Creek had a mixed fish community ranging from cool to warm water species. The sampling locations where these species were observed, as well as RVCA historical sites, are depicted in Figure 30. The codes used in the figure are the MNR species codes provided in Table 2. For comparisons across sampling years and a complete list of RVCA historical fish records from Hunt Club Creek refer to page 18 of this report.

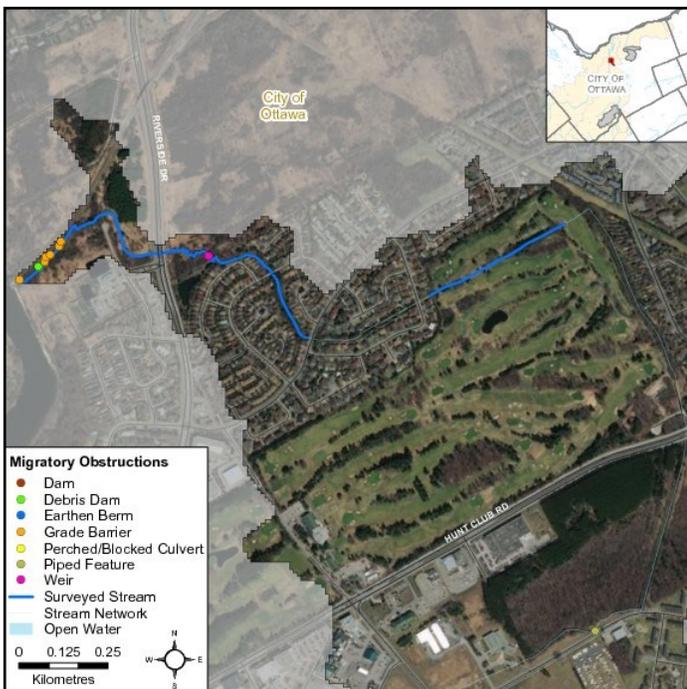
**Figure 31** Locations of migratory obstructions along Hunt Club Creek catchment

The locations of ten migratory obstructions observed in the surveyed portion of Hunt Club Creek are shown in Figure 31. Most of the obstructions on Hunt Club Creek are natural, they are grade barriers formed from bedrock. Upstream of Riverside Drive the obstructions are caused by anthropogenic changes in the features, including piping of headwater reaches and the weir in the main channel as part of the stormwater management facility.

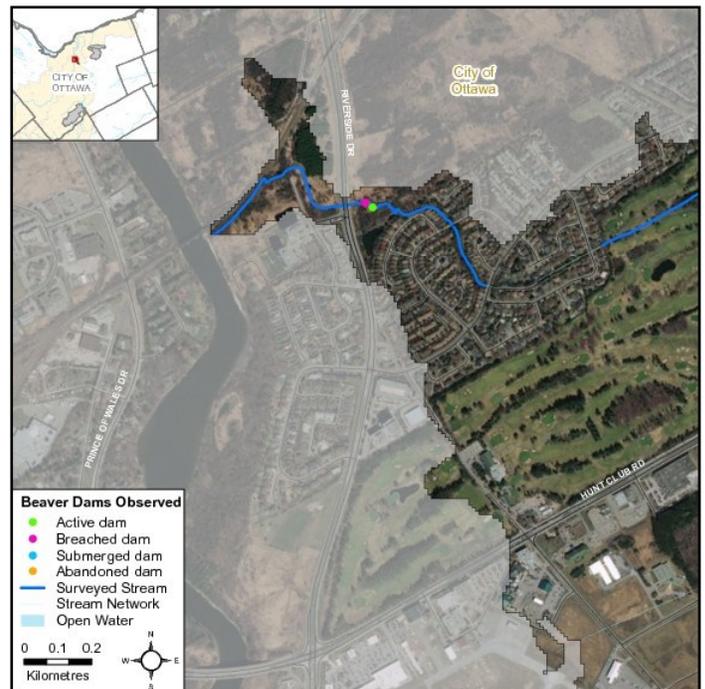
**Figure 32** Locations of beaver dams along Hunt Club Creek

In 2019 two beaver dams were identified on the surveyed portions of Hunt Club Creek and are shown in Figure 32.

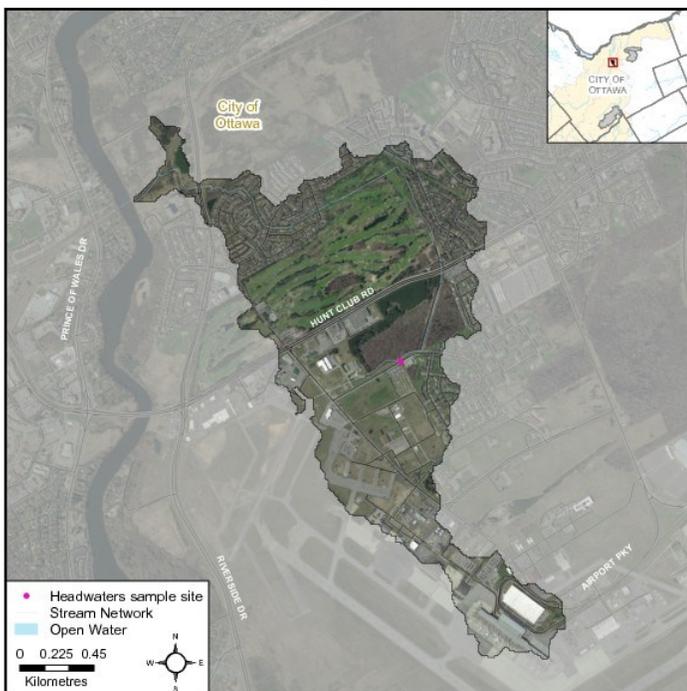
**Figure 33** Location of headwater drainage feature sampling site in the Hunt Club Creek catchment

Features were evaluated as per the Ontario Stream Assessment Protocol (OSAP, 2019). This protocol measures zero, first and second order headwater drainage features. It is a rapid assessment method characterizing the amount of water, sediment transport, and storage capacity within headwater drainage features. In 2019 one HDF site was assessed in the Hunt Club Creek Catchment (Figure 33).

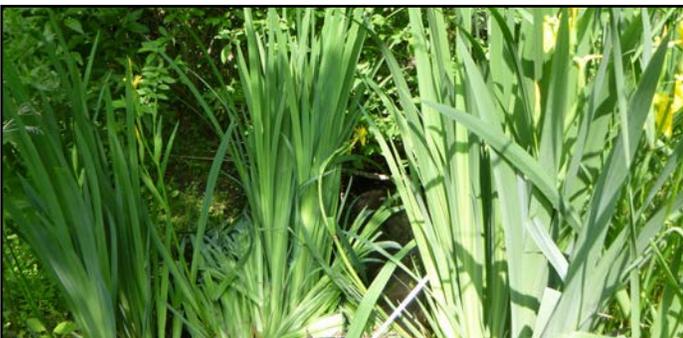
Narrow-leaved emergent, robust emergent and submerged plants present along Hunt Club Creek at Riverside Drive
