# Taylor Creek 2012 Summary Report

As part of the City Stream Watch monitoring activities in 2012, 17 sections along Taylor Creek were surveyed by staff and volunteers. The following is a summary of the 17 macro stream assessments carried out on Taylor Creek.

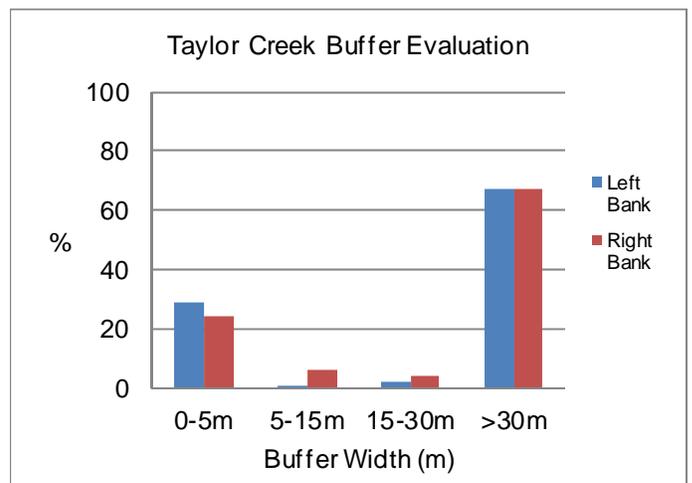
Figure 2. Vegetated buffer width along Taylor Creek

The riparian or shoreline zone is that special area where the land meets the water. Well-vegetated shorelines are critically important in protecting water quality and creating healthy aquatic habitats, lakes and rivers. Natural shorelines intercept sediments and contaminants that could impact water quality conditions and harm fish habitat in streams. Well established buffers protect the banks against erosion, improve habitat for fish by shading and cooling the water and provide protection for birds and other wildlife that feed and rear young near water. A recommended target (from Environment Canada’s Guideline: *How Much Habitat is Enough?*) is to maintain a minimum 30 meter wide vegetated buffer along at least 75 percent of the length of both sides of rivers, creeks and streams. Figure 2 demonstrates the buffer conditions on Taylor Creek for the left and right banks separately. Results show that 67 percent of both the left and right bank of Taylor Creek has a buffer width greater than 30 meters.

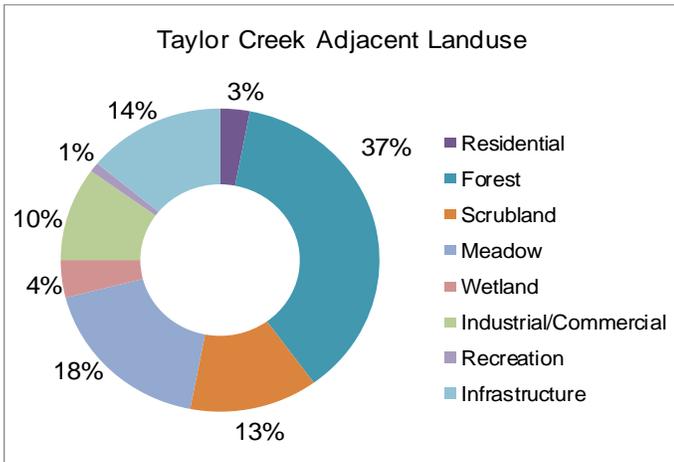
Figure 3. Landuse alongside Taylor Creek

Figure 3 demonstrates the eight different land uses identified along the banks adjacent to Taylor Creek. Surrounding land use is considered from the beginning to end of the survey section (100 metres) and up to 100 metres on each side of the creek. Land use outside of this area is not considered for the surveys but is nonetheless part of the subwatershed and will influence the creek. Natural areas made up 72 percent of Taylor Creek, characterized by forest, scrubland meadow and wetland. The remaining land use consisted of residential, infrastructure, recreation, and industrial/commercial.

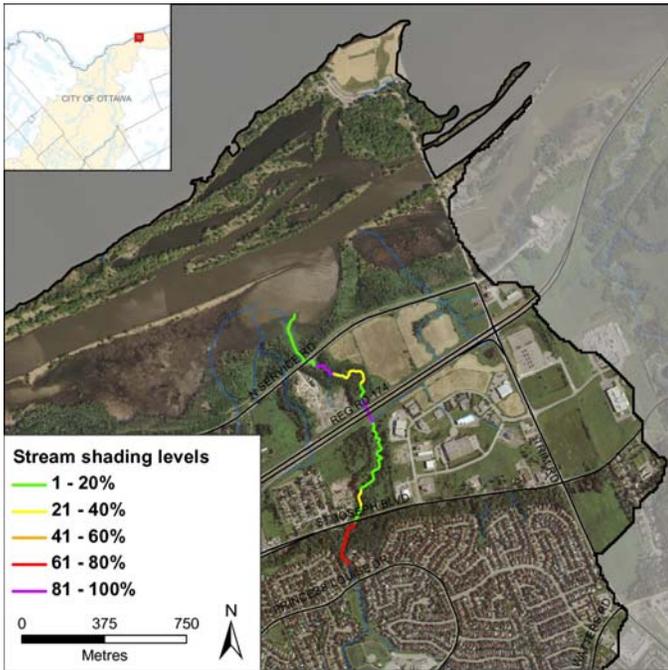
Figure 6. Stream shading along Taylor Creek

Grasses, shrubs and trees all contribute towards shading a stream. Shade is important in moderating stream temperature, contributing to food supply and helping with nutrient reduction within a stream. Figure 6 shows the varying degrees of stream shading along Taylor Creek.

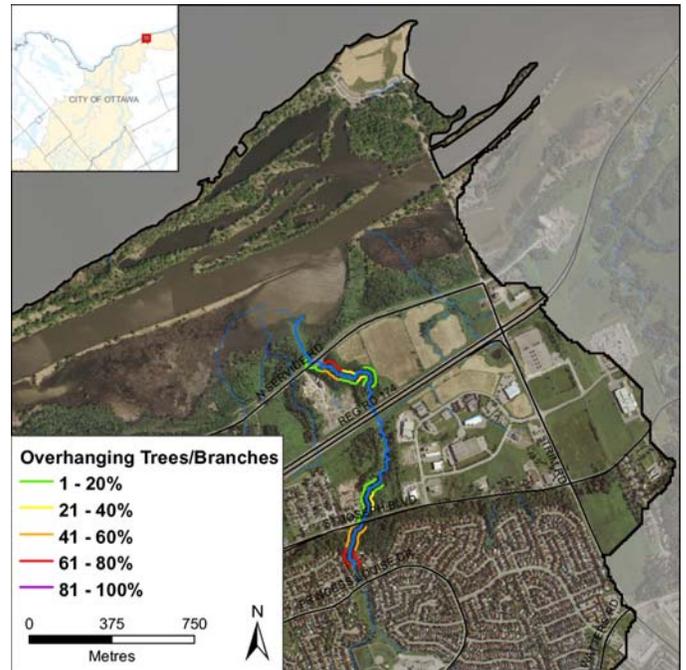
Figure 8. Overhanging trees and branches

Figure 8 shows that although there are some sections of the creek with no overhanging trees and branches, the majority of Taylor Creek has varying levels of overhanging branches and trees. Overhanging branches and trees provide a food source, nutrients and shade which helps to moderate instream water temperatures.

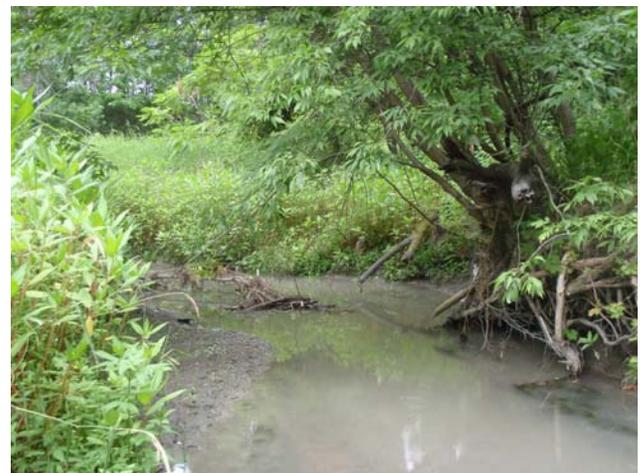
Photo 1. Overhanging trees and branches on Taylor Creek

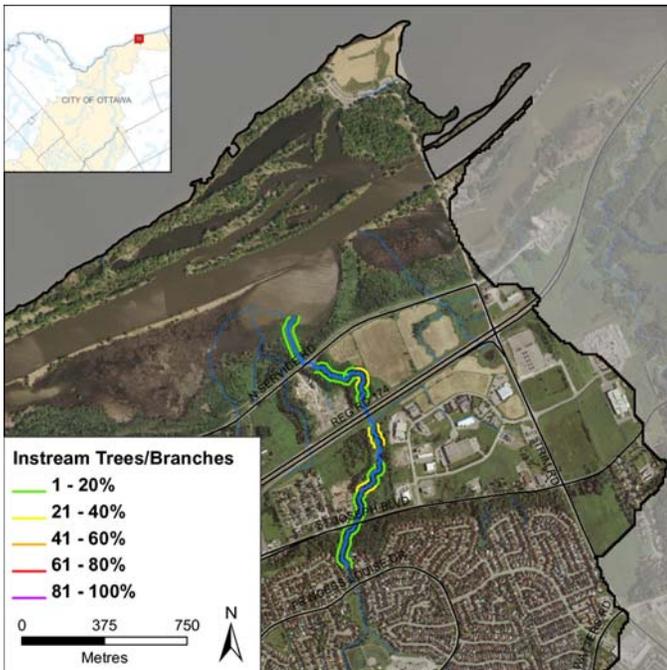
Figure 9. Instream trees and branches

Figure 9 shows that the majority of Taylor Creek has moderate to low levels of instream woody debris in the form of branches and trees. Instream woody debris is important for fish and benthic habitat, by providing refuge and feeding areas.

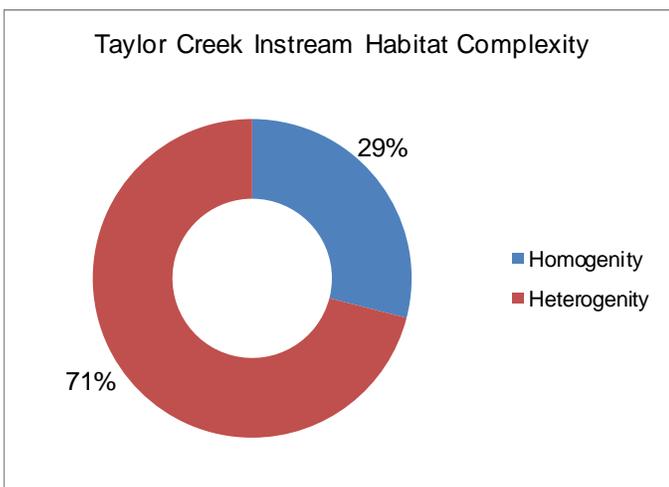
Figure 10. Instream habitat complexity in Taylor Creek

Streams are naturally meandering systems and move over time. As such, there are varying degrees of habitat complexity depending on the creek. A high percentage of habitat complexity (heterogeneity) typically increases biodiversity of aquatic organisms within a system. Seventy-one percent of Taylor Creek was considered heterogeneous as shown in Figure 10.

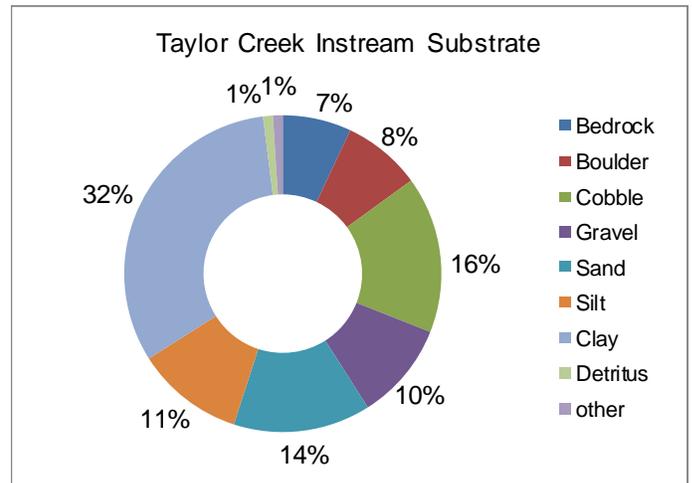
Figure 11. Instream substrate in Taylor Creek

Diverse substrate is important for fish and benthic invertebrate habitat because some species have specific substrate requirements and for example will only reproduce on certain types of substrate. Figure 11 demonstrates that the composition of the substrate in Taylor Creek is fairly diverse.

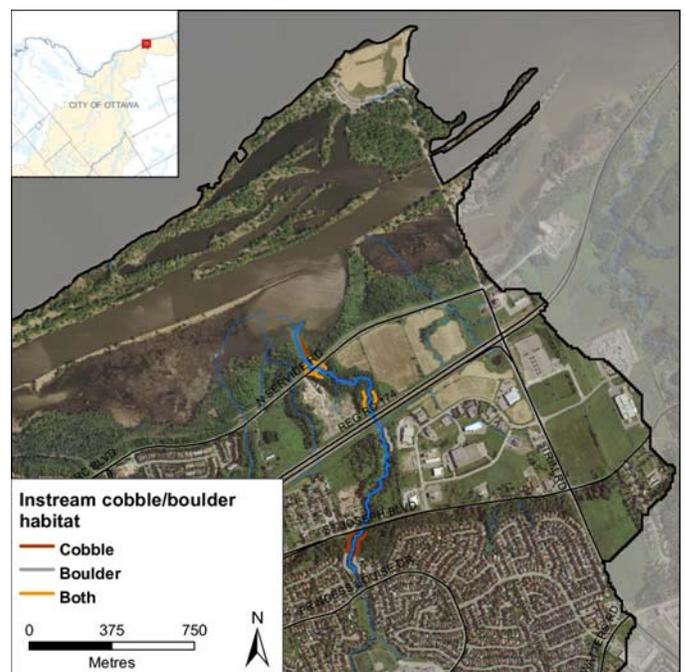
Figure 12. Cobble and boulder habitat along Taylor Creek

Boulders create instream cover and back eddies for large fish to hide and/or rest out of the current. Cobble provides important over wintering and/or spawning habitat for small or juvenile fish. Cobble can also provide habitat conditions for benthic invertebrates that are a key food source for many fish and wildlife species. Figure 12 shows various locations where cobble and boulder substrate is found in Taylor Creek.

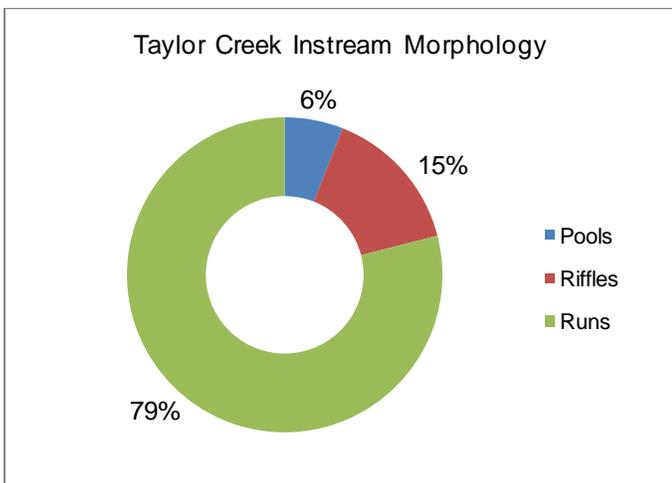
Figure 13. Instream morphology in Taylor Creek

Pools and riffles are important features for fish habitat. Riffles are areas of agitated water that contribute higher dissolved oxygen to the stream and act as spawning substrate for some species of fish, such as walleye. Pools provide shelter for fish and can be refuge pools in the summer if water levels drop and water temperature in the creek increases. Pools also provide important overwintering areas for fish. Runs are usually moderately shallow, with unagitated surfaces of water and areas where the thalweg (deepest part of the channel) is in the center of the channel. Figure 13 shows that Taylor Creek is somewhat complex; consisting of runs at 79 percent, riffles at 15 percent and pools at six percent.

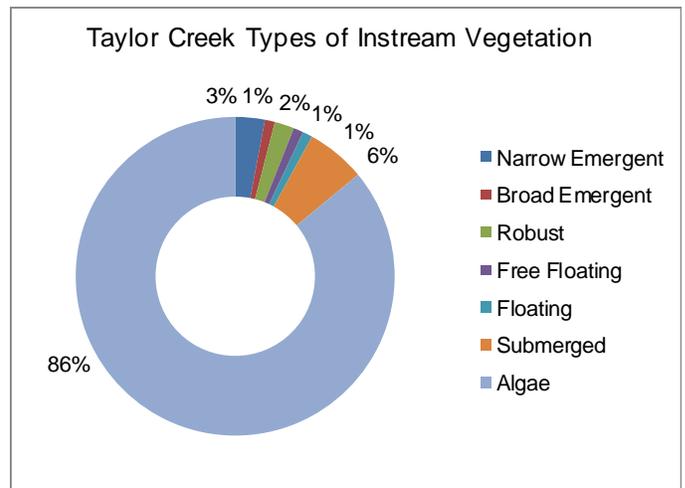
Figure 14. Instream vegetation types in Taylor Creek

Taylor Creek has very limited diversity of instream vegetation, as seen in Figure 14. The dominant vegetation type at eighty-six percent consisted of algae. A total of six percent of the vegetation community was recorded as submerged vegetation. Narrow emergent, robust emergent, broad emergent, free-floating and floating vegetation made up the remaining eight percent of the vegetation community.

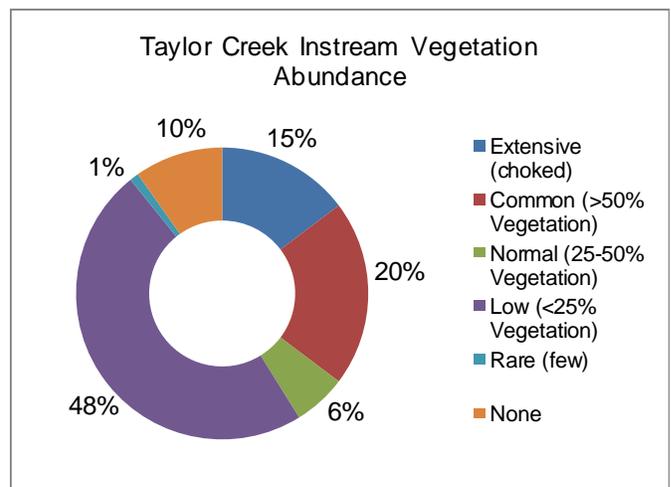
Figure 15. Vegetation abundance in Taylor Creek

Instream vegetation is an important factor for a healthy stream ecosystem. Vegetation helps to remove contaminants from the water, contributes oxygen to the stream, and provides habitat for fish and wildlife. Too much vegetation can also be detrimental. Figure 15 demonstrates the frequency of instream vegetation in Taylor Creek. Taylor Creek has varying levels of instream vegetation for most of its length. Forty-eight percent of the creek had low levels of vegetation, and eleven percent had rare or no vegetation. Twenty percent had common levels of vegetation and 15 percent of the creek had extensive levels of vegetation. The remaining six percent of the creek had normal levels of vegetation.

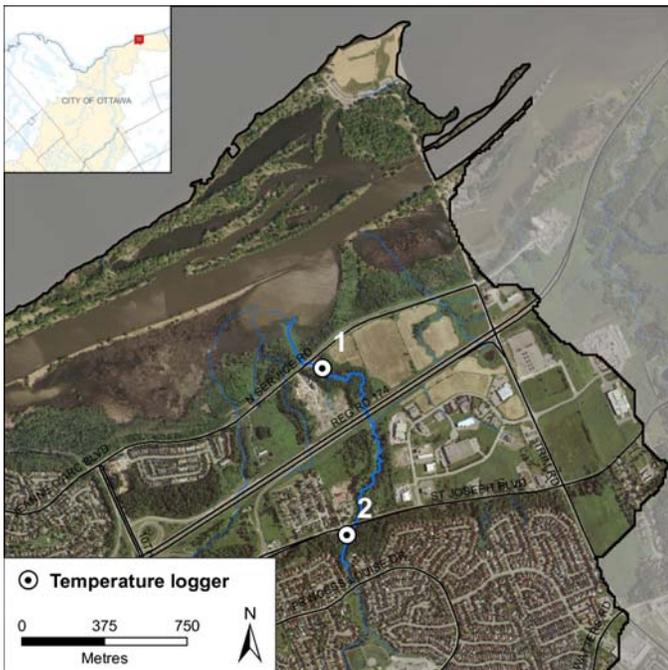
Figure 18. Temperature dataloggers along Taylor Creek

Temperature is an important parameter in streams as it influences many aspects of physical, chemical and biological health. Figure 18 shows where two temperature dataloggers were deployed in Taylor Creek from April to late September 2012 to give a representative sample of how water temperature fluctuates. Unfortunately the temperature datalogger that was installed near St. Joseph boulevard was taken over the course of the season so temperature data was only available for the site close to Service road.

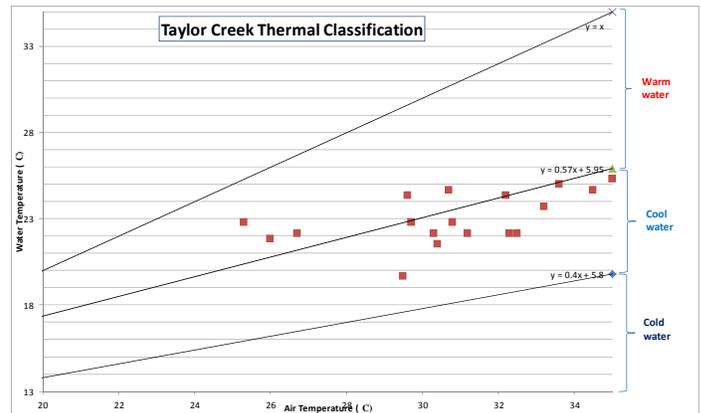
Figure 19. Thermal Classification for Taylor Creek

Many factors can influence fluctuations in stream temperature, including springs, tributaries, precipitation runoff, discharge pipes and stream shading from riparian vegetation. Water temperature is used along with the maximum air temperature (using the Stoneman and Jones method) to classify a watercourse as either warmwater, coolwater or cold water. Figure 19 shows the thermal classification of Taylor Creek. Analysis of the data collected indicates that Taylor Creek is a coolwater system.

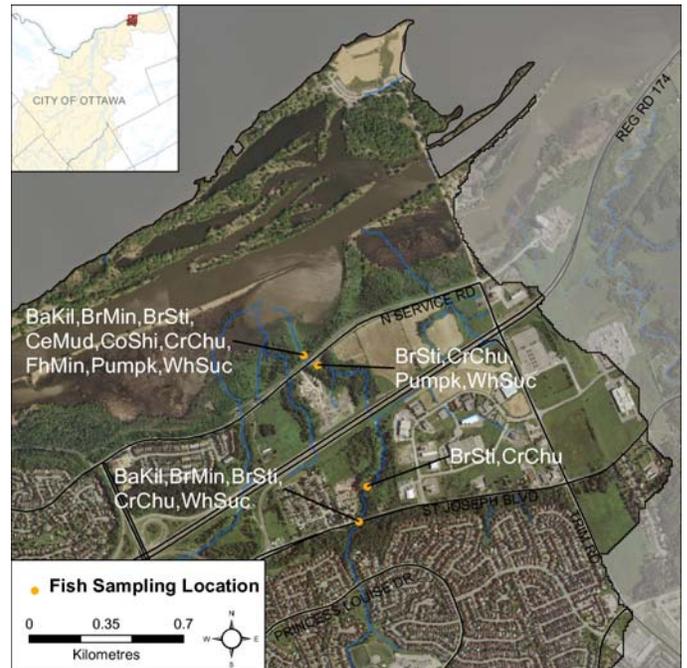
Figure 20. Fish species observed in Taylor Creek

Fish sampling sites located along Taylor Creek are shown in Figure 20. Fish sampling was conducted by the Rideau Valley Conservation Authority and the City of Ottawa. The provincial fish codes shown on the map are listed (in Table 6) beside the common name of those fish species identified in Taylor Creek.

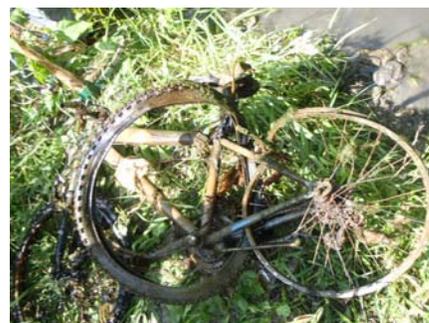
Overall the amount of pollution and garbage in Taylor Creek has increased since 2007. Table 11 shows that in 2007, 13 percent of the stream was free of garbage. In 2012 there was garbage recorded in 100 percent of the stream. The amount of floating garbage and garbage on the stream bottom has also increased since 2007.

Photo 7. A bicycle that was removed from the creek bottom during the 2012 Taylor Creek stream cleanup

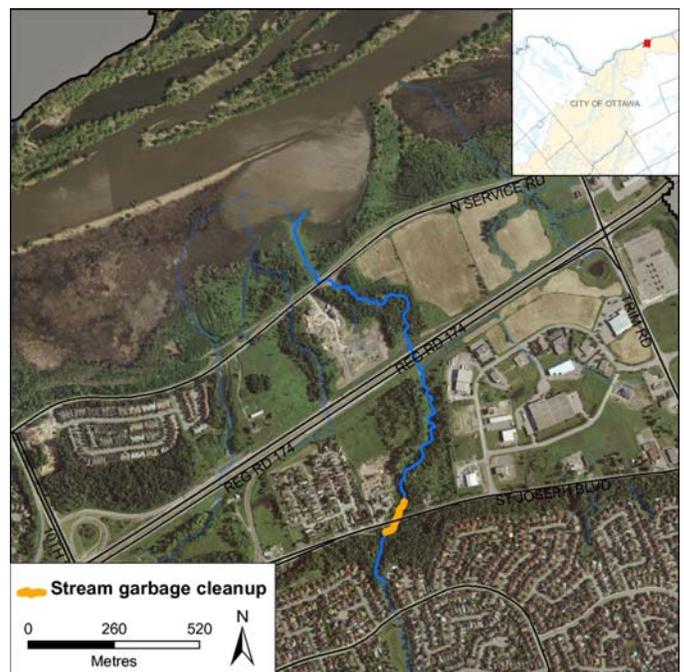
Figure 22. Location of the 2012 Taylor Creek stream cleanup

This year City Stream Watch returned to clean up the area around Princess Louise Falls on Taylor Creek. In late July volunteers and CSW staff cleaned from north of St. Joseph Boulevard to the falls. This section of the stream becomes heavily polluted as debris of human origin accumulates at the base of the falls. Ten volunteers turned out and put in 28 hours of work to help ensure that Princess Louise Falls remains healthy and beautiful for everyone to enjoy. A cleanup is recommended on an annual basis at this site.
